**Re: Environmental Sampling Report for
262 Van Brunt Street
Brooklyn, New York
Site Visit: July 20, 2005**

JCB#: 05-8257

**Environmental Sampling at
262 Van Brunt Street
Brooklyn, New York**

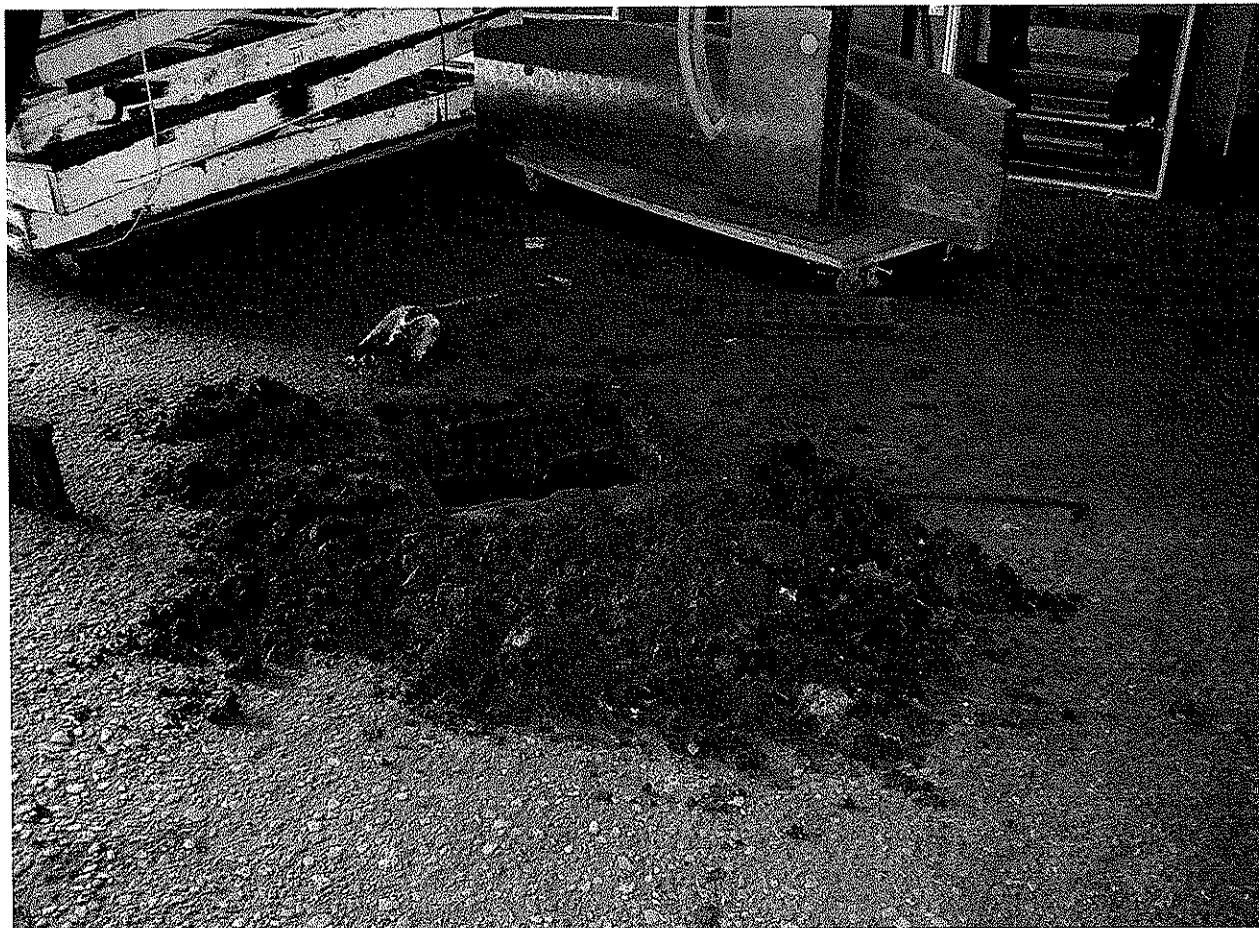
Photo No. 02

**Typical Floor Drain With Grated Cover Removed
Material Removed To Access Drain Pipe**

Each accessible floor drain was inspected to the extent possible with the SeeSnake and also by an owner's representative. The drains were determined to lead to a sewer clean-out which then discharged out of the building toward the municipal sewer system. Therefore, based upon this investigation it is expected that the observed floor drains are attached to the municipal sewer system and do not discharge into an on-site injection well.

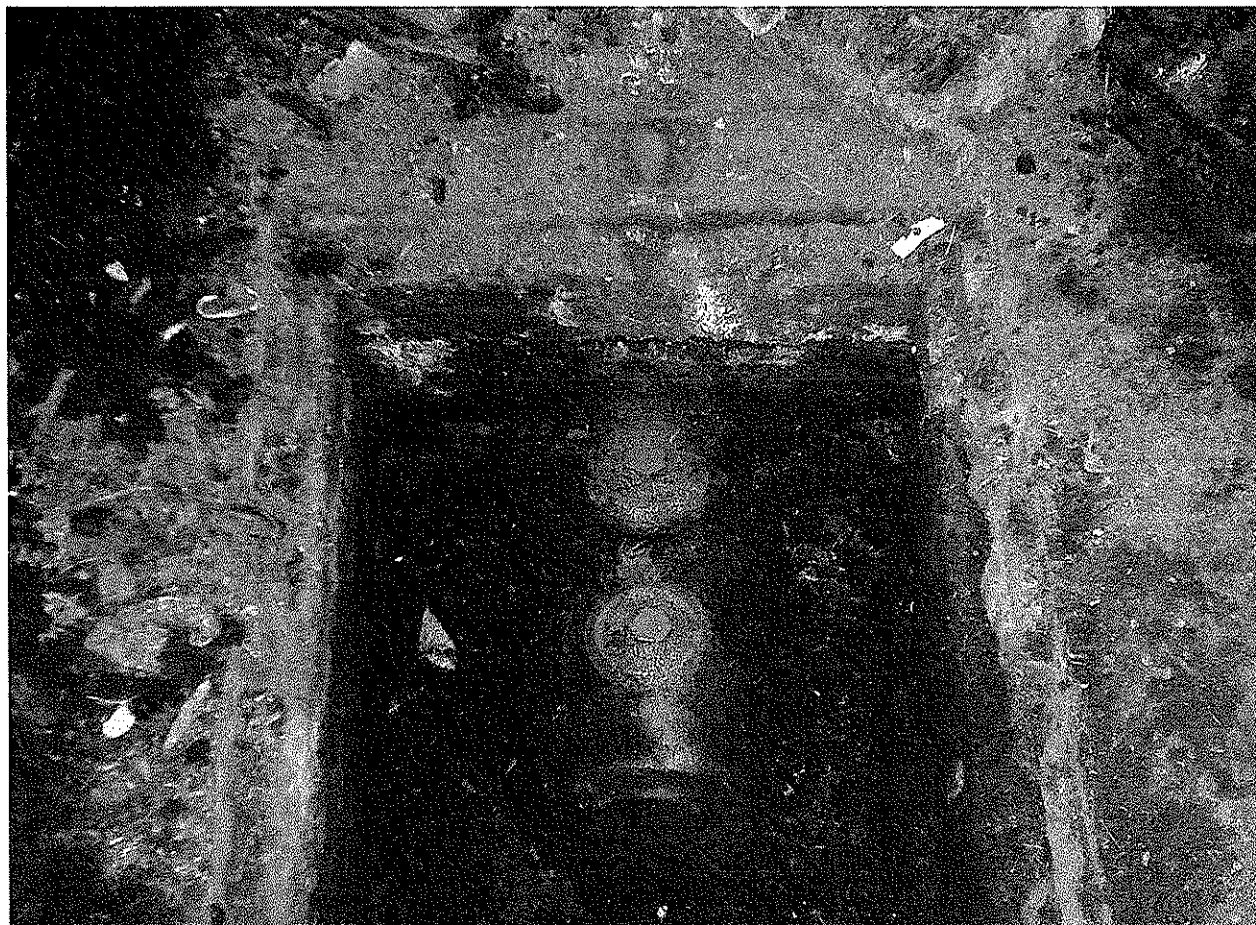
Photo No. 03

**Typical Floor Drain With Grated Cover Removed
Drain Pipe (Green Paint)**

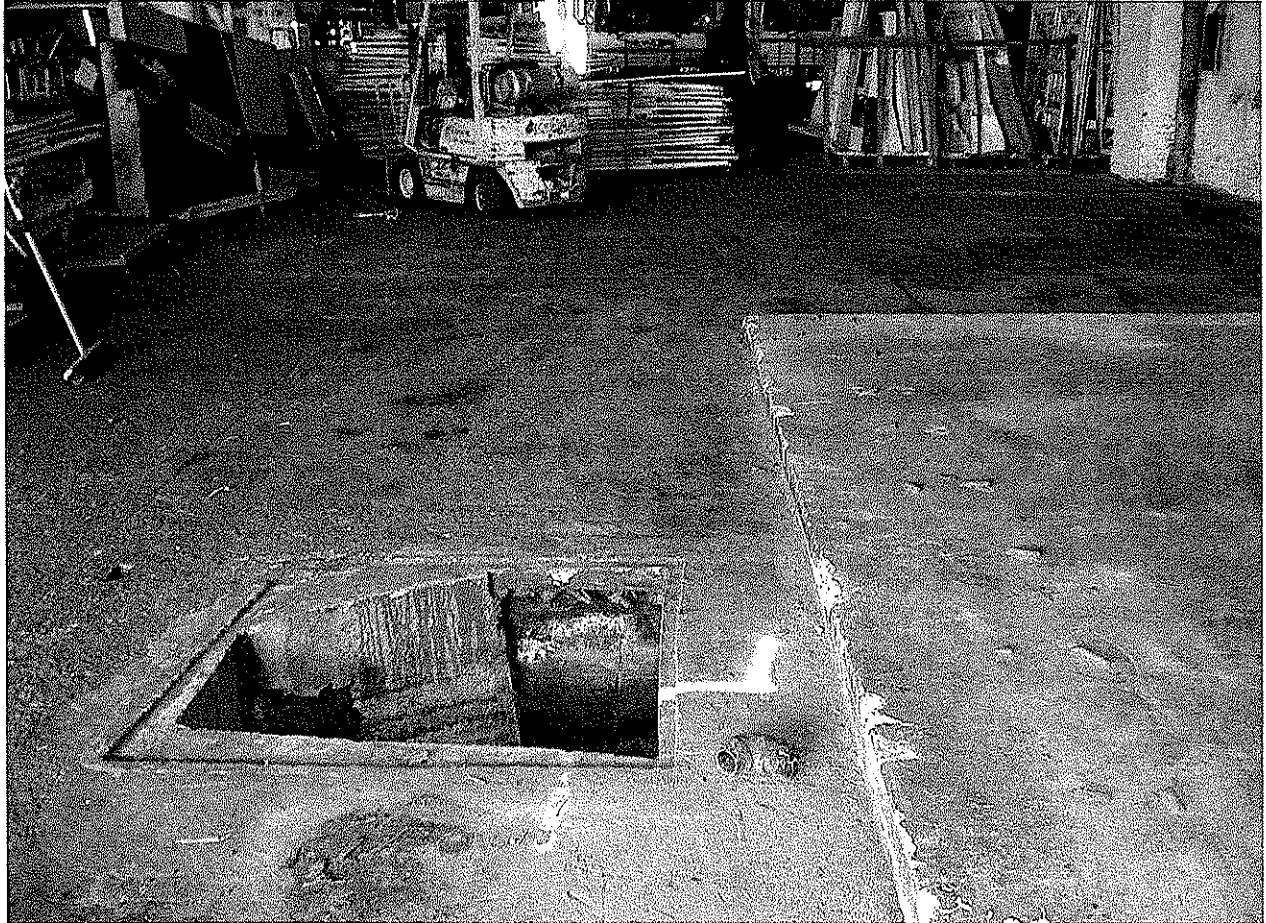
Photo No. 04

The concrete oil-water separator tank was pumped and cleaned for inspection by the property representative. Subsequent to the cleaning JCB performed a visual inspection of the concrete oil-water separator tank for any evidence of an adverse impact to the subject property. The inspection revealed the tank had concrete walls and bottom and revealed no evidence of any significant leaks.

**Oil-Water Separator With Cover Removed
Fuel Oil Fill Pipe (Yellow Paint)**

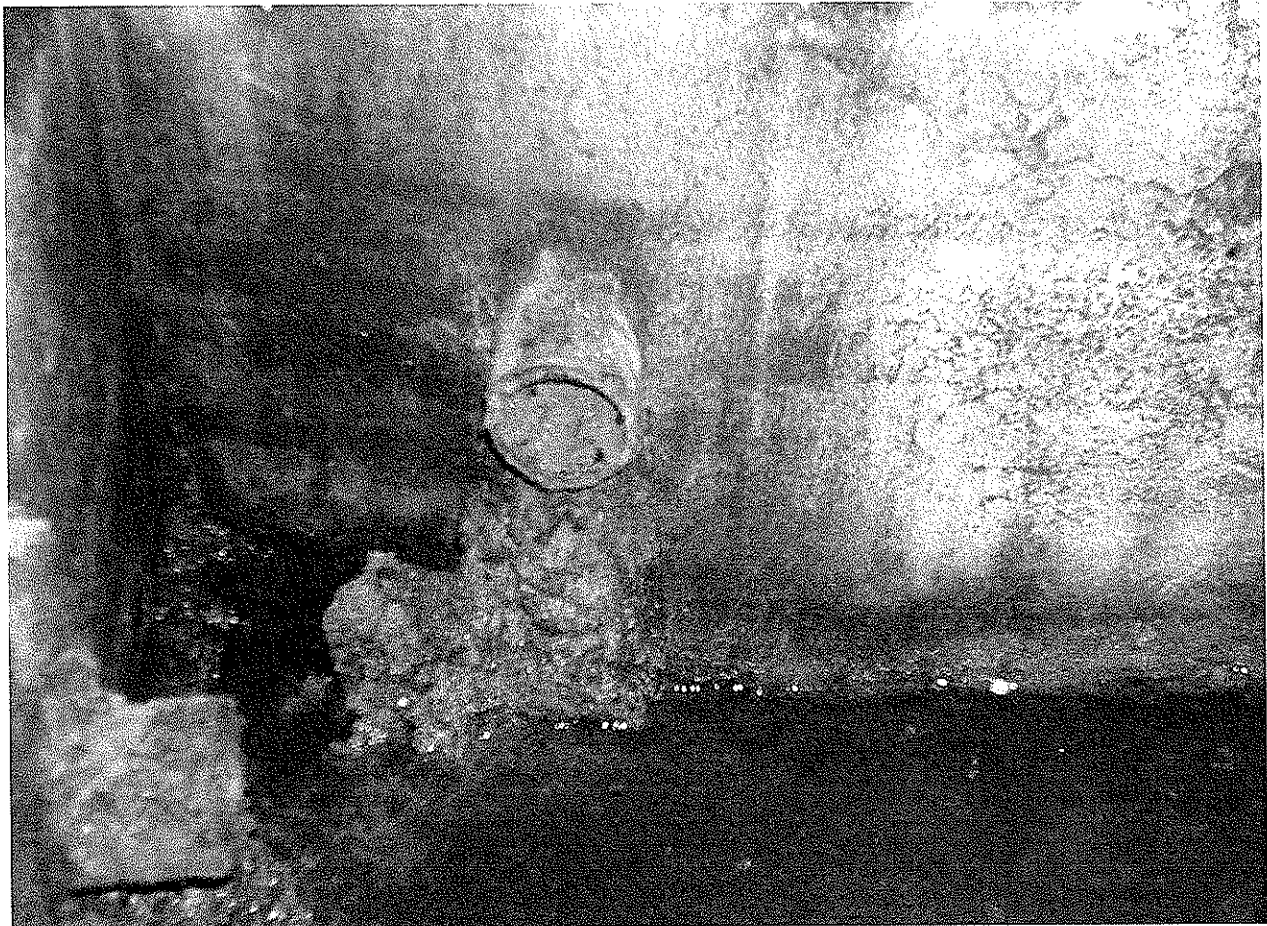
Photo No. 05

**Oil-Water Separator
Concrete Walls And Bottom**

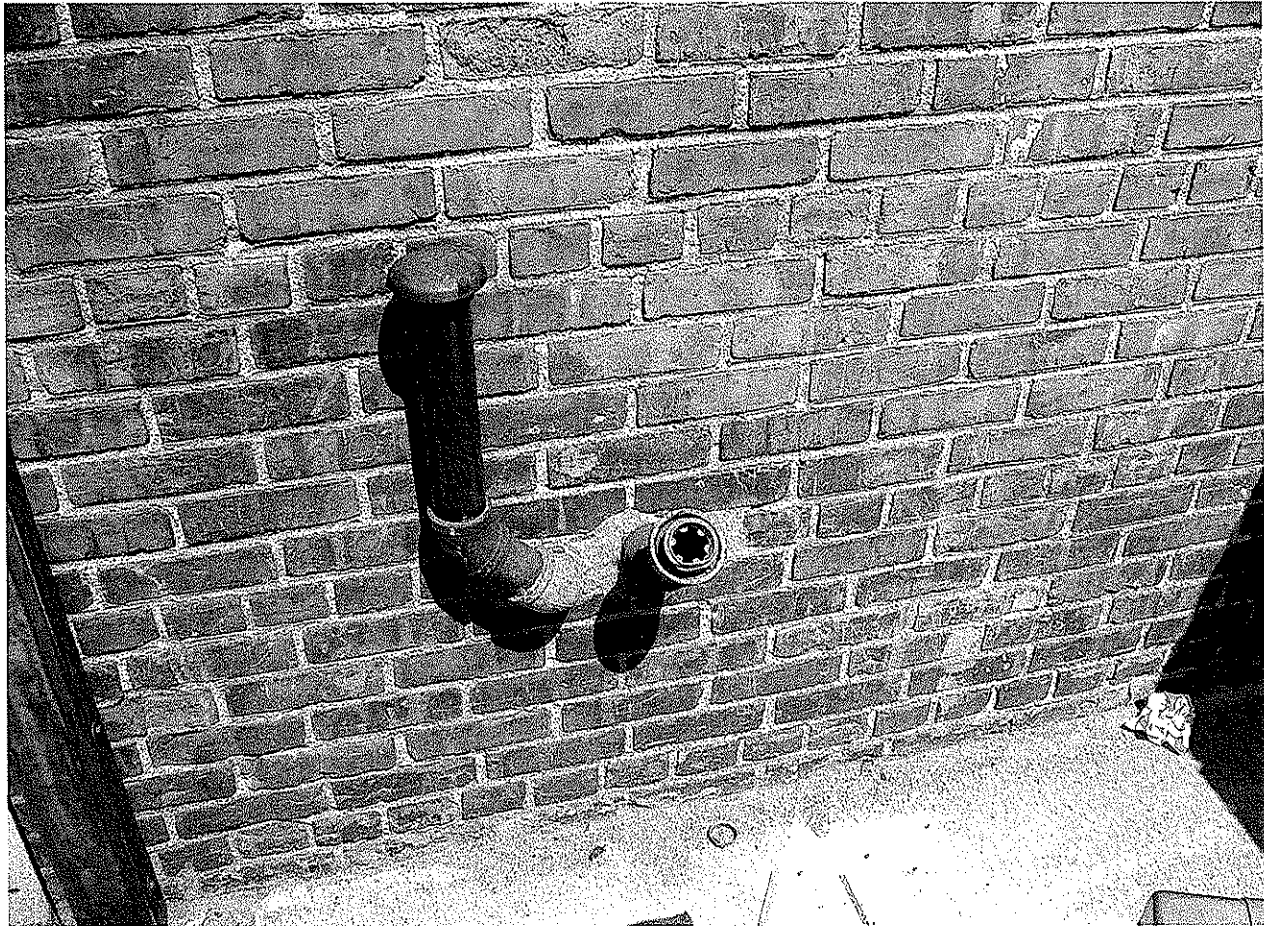
Photo No. 06

**Fuel Oil Vent & Fill Pipes
Exterior of Subject Structure**

An investigation of the (i) vent and fill pipes was performed with the Ridged SeeSnake® and the METROTECH® 810 and revealed that the fill pipe turned 90° into the subject structure towards the concrete oil-water separator tank. The fill pipe was observed entering and exiting the separator tank and then turning west (see site plan). Unfortunately, due to the multiple 90° angle turns in the plumbing line it could not be any further investigated with these units. Also, due to the construction and thickness of the concrete it prohibited the use of any other radar or metallurgical detection equipment.

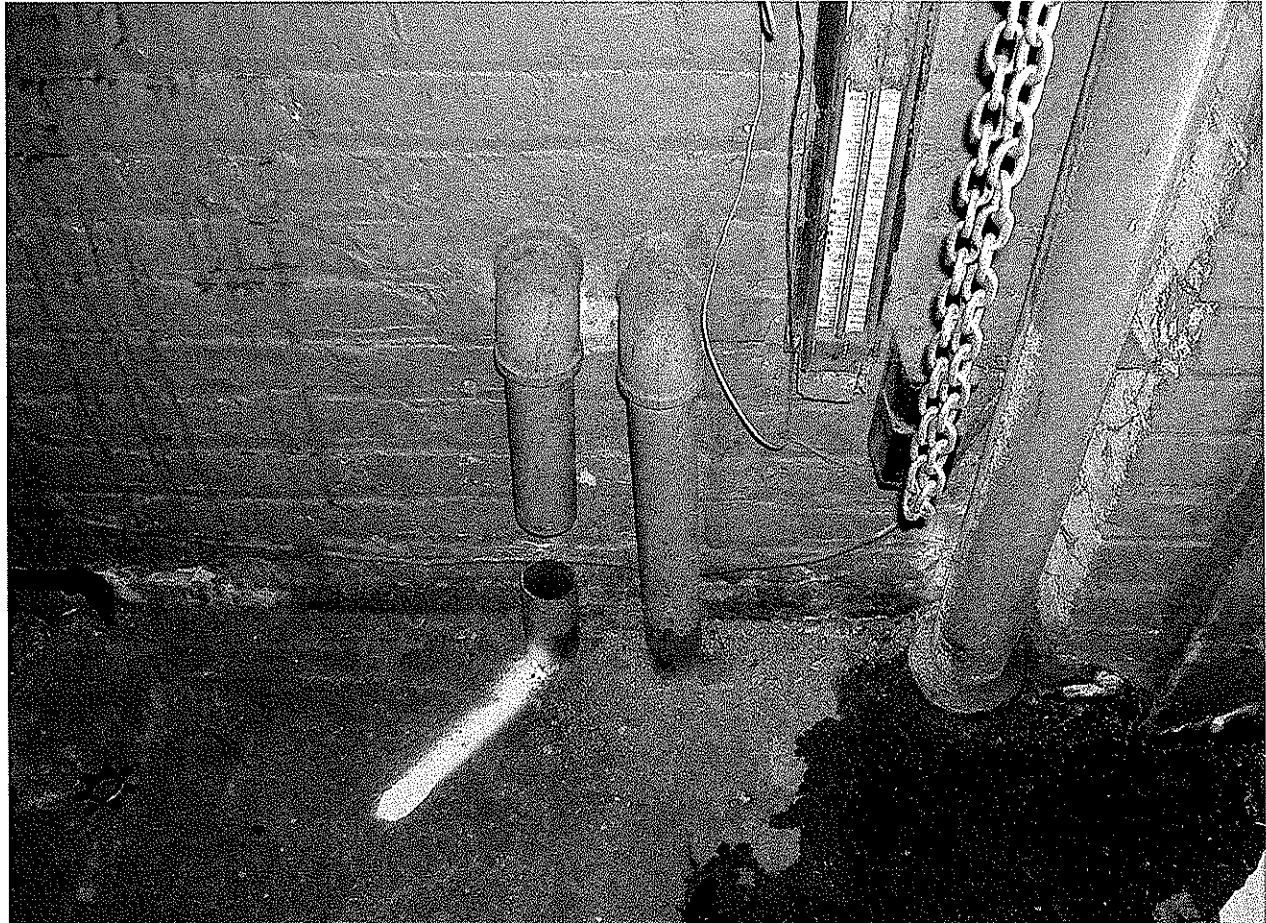
Photo No. 07

**Fuel Oil Vent & Fill Pipes
Interior of Subject Structure**

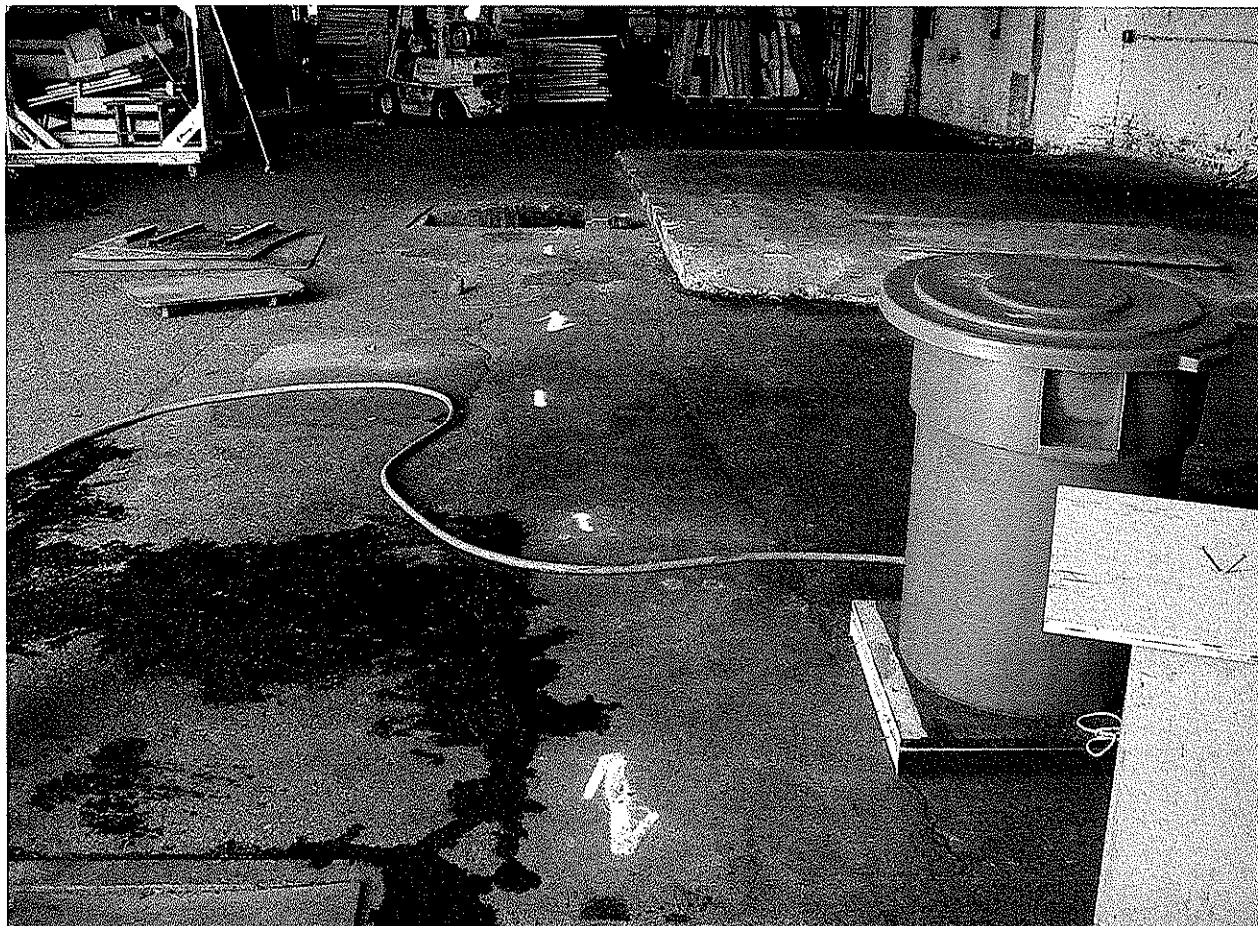
Photo No. 08

A visual inspection of the presumed pathway of the plumbing revealed the presence of a disturbed patch of concrete. This patch could be representative of any area where an underground storage tank was excavated. Therefore two (2) soil borings to a variety of depths was performed utilizing the Geoprobe® unit. The boring locations were identified as the center of the concrete patch and immediately west. Refer to site boring logs and drawing for details.

**Fuel Oil Vent & Fill Pipes
Path of Fill Pipe (Yellow Paint)**

The results of the boring performed in these locations did not reveal any evidence of an underground storage tank or significant petroleum contamination.

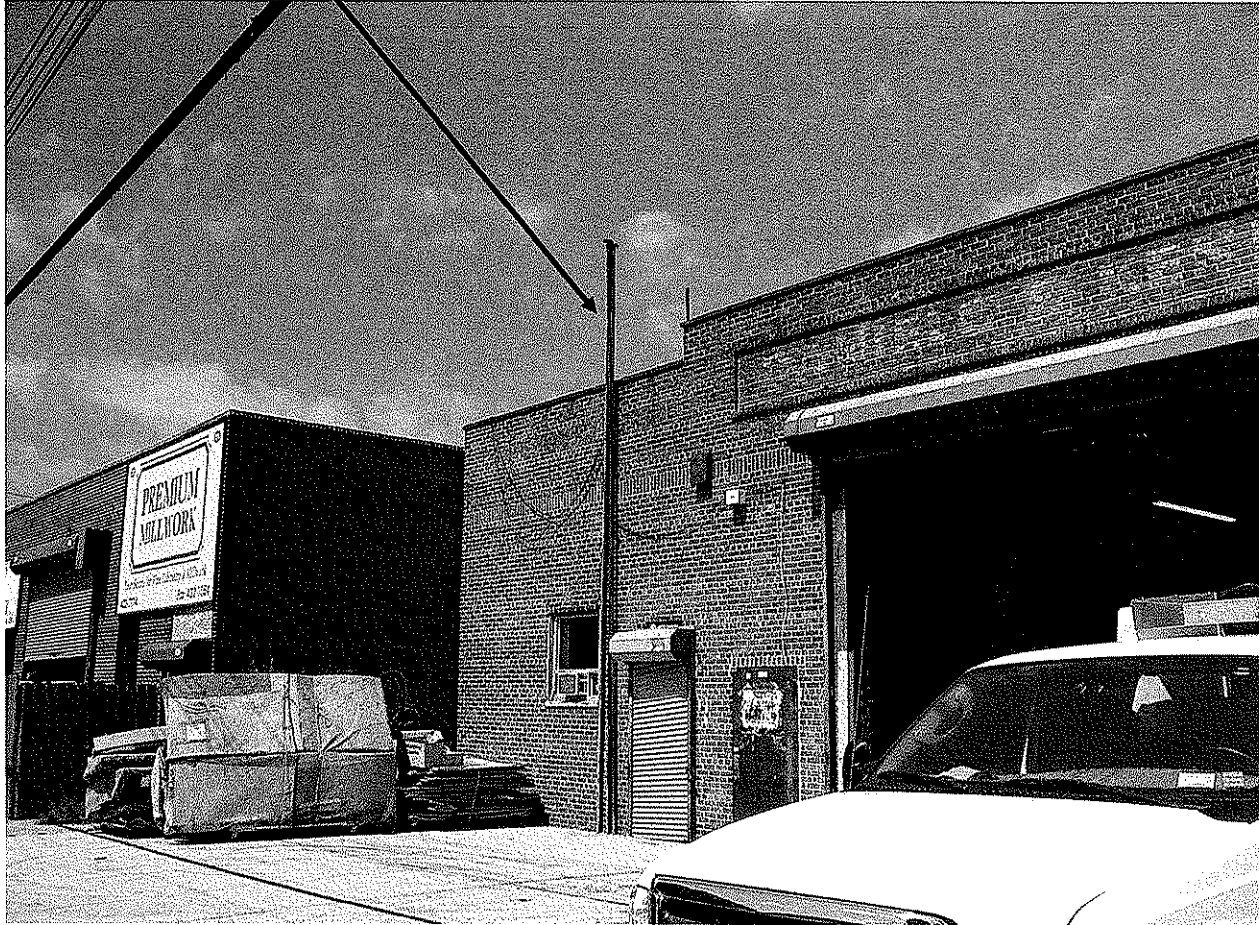
Photo No. 09

An investigation of (ii) the three vent pipes on the eastern exterior of the subject building was also performed utilizing the Ridged SeeSnake® and METROTECH® 810. The investigation revealed that the vent pipes turned 90° away from the subject structure and ended under the concrete pavement on the eastern side of the subject structure. Since this area contained relatively new concrete pavement no distinctions pertaining to the possible presence of underground storage tanks could be made.

**Gasoline Vent Pipes
Set of Three (3)**

It is expected that three (3) underground storage tanks still exist under this concrete paved area. Therefore two (2) soil borings to a variety of depths were performed utilizing the Geoprobe® Model 5410 unit in the vicinity of the suspect tank field. Refer to the soil boring logs and site drawing for additional details.

The results of the borings performed did reveal evidence of the underground storage tanks. However no evidence of any significant petroleum contamination was observed in the subsurface soils and groundwater inspected.

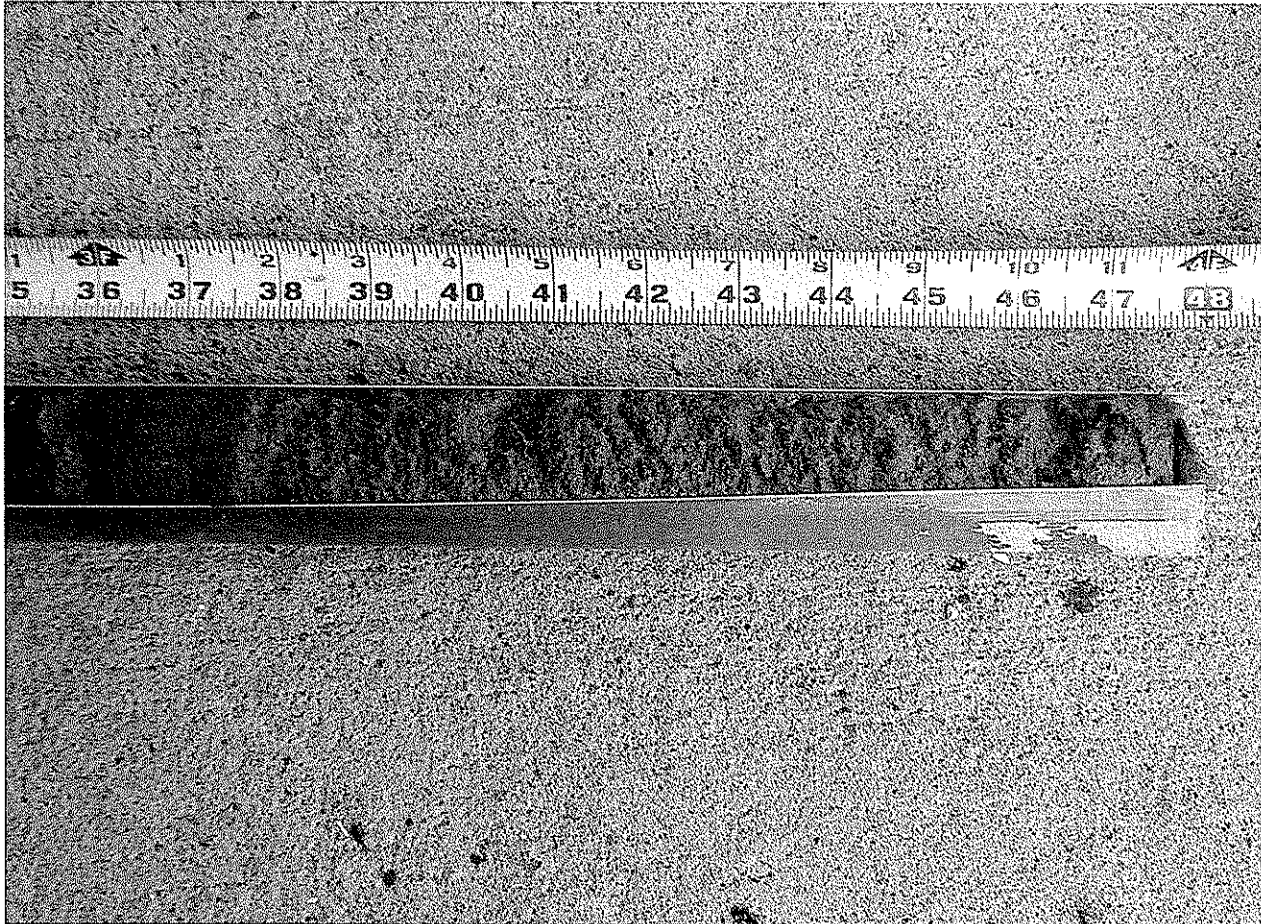
Photo No. 12

Dark brown to black sand, fine grain soils, brick, and fill materials

Groundwater observed at approximately 7.0 feet bsg

No petroleum odor or staining noted

Soil Boring No. 3
Typical Soils at 7.0-8.0 Feet Below Surface Grade (BSG)
