PHASE I ENVIRONMENTAL SITE ASSESSMENT

**260-262 Van Brunt LLC - Sergi's / RIMS #
14-000448-01-1
260 Van Brunt Street
Brooklyn, NY 11231**

**EFI Project No. 94705-05876.1
March 21, 2014**

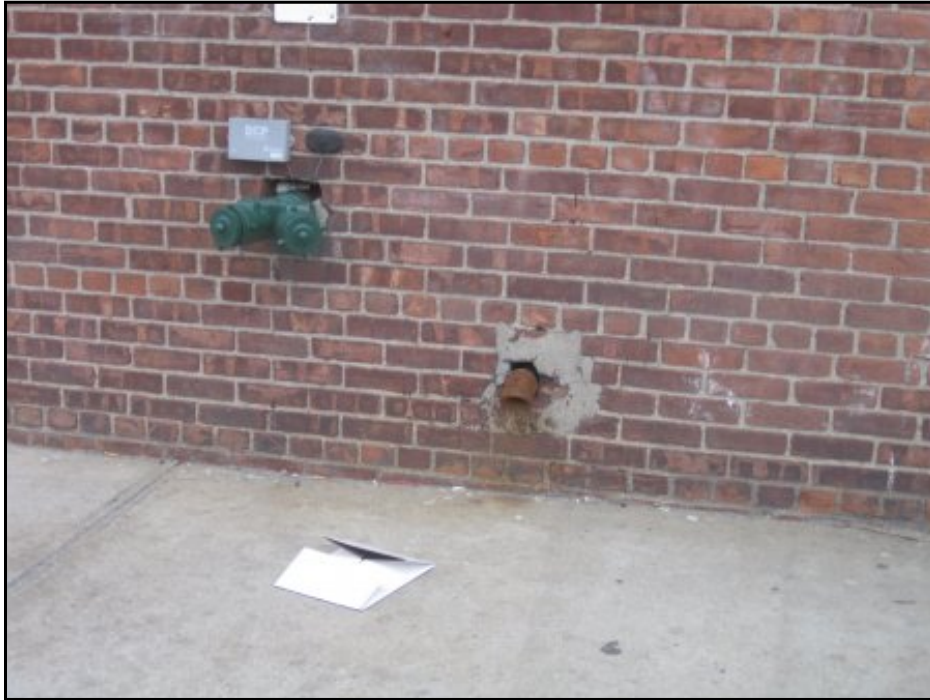
EFI observed a suspect former fill or vent pipe along the southeastern exterior wall of the 260 Van Brunt Street building. It is unknown if the associated former tank has been removed. Additionally, the former contents of the tank are unknown and may have included either fuel oil for heating purposes or gasoline associated with former trucking operations within the building. It should be noted a NYC DOB permit for a gasoline tank was issued in 1963; however, no further details about the tank were included within the permit.

View of suspect former fuel oil vent pipe along 260 Van Brunt Street.

- **USTs** - EFI recommends a Phase II investigations be conducted at the Property to determine if releases from the USTs have impacted the surface of the Property. Additional actions may be required if impact is detected at concentrations exceeding state standards. Additionally, if USTs are identified, UST closure activities will be required.

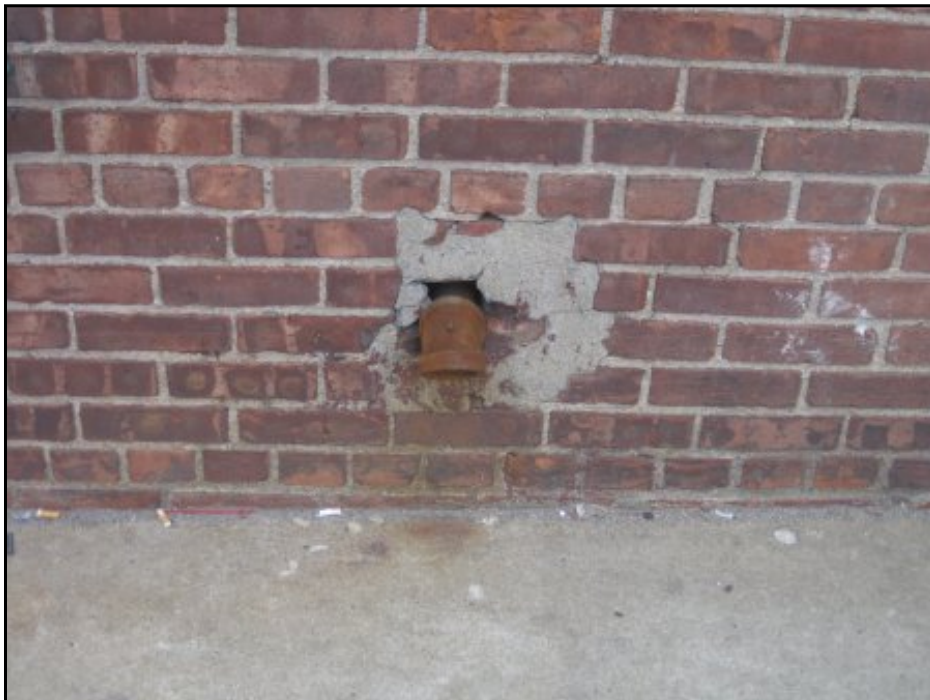
View of suspect former fuel oil vent pipe along 260 Van Brunt Street.

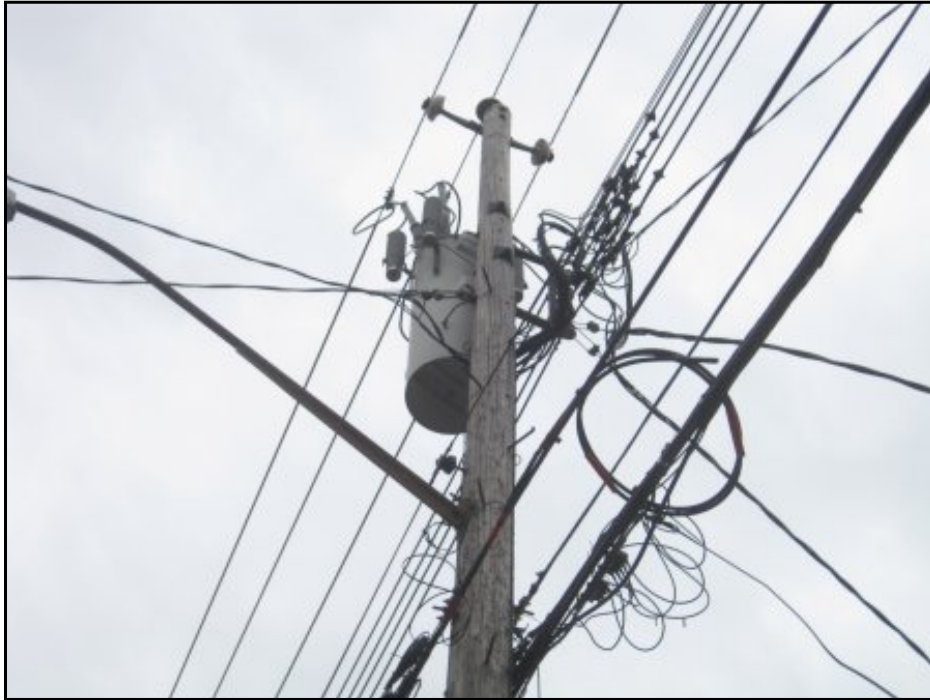
View of transformer along southeastern perimeter of the Property

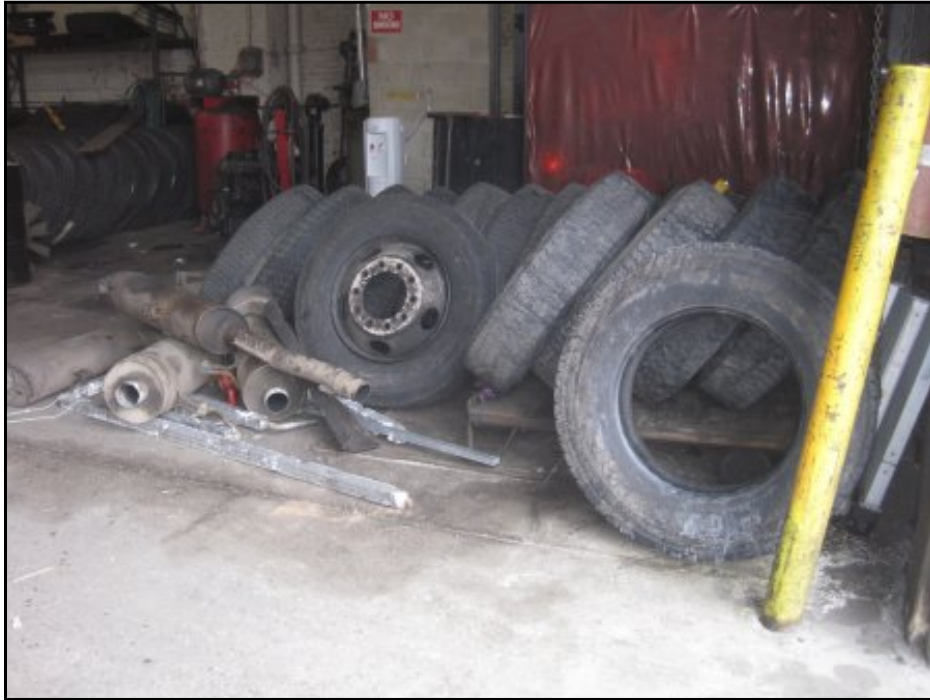
View within the building adjacent to the exterior wall containing fill and vent pipe.

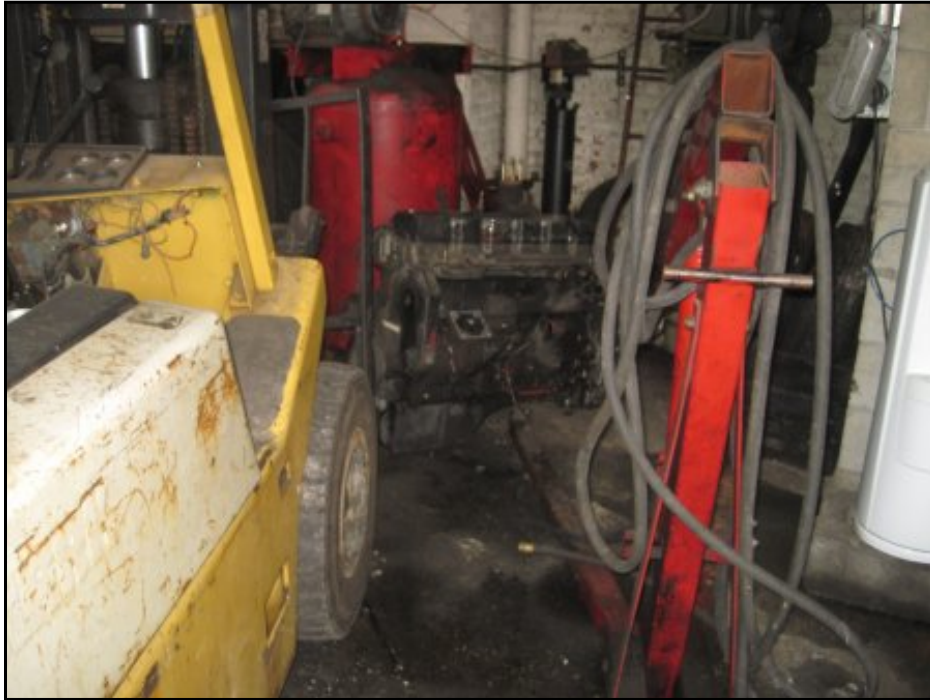
View of typical staining and storage within 262 Van Brunt Street.

- **Drums** - EFI recommends the drums stored through the 262 Van Brunt Street building be organized throughout the space, centrally-located within secondary containment, and properly labeled.

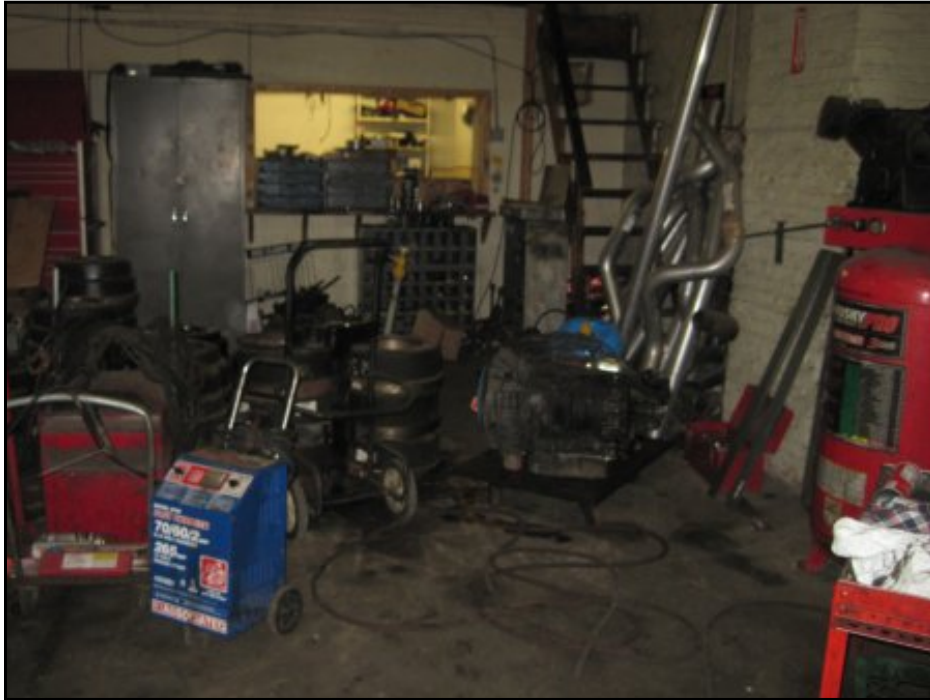
View of typical staining and storage within 262 Van Brunt Street.

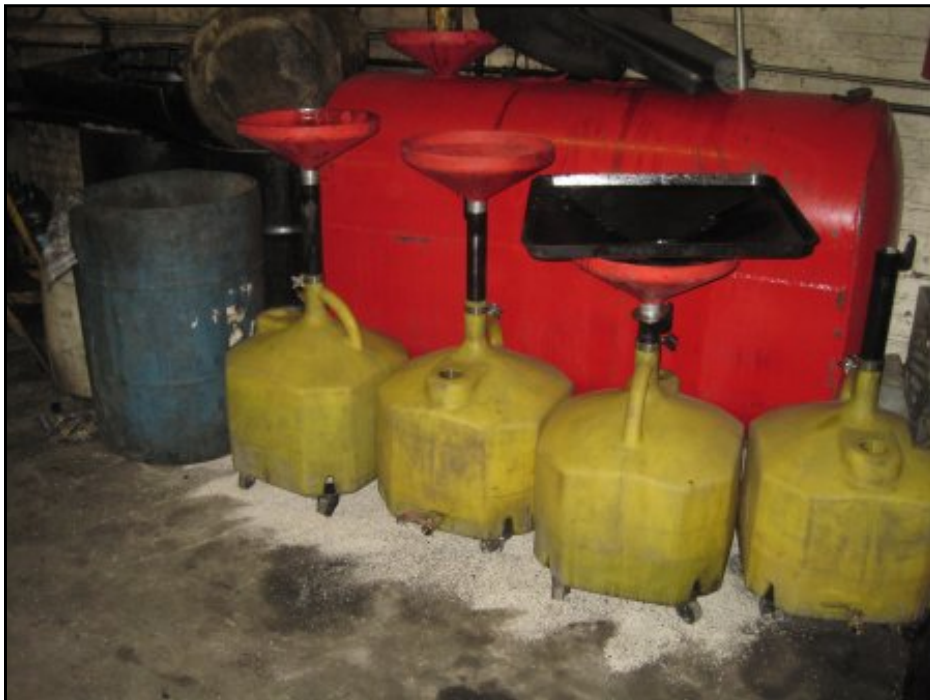
- Two 275-gallon waste oil ASTs are located along the southwestern sidewall of the building. The tanks are not located within secondary containment, but rather are located directly atop concrete flooring. Heavy and wet oil staining was noted around the tanks, along with several additional plastic containers containing waste oil, which surrounds one of the tanks. Additionally, one 275-gallon virgin motor oil AST is located along the southwestern sidewall of the building. The motor oil AST is not located within secondary containment, but rather is located directly atop concrete flooring. Heavy and wet oil staining was noted around the tank.

View of 275-gallon AST and additional oil containers along with staining within 262 Van Brunt Street.

- **ASTs** - The three active ASTs and the waste oil containers should be placed within secondary containment in order to prevent future spills. In addition, the current staining should be treated with absorbent materials in order to cleanup existing conditions.

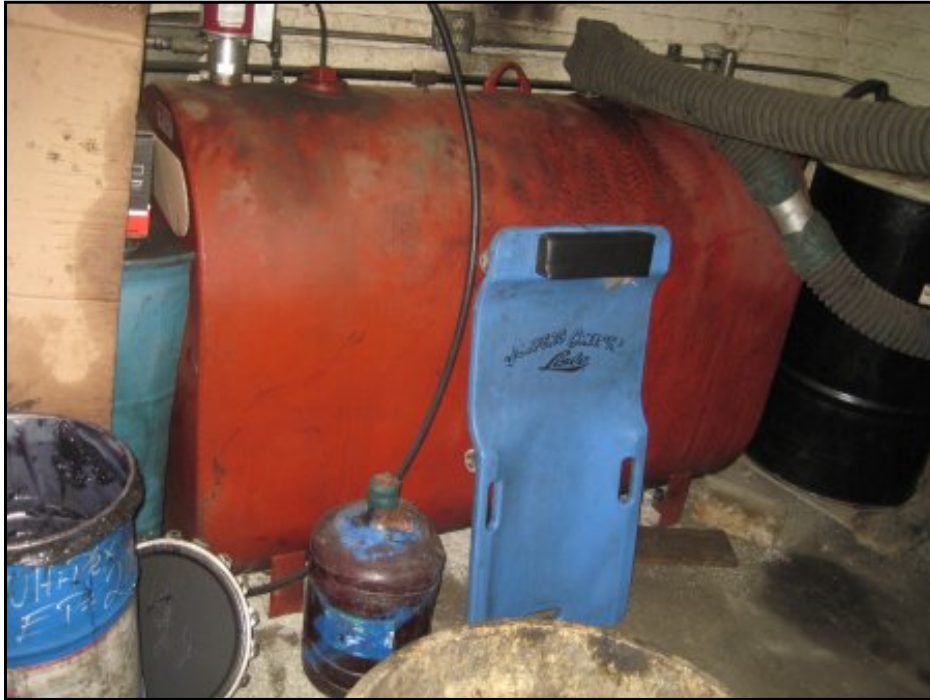
View of 275-gallon AST and additional oil containers along with staining within 262 Van Brunt Street.

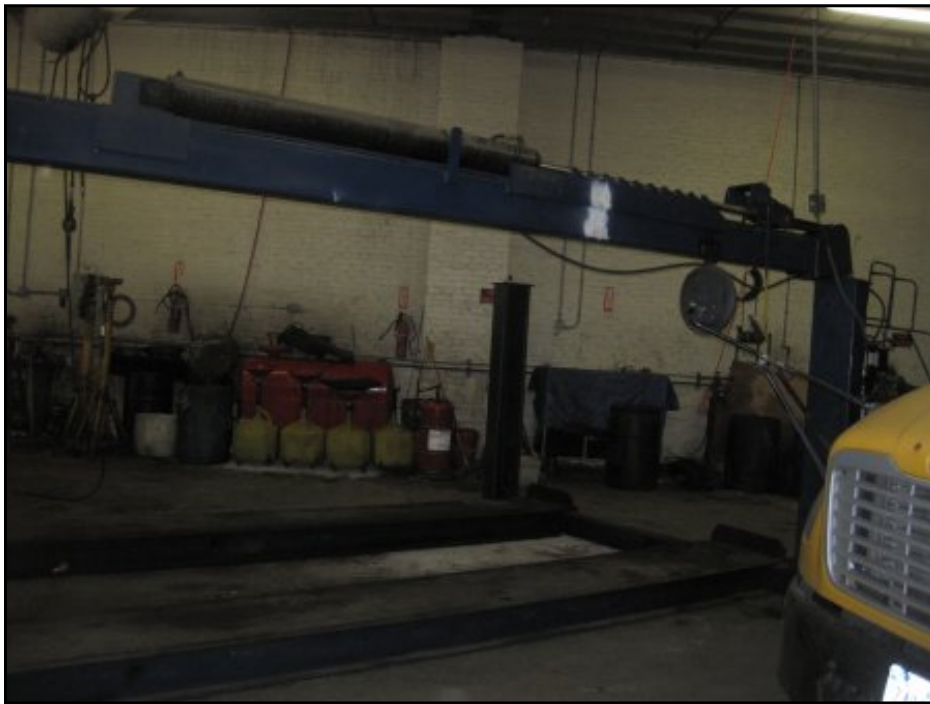
auto garage and trucking company in the late 1940s and 1950s; however, by 1959 at least part of the building was utilized for a "junk shop" including rags and paper and later was utilized by a salvage company. By 1969 this building was utilized for "waste paper baling". By the mid-1970s the building was occupied by a trucking/motor company and may have included repair activities; however, a plastic company occupied at least part of the building in 1985 per review of city directories, which may have included injection molding. Operations such as these often include the use of chlorinated solvents. By the late 1990s and into the mid 2000s, the building was utilized by a theatrical staging company. Additionally, based upon the historical usage of the Property for vehicle repairs since the 1940s, it is possible the Property buildings previously had in-ground hydraulic lifts.

View of hydraulic lift within 262 Van Brunt Street. Note staining.

- **Historical Property Use** - EFI recommends a Phase II investigation to determine if the historical uses have impacted the subsurface of the Property. Additional actions may be required if impact is detected at concentrations exceeding state standards.

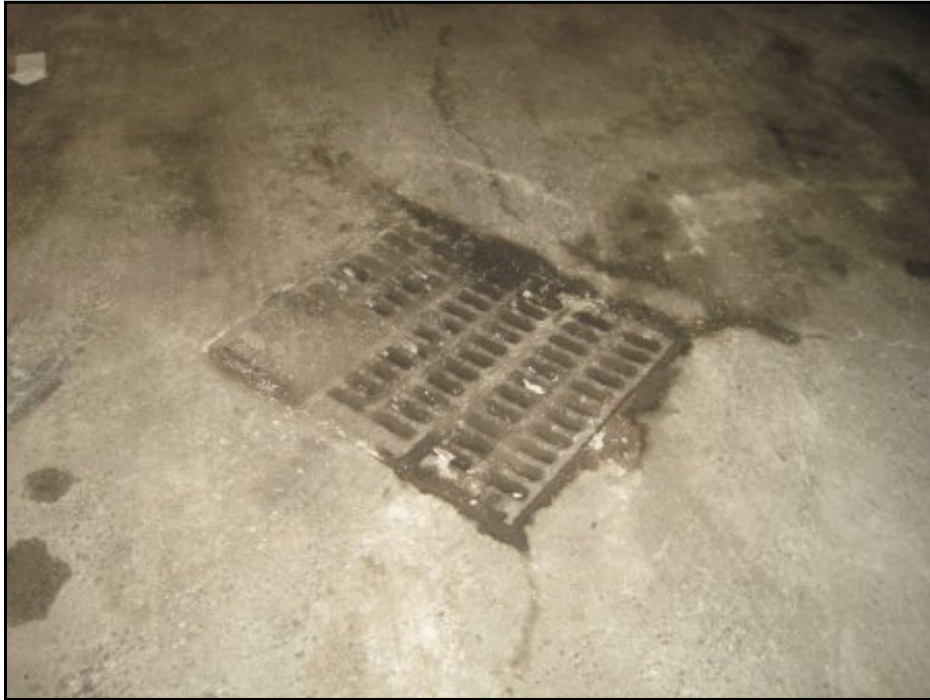
View of storm drain within 262 Van Brunt Street.

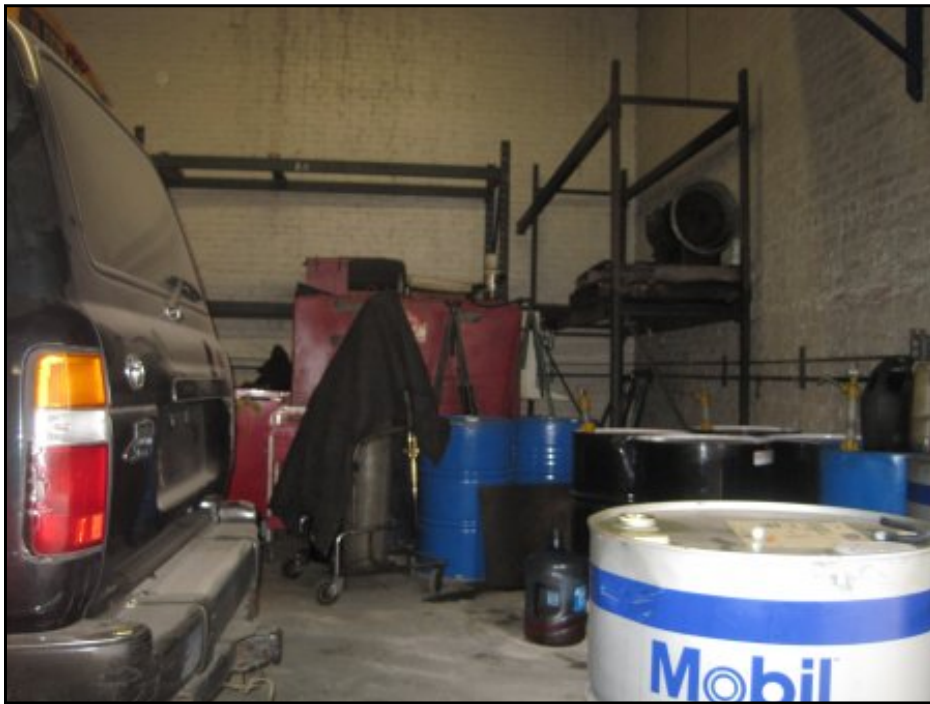
Four ASTs were observed on the Property during the site reconnaissance within the 262 Van Brunt Street building. One approximately 750-gallon empty and disconnected self-contained AST was observed located within the northwestern corner of the building. Two 275-gallon waste oil ASTs with no secondary containment were observed along the southwestern sidewall of the building. Heavy and wet oil staining was noted around the tanks, along with several additional plastic containers containing waste oil. Additionally, one 275-gallon virgin motor oil AST with no secondary containment was observed along the southwestern sidewall of the building. Heavy and wet oil staining was noted around the tank.

View of out-of-service 750-gallon AST and additional oil stored within drums.

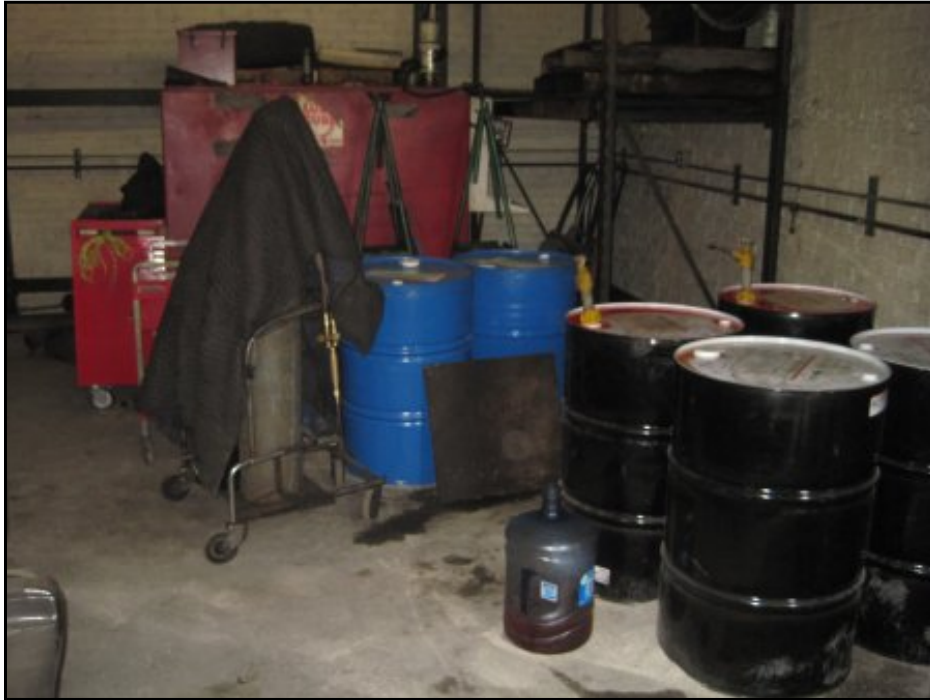
View of out-of-service 750-gallon AST and additional oil stored within drums.

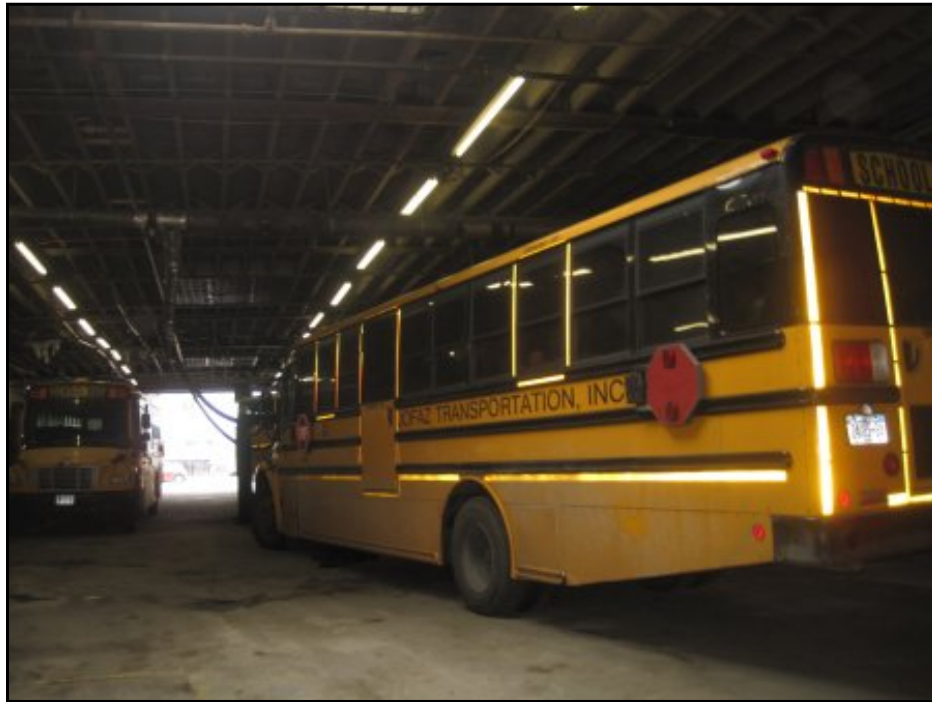
Physical Obstructions to Observations - Much of the interior of the 262 Van Brunt building included several parked vehicles, tanks, drums, equipment, and car parts and as such, not all of the flooring could not be observed.

View within 262 Van Brunt Street. Note parked vehicles obstructing view of flooring.
