TANK CLOSURE SITE ASSESSMENT

SITE REMEDIATION REPORT

**91 North 12th Street
Borough of Brooklyn
Kings County, New York**

NYSDEC Spill File: 9906462

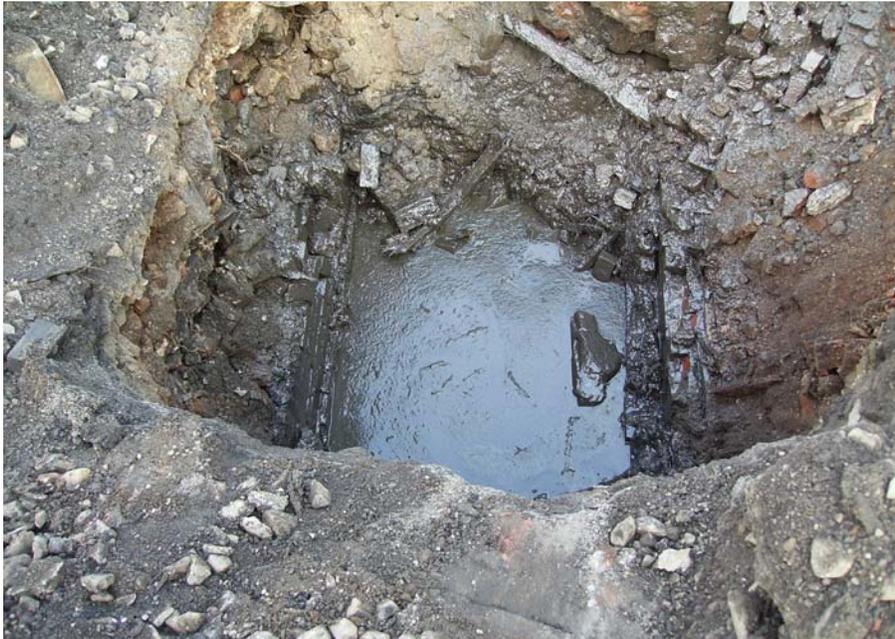
1. **Excavations immediately beneath monitoring well BK-10 revealed the presence of a brick-lined channel containing grossly contaminated soil at 7 feet below surface grade.**

Excavation of contaminated soils in the vicinity of BK-10 revealed the presence of a shallow (18") layer of dark-stained soil immediately beneath the asphalt. This material was excavated and stockpiled on 6 mil plastic for off-site disposal. Beneath the stained material, fill comprised of construction debris (predominantly bricks), was encountered to a depth of approximately seven bsg. This construction debris was free of field evidence of contamination and stockpiled beside the excavation to be used as backfill. Immediately beneath monitoring well BK-10, a brick lined channel was encountered at 10 feet below grade. Extending northwest-southeast for approximately 15 feet, the channel contained grossly contaminated sandy soil and debris (see Photographs 1 and 2, Appendix B). This material was excavated and stockpiled on 6-mil plastic pending off-site disposal. When all grossly contaminated material had been excavated, confirmatory endpoint samples were collected (see section 2.4, below). At the request of NYSDEC personnel present on-site, a sample of standing water from the base of the excavation was collected (sample BK-10-MW).

Bottom samples from the excavation (BK-10-NB and BK-10 SB) contained no PAHs or VOCs above minimum detection limits. The sample of groundwater standing at the bottom of the excavation (BK-10-MW) similarly contained no VOCs or PAHs above minimum detection limits. Wall samples from the same excavation (BK-10-E, BK-10-W, BK-10-S, and BK-10-N) contained four PAHs above their respective guidance levels. No field evidence of contamination was noted during the collection of the wall samples (see Table 1, Appendix E), supporting the conclusion that the PAHs above guidance levels in the four wall samples are likely to be indicative of poor quality urban fill. These results support the conclusion that all grossly contaminated material from the vicinity of former monitoring well BK-10 has been removed.

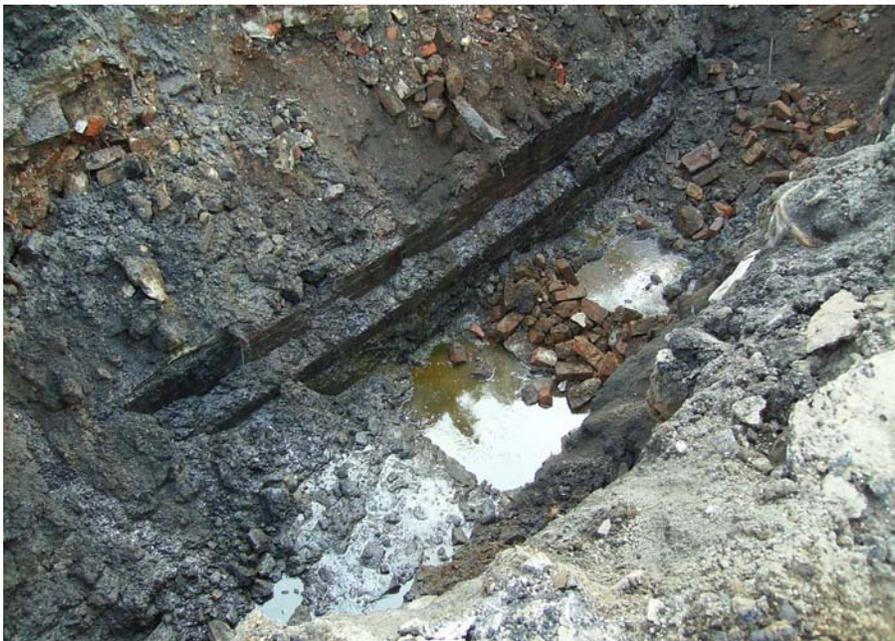
2. **Brick-lined channel beneath BK-10**

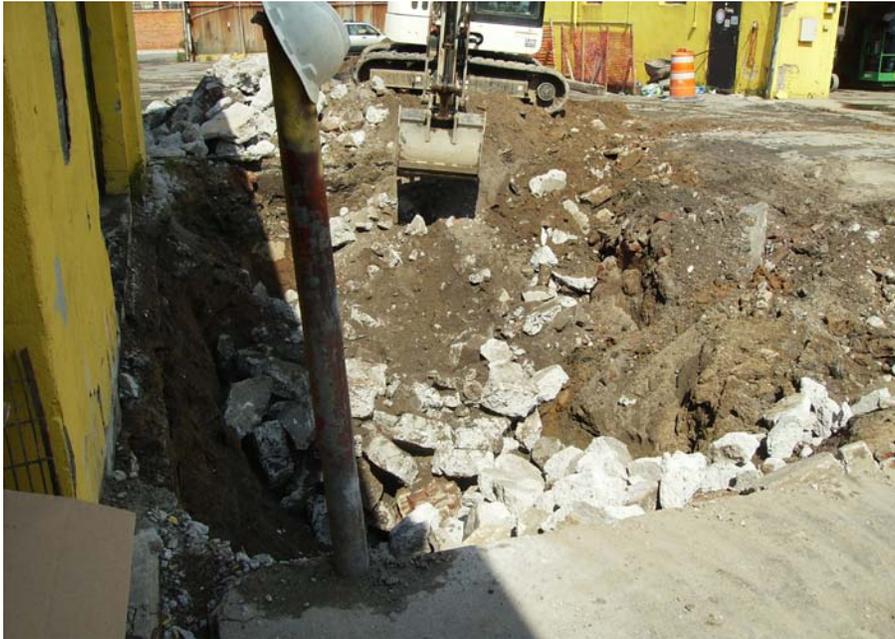
- 3. Excavation of contaminated soil immediately east of machine shop.**

Excavation in the area immediately southeast of the machine shop found no field evidence of contamination until groundwater was encountered at approximately 7 feet bsg and in shallow soils at the far southeastern corner of the excavation where an area of heavy, bituminous material was encountered at between 2 and 3 feet bsg. Contaminated soil was excavated and stockpiled pending off-site disposal and confirmatory endpoint samples were collected prior to backfilling the excavation (see Section 2.4, below).

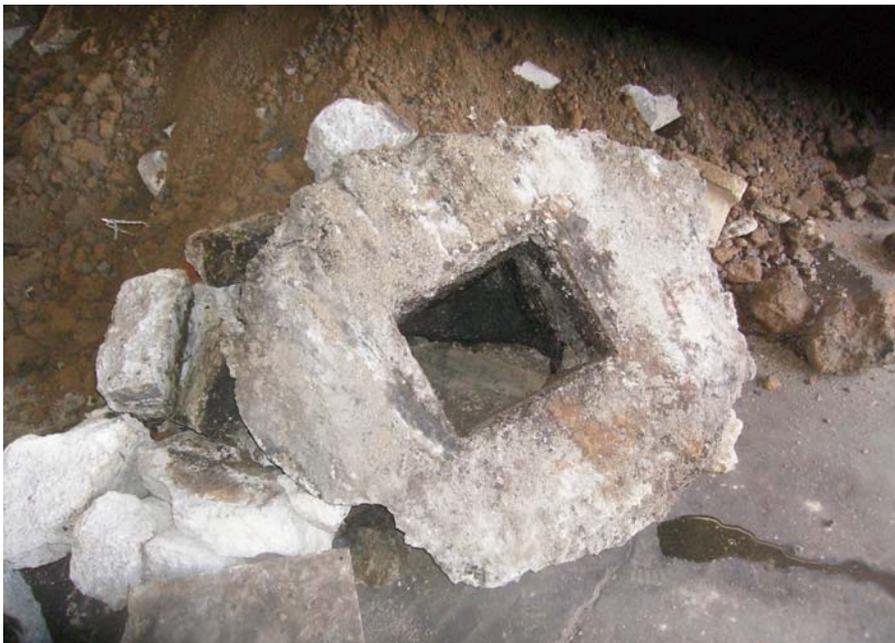
- 4. Drain excavated from floor of machine shop**

Excavations of the area around a floor drain in the immediate vicinity of MW-2 in the machine shop encountered grossly contaminated soil between depths of 5 and 8 feet immediately below the floor drain. This material was excavated and stockpiled on 6 mil plastic sheeting pending off-site disposal. During these excavations MW-2 was destroyed and the northern end of a previously unknown UST was encountered at approximately 2 feet below surface grade (bsg). The tank was found to be located in a northeast-southwest orientation in the southern bay of the machine shop. Given the size of the tank, the presence of utility lines across the top of the tank, and the configuration of the machine shop walls, a determination was made that the UST could not be removed. After discussions with NYSDEC personnel, their approval was given to close the tank in place.

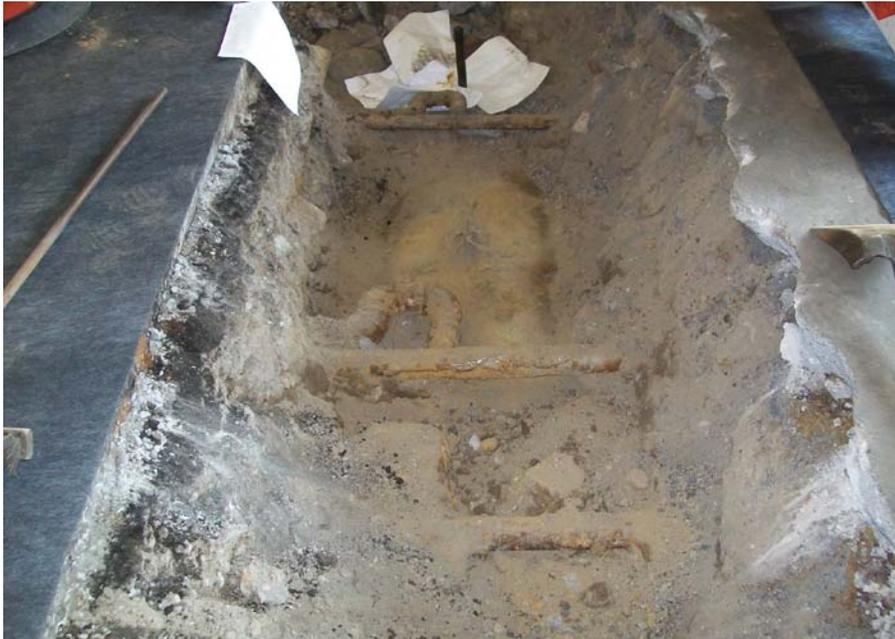
5. Top of 3,000-gallon UST exposed beneath floor of machine shop.

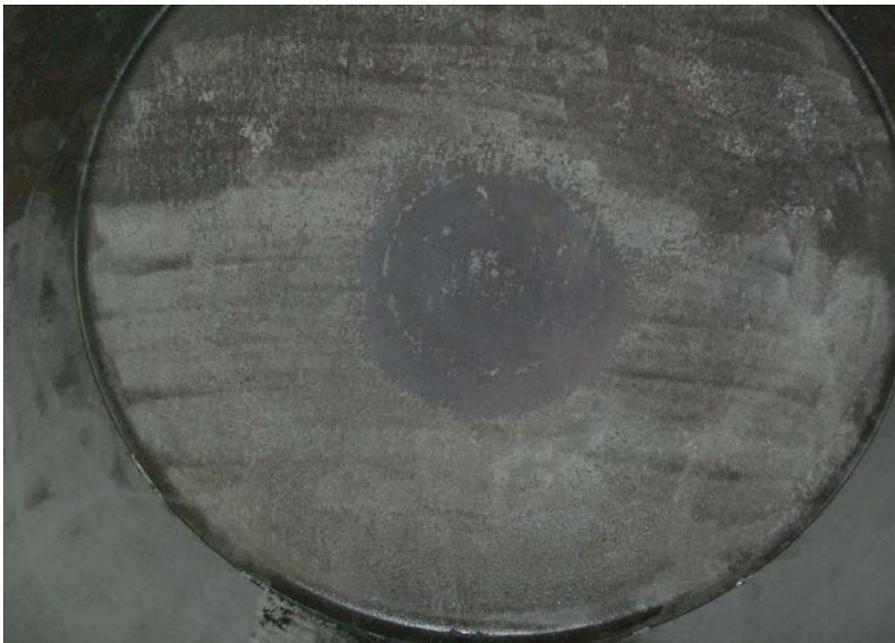
6. Interior of 3,000-gallon tank after pump out and cleaning

After the top of the tank had been cut open it was found to be full of #2 fuel oil. This liquid and residual sludge (3,000 gallons) was removed and the interior of the tank was steam cleaned (this process generated an additional 350 gallons of waste liquid that was pumped from the tank). Holes were cut in the bottom and sides of the tank to facilitate sample collection. Visual examination of the tank interior indicated no surface corrosion or pitting. Following the soil sampling described in Section 2.4 below, the tank was filled with concrete slurry.

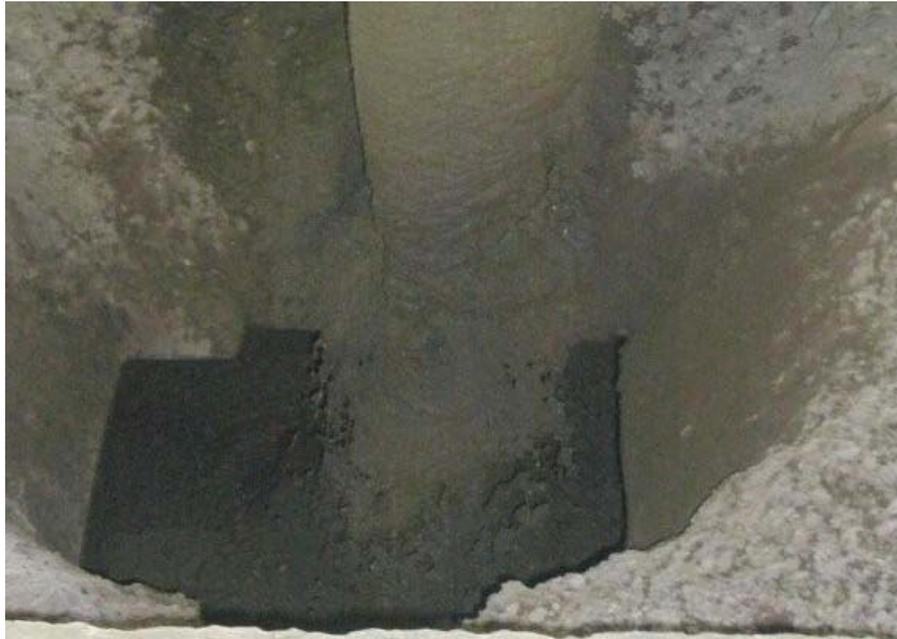
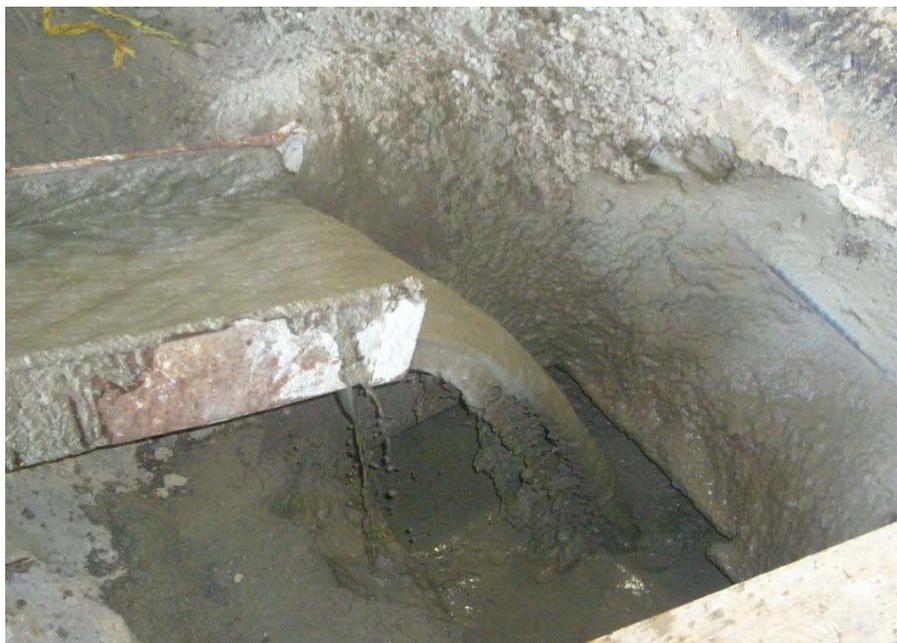
7. 3,000-gallon UST being filled with concrete slurry

8. 3,000-gallon UST being filled with concrete slurry
