# PHASE II ENVIRONMENTAL SITE INVESTIGATION

**450 Union Street  
Brooklyn, New York**

**June 5, 2014**

**Langan Project No. 170301201/170301202**

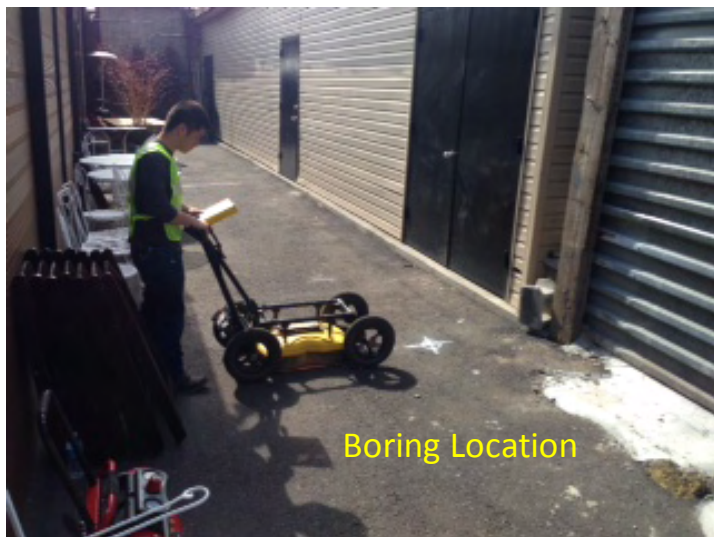
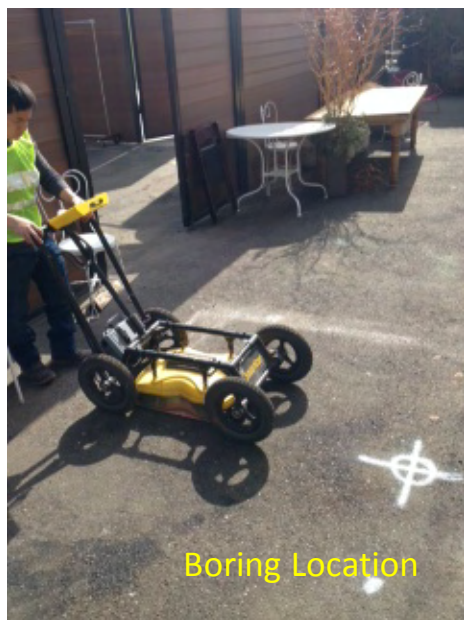
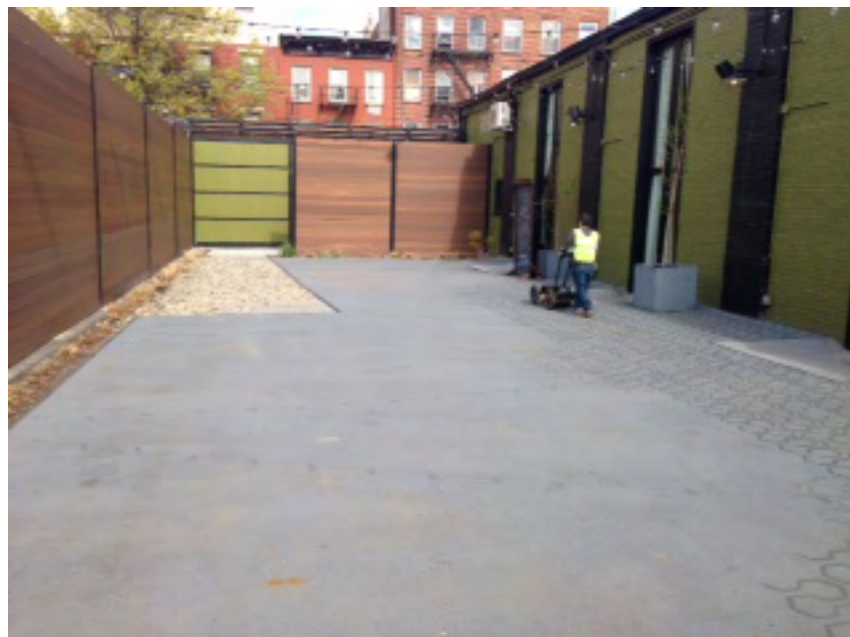
**GEOPHYSICAL IMAGES**

Nova's geophysical survey revealed that the site is transected by buried utility lines at depths of 1 to 4 ft bgs. Sewer lines were identified underneath the events space, on the western portion of the property, and parallel to Union Street underneath the eastern portion of the building. A north-south trending water line was identified in the central portion of the property, and isolated anomalies were observed throughout the central and eastern exterior areas. The anomalies were not indicative of USTs, vaults, or other potential environmental concerns. Signal interference precluded profiling of the buried vault in the metal working area, and the presence of stored construction materials prevented access to the area above the inactive UST.
