#### **DAILY STATUS REPORT**

NYSDEC BCP Site No:	C224219	Date:	06/15/2023
Project Name:	450 Union Street	Weather:	Sunny, 70-75 °F
Client:	2201 Union LLC	Time:	7:00 – 13:20

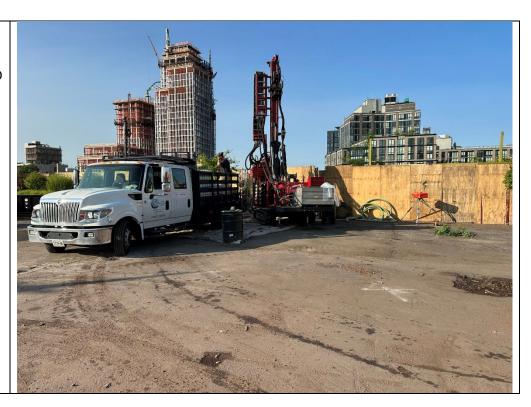
Photo 1: View of CAMP station and Coastal Environmental Solutions drilling DB-6 with Sonic Drill Rig CRS XL 140 DUO

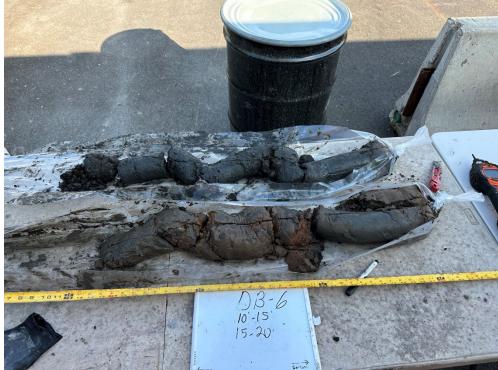
Photo 2: View of DB-6 sonic sleeves 10 to 15 feet bgs. and 15 to 20 feet bgs.

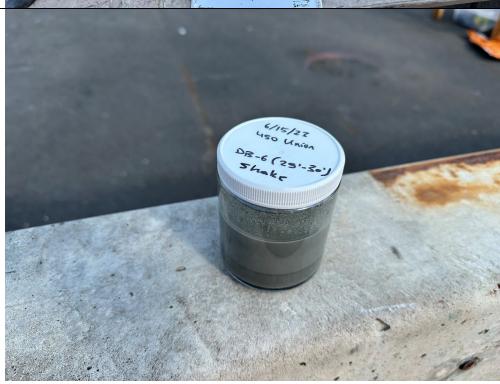
- A shake test was conducted for suspected GCM at 29-30 feet interval and revealed a small amount of LNAPL. A second shake test was conducted to confirm lack of NAPL below 50 feet at the 50-51 feet interval.

Photo 3: View of shake test from DB-6 29 to 30 feet bgs.

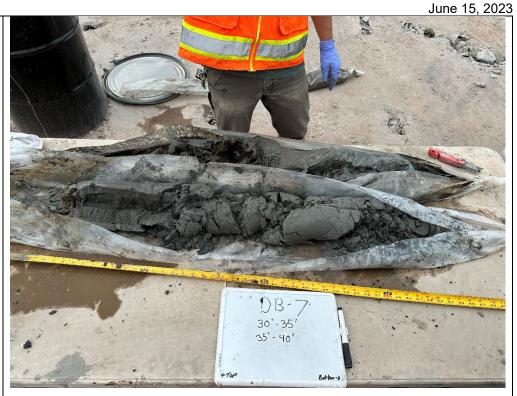
- GCM as evidenced by staining, sheen, odors, and PID readings was encountered starting at a depth of approximately 32 feet below grade surface (bgs). Visually impacted soils continued until approximately 35.5 feet. Coated soil was encountered at a depth of 35 to 35.5. No olfactory or PID evidence of impacted soils were present below 36 feet bgs.

Photo 4: View of DB-7 sonic sleeves 30 to 35 feet and 35 to 40 feet.

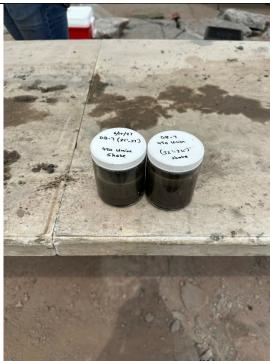
- A shake test was conducted for suspected GCM at 32-34 feet interval and revealed a small amount of LNAPL. A second shake test was conducted to confirm lack of NAPL below 36 feet at the 36-37 feet interval.

Photo 5: View of shake tests from DB-7 36 to 37 feet bgs and DB07 32 to 34 feet bgs.
