DAILY STATUS REPORT

NYSDEC BCP Site No:	C224219	Date:	9/24/2024
Project Name:	450 Union Street, Brooklyn, NY

**IN-SITU SOIL STABILIZATION - AUGER MIXING
COLUMN LOG**

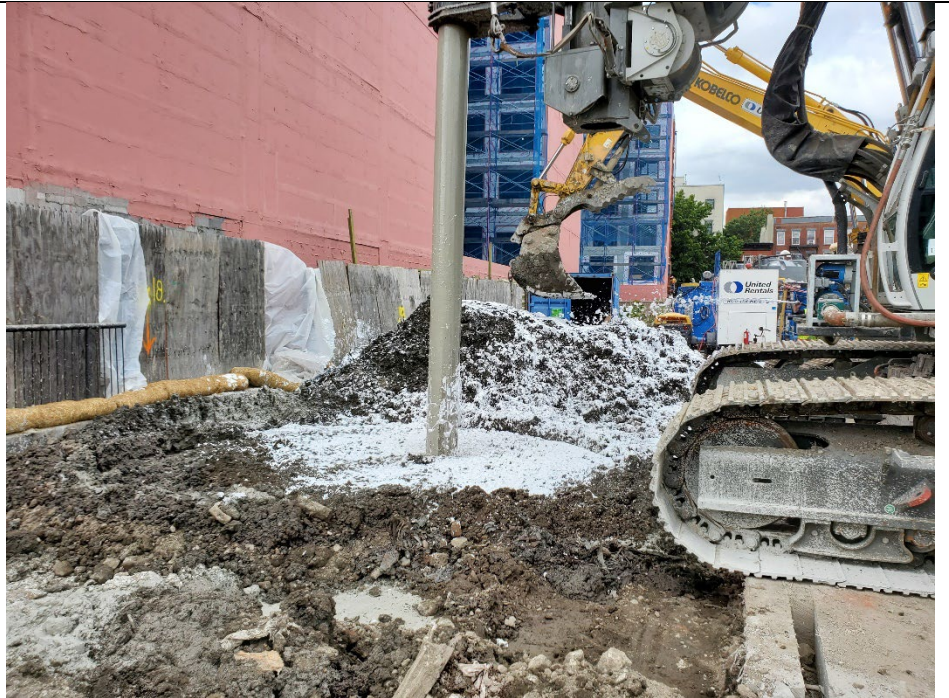
Photo 1:

View of GSI introducing 9% mixture at column/cell C2 with application of foam to mitigate odors, facing southwest.

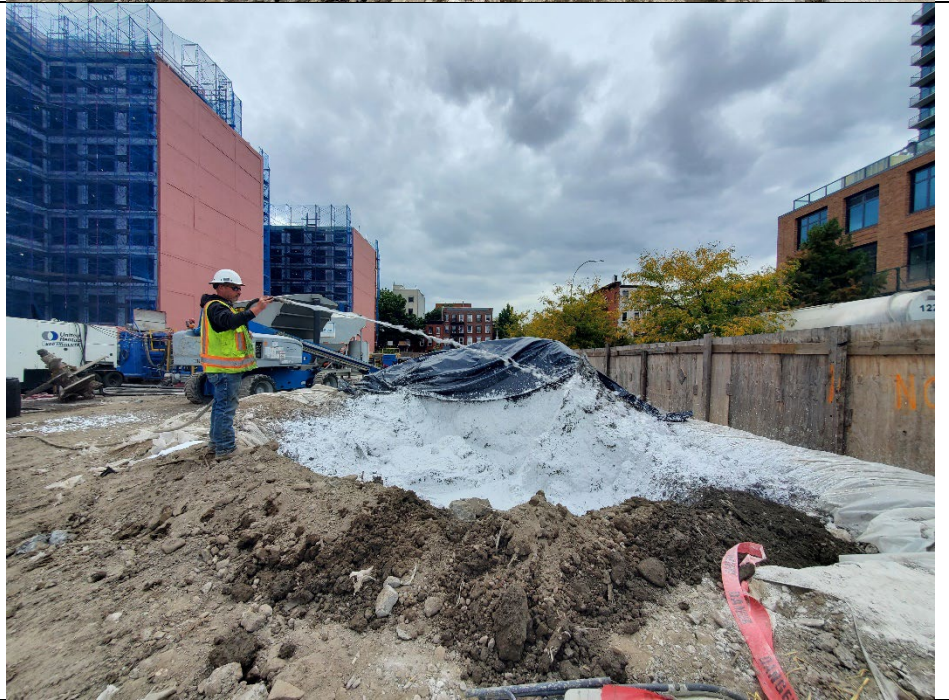
Photo 2:

View of GSI applying foam to ISS swell material within the berm, facing west.

- NYSDEC received a complaint from the community pertaining to the ISS swell material sitting within the berm with insufficient foam coverage and noting a Naphthalene smell. WSP personnel visited the site and confirmed NYSDEC's request for constant foam coverage for the berm and ISS swell material throughout the work day and a minimum of 6 inches of ATMOS foam for the ISS swell material stockpiled and within the work area at the end of the day.

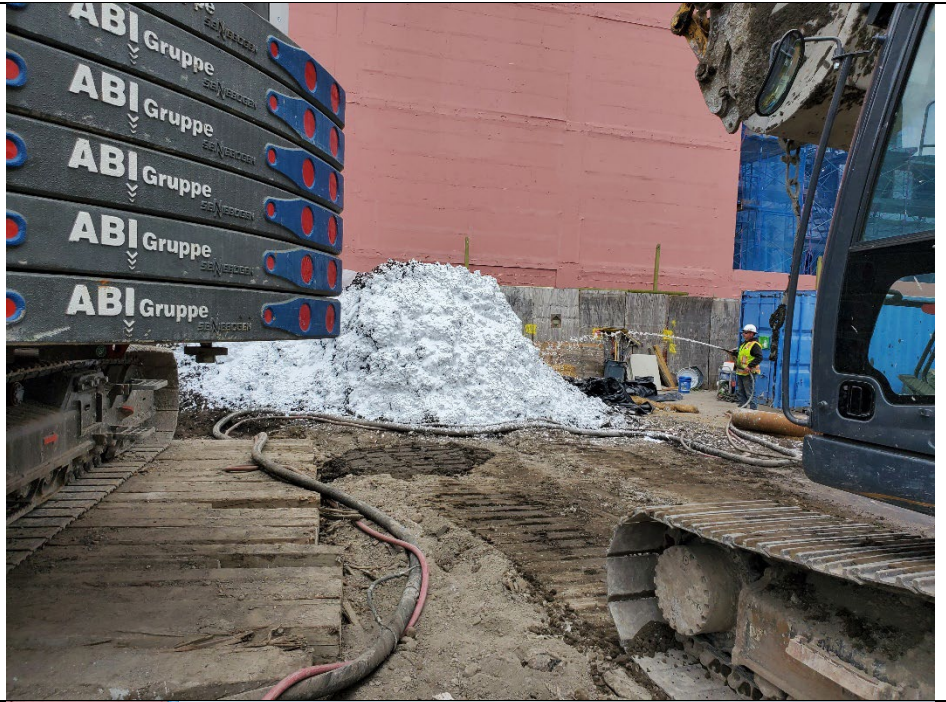
Photo 3:
View of GSI applying foam to ISS
swell material staged within the
drilling area, facing south.

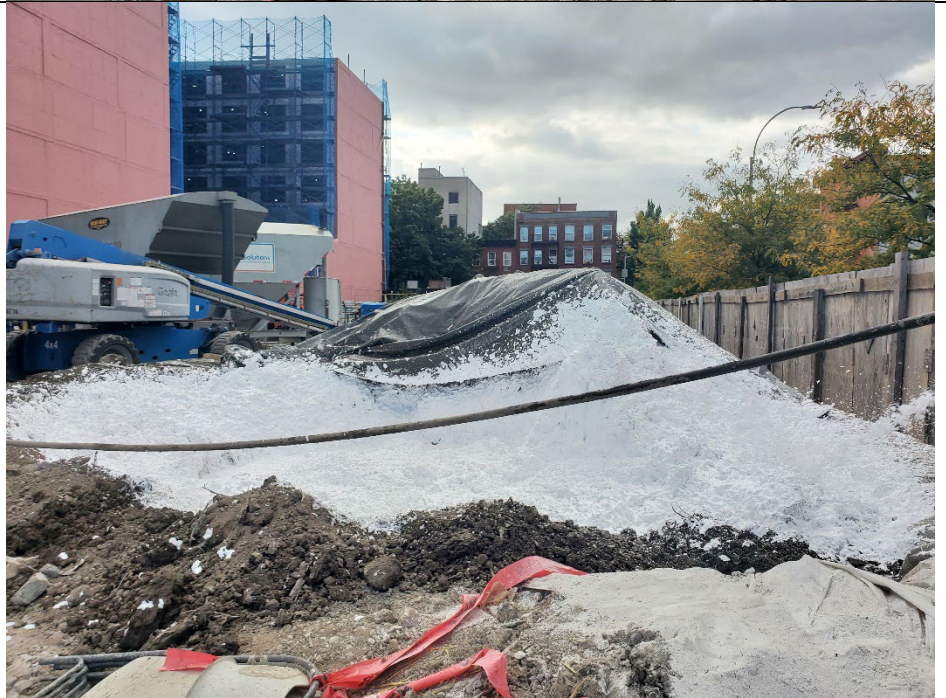
Photo 4:
GSI applying foam on top of spoils
within berm at the end of the day,
facing west.

- GSI, Vektor and WSP took action based on a community complaint from September 23rd 2024 regarding odors from the ISS operations, spoils management and foaming on-site observed after hours. Vektor and WSP oversaw GSI implement soil management practices for ISS spoils (see foam deodorizing and covering of stockpiles with poly-sheeting) and documented site conditions upon the end of the shift.

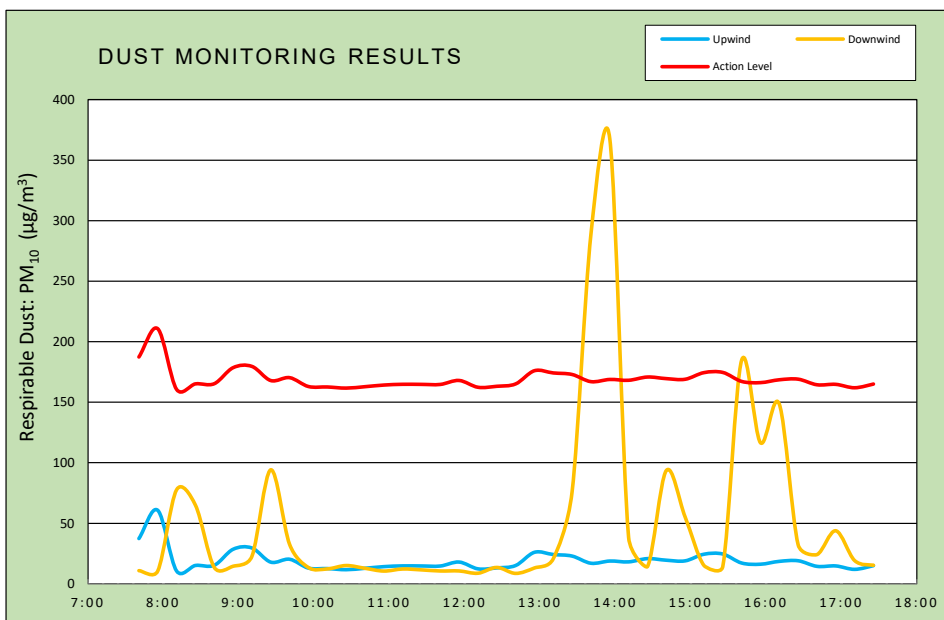
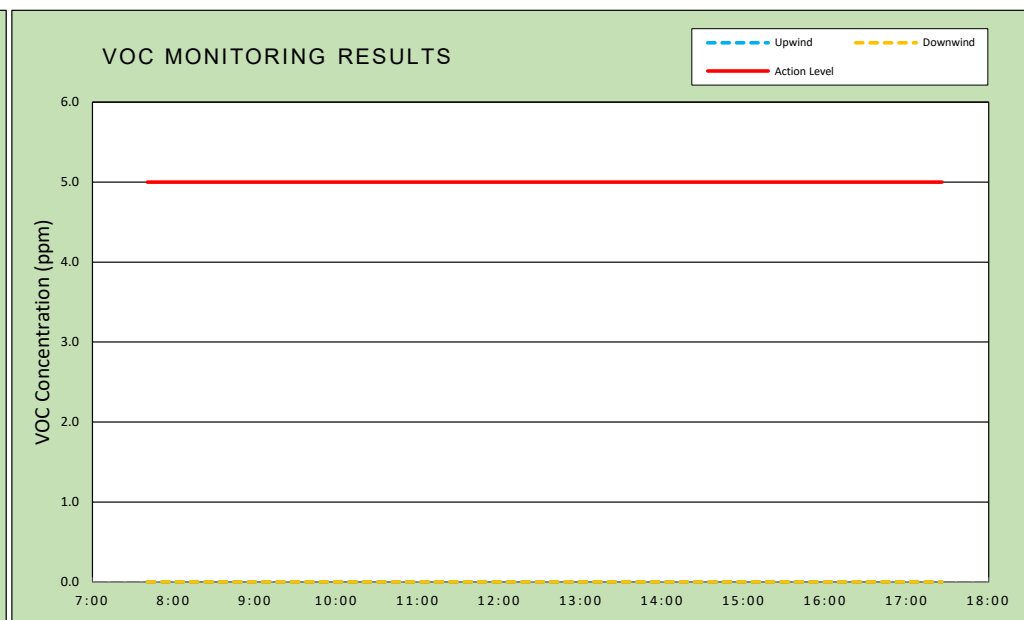
- Two particulate 15-minute average exceedances were recorded at the Downwind CAMP from 1:41 to 1:56 PM (Max. 0.3676 mg/m³) and from 3:41 to 3:56 PM (Max. 0.1847 mg/m³) due to the enclosure's proximity to the batch plant silo during materials delivery. The elevated readings were not due to intrusive work. GSI applied dust suppression with water and particulate readings returned to background levels.

Station Location	Daily Avg. Dust Concentration ($\mu\text{g}/\text{m}^3$)	Max 15-Min Dust Concentration ($\mu\text{g}/\text{m}^3$)	Time of Max Dust Reading	Daily Avg. VOC Concentration (ppm)	Max 15-Min VOC Concentration (ppm)	Time of Max VOC Reading
Upwind	19.1	60.7	7:56	0.0	0.0	7:41
Downwind	51.2	367.6	13:56	0.0	0.0	7:41

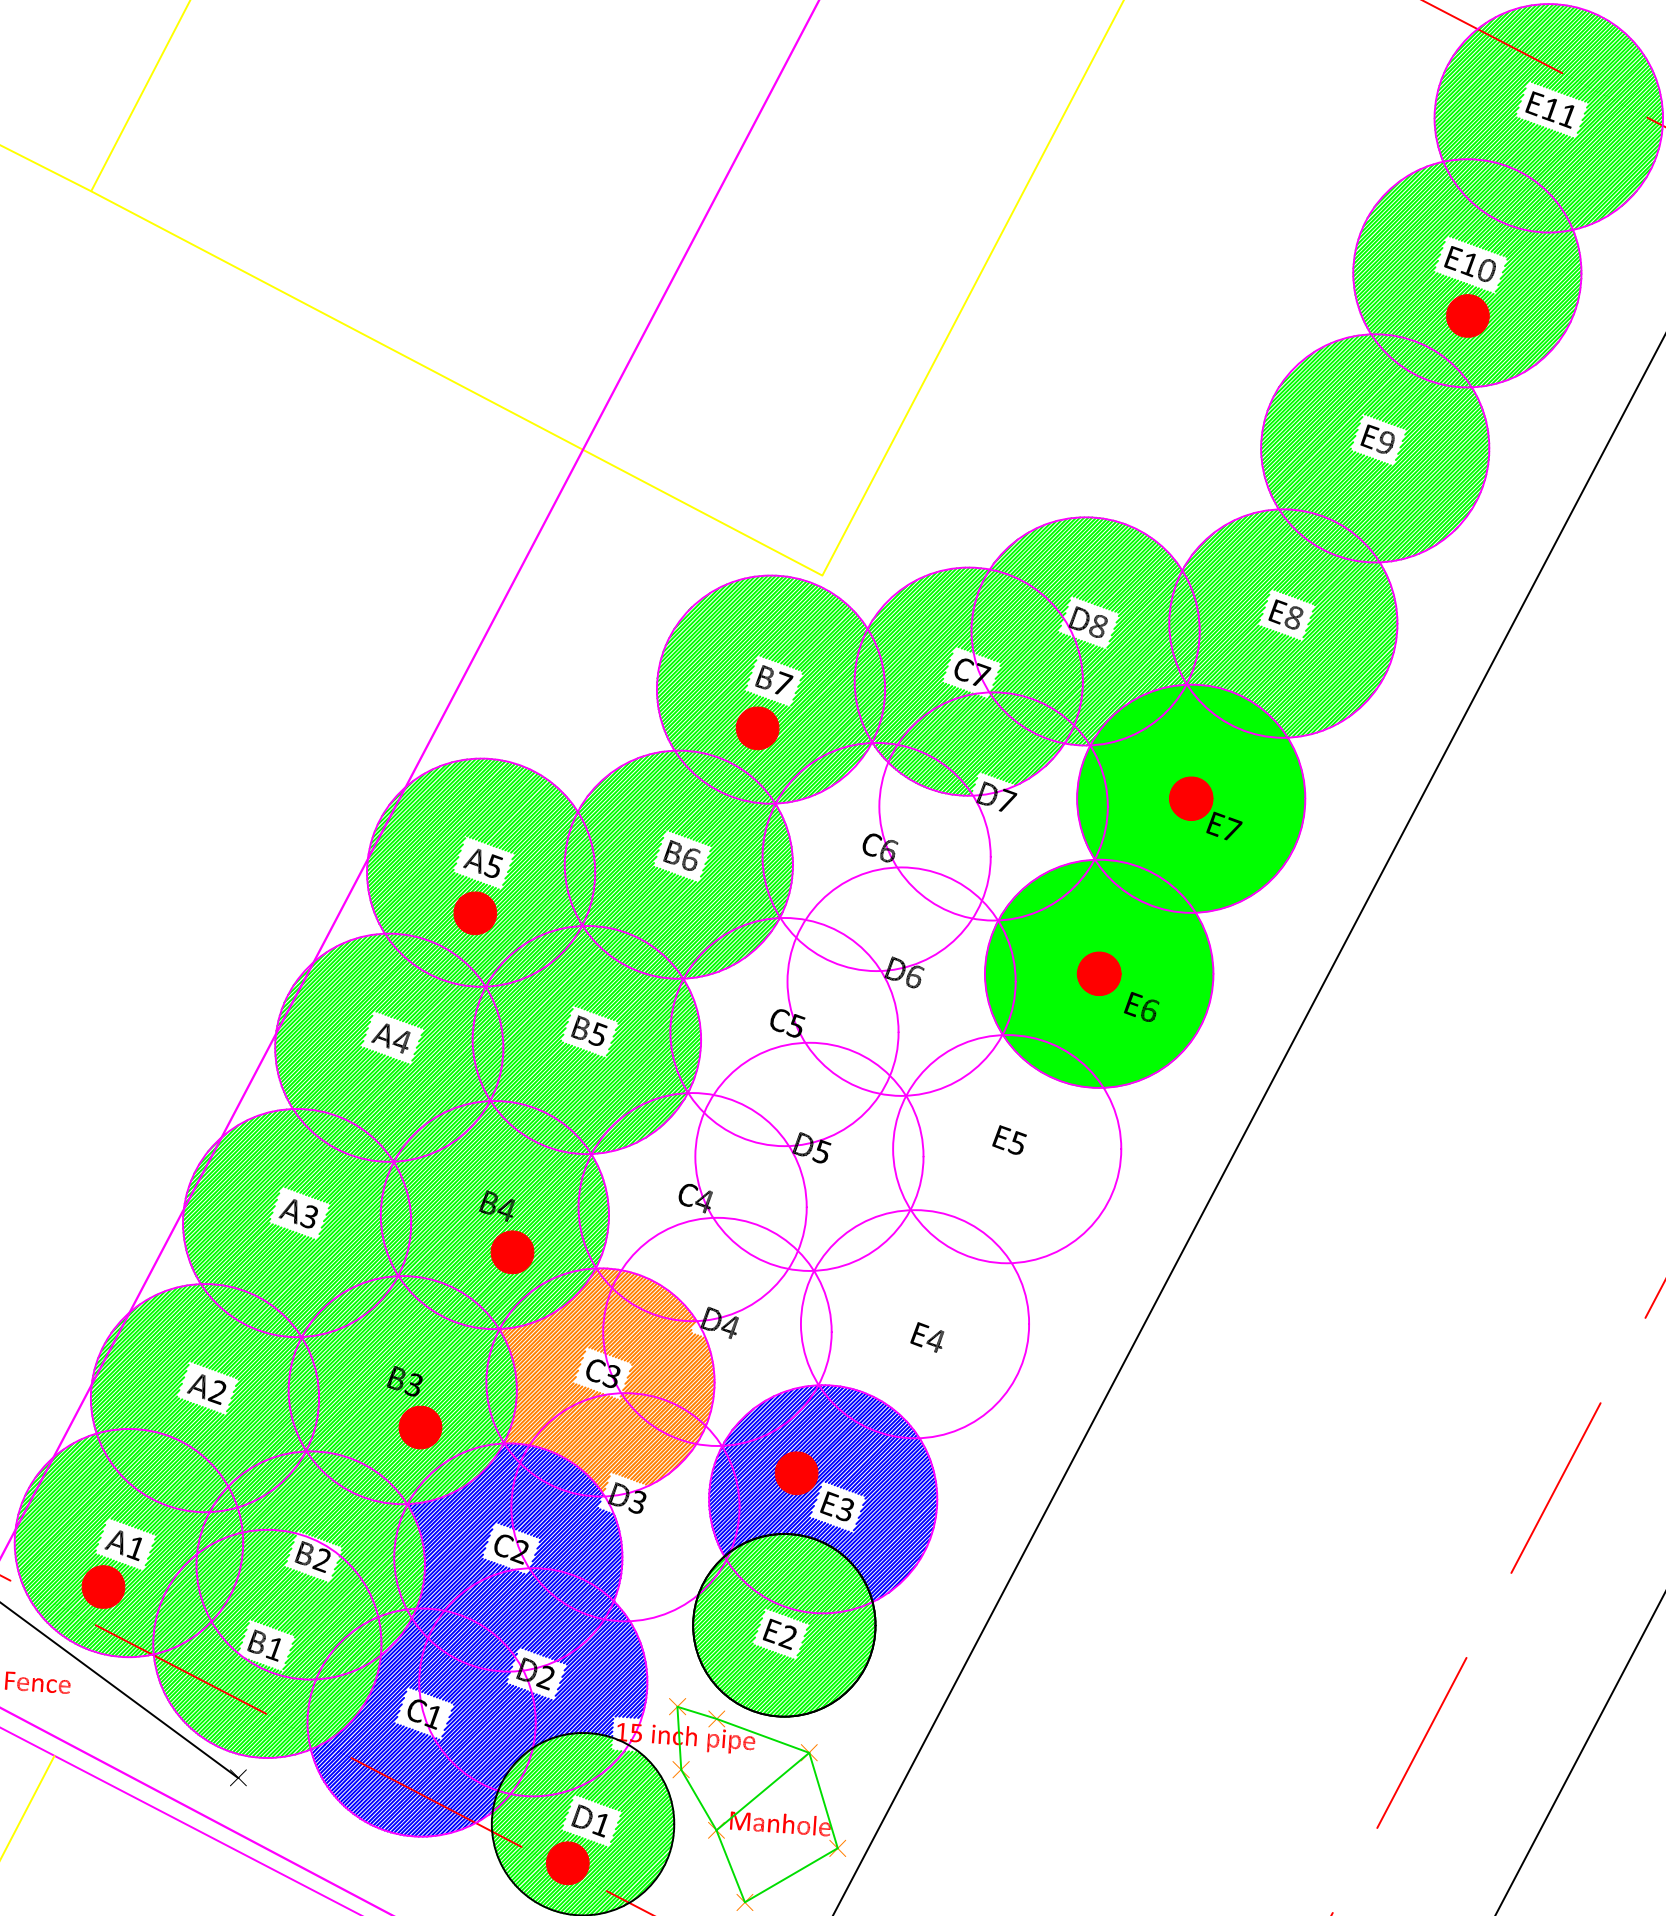
- Previously completed Columns
- Columns completed today
- Sampled Columns
- Obstructed Columns

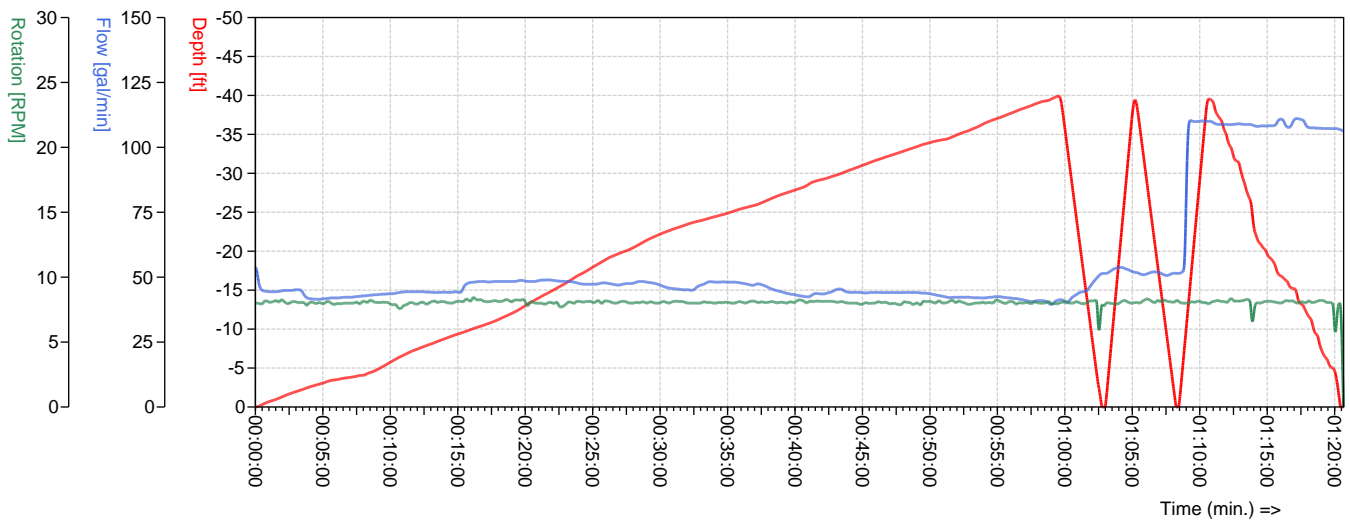
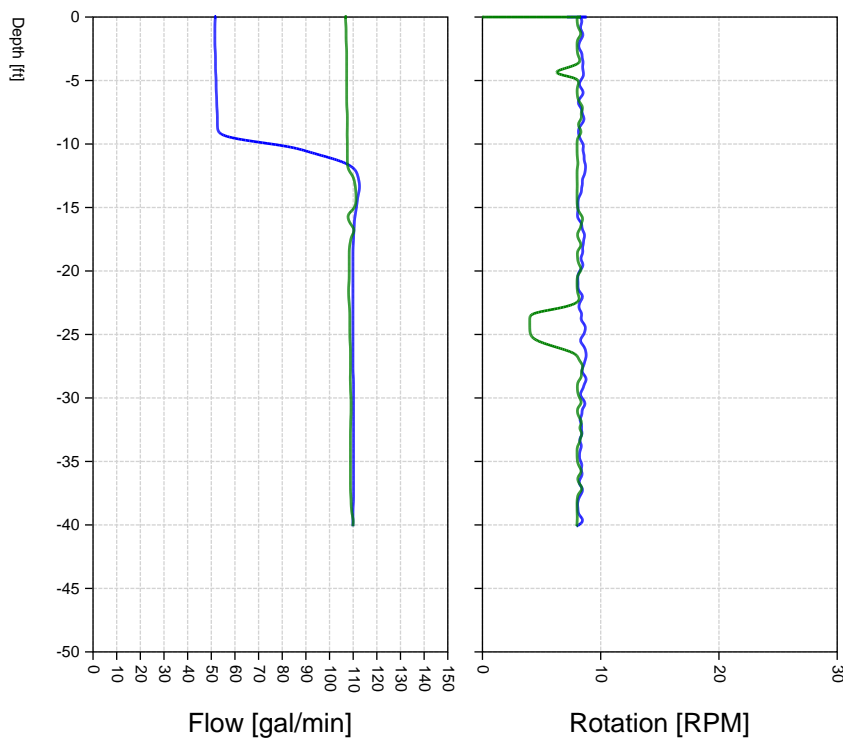
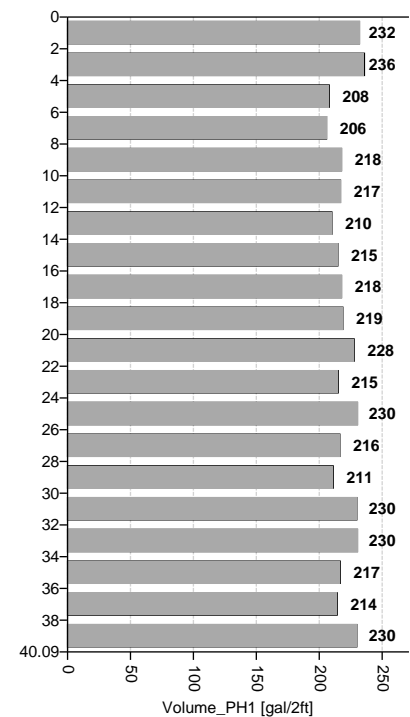
Data for Pile No: C1

Date: 9/24/2024
Start of production: 8:09:51 AM
End of production: 9:30:30 AM
Total time: 01:20:39
Pause time: 00:00:00

Pile length: 40.09 ft
Total Grout: 4413 gal
Strokes: 3

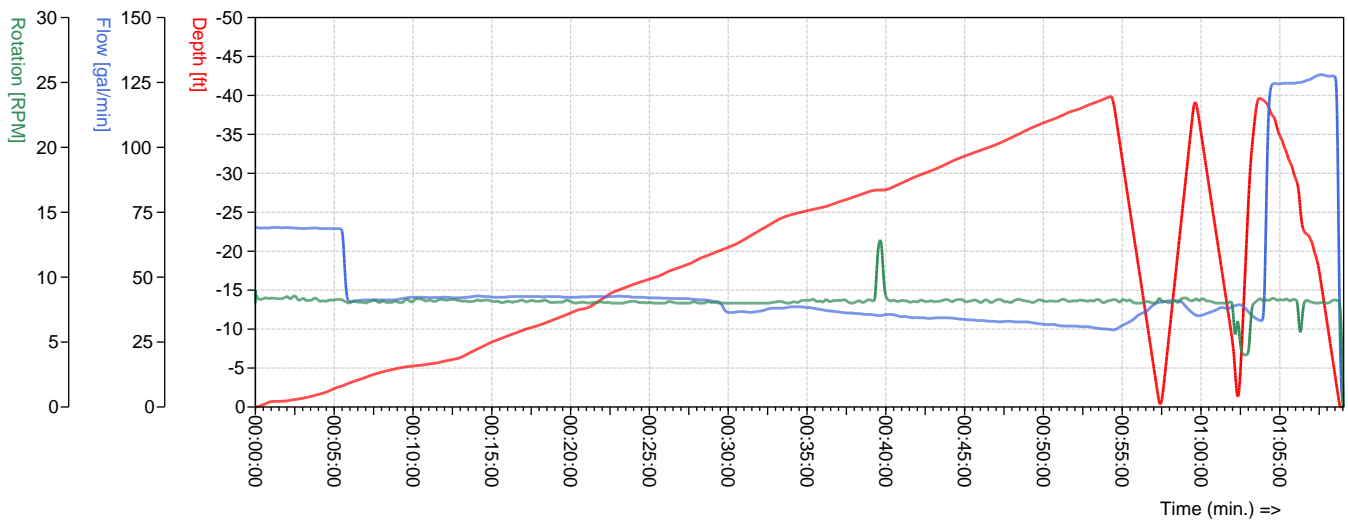
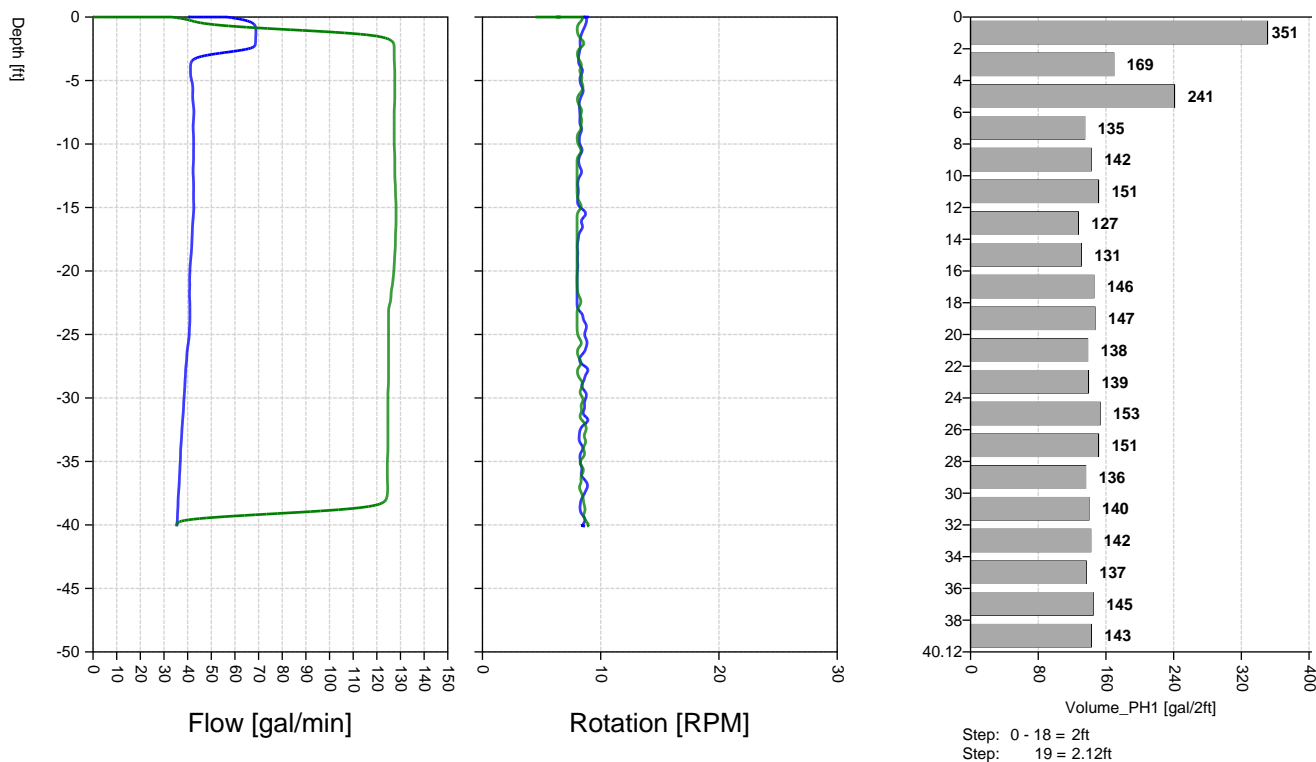
Data for Pile No: D2

Date: 9/24/2024
Start of production: 9:54:18 AM
End of production: 11:03:20 AM
Total time: 01:09:02
Pause time: 00:00:00

Pile length: 40.12 ft
Total Grout: 3190 gal
Strokes: 3

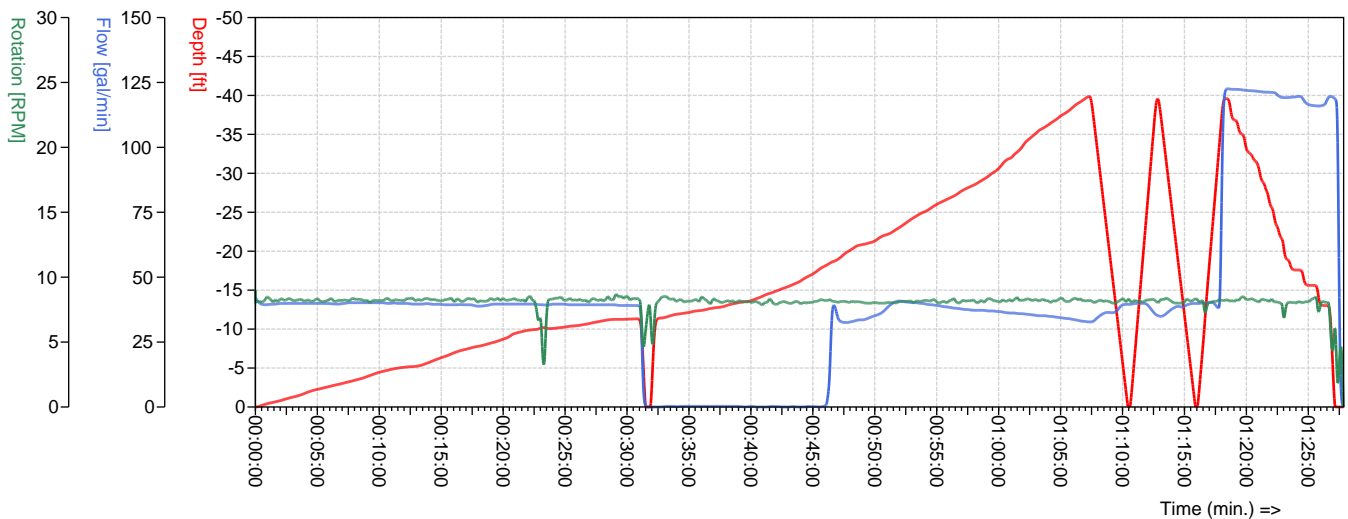
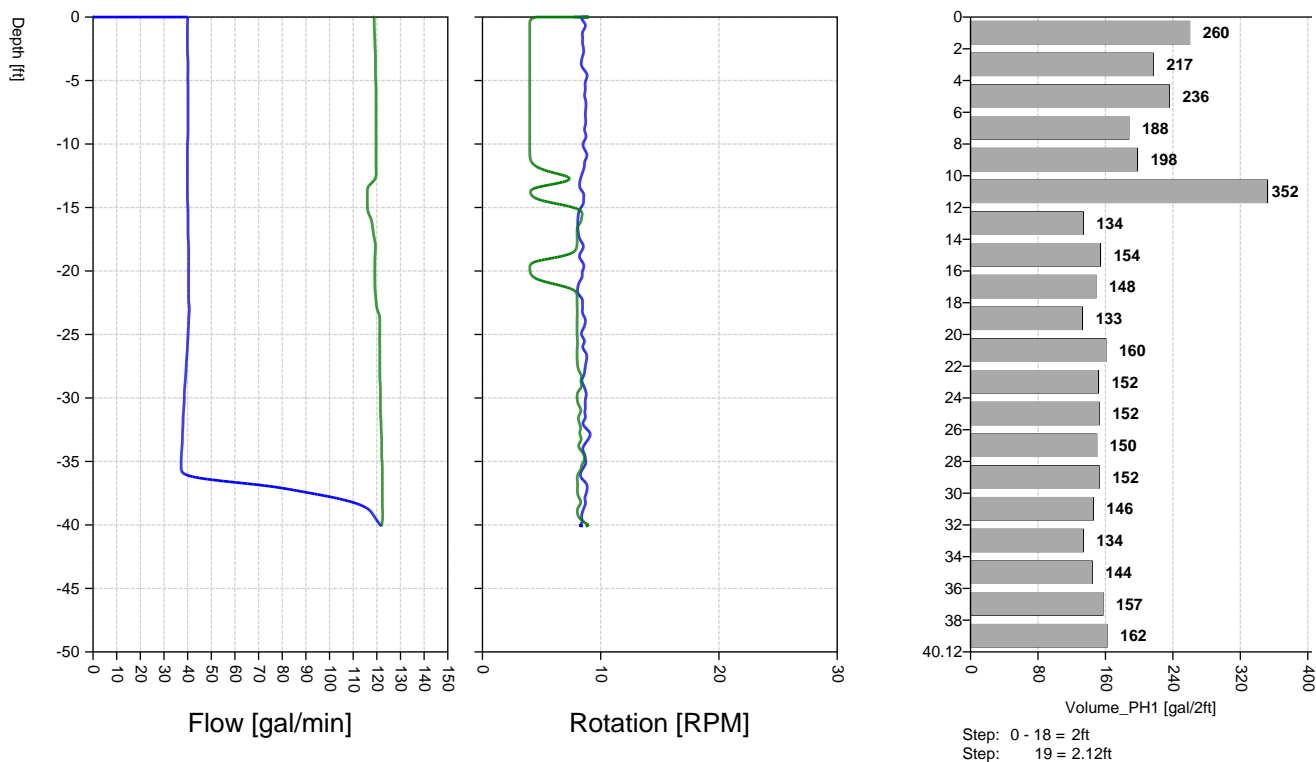
Data for Pile No: C2

Date: 9/24/2024
Start of production: 11:18:38 AM
End of production: 12:46:28 PM
Total time: 01:27:50
Pause time: 00:00:00

Pile length: 40.12 ft
Total Grout: 3543 gal
Strokes: 3

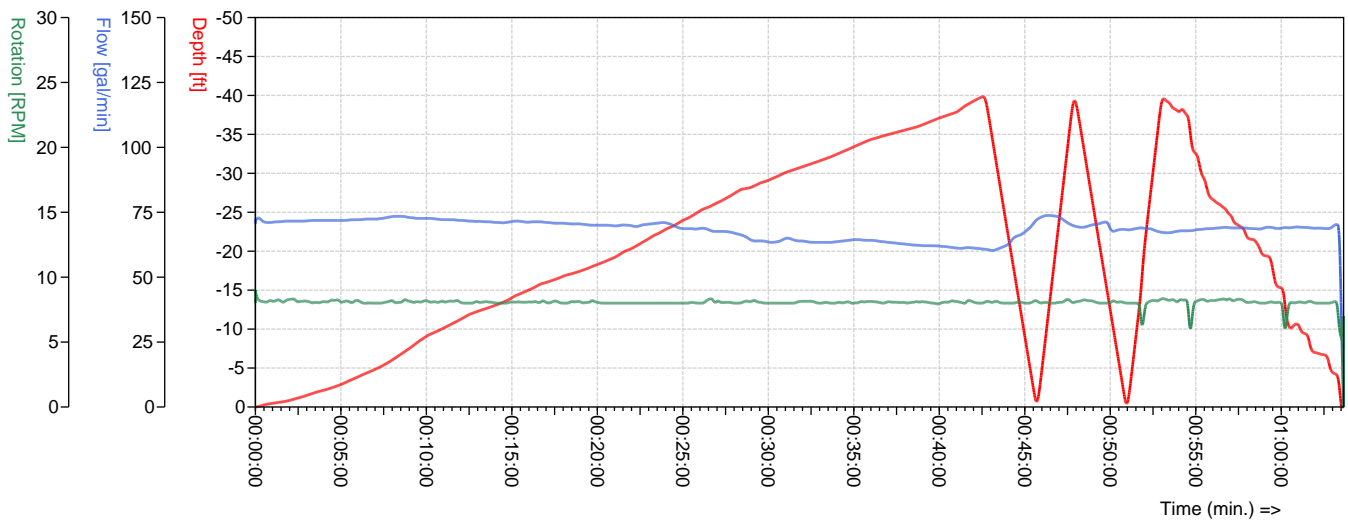
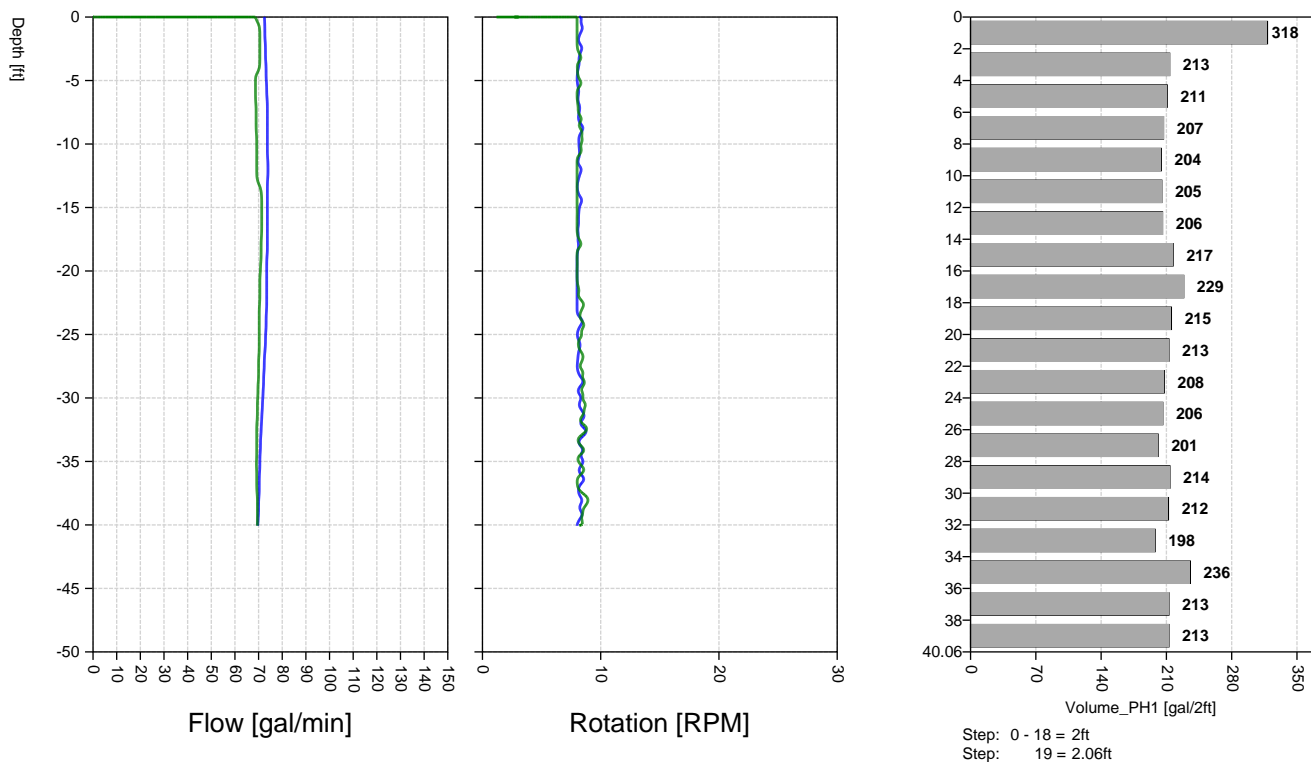
Data for Pile No: E3

Date: 9/24/2024
Start of production: 1:28:32 PM
End of production: 2:32:10 PM
Total time: 01:03:38
Pause time: 00:00:00

Pile length: 40.06 ft
Total Grout: 4347 gal
Strokes: 3

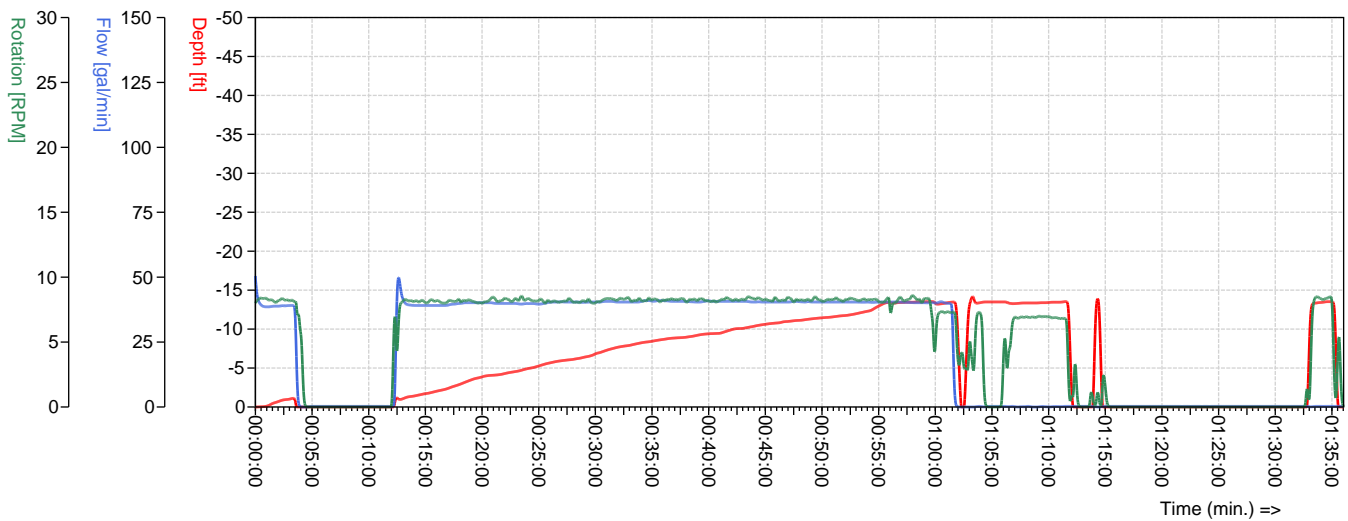
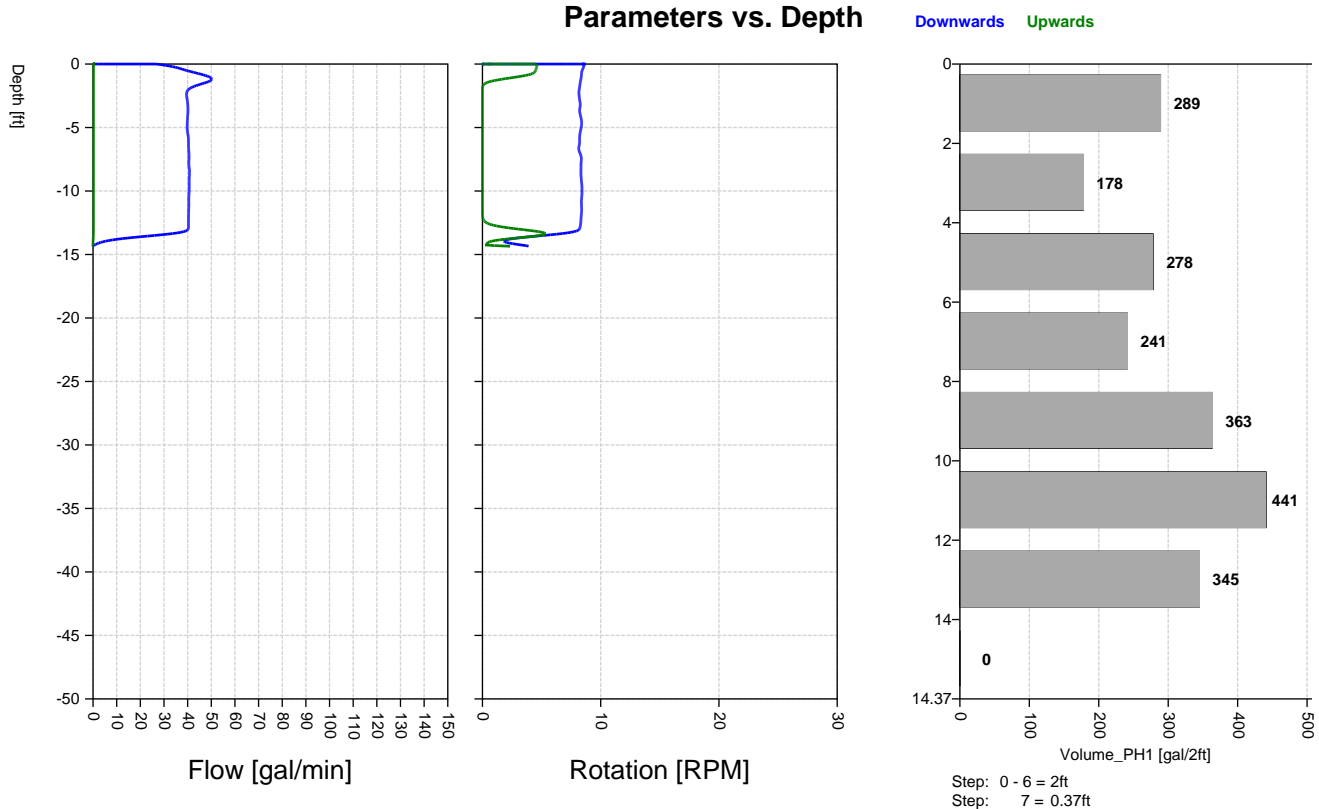
Data for Pile No: C3

Production Delays:					
GSI started drilling columns C3 and had an obstruction at 14.37ftbgs, GSI attempted to clear the obstruction using Kobelco 210 excavator for 30 minutes. GSI was unsuccessful in removing the obstruction. The column was abandoned with remaining grout and spoils. GSI will relocate and attempt the column during the next shift.

Date: 9/24/2024
Start of production: 2:56:28 PM
End of production: 4:32:29 PM
Total time: 01:36:01
Pause time: 00:00:00

Pile length: 14.37 ft
Total Grout: 2134 gal
Strokes: 4
