DAILY STATUS REPORT

Prepared By: Antonio Cardenas		WEATHER	Snow	Ra	ain		Overcast		Partly Cloudy	х	Bright Sun	
		TEMP.	< 32	32	2-50		50-70	х	70-85		>85	
NYSDEC BCP Site No: C224219				Date:				10/15/2024				
Project Name: 450 Union Street, Brooklyn, NY												
Consultant:					l On-S							
Vektor Consultants – Dominick Basilone			Geo-Solutions Inc Subcontractor Time On-Site:

N A B	t: +1. f: +1. e: infe	or consultants 347.871.0750 347.402.7735 o@vektorconsultants.com .vektorconsultants.com					
		S COLUMN LOCATIONS					
	Notes: 1. All feature locations are approximate 2. ISS-2S (B3) 9/03/2024 ISS-2C (B3/B4) 9/03/2024 ISS-3C (E6/E7) 9/03/2024 and 9/27/2024 ISS-4C (C1/C2) 10/08/2024 ISS-5C (C2/D2) 10/09/2024 ISS-5C (C2/D2) 10/09/2024 ISS-6C (B5/B6) 10/10/2024 ISS-7C (E9/E10) 10/11/2024 3. All areas (except E6 and E7) are entirely 9% design						
	Scale: AS SHOW Figure No.	N 8					
	Figure Name:	ISS Locations Plan					
	Report:	Excavation Work Plan					
	Date:	10/15/24					
	Drawn By:	КВ					
	Site Address:	450 Union Street Brooklyn, New York

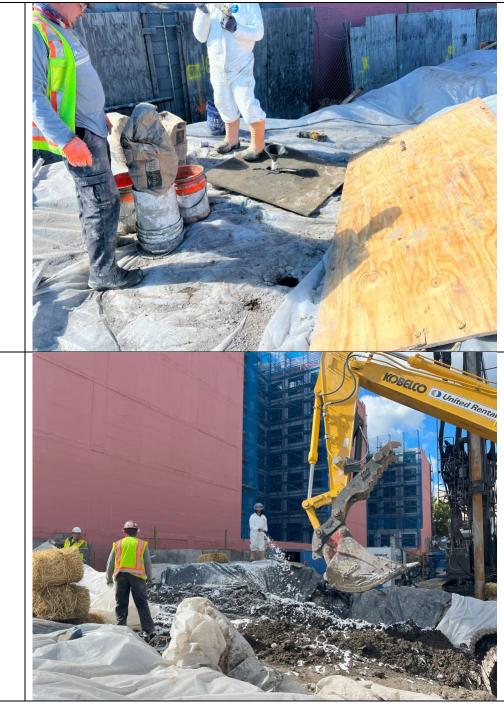
Photo 1: View of GSI filling ISS-4C, facing Southwest. Photo Log

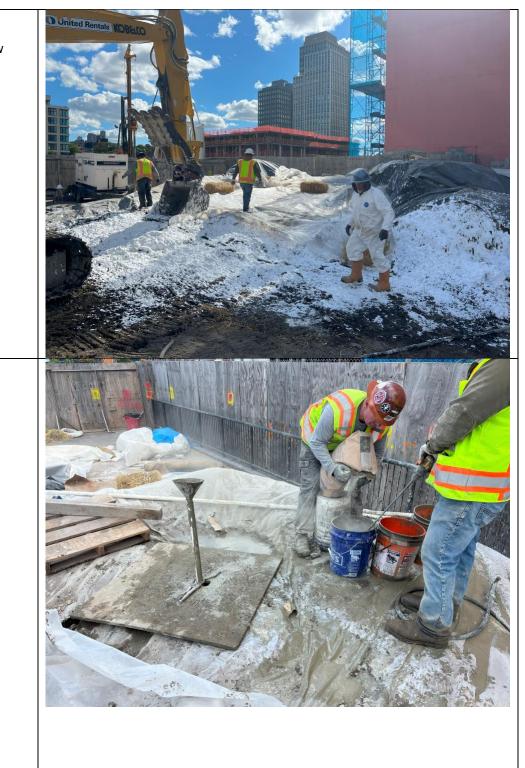
Photo 2: Moving and grading stockpile while applying foam deodorizer Photo 3: Exposed ISS Spoils in ISS area covered in foam deodorizer. View facing southwest

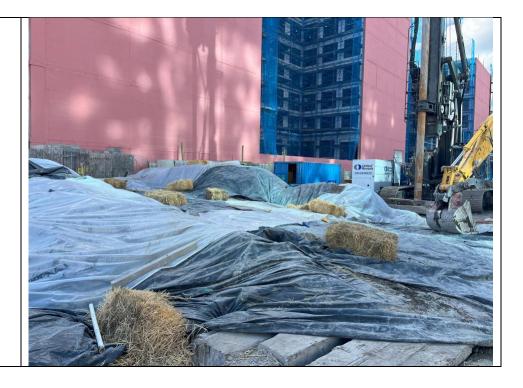
Photo 4: GSI filling ISS-5C with cement Photo 6: Poly sheeting placed atop of ISS spoils and secured at the end of the day, facing south.
