BROWNFIELD CLEANUP PROGRAM (BCP) APPLICATION FORM

The Atlantic Chestnut – Lot 1 project site (Site) is located at 3264 Fulton Street in the Cypress Hills neighborhood of Brooklyn, New York and is legally defined as Tax Block 4143, Lot 1. The Site is approximately 65,944 square feet and consists of a concrete and asphalt-paved parking and loading area (northern portion) and the northern extents of a series of vacant, interconnected, fire-damaged factory buildings (southern portion). The Site is rectangular in shape, and is bound by Fulton Street and the elevated J and Z Metropolitan Transit Authority (MTA) subway tracks to the north, Euclid Avenue, followed by residential properties to the east; vacant manufacturing buildings to the south; and Chestnut Street, followed by commercial properties to the west. The Site is located in a developed area predominantly consisting of residential, commercial, transportation, and manufacturing properties. A Site Location map is included as *Figure 1* in *Attachment B*.

FIGURES

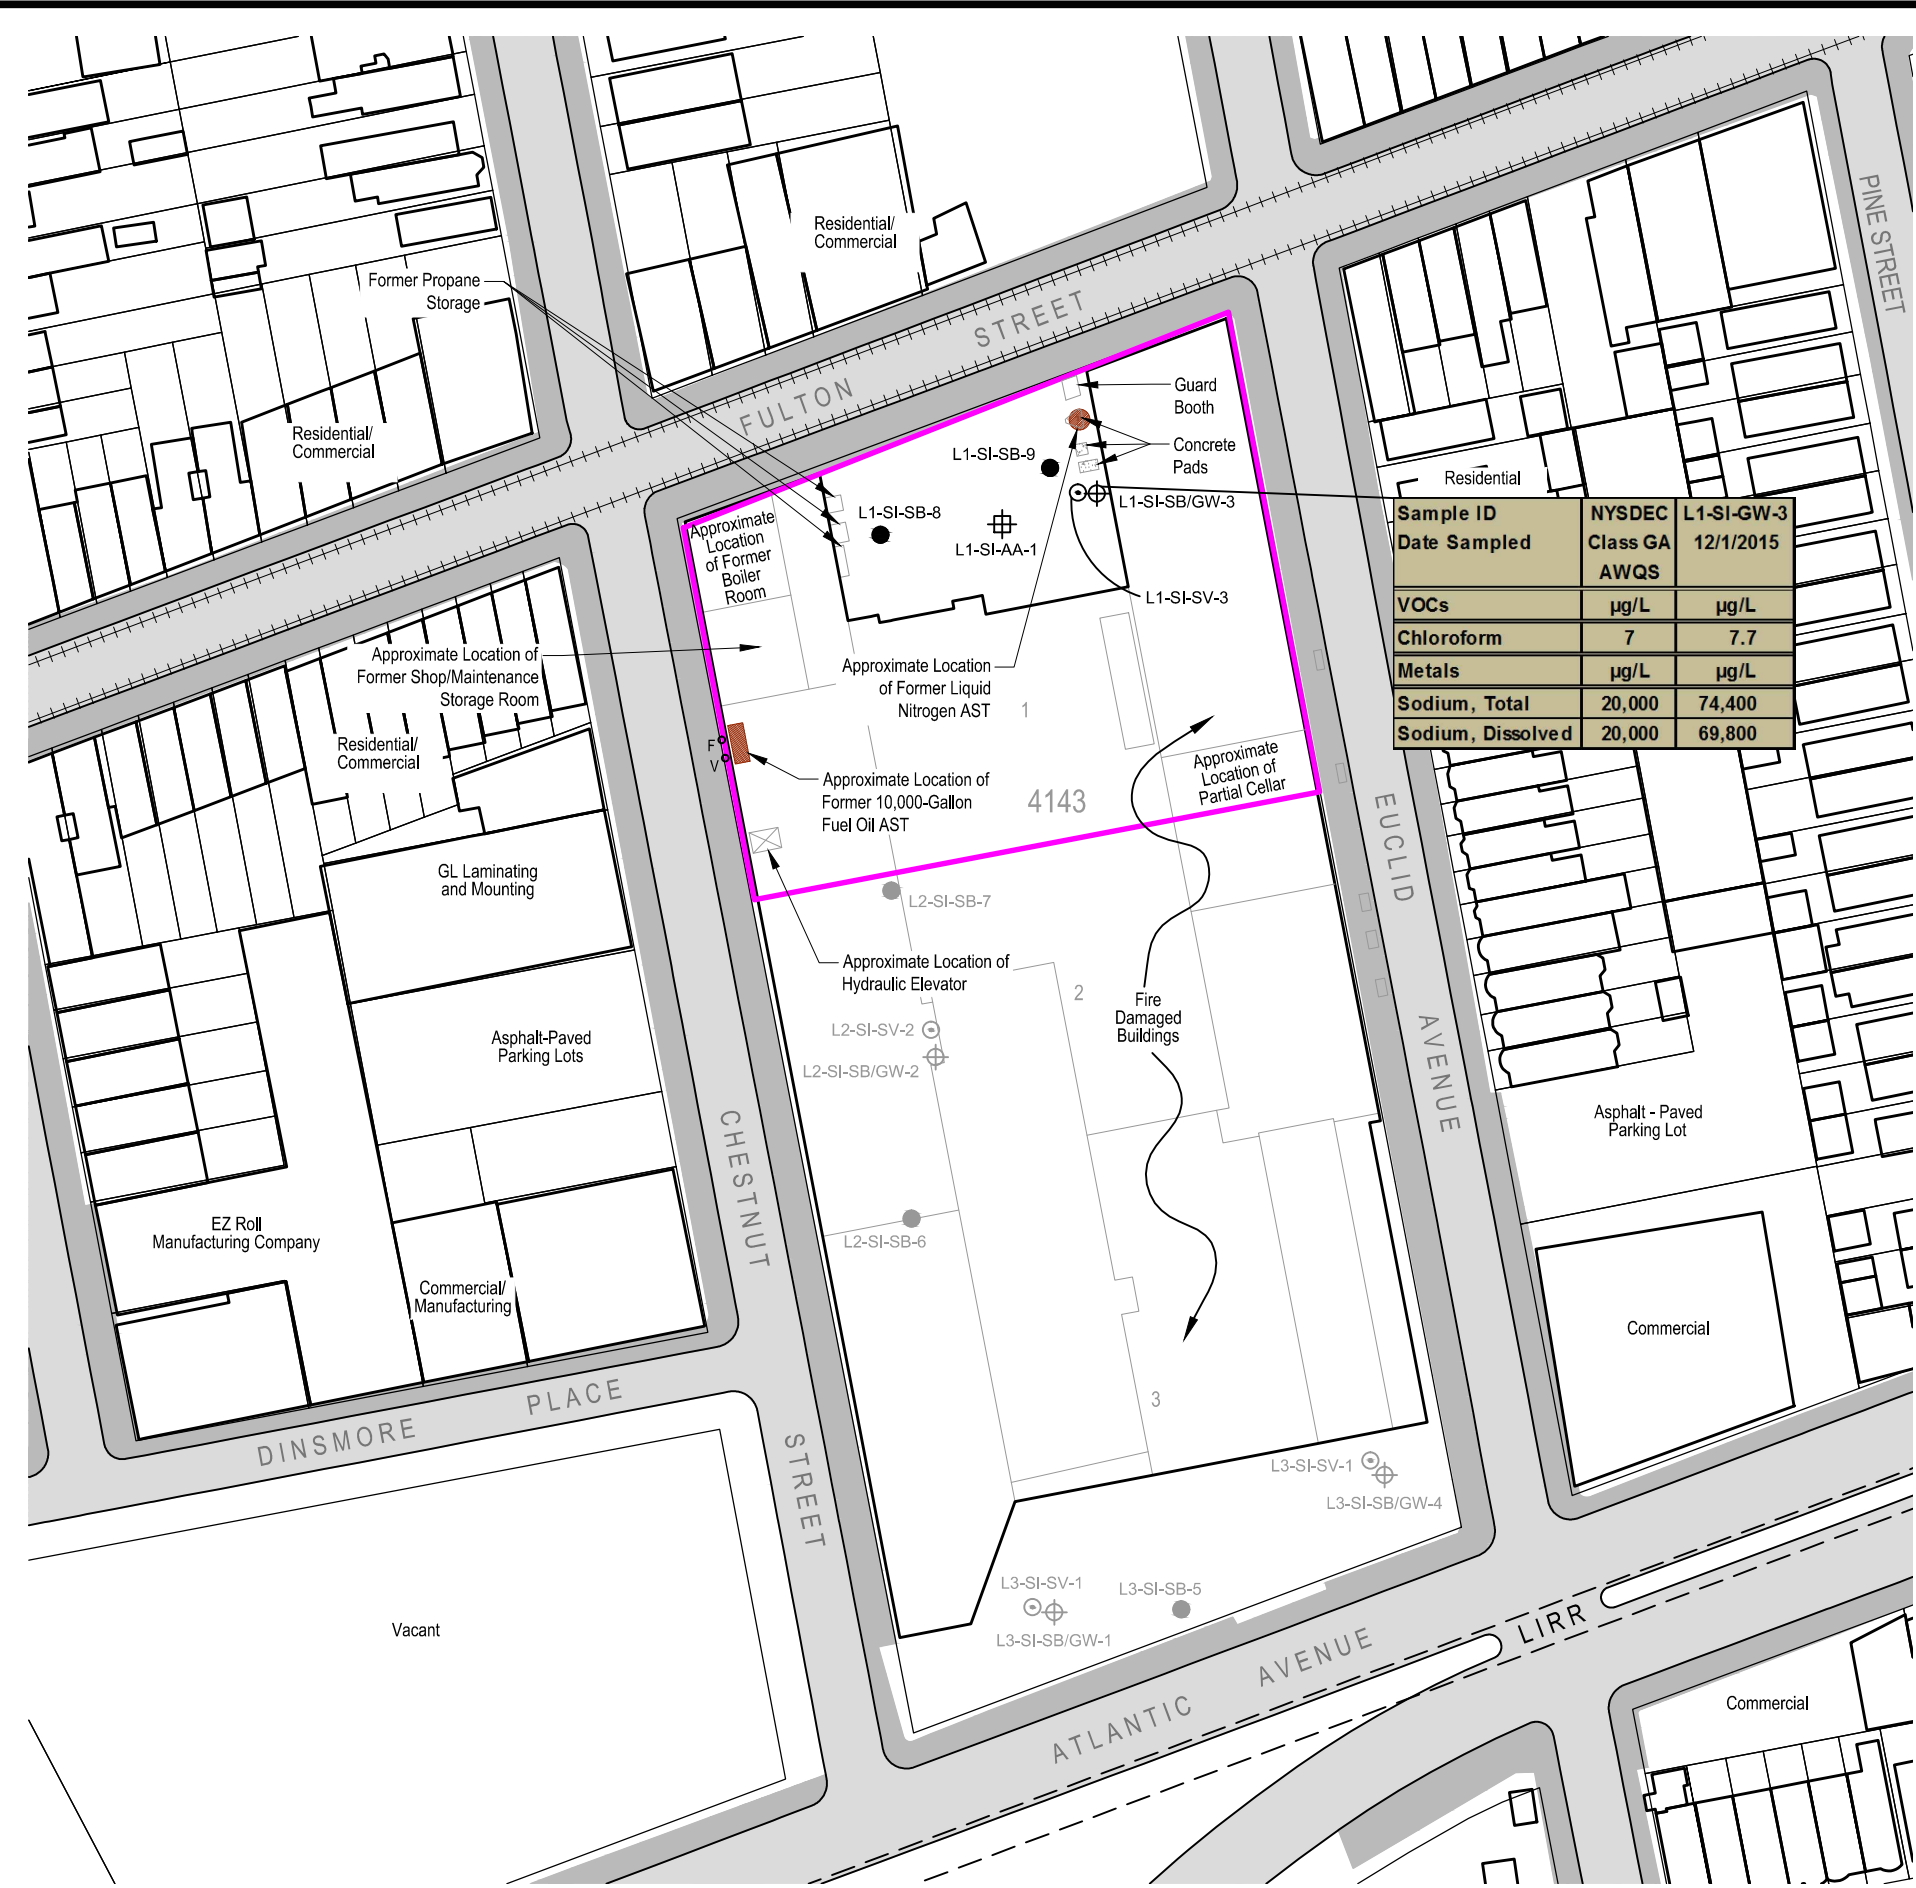
Sample ID	NYSDEC Class GA AWQS	L1-SI-GW-3 12/1/2015
VOCs	µg/L	µg/L
Chloroform	7	7.7
Metals	µg/L	µg/L
Sodium, Total	20,000	74,400
Sodium, Dissolved	20,000	69,800

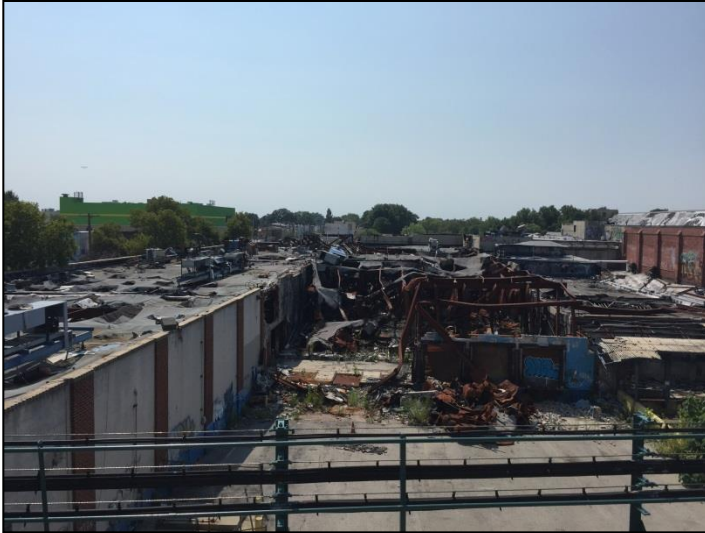
Photograph 1: View of the eastern exterior portion of the Site, facing south.

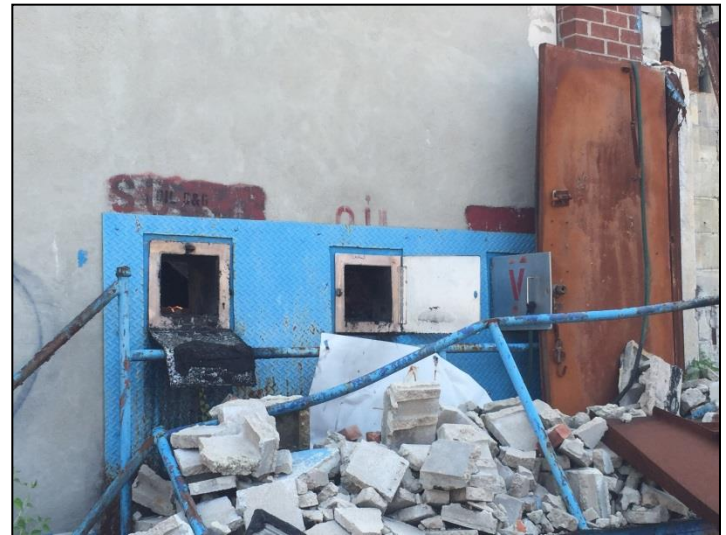
Photograph 4: Former apparent fuel oil fill ports on the eastern portion of the Site.

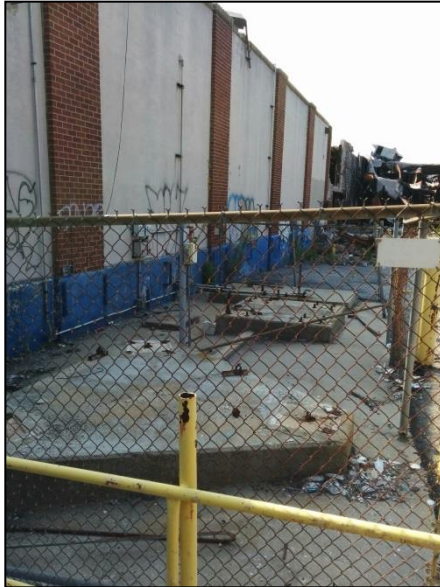
Photograph 5: Concrete pads at former liquid nitrogen tank locations on the eastern portion of the Site, facing south.

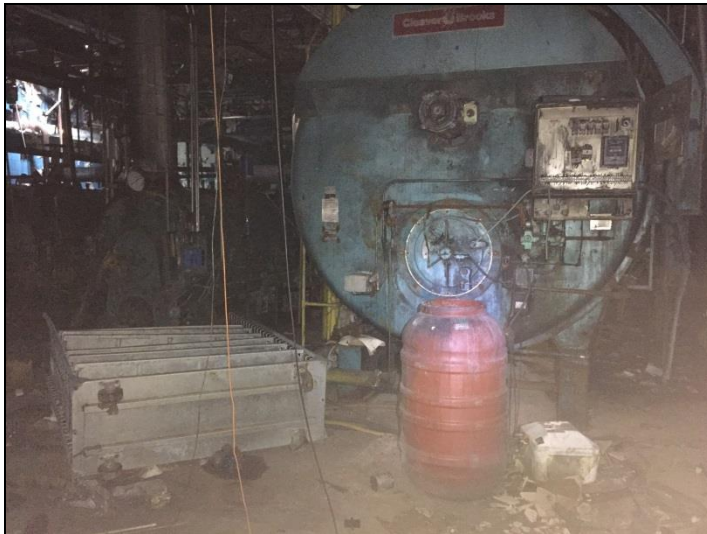
Photograph 7: Former boiler room in the northwestern portion of the Site buildings.

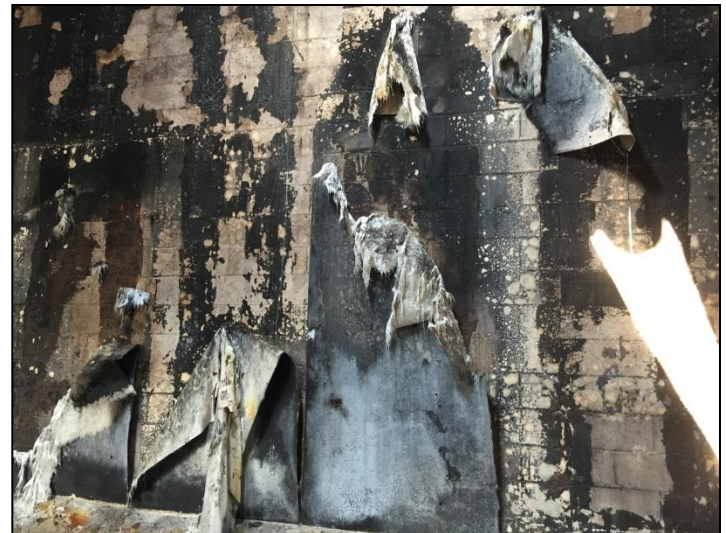
Photograph 8: Fire damage to the eastern portions of the Site buildings.

- The interconnected factory buildings on the southern portion of the Site were damaged by a fire in 2012. Abundant debris, including metal, wood, and ash were observed throughout the buildings during the Site inspection. Based on the documented storage of petroleum and chemicals, undocumented discharges due to the fire may have affected subsurface conditions at the Site, including high concentrations of metals and semivolatile organic compounds (SVOCs) in the ash.
