**PHASE I ENVIRONMENTAL SITE ASSESSMENT REPORT**

***Property located at 80 Richards Street***

***In Brooklyn, New York***

***October 2, 2003***

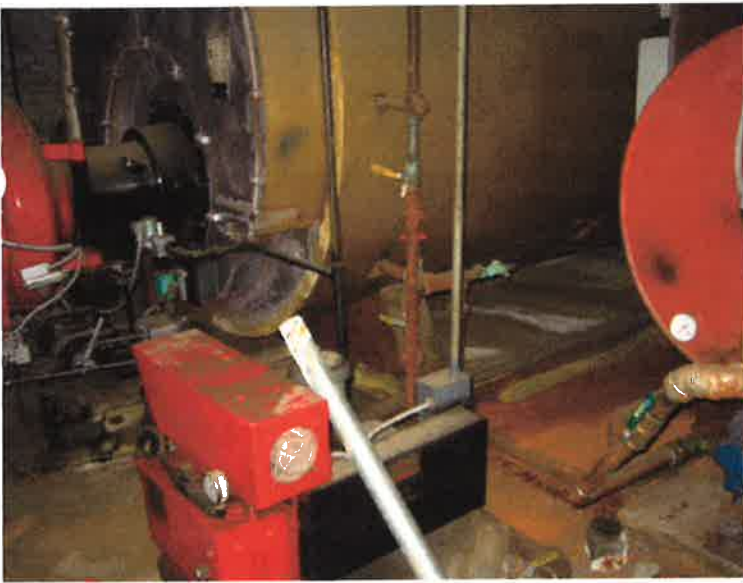
***BOILER IN BASEMENT OF LARGE BUILDING***

*The boilers in the basements were not insulated by friable Presumed Asbestos Containing Material (PACM). However, the overhead pipes in the basement of the large building were insulated by PACM. This majority of this material has been encapsulated and was in good condition. Removal of this material is not recommended (it should be noted that there was previously PACM on the overhead pipes on the upper floors that has been removed). There were no signs of PACM fireproofing noticed inside the buildings.*

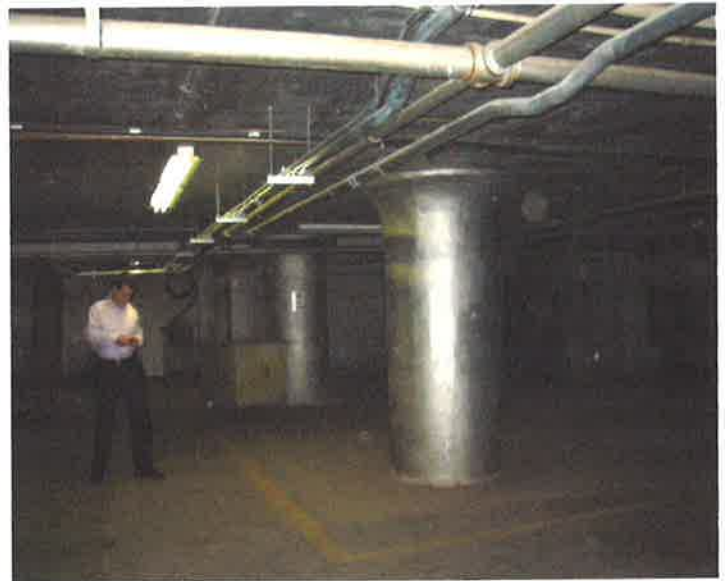
***BASEMENT OF LARGE BUILDING***

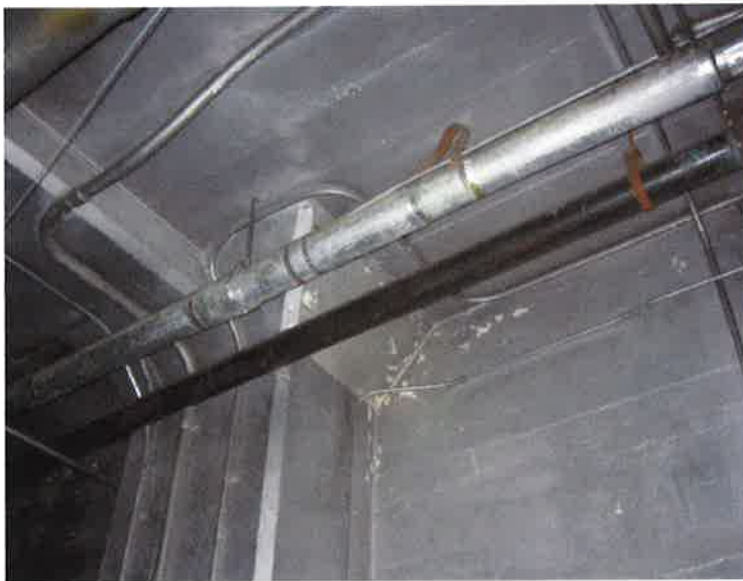
*The boiler in the basement of the large building was not insulated by friable Presumed Asbestos Containing Material (PACM). However, the overhead pipes in the basement were insulated by PACM. This majority of this material has been encapsulated and was in good condition. Removal of this material is not recommended (it should be noted that there was previously PACM on the overhead pipes on the upper floors that has been removed). There were no signs of PACM observed in the smaller building.*

***PACM ON PIPES IN BASEMENT***

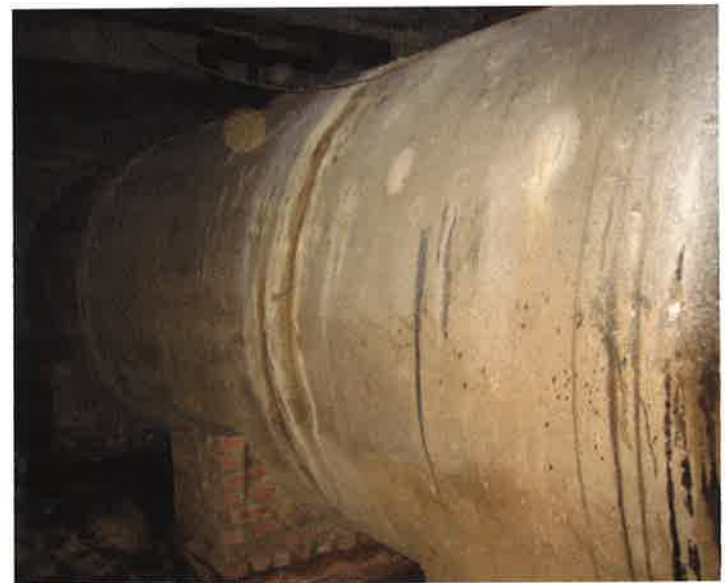
***HEATING OIL TANK IN BASEMENT***

*The large building is heated by oil that is stored in a 5,000 gallon above ground storage tank. This tank did not show any signs of staining or leakage. This tank is properly registered with the NYCFD. However, this tank is not presently registered with the NYSDEC and it is recommended that this tank be properly registered as soon as possible.*

*It is the opinion of Middleton Environmental Incorporated that no further testing (subsurface or otherwise), is required on the subject site. However, it is recommended that the 5,000 gallon above ground heating oil storage tank for the larger building be properly registered with the NYSDEC as soon as possible. It is also recommended that the piles of debris and 55 gallon drums behind the smaller building be removed from the site.*

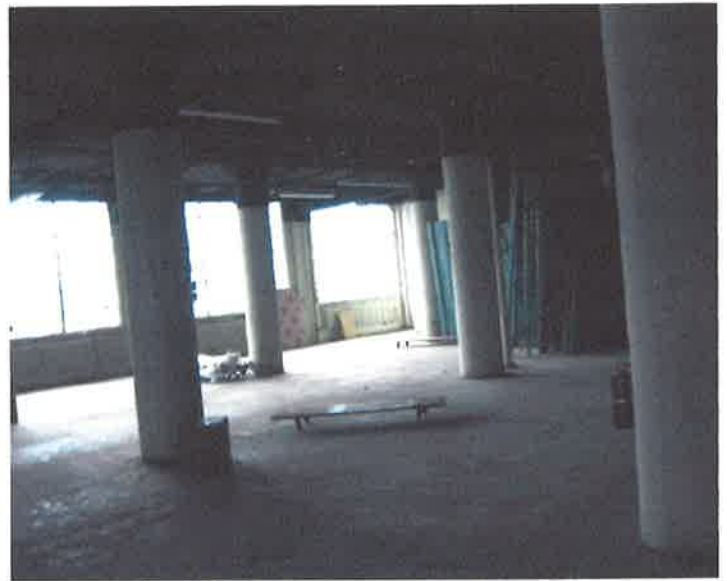
***4TH FLOOR AREA***

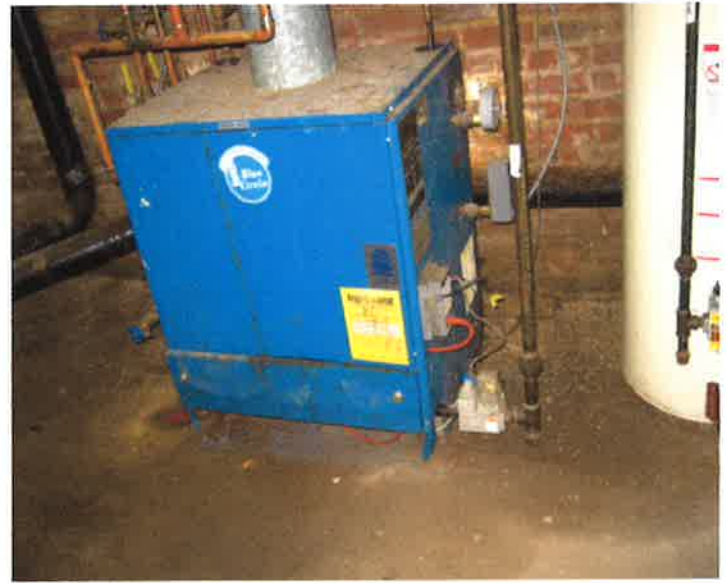
***BOILER IN SMALLER BUILDING***

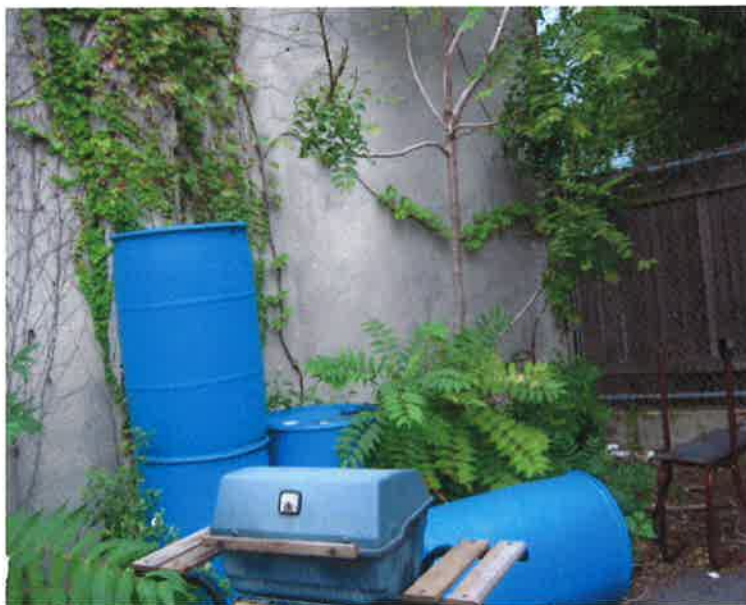
***DRUMS BEHIND SMALLER BUILDING***

*There were no 55 gallon drums noticed inside the buildings. However, there were six (6) unmarked 55 gallon drums noticed behind the smaller building that did not show any signs of leakage. It is recommended that these drums be removed from the subject site.*

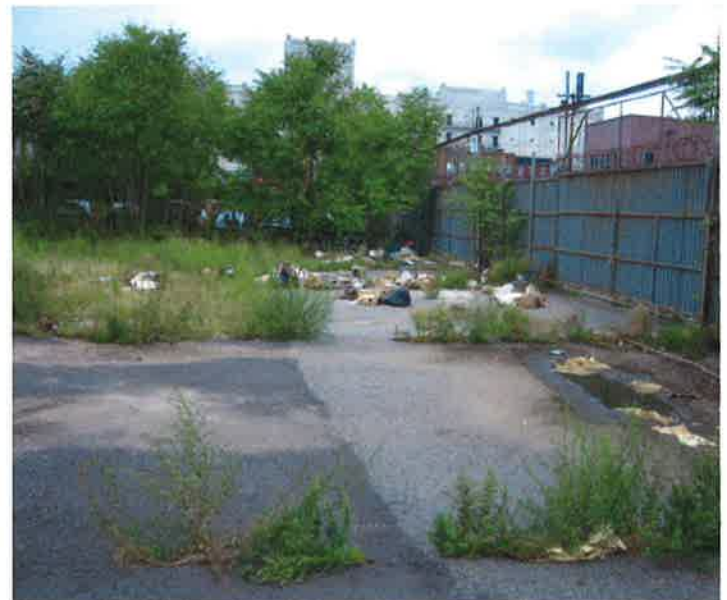
***DEBRIS OUTSIDE BUILDINGS***

*All solid wastes generated on-site are carted away by a licensed waste hauler to an approved solid waste facility and are not disposed on-site. There were no areas on site that appeared to be filled or graded by non-natural causes. There were several piles of miscellaneous debris noticed outside the large building and it is recommended that these piles be removed from the site.*
