# 85 Jay Street

Brooklyn, New York

## PHASE I ENVIRONMENTAL ASSESSMENT AKRF Project Number 20111

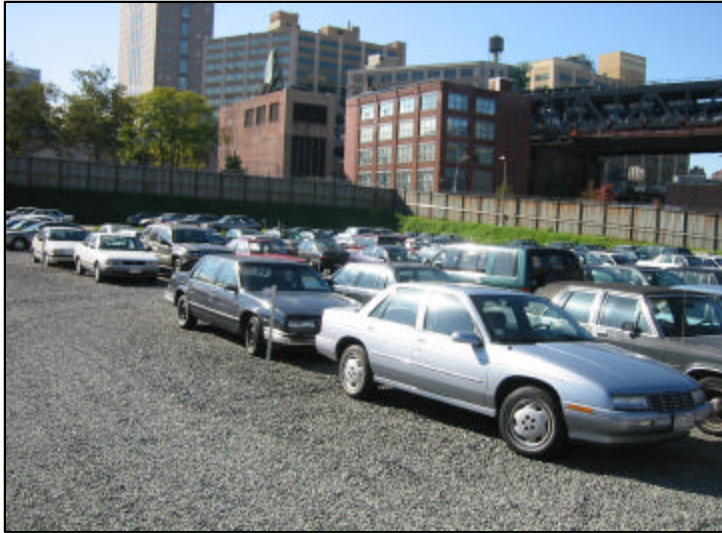
Photograph 1: Parking lot portion of Site facing southeast.

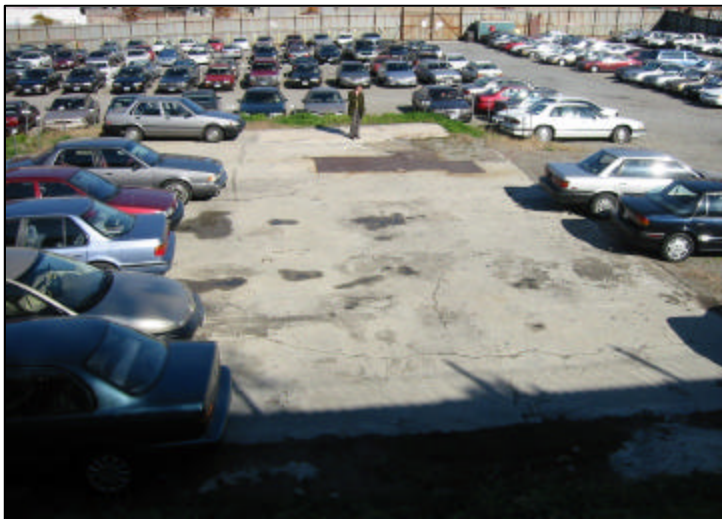
The parking lot portion of the Site contained street lamps inside the fence at regular intervals. Two concrete pads were observed against the eastern wall of the parking lot portion of the Site (Appendix A, Photos 3 and 5). The larger, west-adjacent pad was approximately 40' x 30', and had four metal plates at the western end of the pad. The plates appeared to be welded to the pad. The concrete was in fair to poor condition with large cracks and depressions throughout the pad. Steel I-beams were noted in the concrete at six-foot intervals. The pad was slightly elevated from the rest of the sight, approximately two feet above grade. The east-adjacent pad was smaller, approximately 24' x 18', and was approximately three feet above grade. The concrete of the small pad had no protrusions, and was generally in good condition. Mr. Cady did not know the purpose of the concrete pads.

Photograph 3: Large concrete pad on the parking lot portion of the Site.

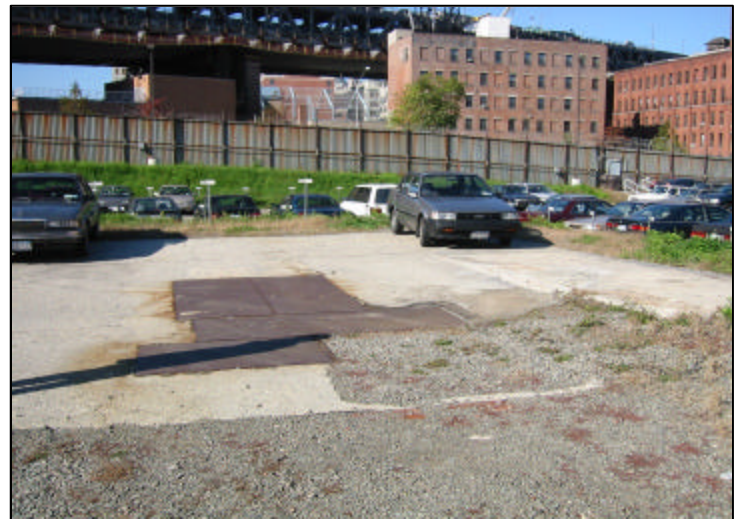
- During the site inspection, a concrete pad with four steel plates was noted against the southern perimeter of the western parking lot. These plates could indicate the presence or former presence of underground storage tanks.

During the site inspection, a concrete pad with four steel plates was noted against the southern perimeter of the western parking lot. These plates could indicate the presence or former presence of underground storage tanks, but a review of the State regulatory records did not cite any underground storage tanks for the subject property. New York City Fire Department and/or Manhattan Buildings Department records were not reviewed for the subject property as part of this assessment.

Photograph 4: Four steel plates on the concrete pad.

Prior to activities that disturb the soil, AKRF recommends conducting a subsurface (Phase II) investigation to determine whether contamination is present in the soil and/or groundwater beneath the subject property. Soil and groundwater samples should be collected in areas of the Site where historical industrial operations took place, such as where corroding beds were located for the lead

company, the area of the former smelting company, and the area of the former electrical substation. To determine whether adjacent off-site potential sources of contamination have affected the study site, samples should be taken from areas of the Site adjacent to Apex Thermoplastics and the former manufactured gas plant. In addition, AKRF recommends removing the metal plates from the concrete pad and excavating test pits to determine whether underground storage tanks are present.

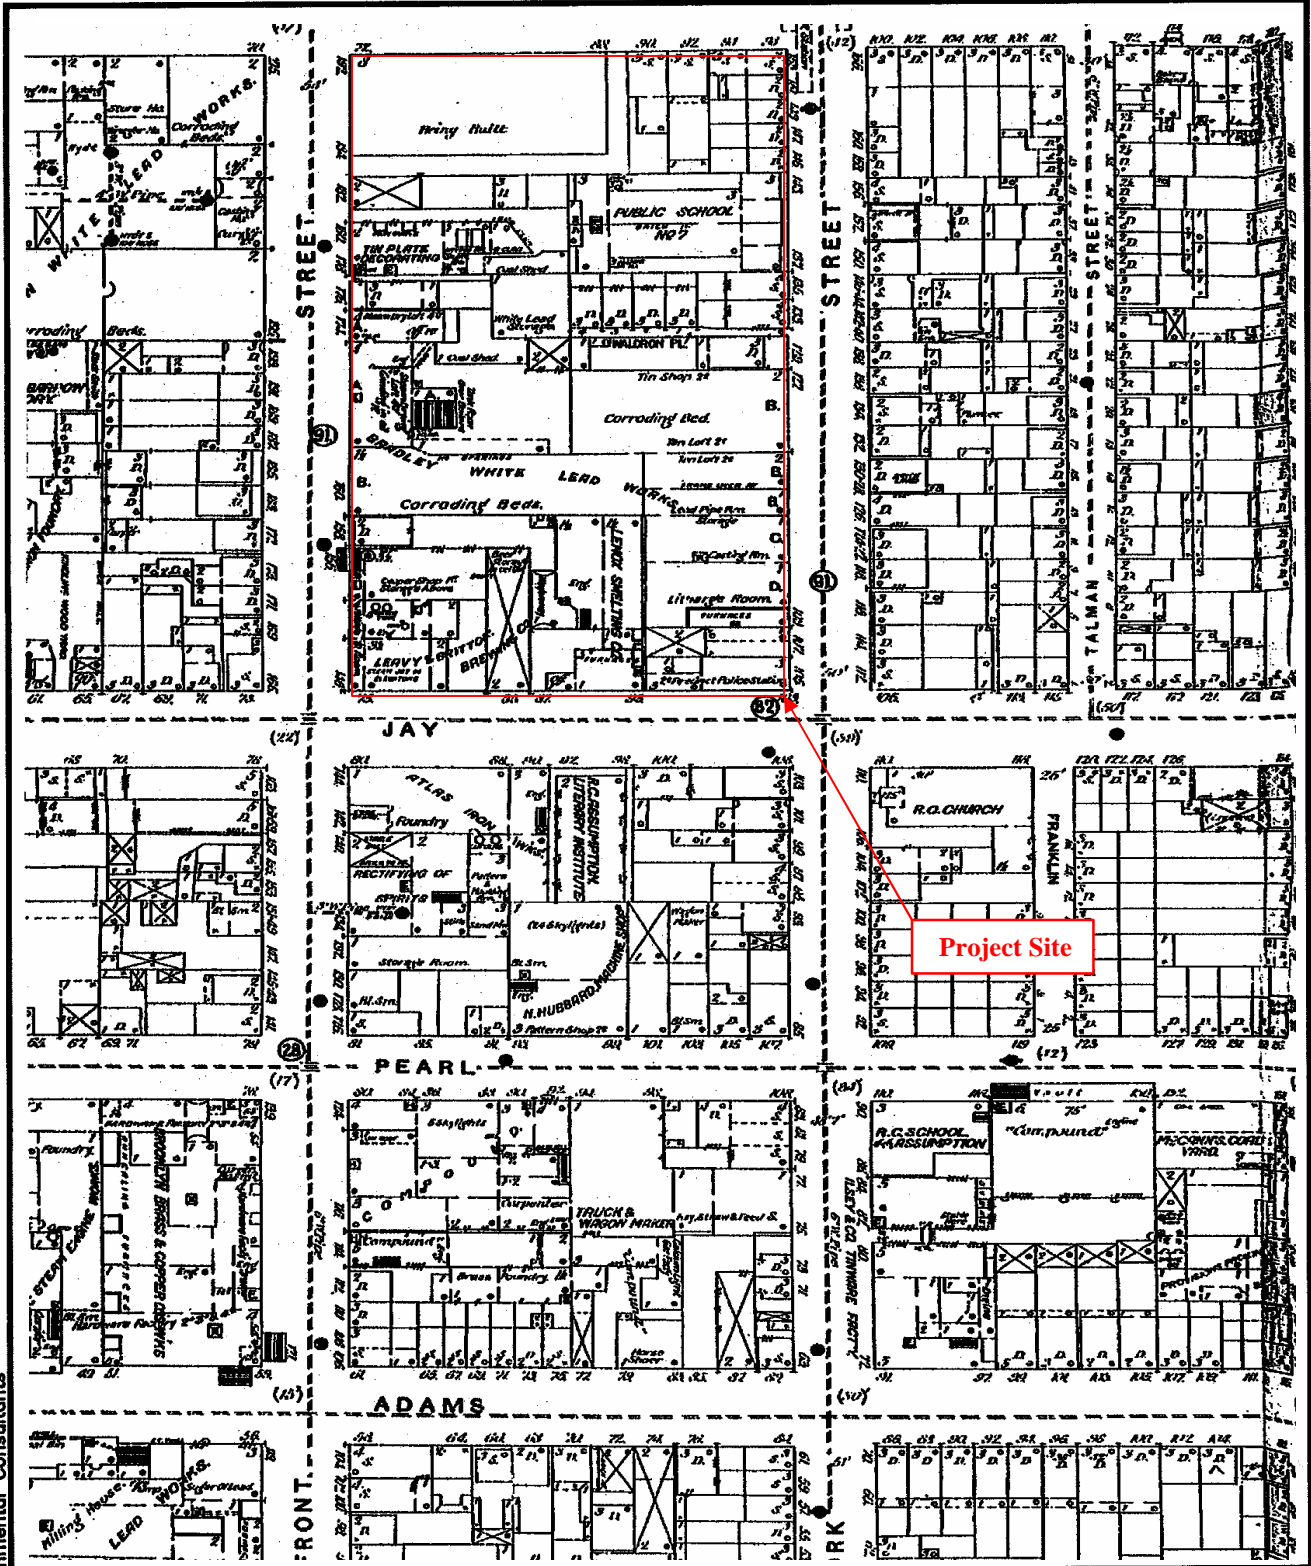
1887 Sanborn

The eastern portion of the subject property was shown to contain Public School No. 7, a tin plate decorating company with an associated coal shed, and three-story residential dwellings above ground floor stores. The middle of the subject property was occupied by Bradley White Lead Works, containing a coal shed, four horizontal boilers, two corroding beds, and storage and office space. The western portion of the subject property contained Leavy & Britton Brewing Co. and Lenox Smelting Co.

The west-adjacent block was occupied by an iron foundry, a literary institute, a machine shop and residential and commercial spaces. The north-adjacent block was occupied by Union White Lead works, an iron wheelbarrow factory and an iron foundry. The south-adjacent block was primarily residential.

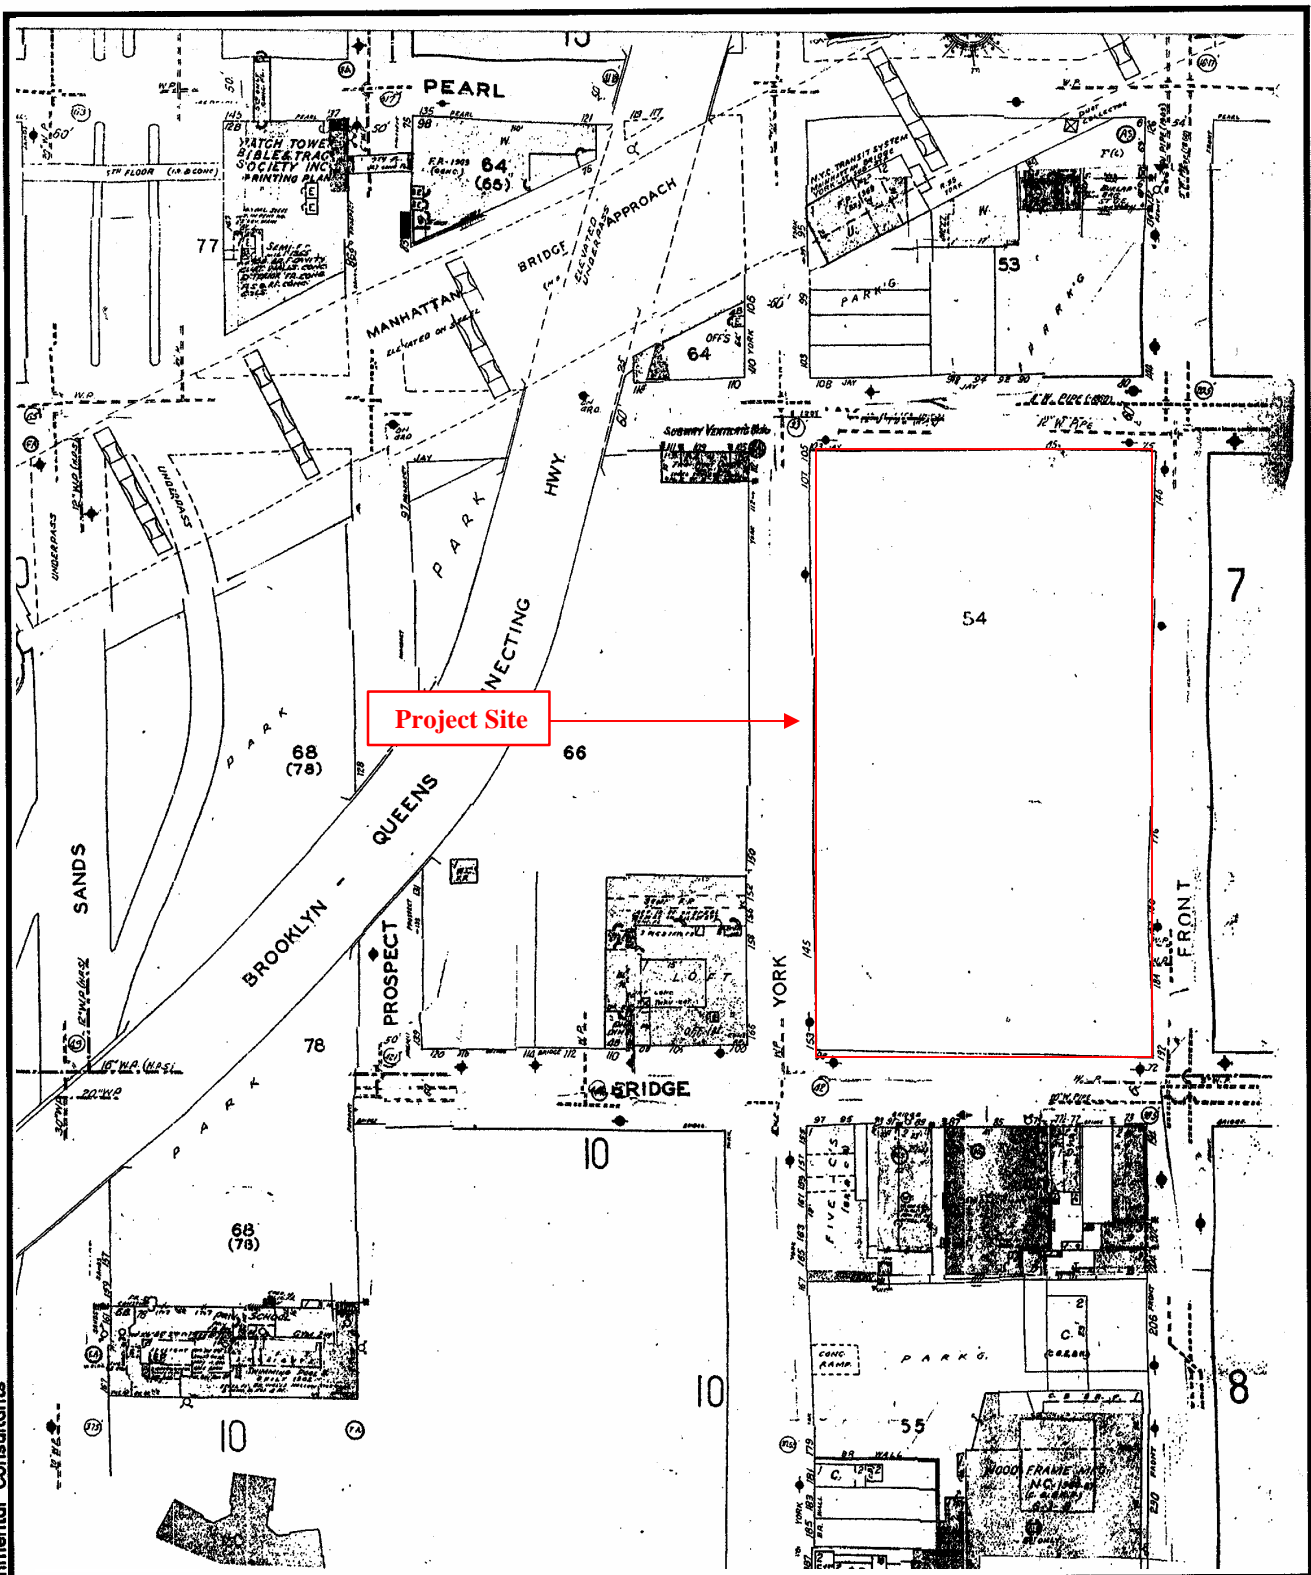
2001 Sanborn

The subject property was vacant. No significant changes were noted for the surrounding blocks.
