DAILY FIELD REPORT – Day 010

DATE: Mon., September 15, 2025

145-165 Wolcott Street

Langan was present to document remediation activities in accordance with the New York State Department of Environmental Conservation (NYSDEC)-approved July 22, 2025 Remedial Action Work Plan (RAWP) at the 145-165 Wolcott Street site in Brooklyn, New York (Site No. C224256).

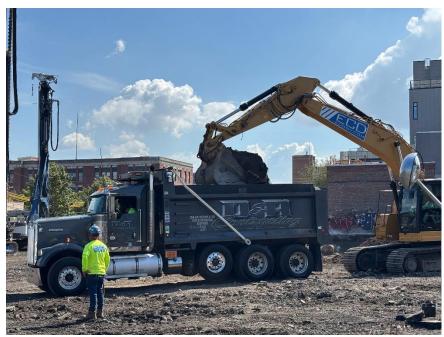
Photo 1: ECD loading non-hazardous non-native fill in the western part of the site for off-site disposal (facing east)

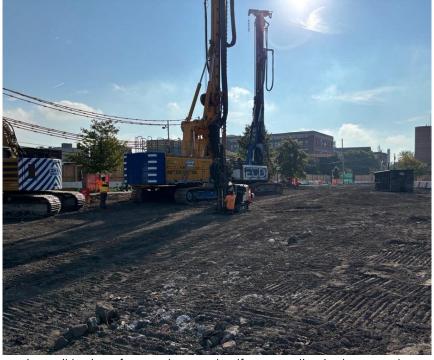
Photo 2: Lakewood advancing soil borings for supplemental sulfate sampling in the central part of the site (facing east).

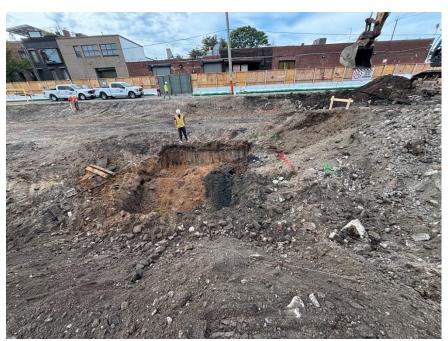
Photo 1: Excavated RCRA D008 non-native fill in the western part of the site (facing southwest)

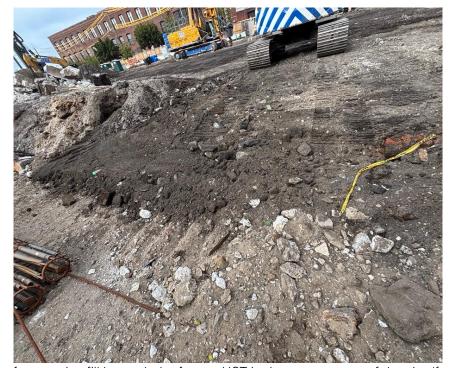
Photo 2: Area of non-native fill beneath the former UST in the western part of the site (facing northeast).

- IRT used a Part 364-permmited vacuum truck to extract about 210 gallons of non-hazardous petroleum-impacted water from an underground storage tank (UST) in the western part of the site. ECD used a rock hammer attachment to chip the remaining concrete encasement. Following removal of the concrete encasement, ECD relocated the emptied UST to the western part of the site where the UST was staged on and covered with polyethylene sheeting for future off-site disposal to a permitted facility.

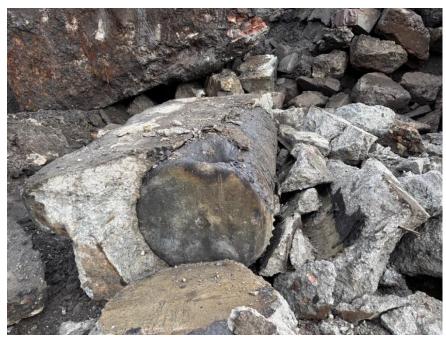
boiler was measured to be about 4-feet-long with a 28-inch diameter and was observed to contain a thin layer with sediment. The suspected boiler was screened for odors, staining, and organic vapors using a PID. Petroleum-like odors were detected and a maximum PID reading of 668.0 parts per million was recorded. No staining was observed on the concrete nor the surrounding non-native fill, and evidence of a release was not observed. Following removal of the concrete encasement, ECD relocated the suspected boiler to the western part of the site where the suspected boiler was staged on and covered with polyethylene sheeting for future off-site disposal to a permitted facility.

Photo 1: View of suspected boiler encased in concrete in the western part of the site (facing west)

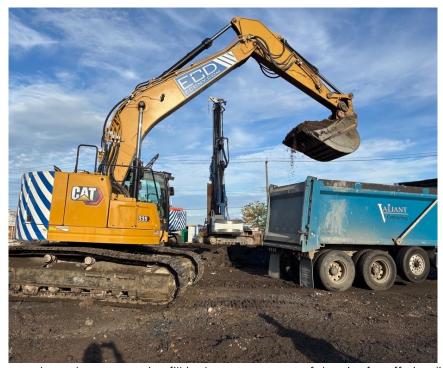
Photo 2: ECD loading non-hazardous non-native fill in the western part of the site for off-site disposal (facing north).

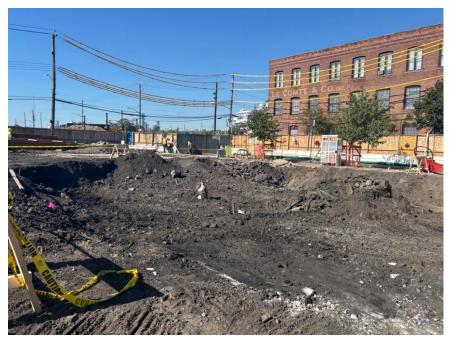
Photo 1: View of the excavation in the northern part of the site (facing northeast)

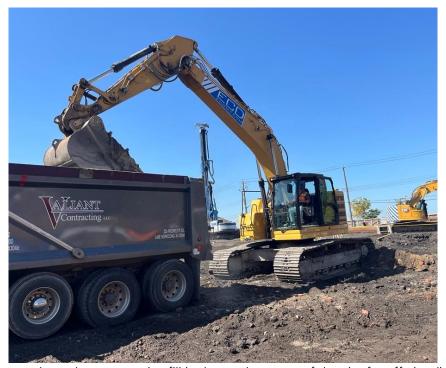
Photo 2: ECD loading non-hazardous non-native fill in the northern part of the site for off-site disposal (facing north).

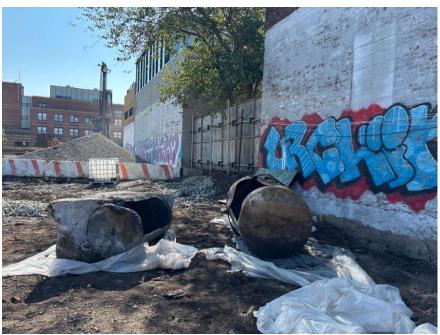
Photo 1: View of the emptied UST and suspected boiler staged on polyethylene sheeting in the central part of the site (facing southeast)

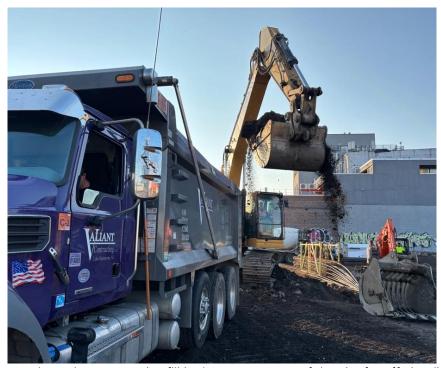
Photo 2: ECD loading non-hazardous non-native fill in the western part of the site for off-site disposal (facing south).

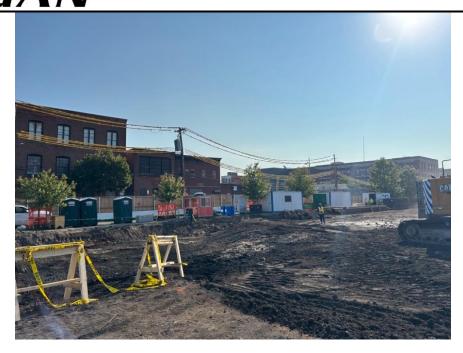
Photo 3: ECD spraying water for dust suppression within the northern part of the site (facing southeast).
