| <b>PROJECT No.:</b> 170452203<br><br><b>PROJECT:</b> 145-165 Wolcott Street<br><br><b>LOCATION:</b> Brooklyn, New York<br><br><b>SITE CODE:</b> C224256 | <b>CLIENT:</b><br><br>NYM 145 Wolcott, LLC<br>233 Broadway, 10 <sup>th</sup> Fl.,<br>New York, NY 10279 | <b>DATE:</b> Mon., October 13, 2025<br><br><b>WEATHER:</b> Rainy; 52 – 58 °F<br>Wind: SSW @ 1.4 – 6.2 mph<br><br><b>TIME:</b> 6:45am – 4:20pm<br><br><b>MONITOR:</b> Emma Bitar |
| <b>OBSERVATIONS, DISCUSSIONS, TEST RESULTS, ETC.:</b><br><br>Langan was present to document remediation activities in accordance with the New York State Department of Environmental Conservation (NYSDEC)-approved July 22, 2025 Remedial Action Work Plan (RAWP) at the 145-165 Wolcott Street site in Brooklyn, New York (Site No. C224256).<br><br><b>Site Activities</b> <ul style="list-style-type: none"> <li>ECD used a CAT 335F to load stockpiled non-hazardous non-native fill from WCSP03 into tri-axel trucks for off-site disposal.</li> <li>ECD used a CAT 335F to excavate an about 5-foot-long by 5-feet-wide test pit to about 11 feet below grade surface (bgs) for waste characterization sampling in the central part of site . Excavated non-native fill was scr

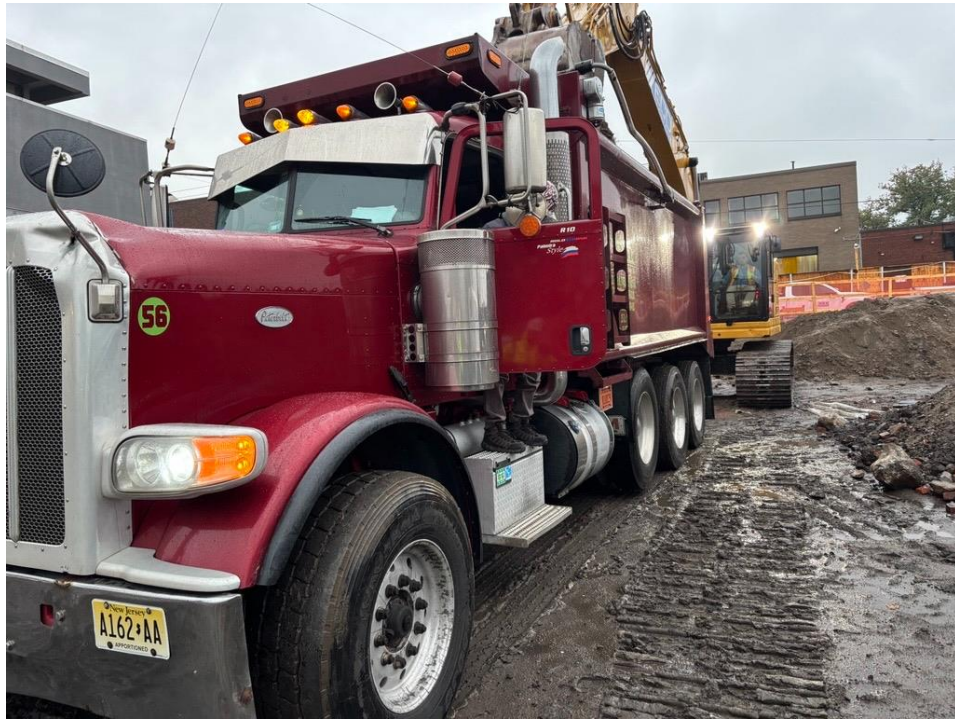
**Photo 1:** ECD loading non-hazardous non-native fill in the northwestern part of the site for off-site disposal (facing west).

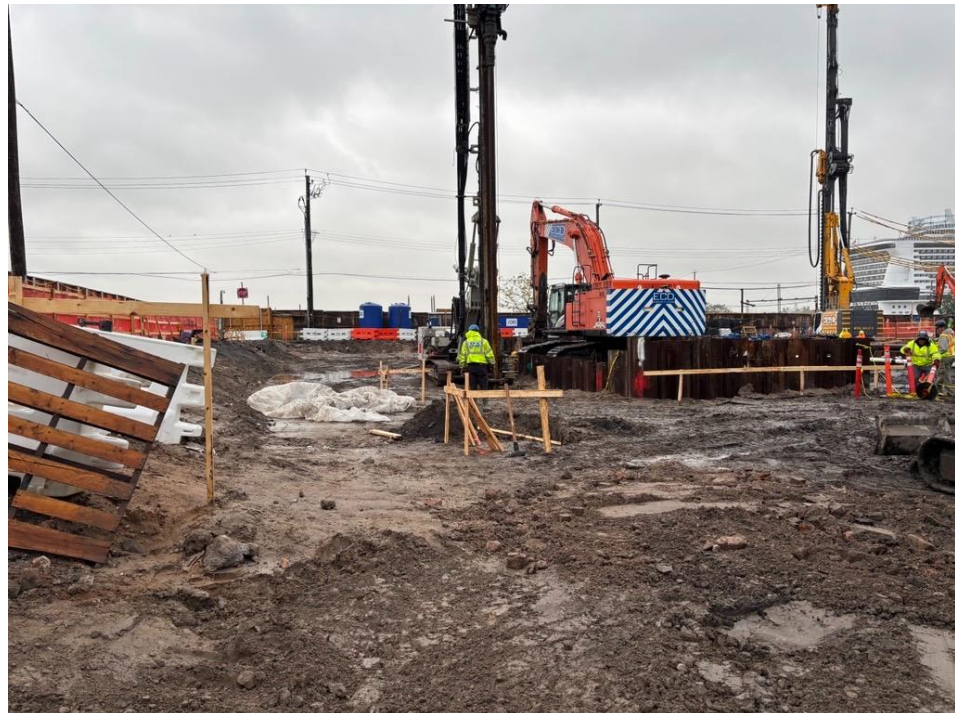
**Photo 2:** ECD installing CFA piles in the northern part of the site (facing north).

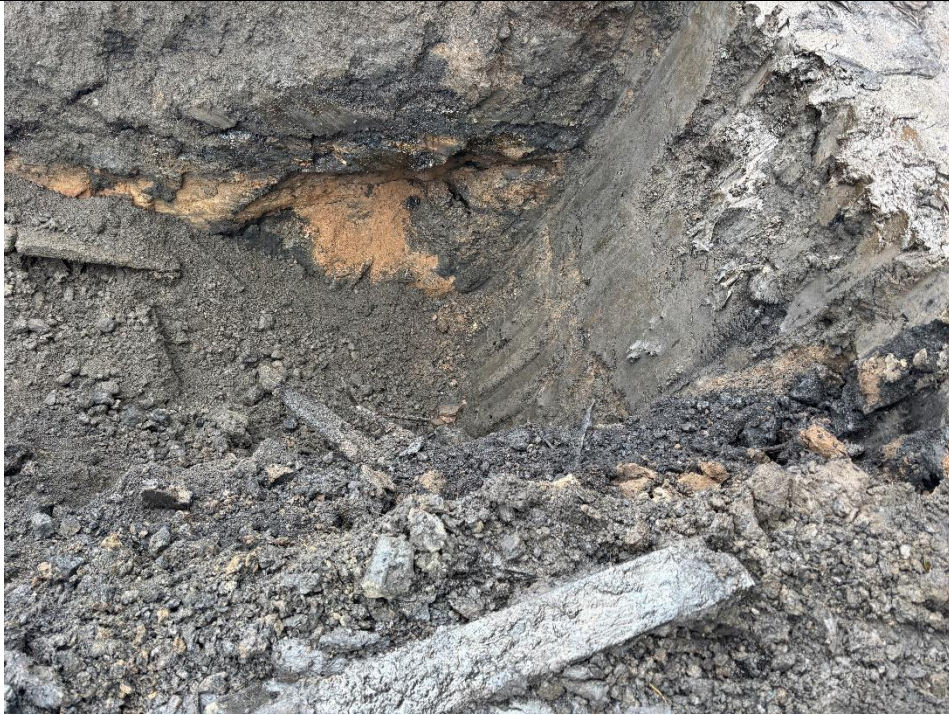
**Photo 3:** Test pit advanced in the central part of the site

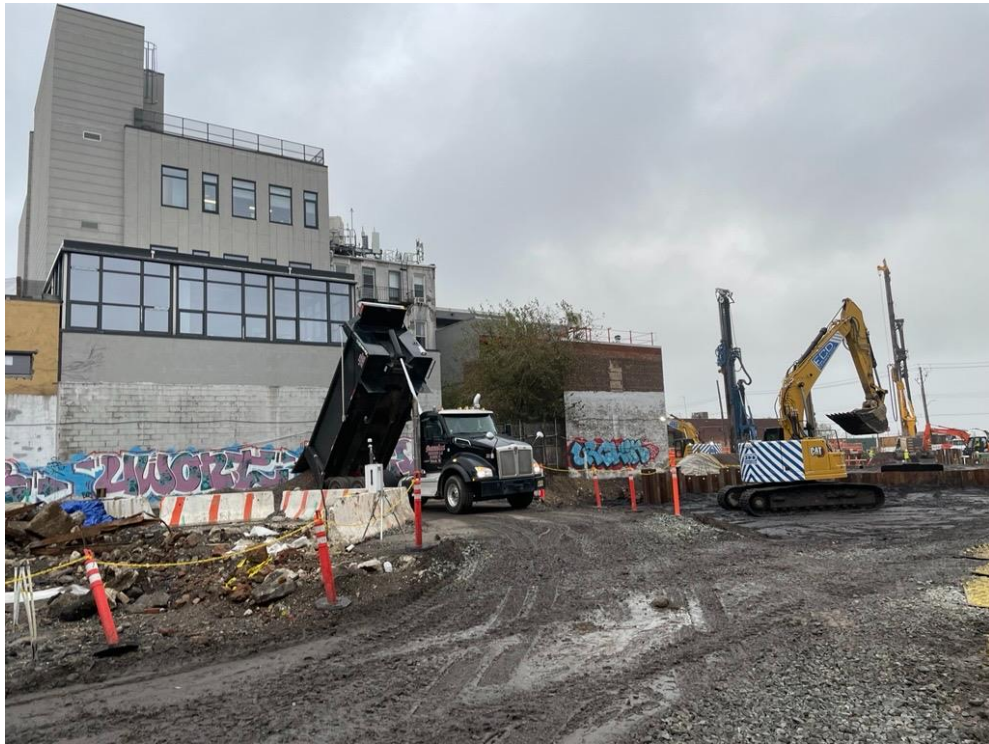
**Photo 1:** ECD importing 3/4-inch recycled clean stone (facing west)

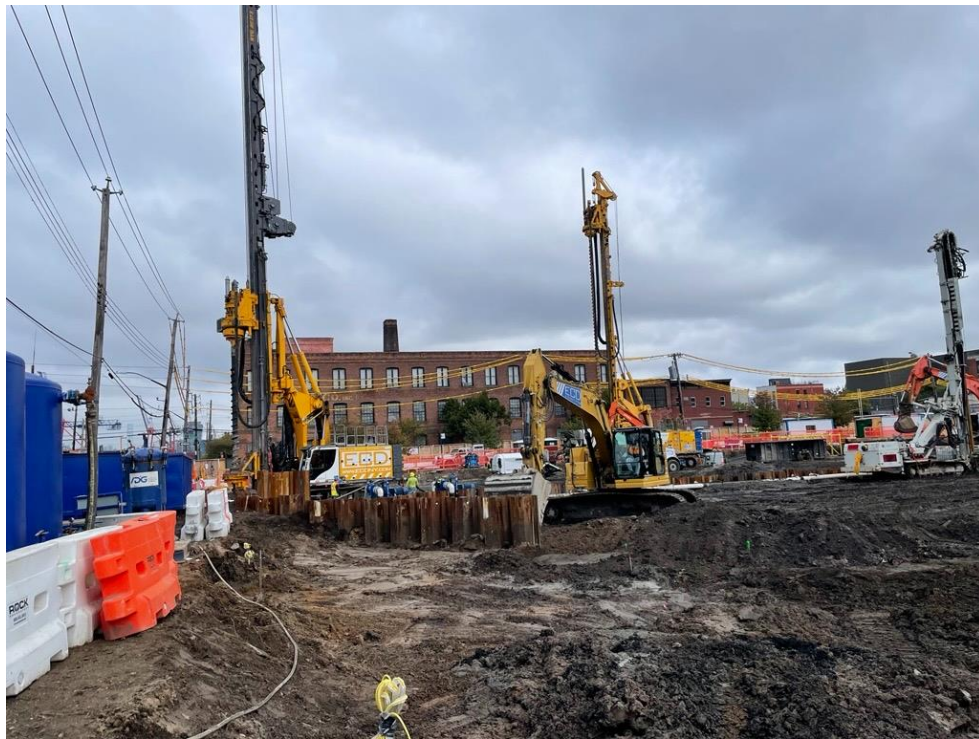
**Photo 2:** ECD installing CFA piles in the northern part of the site (facing northeast)

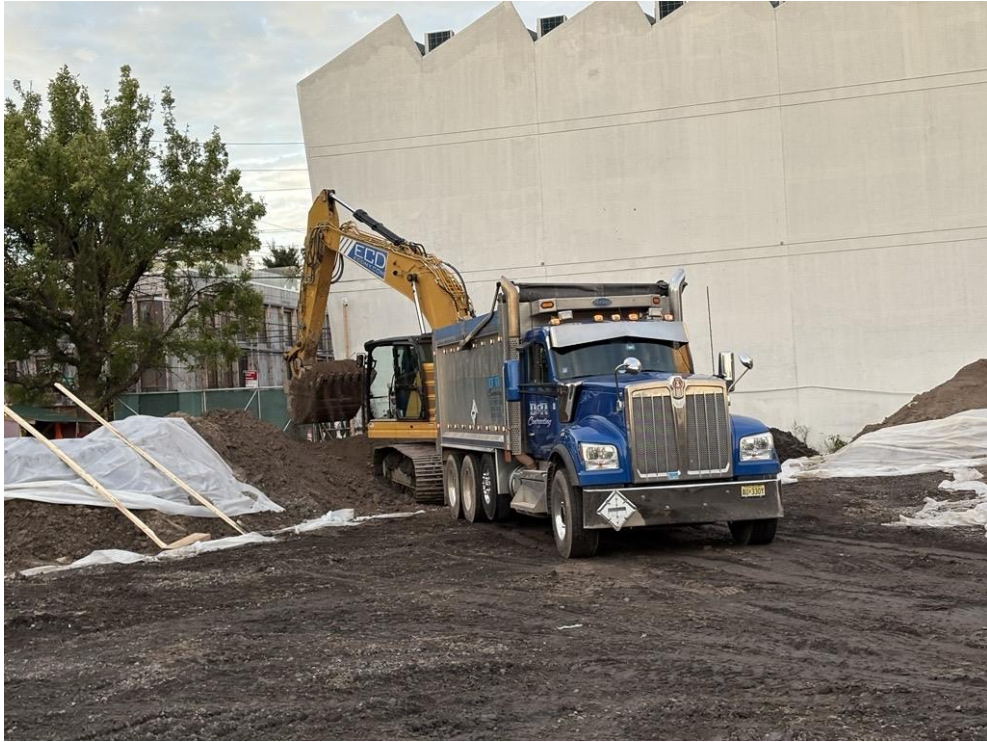
**Photo 1:** ECD live-loading stockpiled non-hazardous non-native fill into tri-axle trucks for off-site disposal (facing south)

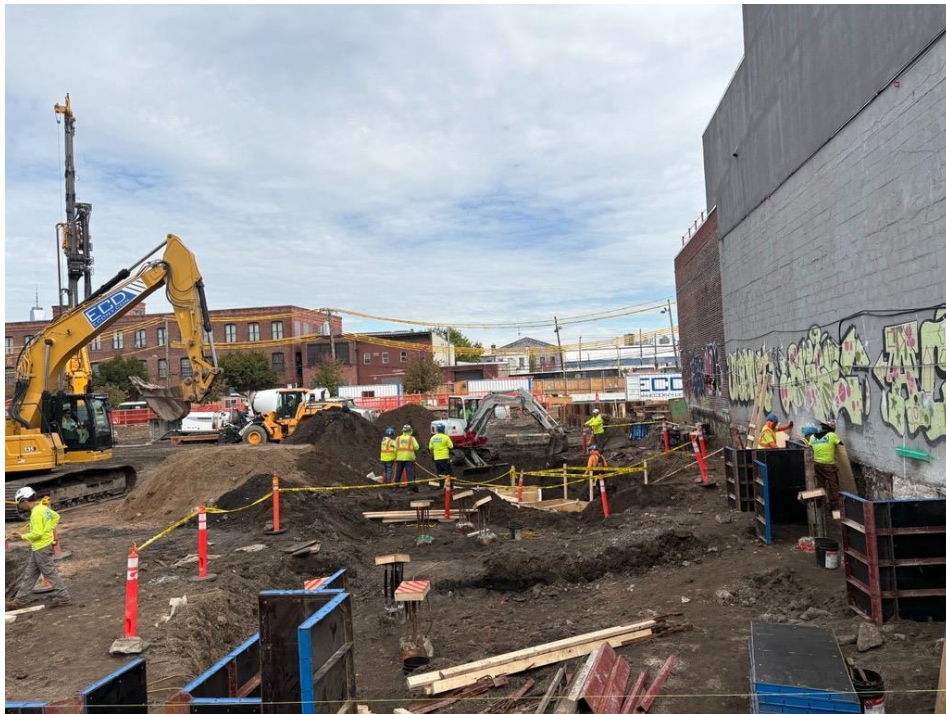
**Photo 2:** ECD excavating to crush/form pile caps (facing northeast)

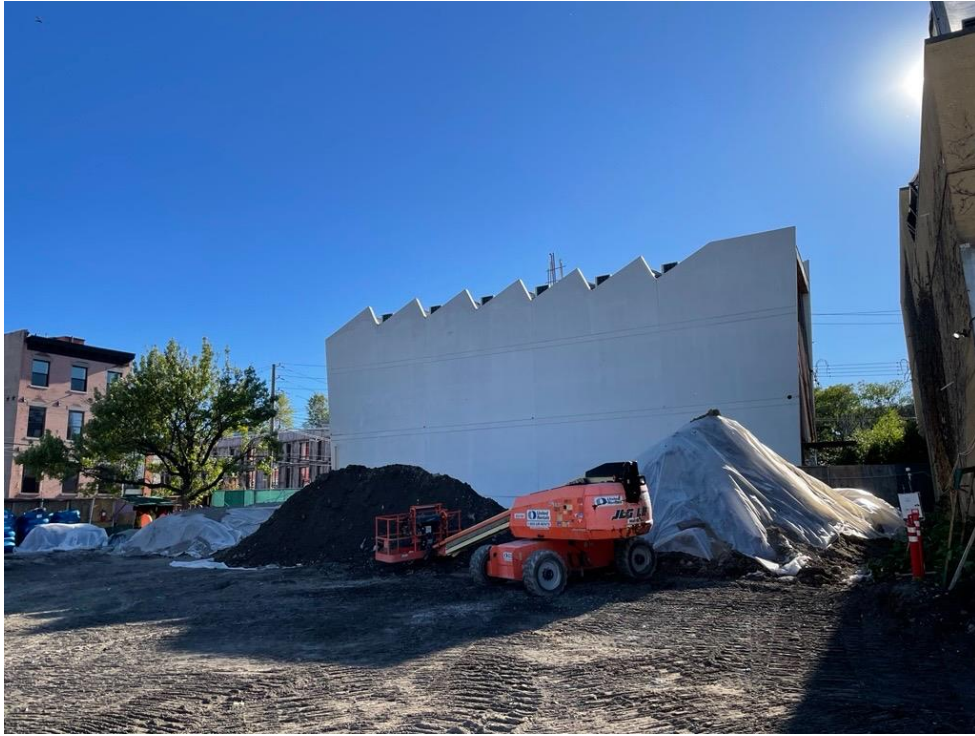
**Photo 1:** Stockpiled non-native fill generated during CFA advancement area in the southern part of the site (facing south)

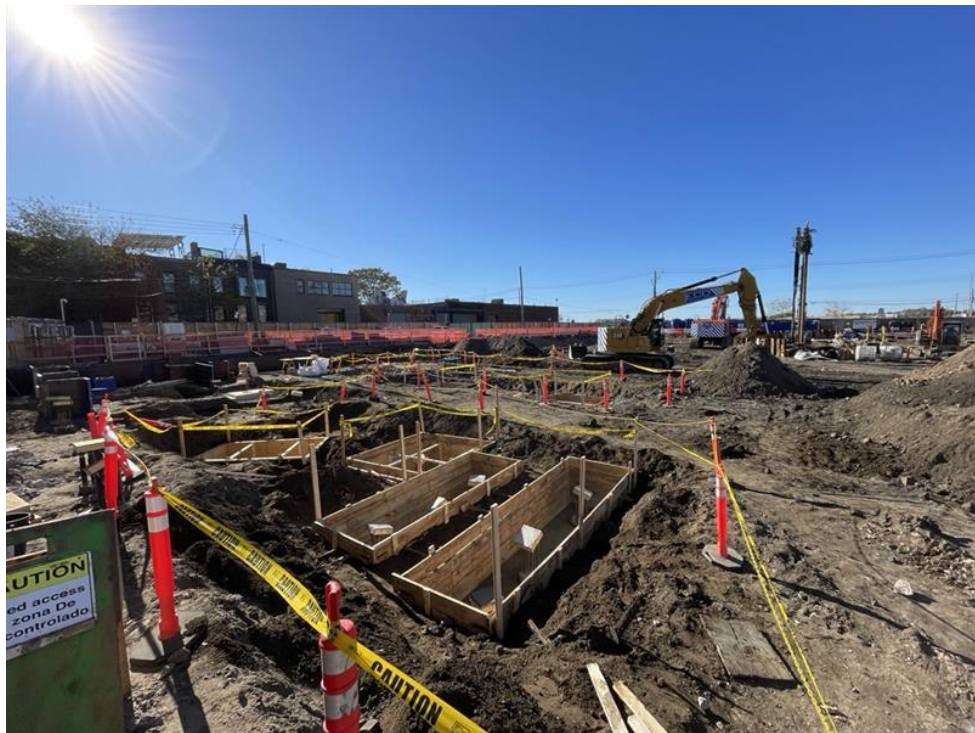
**Photo 2:** Excavated area to crush/form pile caps (facing west)

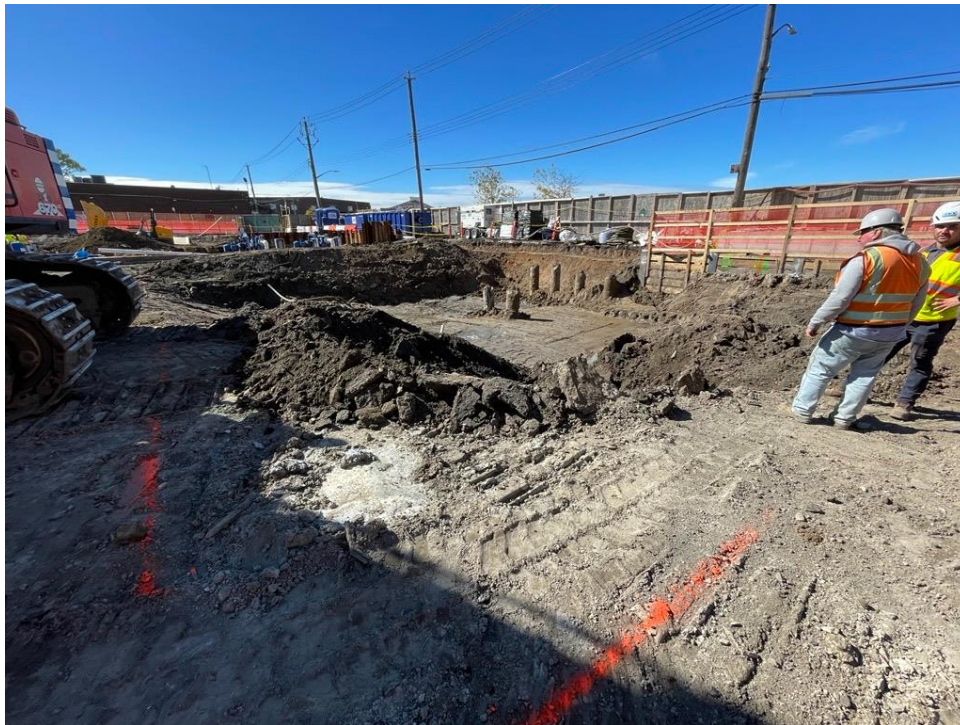
**Photo 2:** Excavated area in the northern part of the site (facing west)

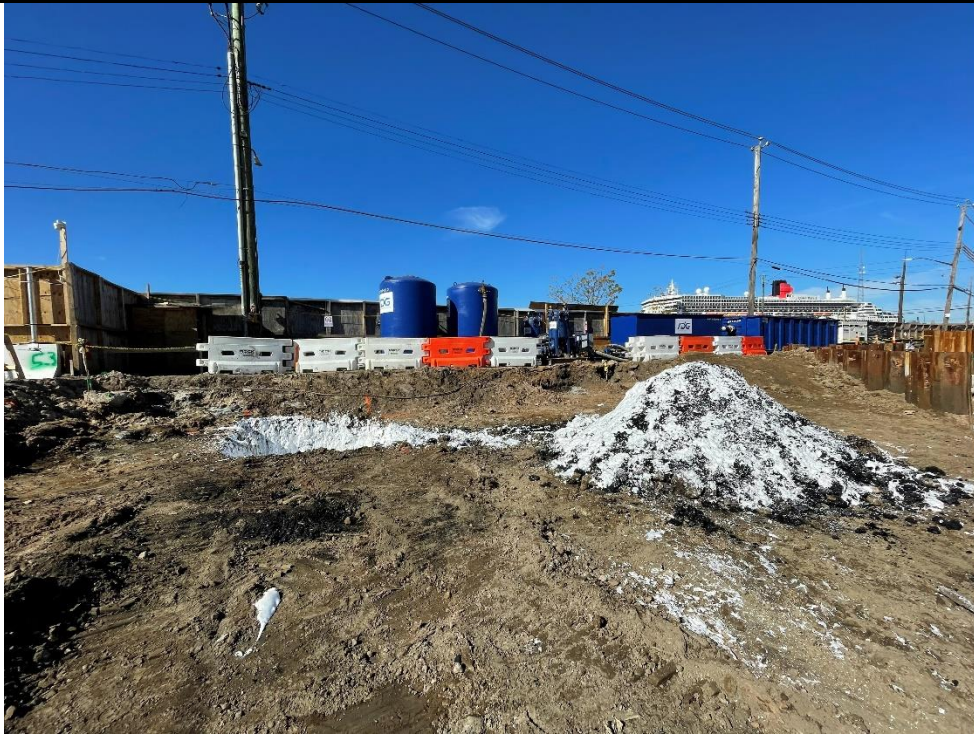
**Photo 3:** Odor suppressing foam over open excavation and stockpiled non-native fill in the northern part of the site (facing northwest)

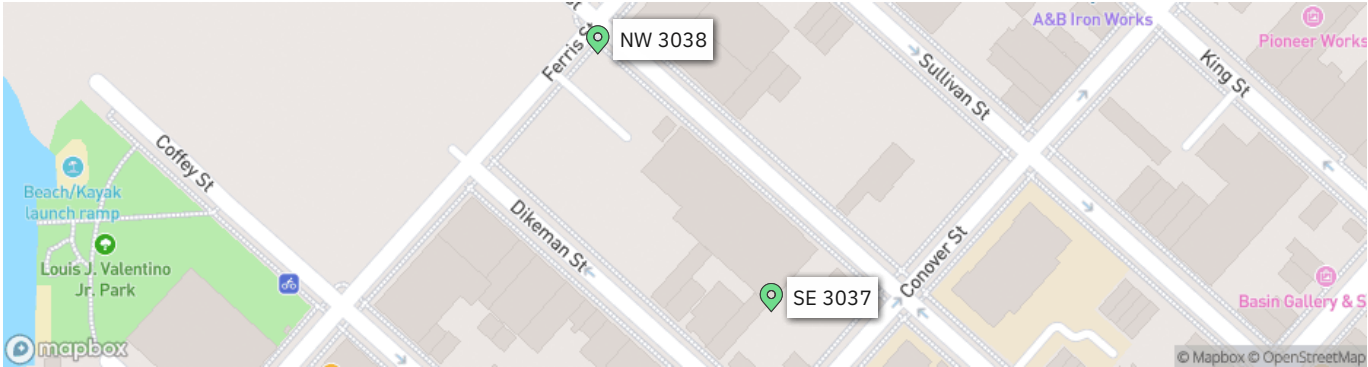
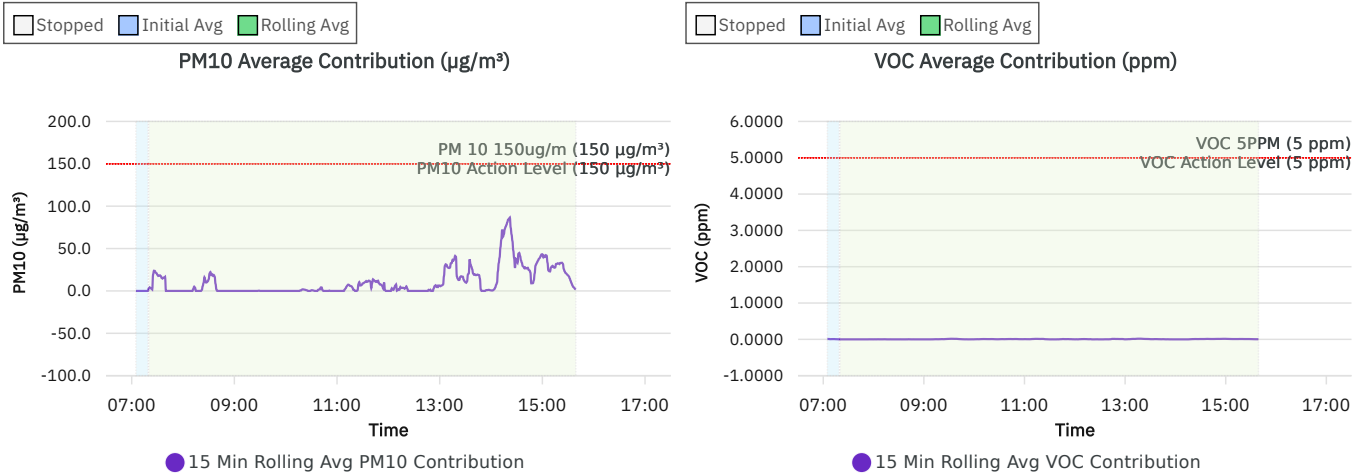
| Daily Monitoring Summary | PM10 (µg/m³) | Time | VOC (ppm) | Time |
|---|---|---|---|---|
| Max Contribution (15 min avg.) - 10/17/2025 | 86.6 | 14:22 | 0.0180 | 13:15 |
| Daily Avg. Contribution (15 min avg.) - 10/17/2025 | 10.3 | - | 0.0052 | - |
