# LANGAN SITE OBSERVATION REPORT- Day 100

<b>PROJECT No.:</b> 170452203	<b>CLIENT:</b> NYM 145 Wolcott, LLC 233 Broadway, 10 <sup>th</sup> Fl., New York, NY 10279	<b>DATE:</b> Thu., January 29, 2026
<b>PROJECT:</b> 145-165 Wolcott Street		<b>WEATHER:</b> Clear, 11 – 14 °F Wind: NW @ 1.1 – 7.1 mph
<b>LOCATION:</b> Brooklyn, New York		<b>TIME:</b> 6:45 am – 4:15 pm
<b>SITE CODE:</b> C224256		<b>MONITOR:</b> Brayden Klein

# LANGAN SITE OBSERVATION REPORT- Day 101

<b>PROJECT No.:</b> 170452203	<b>CLIENT:</b> NYM 145 Wolcott, LLC 233 Broadway, 10 <sup>th</sup> Fl., New York, NY 10279	<b>DATE:</b> Fri., January 30, 2026
<b>PROJECT:</b> 145-165 Wolcott Street		<b>WEATHER:</b> Clear, 6 – 20 °F Wind: NNW @ 3.5 – 12.5 mph
<b>LOCATION:</b> Brooklyn, New York		<b>TIME:</b> 6:45 am – 5:00 pm
<b>SITE CODE:</b> C224256		<b>MONITOR:</b> Emma Bitar

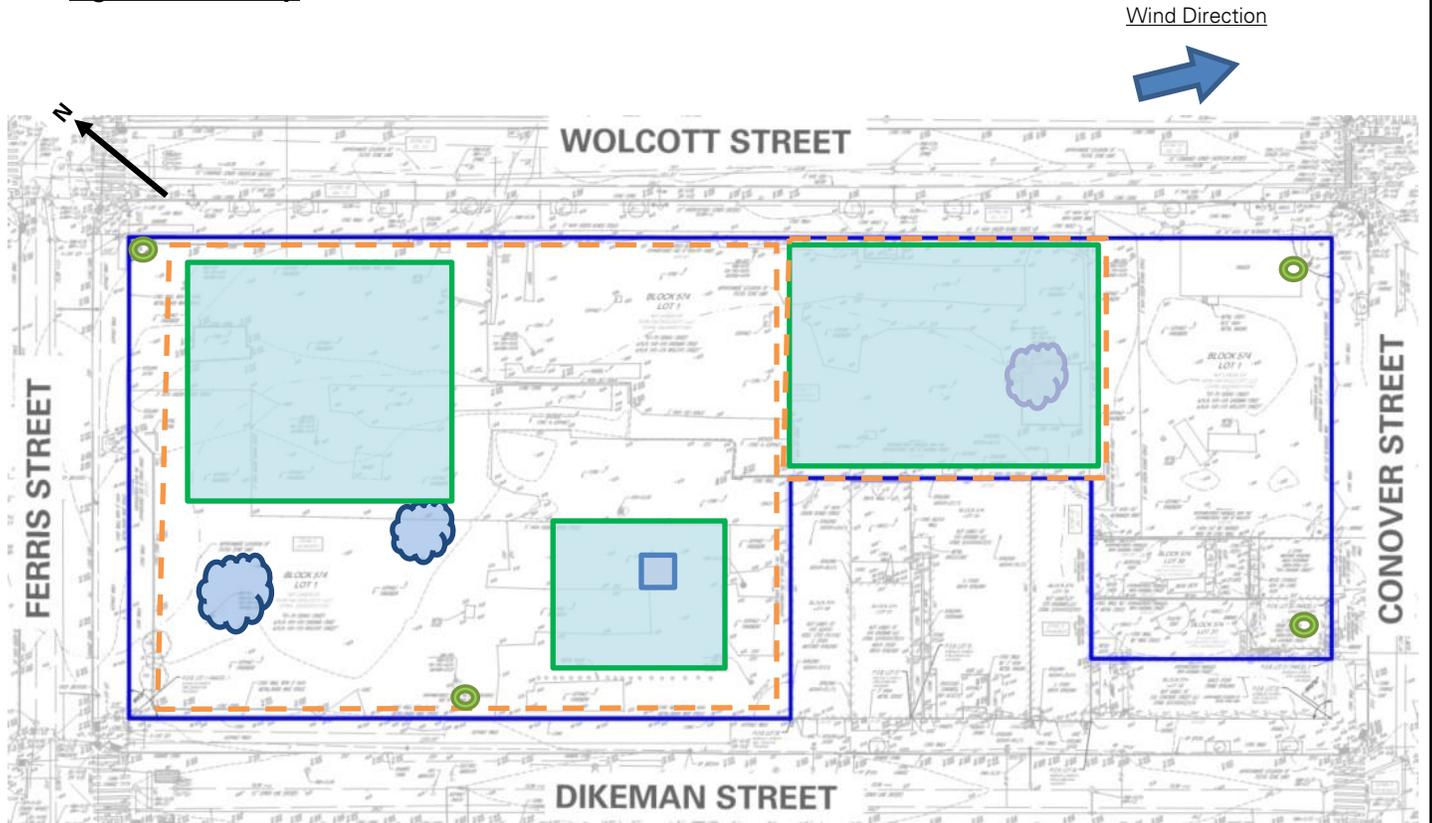
**Figure 1: Site Map**

- ECD used a CAT 335F to clear snow in the northern, southern, and western parts of site.
- ECD used a CAT 335F to excavate an about 10 foot-long by 5-foot-wide area to about 9 feet below grade surface (bgs) within the central part of the site for the installation of foundation elements.

- Excavated fill was stockpiled adjacent to the area of excavation and graded to create a level working surface.
  - Excavated non-native fill was screened for odors, staining, and organic vapors using a PID. No impacts were observed.

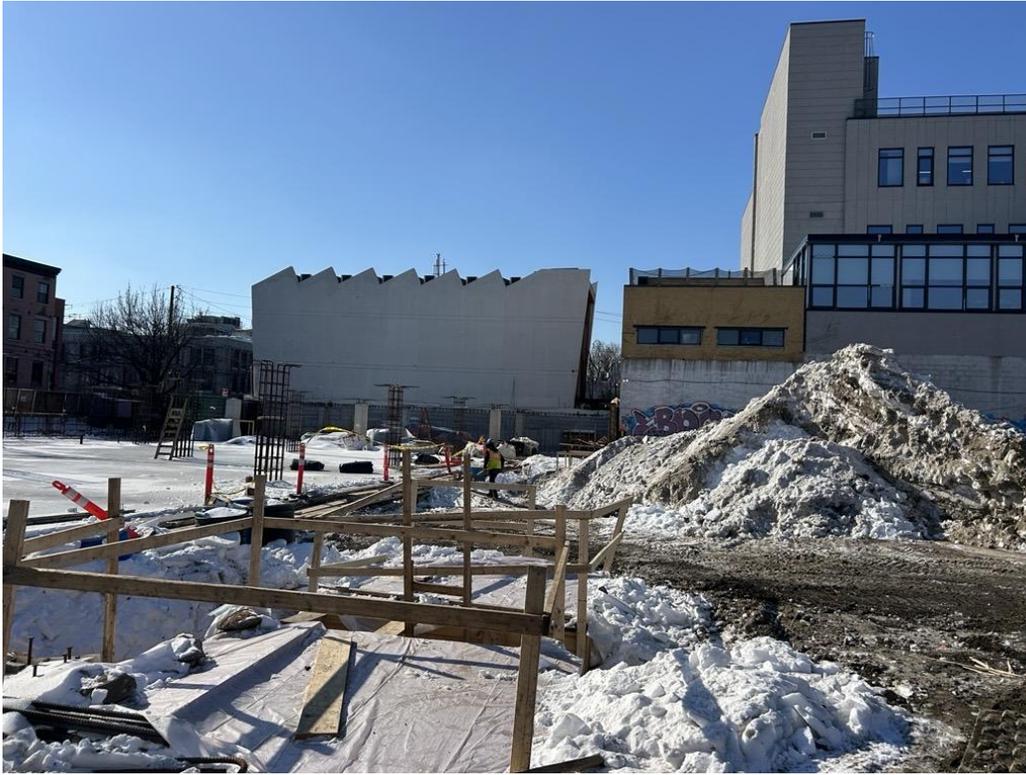
**Photo 1:** ECD stockpiling snow in the southern part of site (facing south)

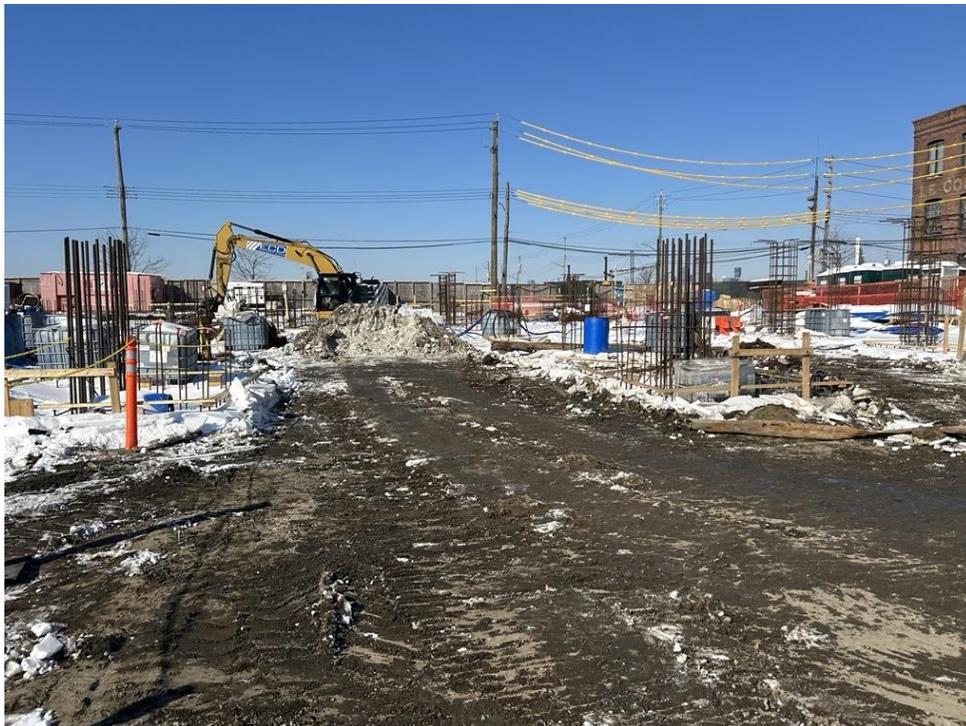
**Photo 2:** ECD clearing snow in the northern part of site (facing northwest)

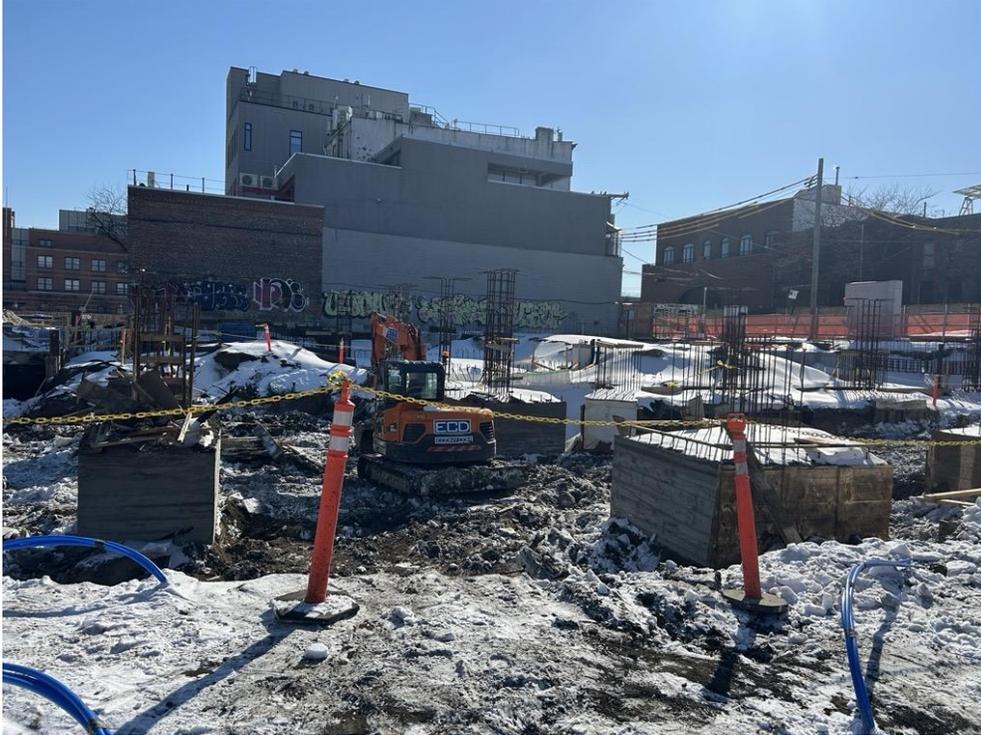
**Photo 3:** ECD using a CAT 335F to excavate fill in the central part of site (facing southeast)

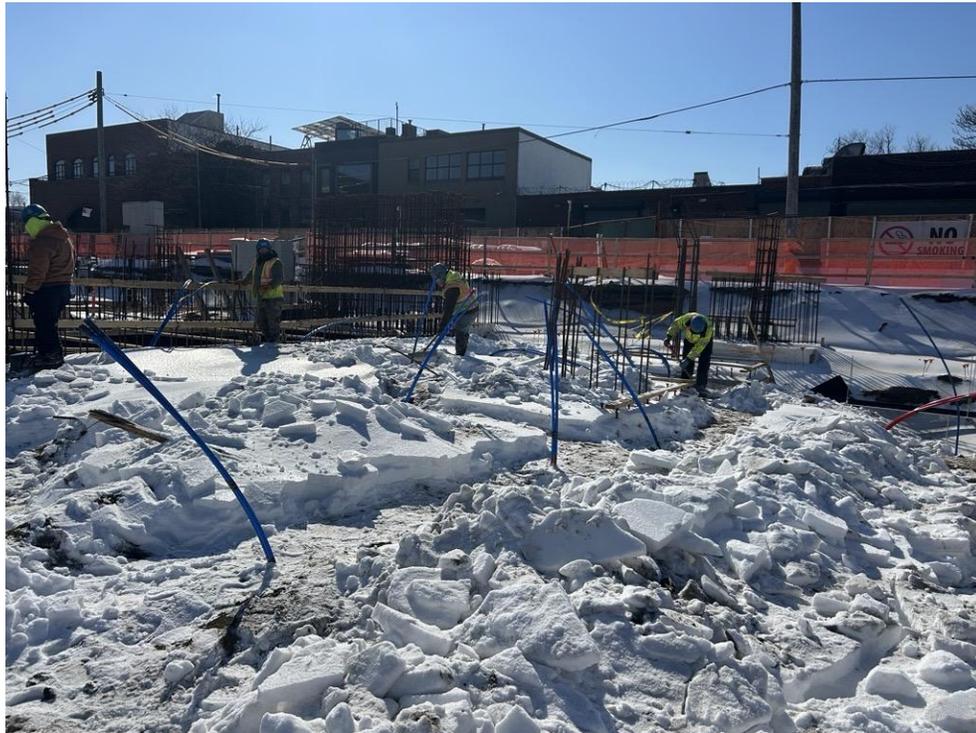
**Photo 4:** ECD injecting PetroFix in Treatment Area 3 (facing south)

- ECD continued in-situ injections of PetroFix in the southern part of the site (Area 3). ECD used an MQ submersible pump (Serial No. 804633) to inject a diluted PetroFix mixture (30 to 1 ratio of Water:Petrofix) to the following 8 injection points:

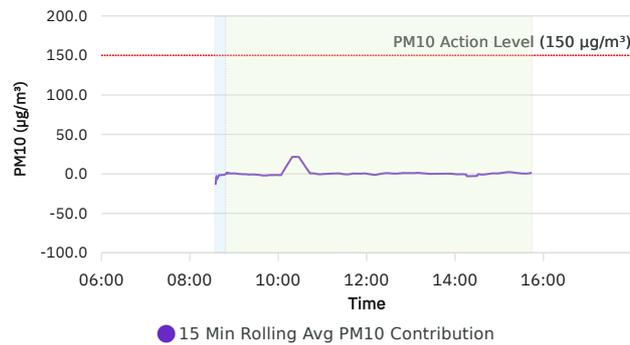
PM10 Average Contribution ( $\mu\text{g}/\text{m}^3$ )

Daily Monitoring Summary	PM10 ( $\mu\text{g}/\text{m}^3$ )	Time	VOC (ppm)	Time
Min Contribution (15 min avg.) - 1/29/2026	-12.6	08:35	-0.0133	11:19
Max Contribution (15 min avg.) - 1/29/2026	21.7	10:23	0.0107	10:19
Daily Avg. Contribution (15 min avg.) - 1/29/2026	1.1	-	-0.0034	-

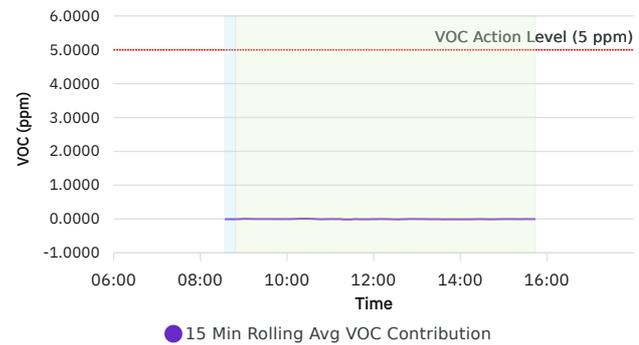
VOC Average Contribution (ppm)

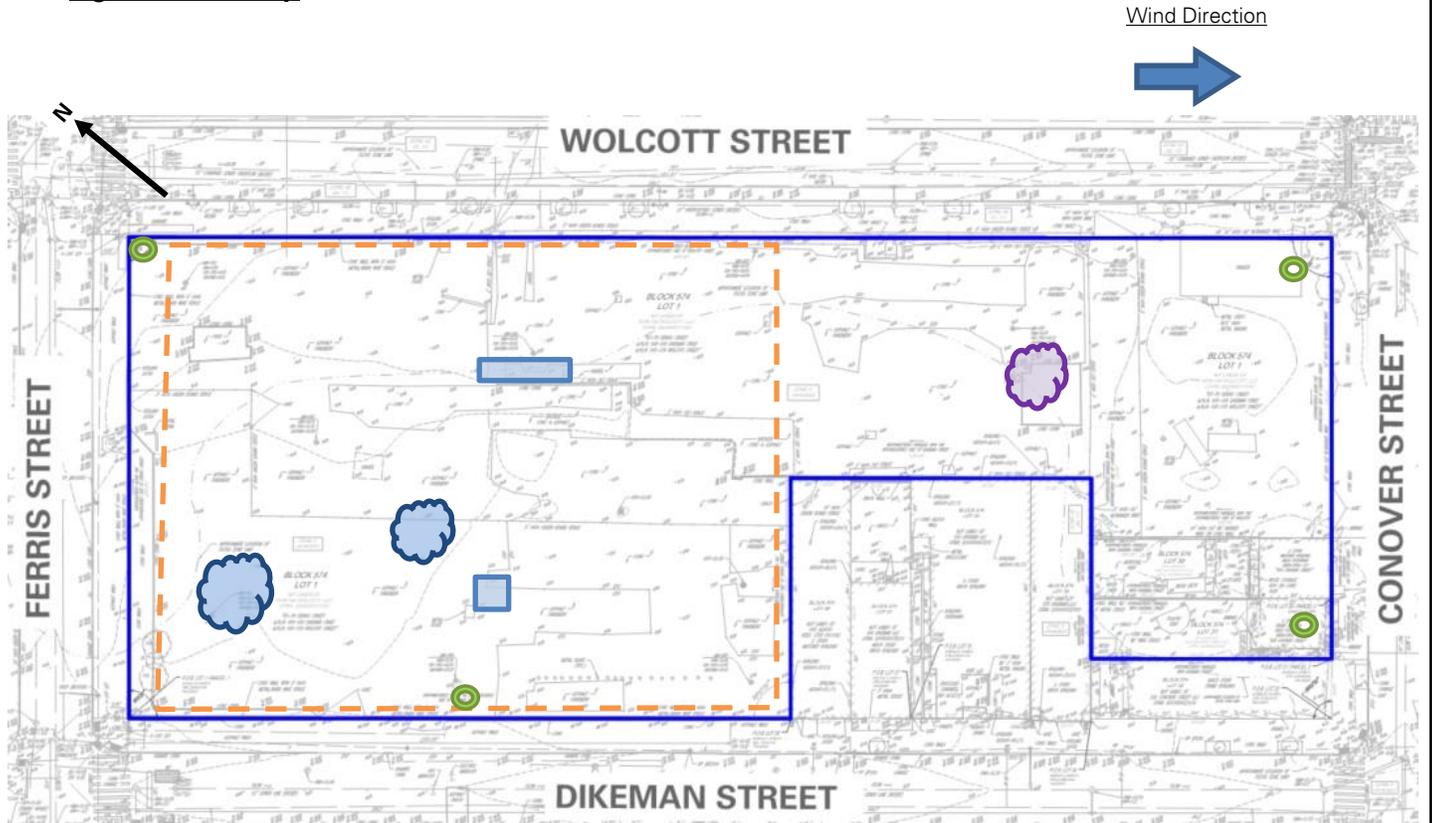
**Figure 1: Site Map**

- ECD used a CAT 335F to excavate an about 20-foot-long by 10-foot-wide area to about 9 feet below grade surface (bgs) within the central part of the site for the installation of foundation elements.

- ECD used a CAT 335F to excavate an about 10-foot-long by 10-foot-wide area to about 9 feet bgs within the western part of the site for the installation of foundation elements.

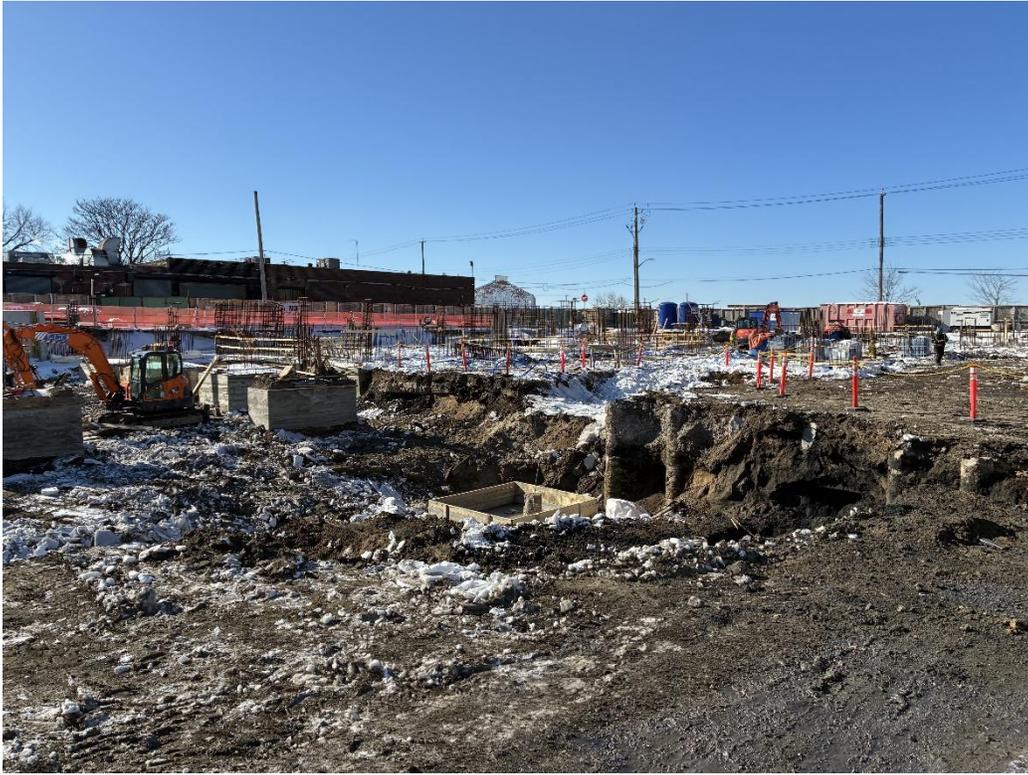
**Photo 1:** View of the western part of site (facing northwest)

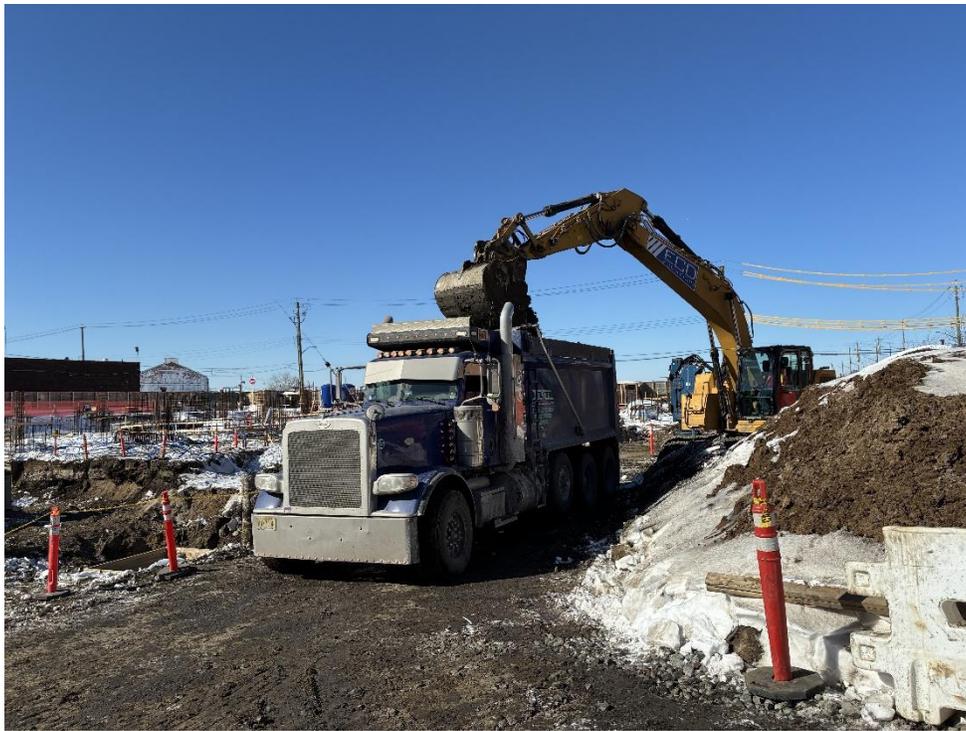
**Photo 2:** ECD live-loading non-native fill into permitted tri-axle trucks for off-site disposal in the northern part of site (facing northwest)

- Excavated non-native fill was live-loaded into permitted tri-axle trucks for off-site disposal.
  - Excavated non-native fill was screened for odors, staining, and organic vapors using a PID. No impacts were observed.

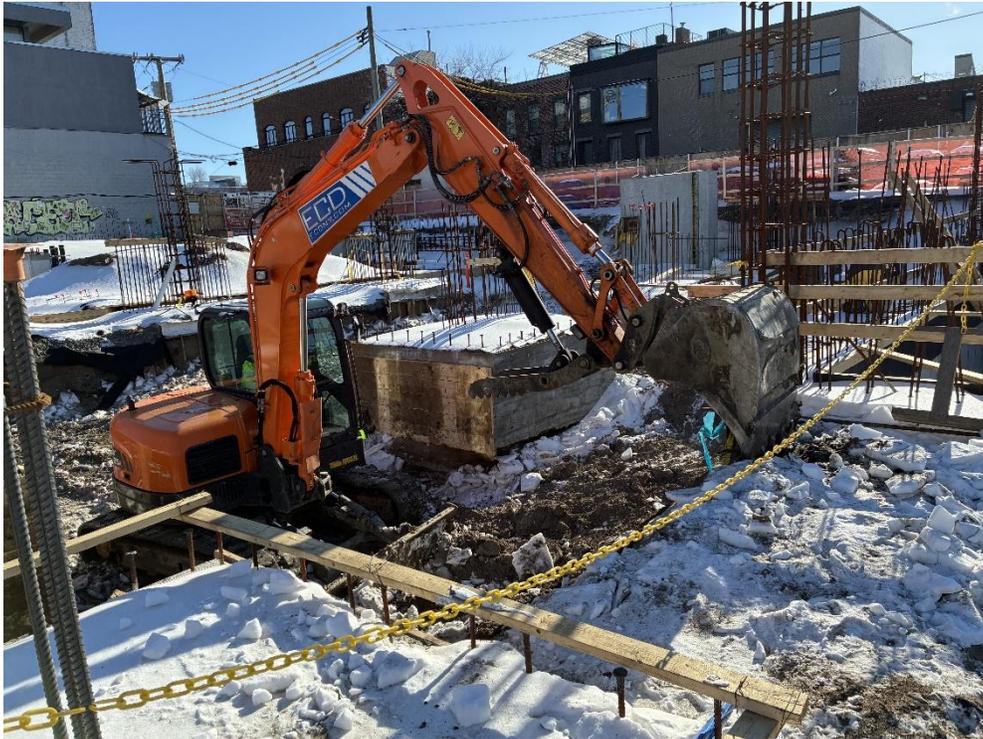
**Photo 3:** ECD using a CAT 335F to excavate fill in the western part of site (facing southwest)

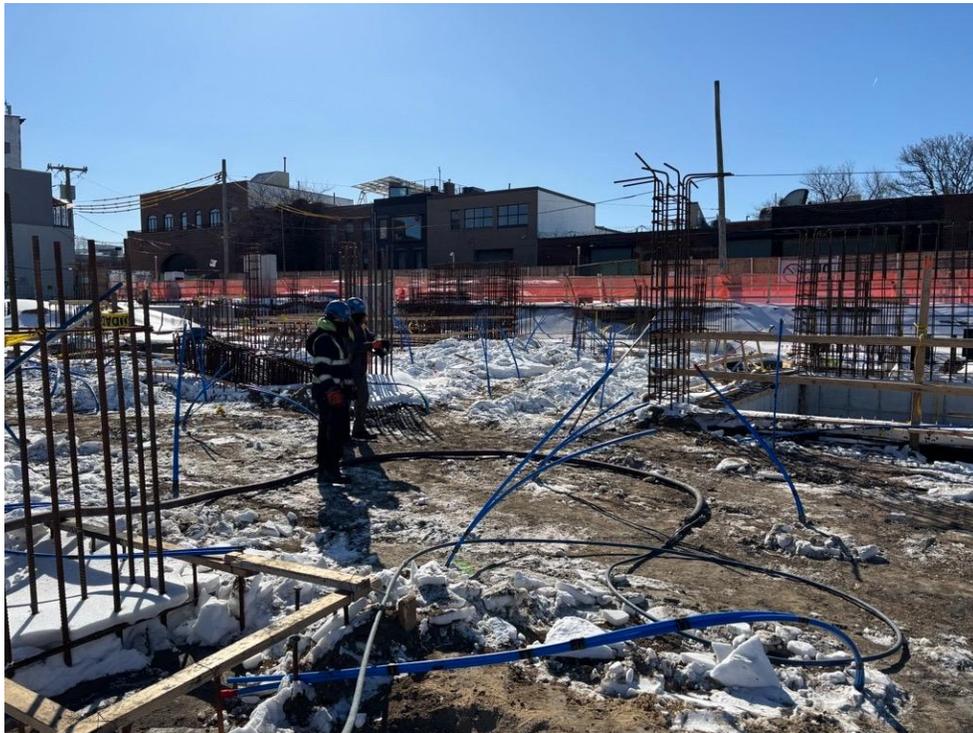
**Photo 4:** ECD injecting PetroFix in Treatment Area 3 (facing southwest)

- ECD continued in-situ injections of PetroFix in the southern part of the site (Area 3). ECD used an MQ submersible pump (Serial No. 804633) to inject a diluted PetroFix mixture (30 to 1 ratio of Water:Petrofix) to the following 9 injection points:

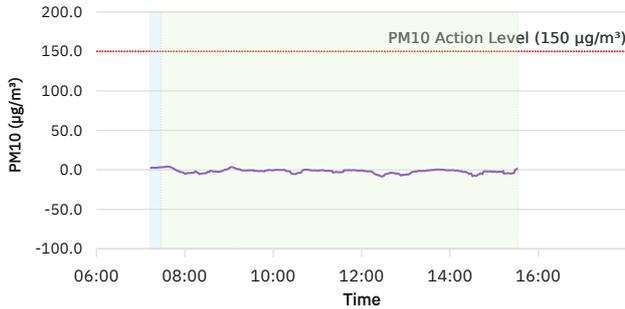
PM10 Average Contribution ( $\mu\text{g}/\text{m}^3$ )

● 15 Min Rolling Avg PM10 Contribution

Daily Monitoring Summary	PM10 ( $\mu\text{g}/\text{m}^3$ )	Time	VOC (ppm)	Time
Min Contribution (15 min avg.) - 1/30/2026	-8.4	12:28	-0.0127	07:55
Max Contribution (15 min avg.) - 1/30/2026	4.1	07:35	0.0180	07:18
Daily Avg. Contribution (15 min avg.) - 1/30/2026	-1.8	-	-0.0025	-

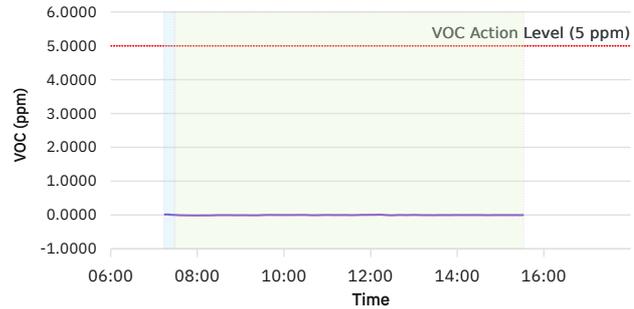
VOC Average Contribution (ppm)

● 15 Min Rolling Avg VOC Contribution
