# LANGAN SITE OBSERVATION REPORT- Day 140

<b>PROJECT No.:</b> 170452203	<b>CLIENT:</b> NYM 145 Wolcott, LLC 233 Broadway, 10 <sup>th</sup> Fl., New York, NY 10279	<b>DATE:</b> Mon., March 23, 2026
<b>PROJECT:</b> 145-165 Wolcott Street		<b>WEATHER:</b> Clear, 37-43 °F Wind: SSW @ 1.0 – 8.0 mph
<b>LOCATION:</b> Brooklyn, New York		<b>TIME:</b> 6:45 am – 6:00 pm
<b>SITE CODE:</b> C224256		<b>MONITOR:</b> Max Ringold

Langan was present to document remediation activities in accordance with the New York State Department of Environmental Conservation (NYSDEC)-approved July 22, 2025 Remedial Action Work Plan (RAWP) at the 145-165 Wolcott Street site in Brooklyn, New York (Site No. C224256).

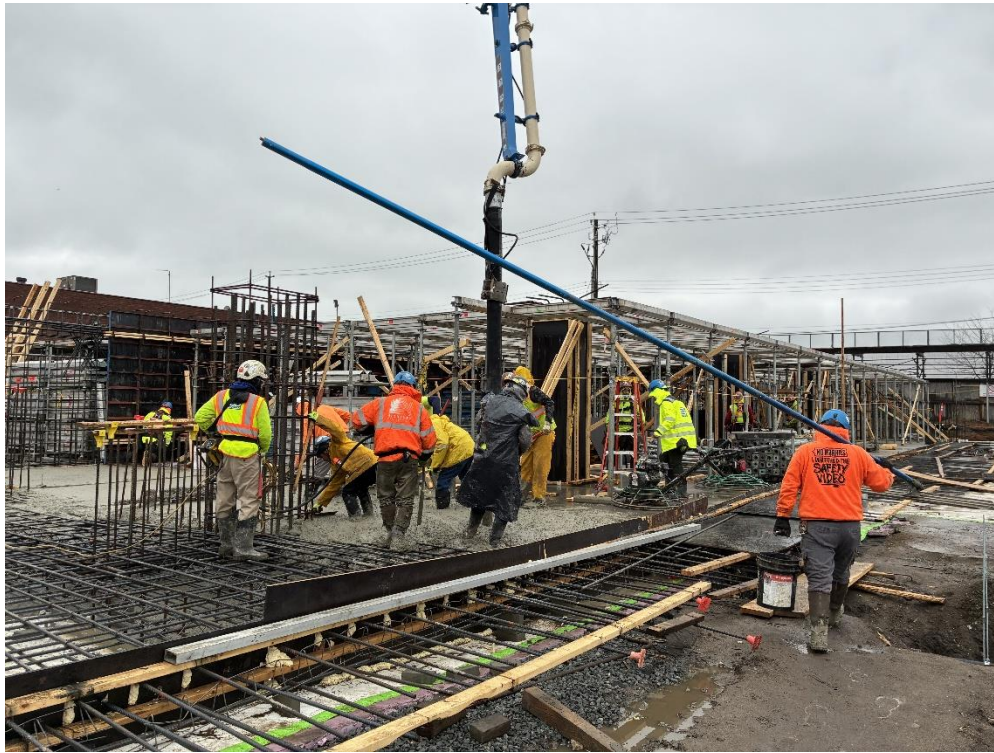
**Photo 1:** ECD pouring an about 8-inch-thick concrete slab in the northeastern part of the site (facing east)

- ECD poured an about 8-inch-thick concrete slab within an about 85-foot-long by 80-feet-wide area in the northeastern part of the site.
- ECD used a CAT 335F to excavate an about 50-foot-long by 8-feet-wide area to about 5 feet below grade surface (bgs), and an about 25-foot-long by 8-feet-wide area to about 3 feet bgs in the southeastern part of the site for the installation of utility piping.

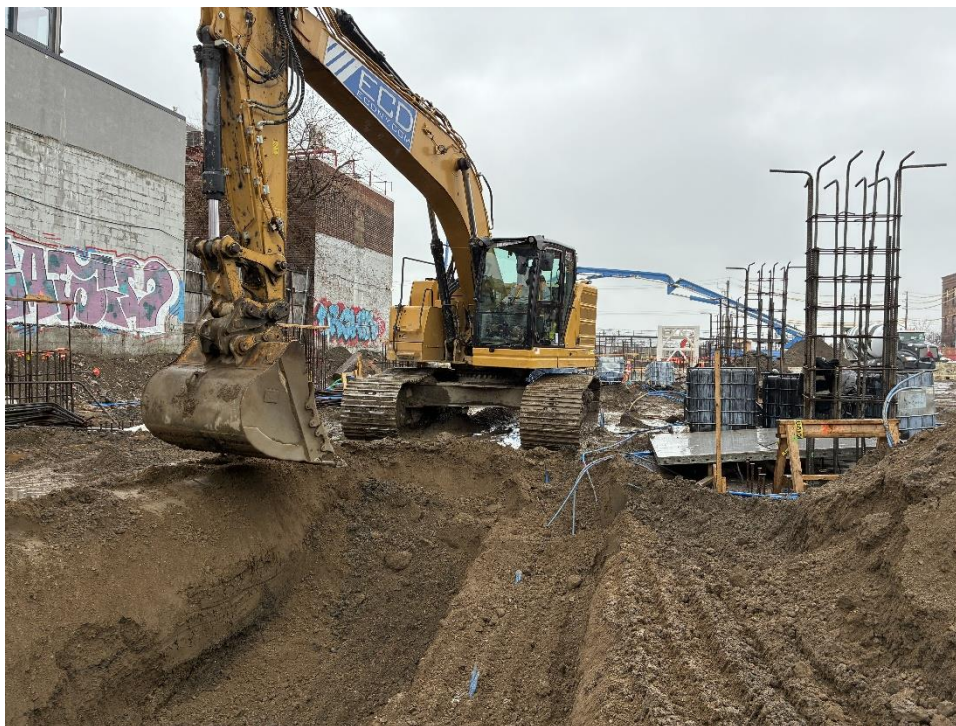
**Photo 2:** ECD excavating within clean fill for utility piping installation in the southern part of the site (facing north)

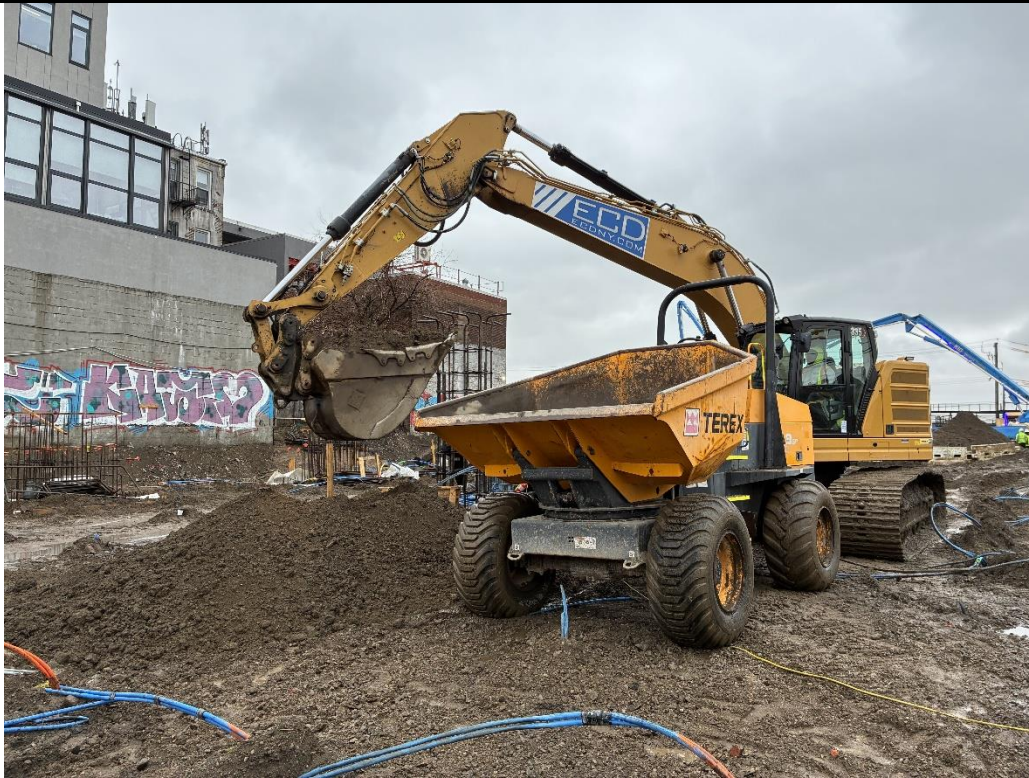
**Photo 3:** ECD relocating clean fill in the southern part of the site (facing east)

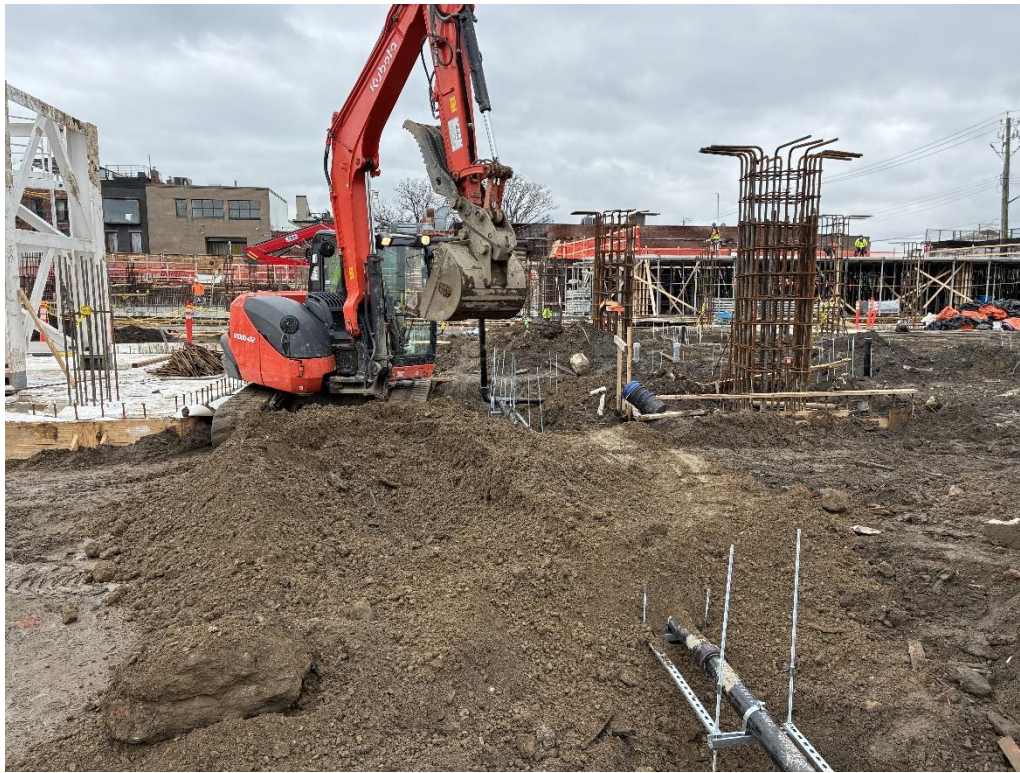
**Photo 4:** ECD backfilling clean fill to working grade in the northern part of site (facing east).

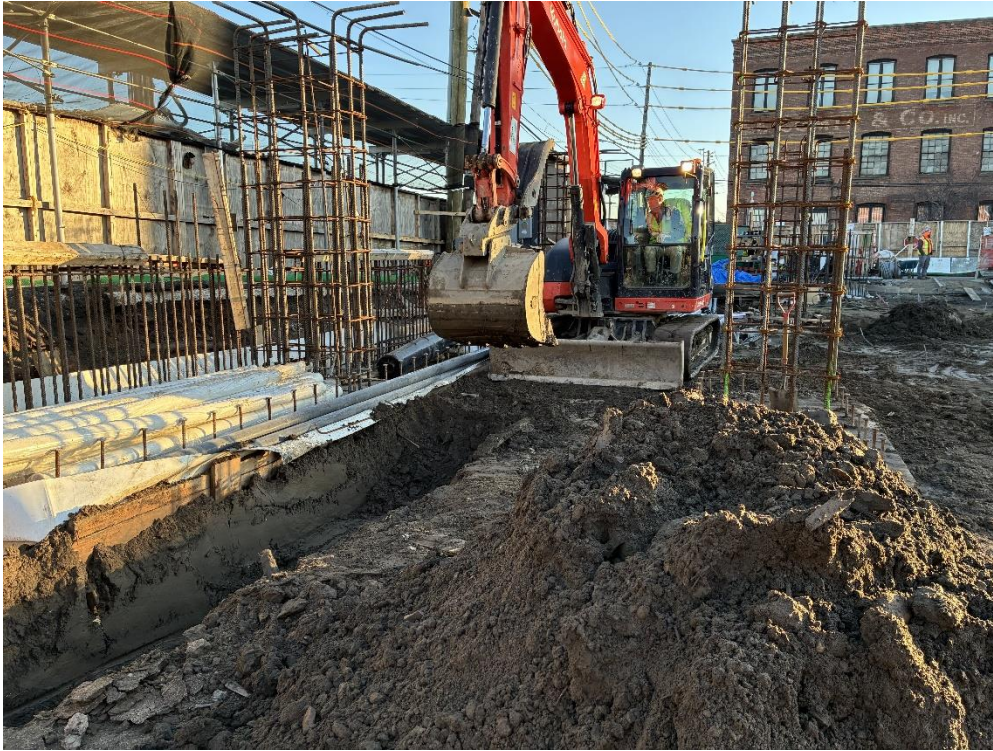
- Excavated non-native fill was screened for odors, staining, and organic vapors using a PID. No impacts were observed, and excavated non-native fill was graded adjacent to the excavation.

**Photo 1:** ECD excavating within non-native fill for installation of SVE system components in the northern part of the site (facing north)

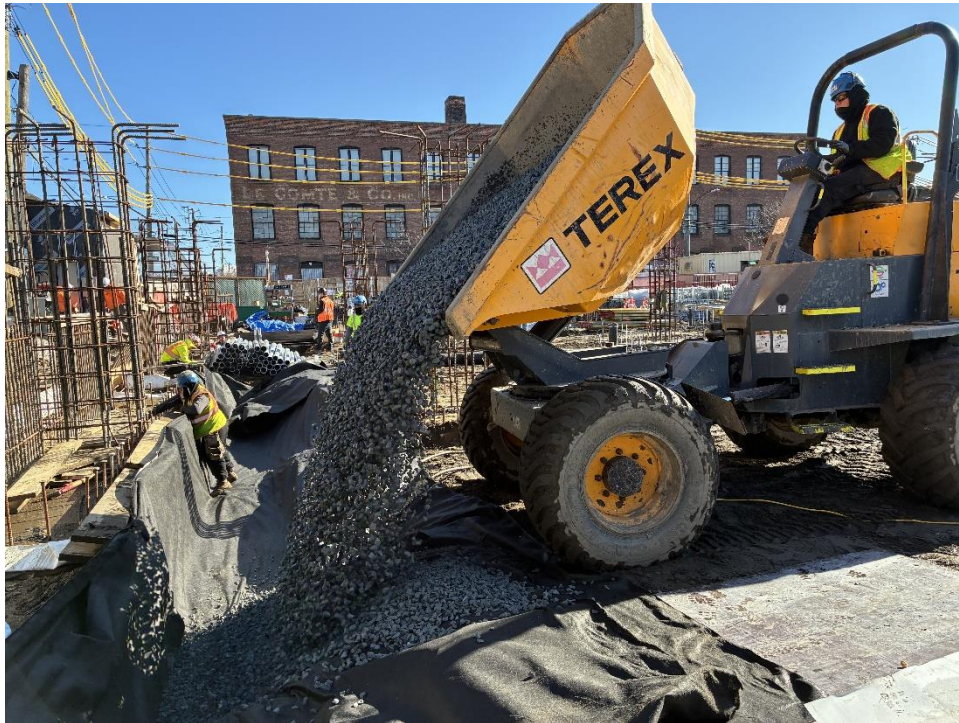
**Photo 2:** ECD backfilling  $\frac{3}{4}$ -inch virgin stone (ASTM No. 5) as part of the SVE system in the northern part of the site (facing northwest)

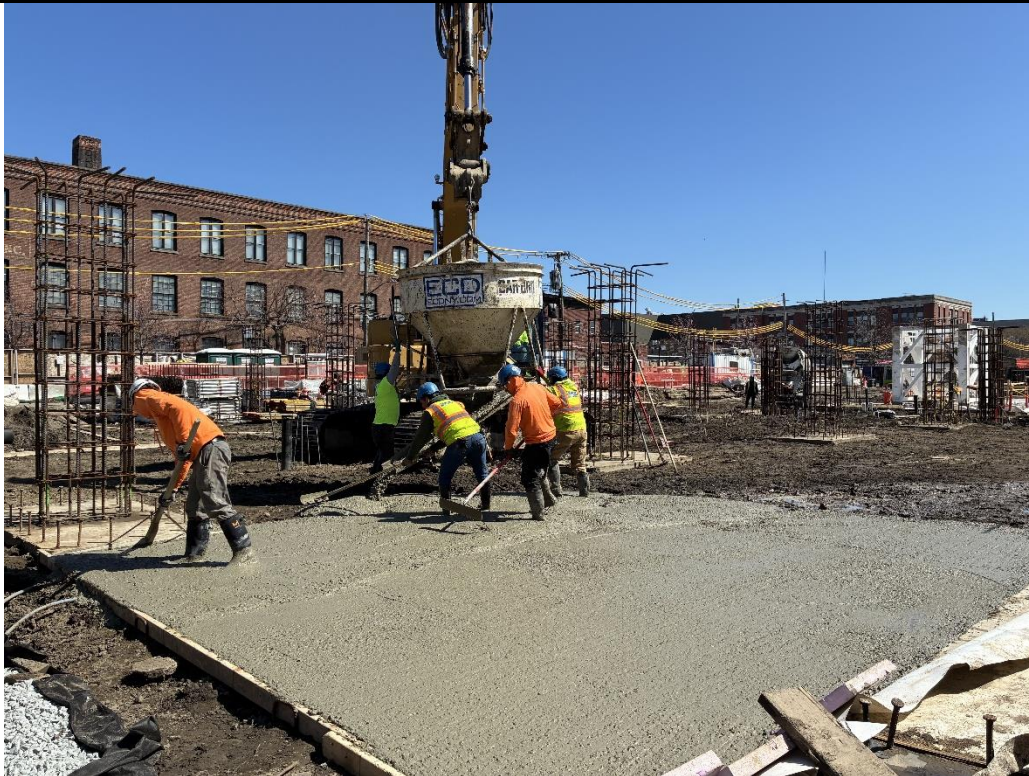
**Photo 3:** ECD pouring an about 3-inch-thick concrete rat slab in the northwestern part of the site (facing east)

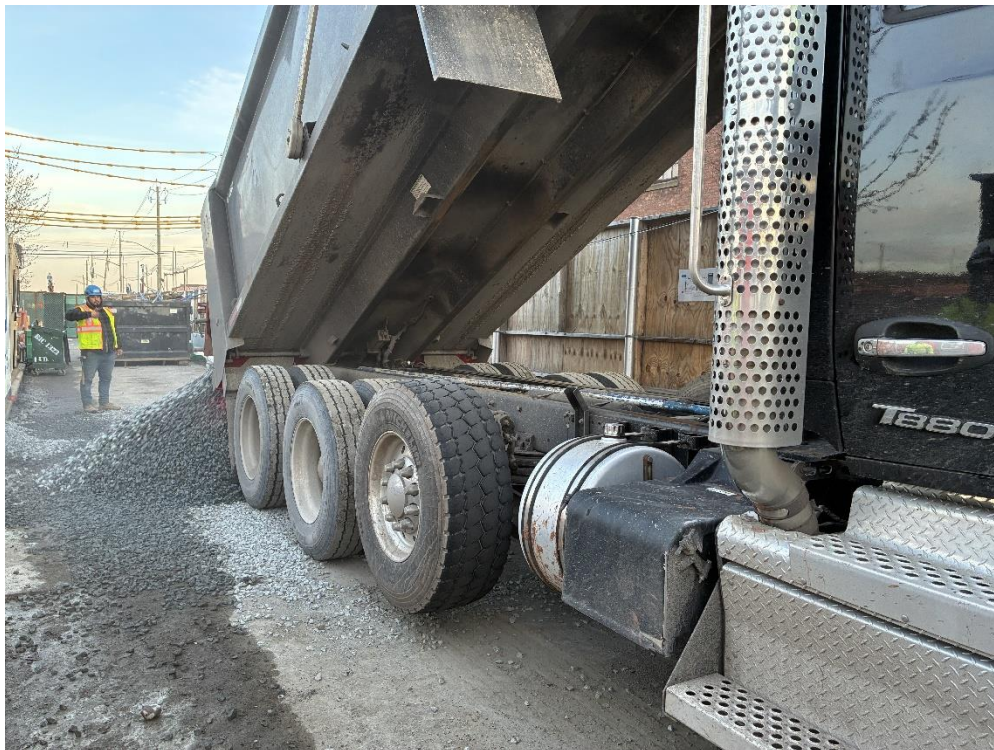
**Photo 1:** ECD importing ASTM #5 stone in the northeastern part of the site (facing north)

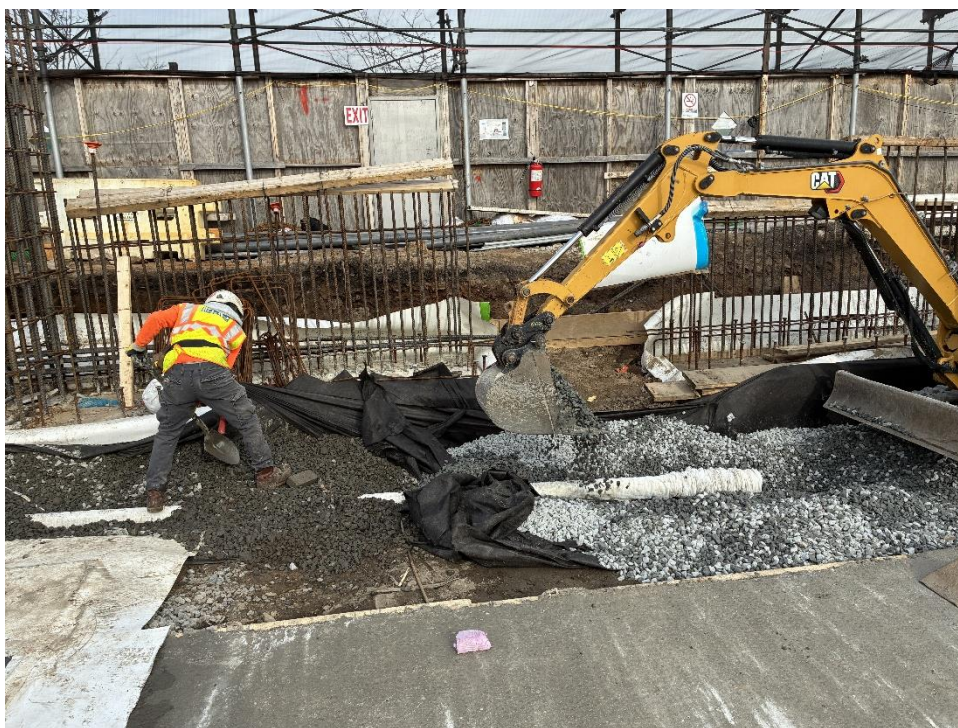
**Photo 2:** ECD backfilling  $\frac{3}{4}$ -inch virgin stone (ASTM No. 5) as part of the SVE system in the northern part of the site (facing north)

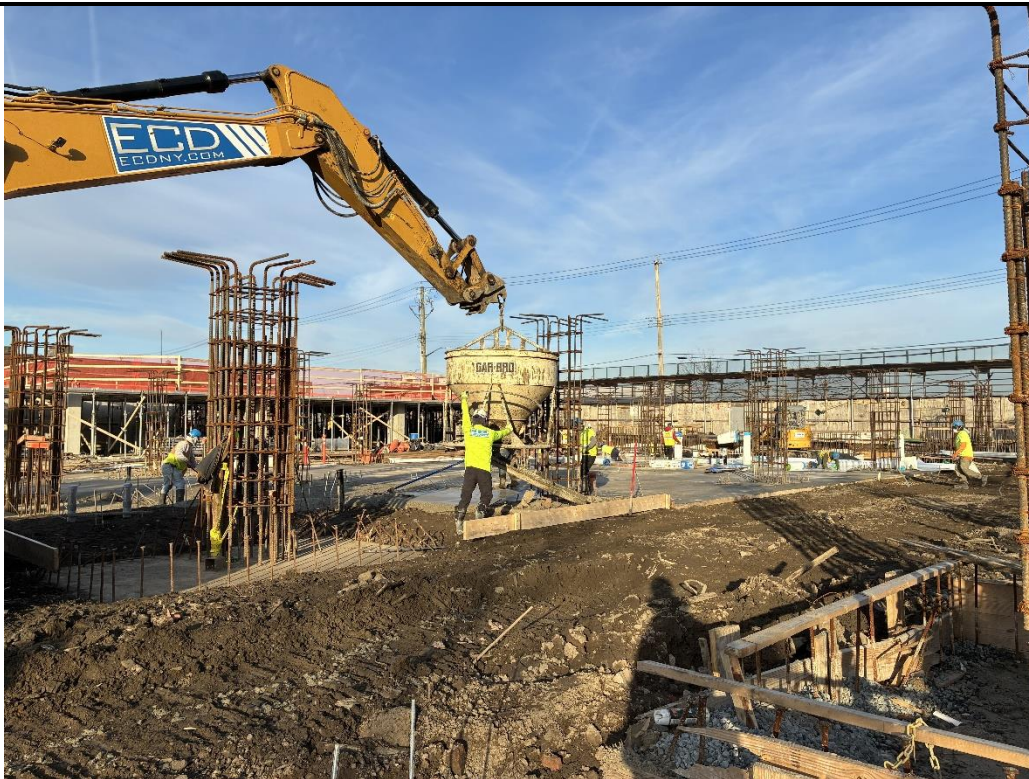
**Photo 3:** ECD pouring an about 3-inch-thick concrete rat slab in the northern part of the site (facing west)

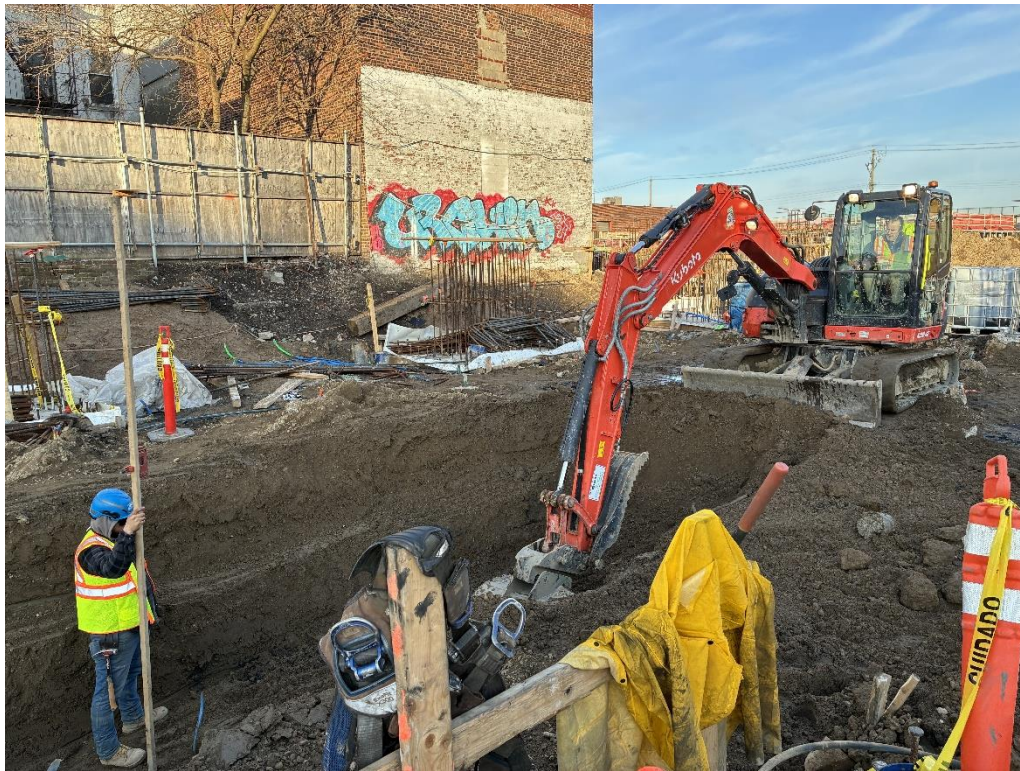
**Photo 4:** ECD excavating within clean fill for utility piping installation in the southern part of the site (facing west)

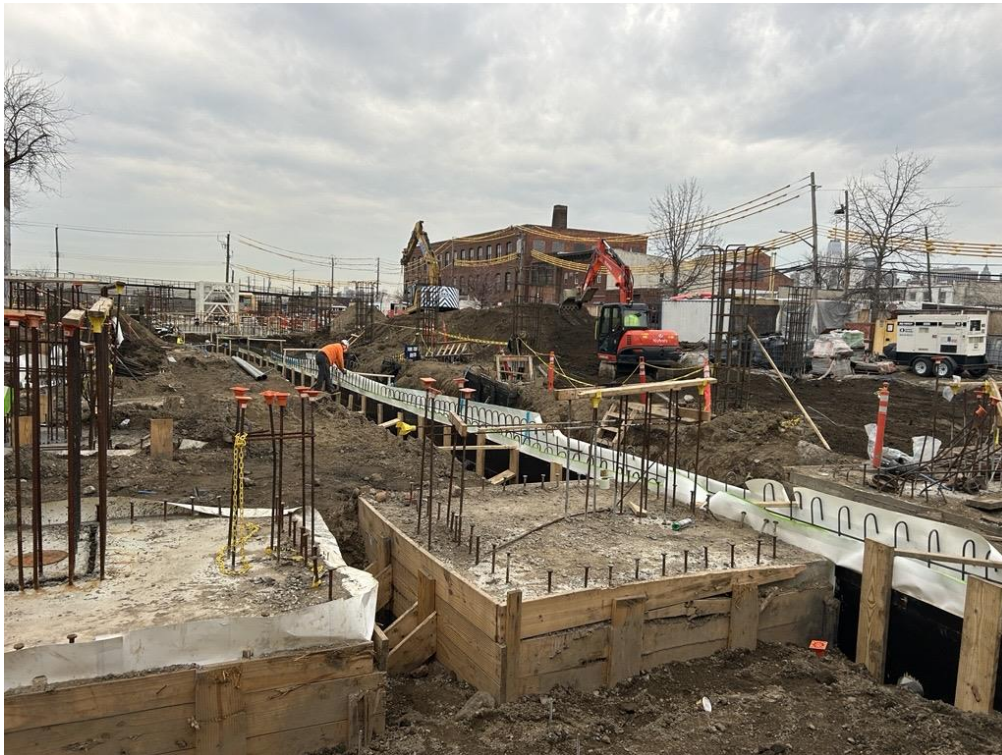
**Photo 1:** ECD adding previously imported clean fill to the stockpile in the central part of the site (facing northeast)

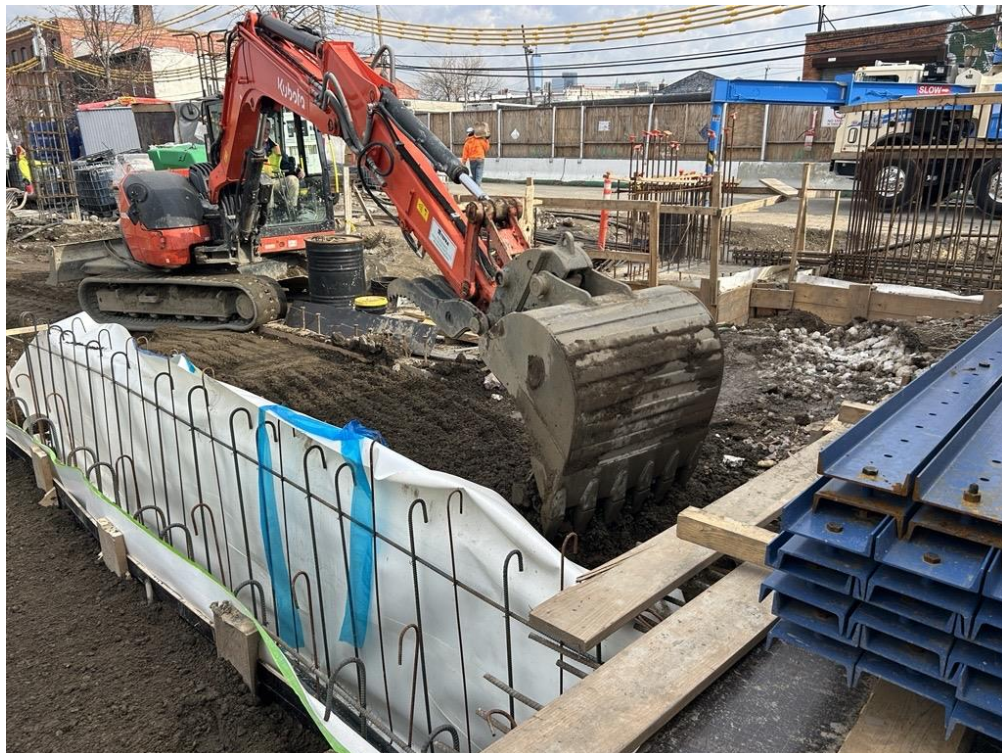
**Photo 2:** ECD backfilling with previously imported clean fill to surface grade in the southeastern part of the site (facing north)

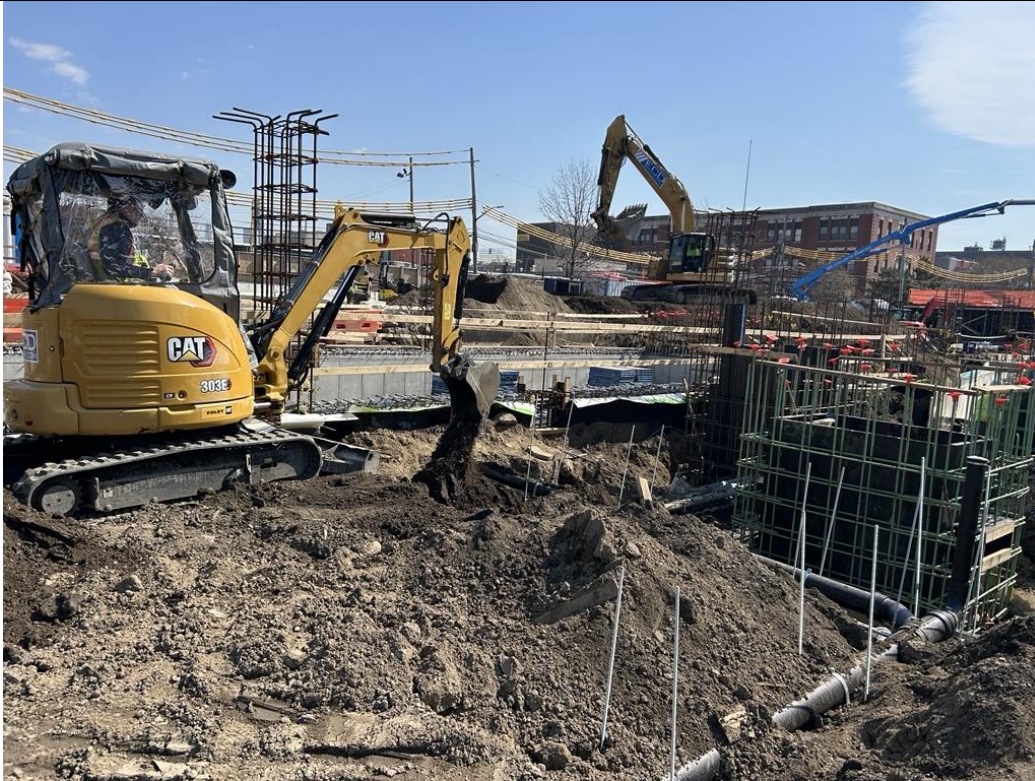
**Photo 3:** ECD backfilling with previously imported clean fill to surface grade around the detention tank in the central part of the site (facing east)

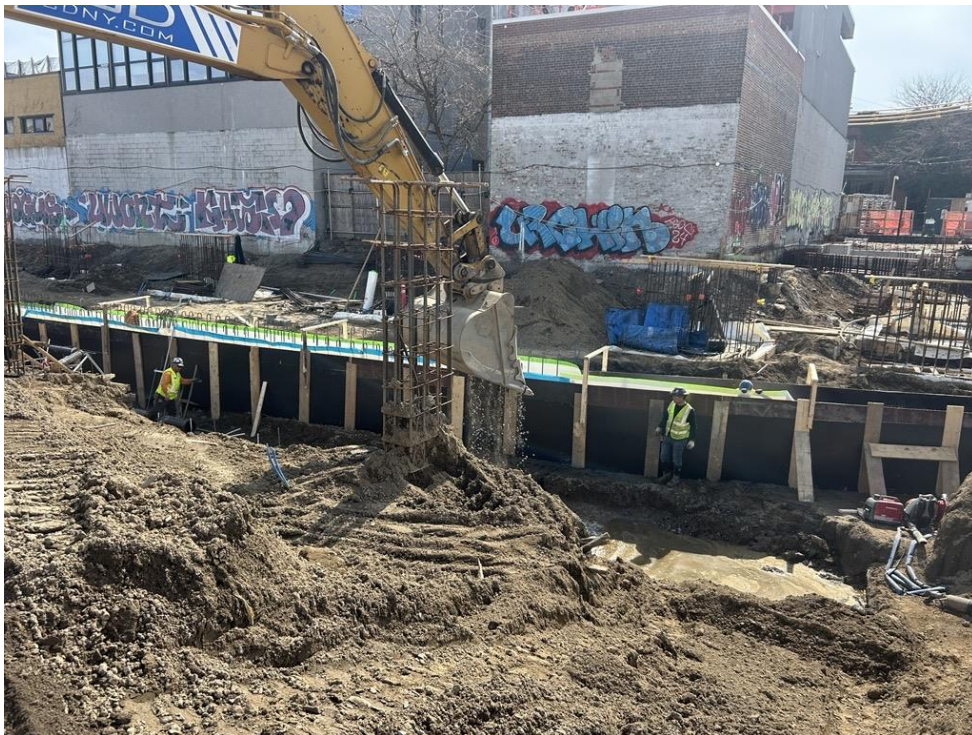
**Photo 4:** ECD backfilling an about 6-inch-thick layer of previously imported ¾-inch stone for utility piping installation (facing west)

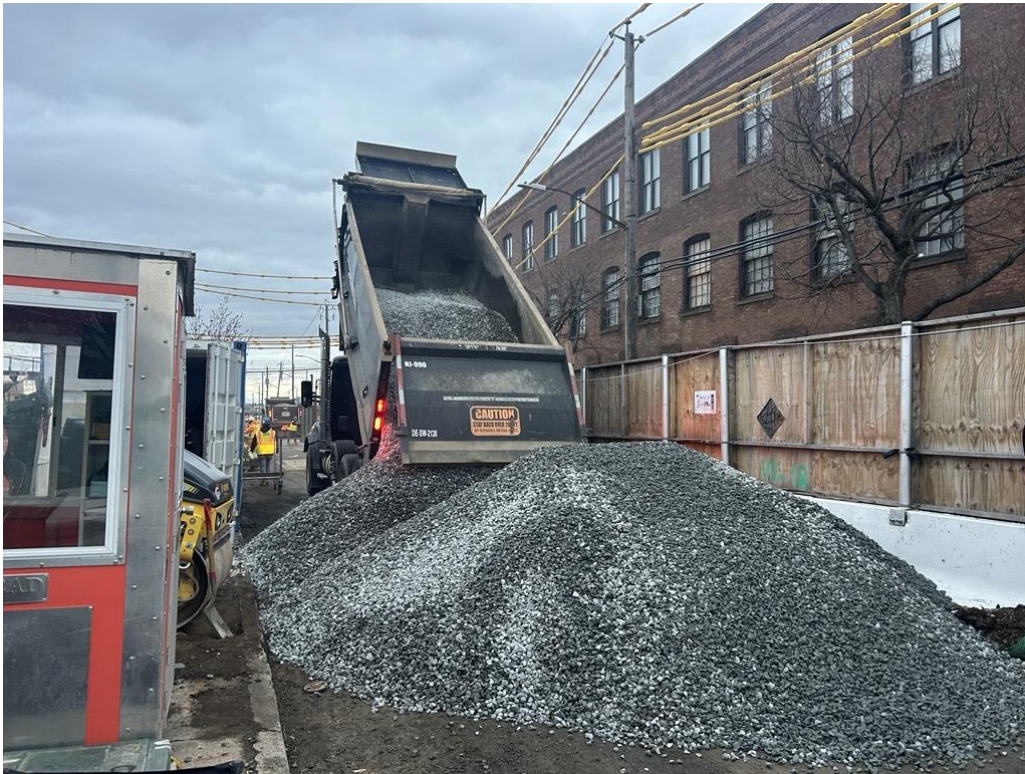
**Photo 1:** ECD importing 3/4-inch virgin stone in the eastern part of the site (facing northwest)

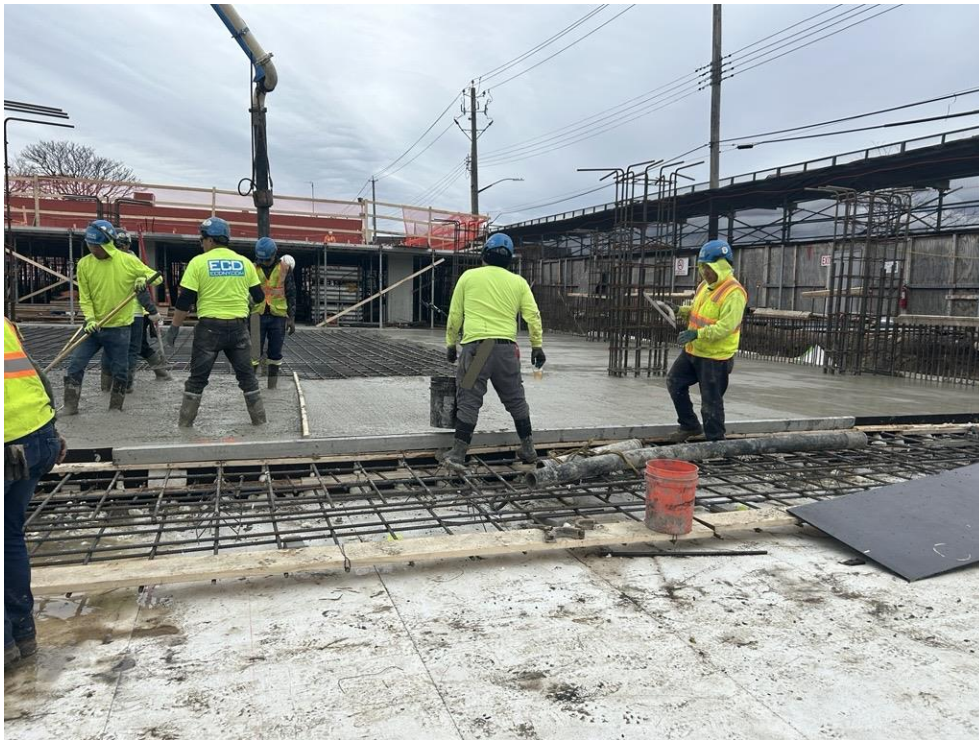
**Photo 2:** ECD pouring a 12-inch-thick concrete slab in the northern part of the site (facing west)

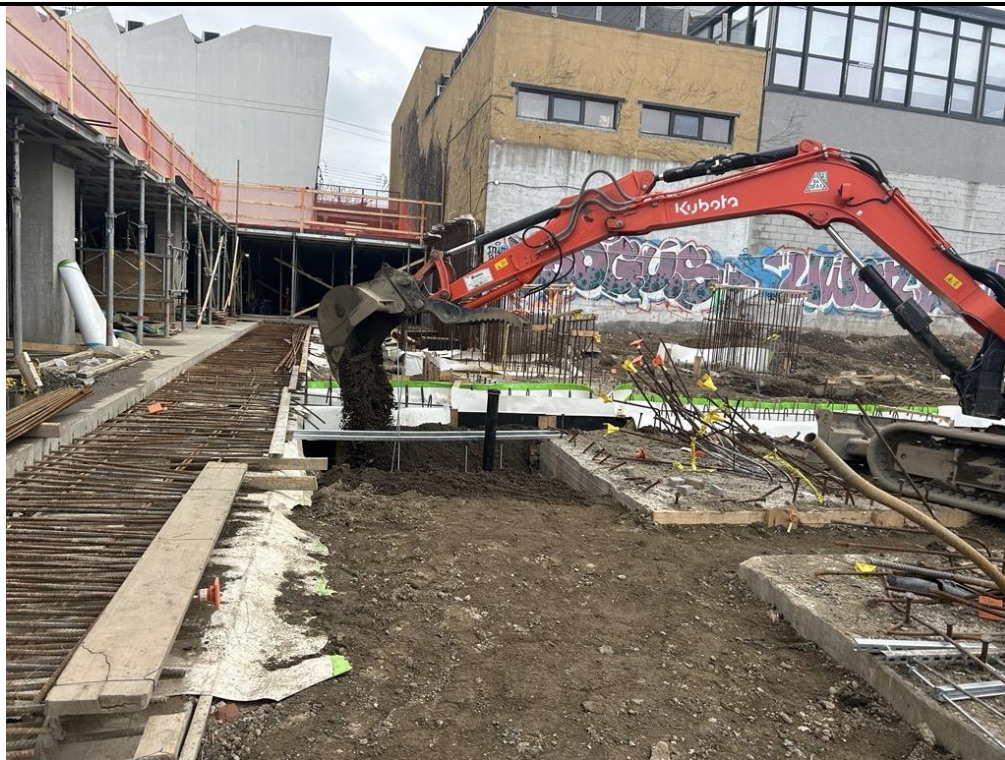
**Photo 3:** ECD backfilling with previously imported clean fill to surface grade around utility piping in the southern part of the site (facing southwest)

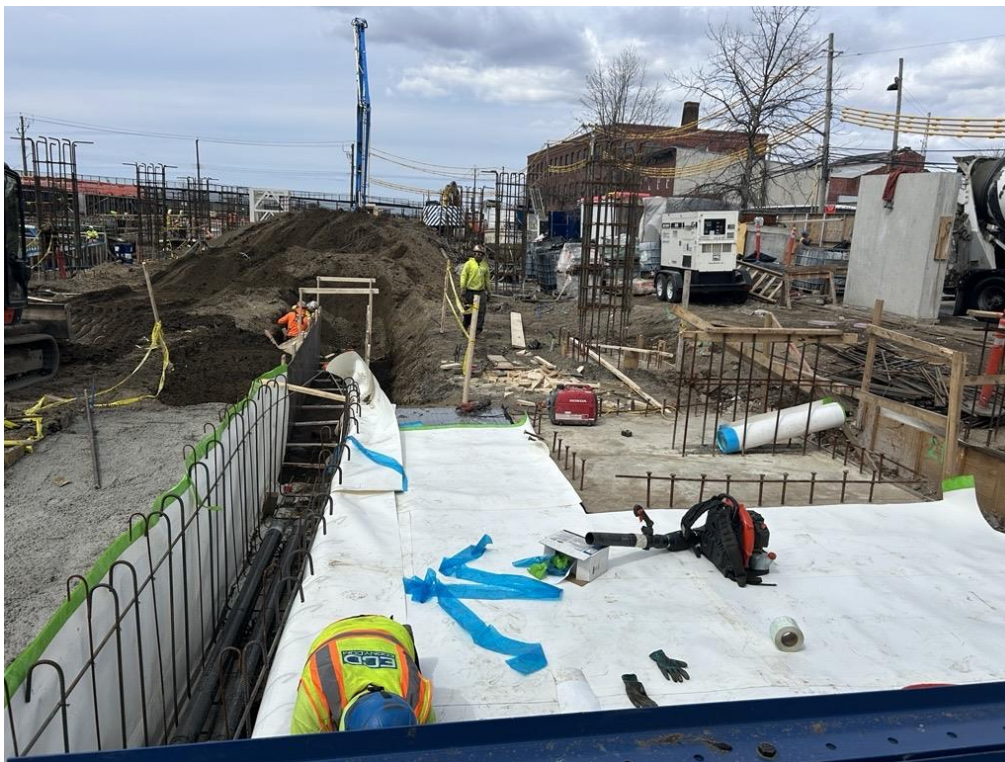
**Photo 4:** ECD installing Preprufe 300R Plus waterproofing / vapor barrier atop rat slab in the southern part of the site (facing north)
