LANGAN SITE OBSERVATION REPORT- Day 145

PROJECT No.: 170452203	CLIENT: NYM 145 Wolcott, LLC 233 Broadway, 10 th Fl., New York, NY 10279	DATE: Mon., March 30, 2026
PROJECT: 145-165 Wolcott Street		WEATHER: Partly Cloudy, 46 - 69 °F Wind: SSE @ 0.5 – 7.0 mph
LOCATION: Brooklyn, New York		TIME: 6:45 am – 6:00 pm
SITE CODE: C224256		MONITOR: Brayden Klein

Langan was present to document remediation activities in accordance with the New York State Department of Environmental Conservation (NYSDEC)-approved July 22, 2025 Remedial Action Work Plan (RAWP) at the 145-165 Wolcott Street site in Brooklyn, New York (Site No. C224256).

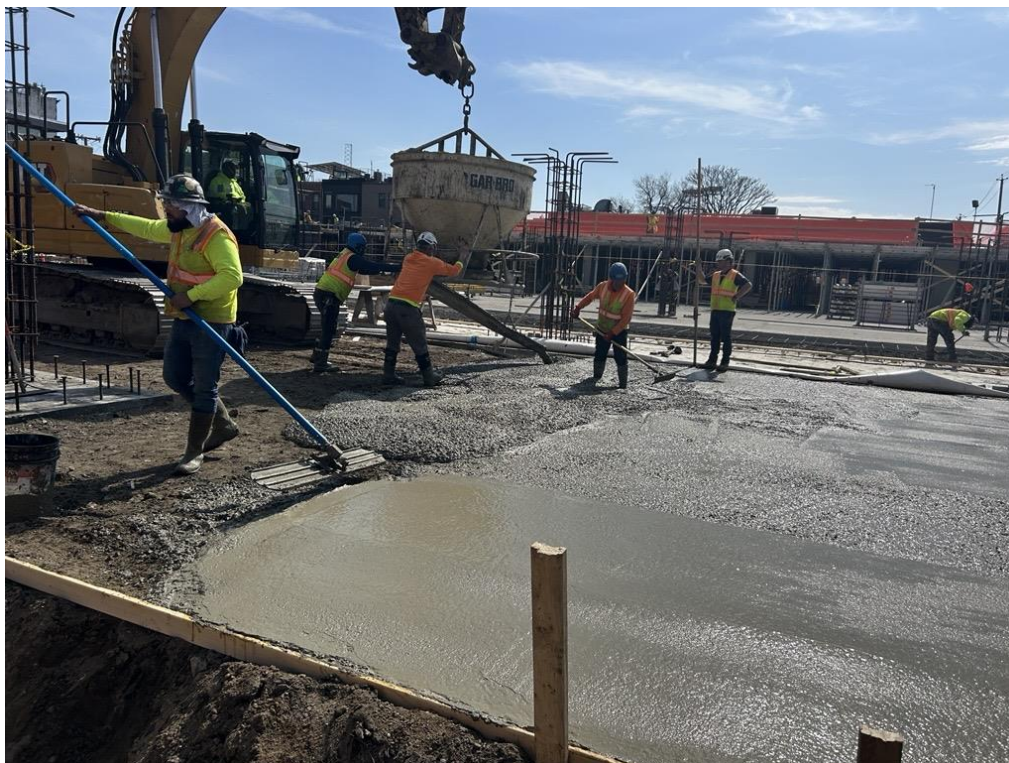
Photo 2: ECD pouring a 3-inch-thick rat slab in the northern part of the site (facing southwest)

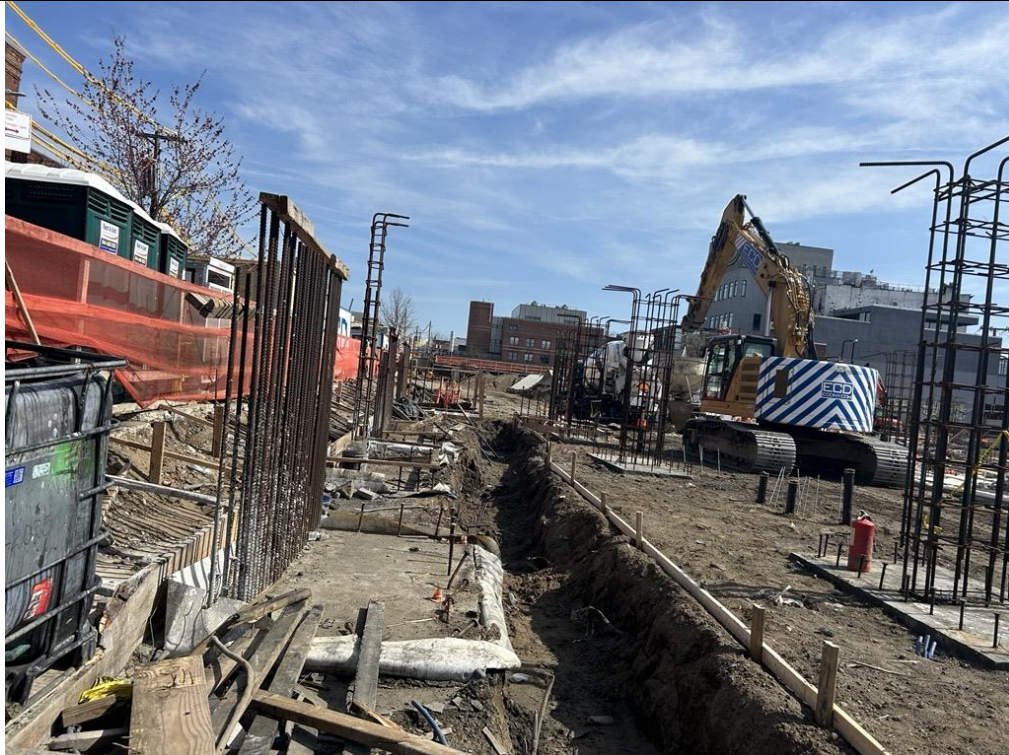
Photo 3: ECD excavating previously imported clean fill for SVE installation in the northern part of the site (facing southeast)

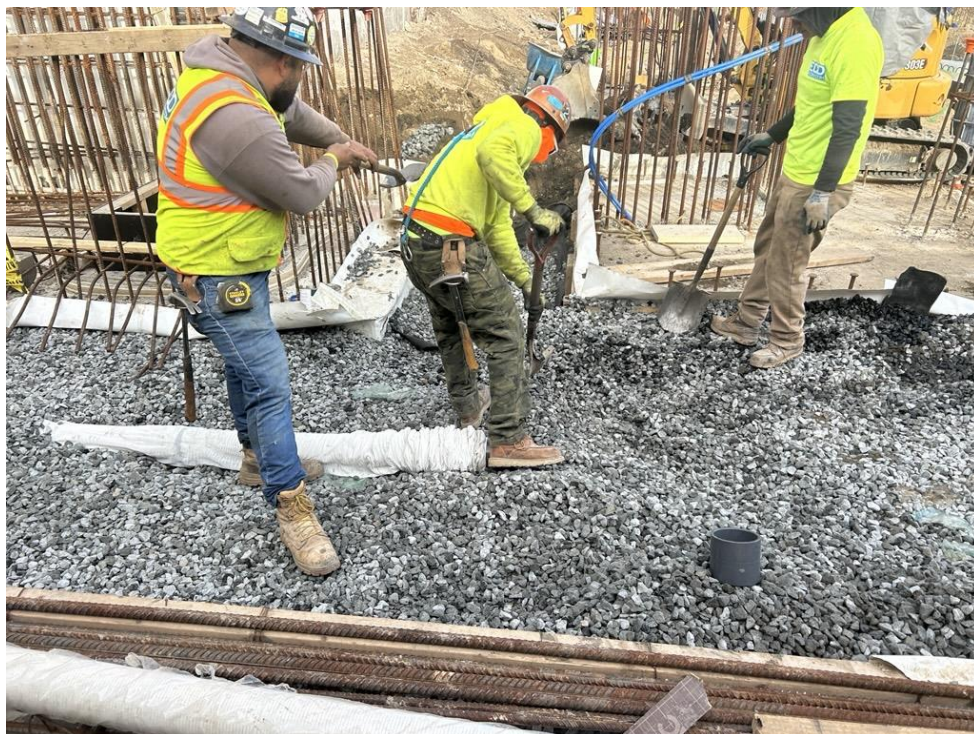
Photo 4: ECD backfilling with $\frac{3}{4}$ -inch virgin stone (gas permeable aggregate) as part of the SSDS in the southern part of the site (facing northwest)

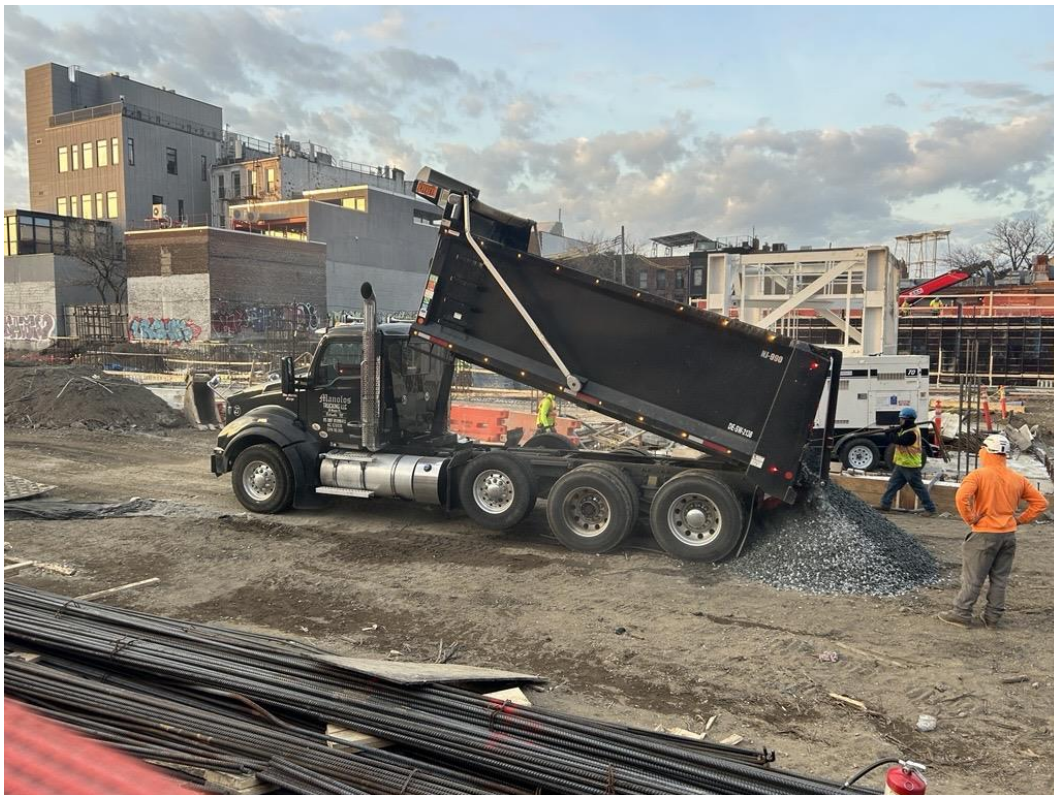
Photo 1: ECD importing ¾-inch virgin stone in the central part of the site (facing southwest)

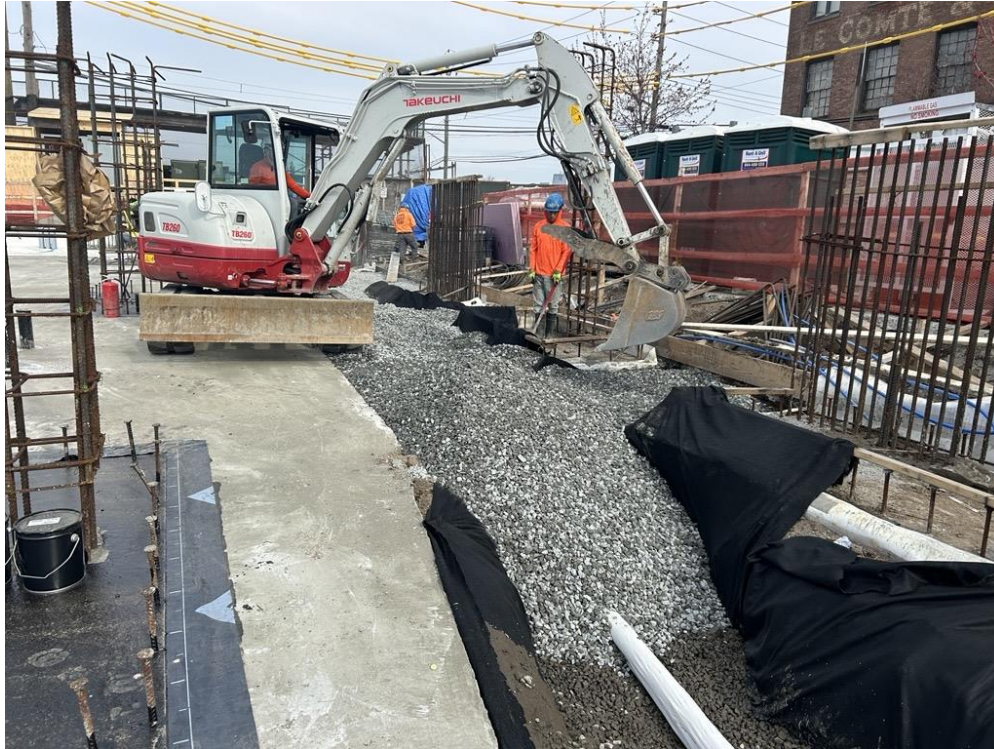
Photo 3: ECD backfilling with $\frac{3}{4}$ -inch virgin stone (gas permeable aggregate) as part of the SVE system in the northern part of the site (facing north)

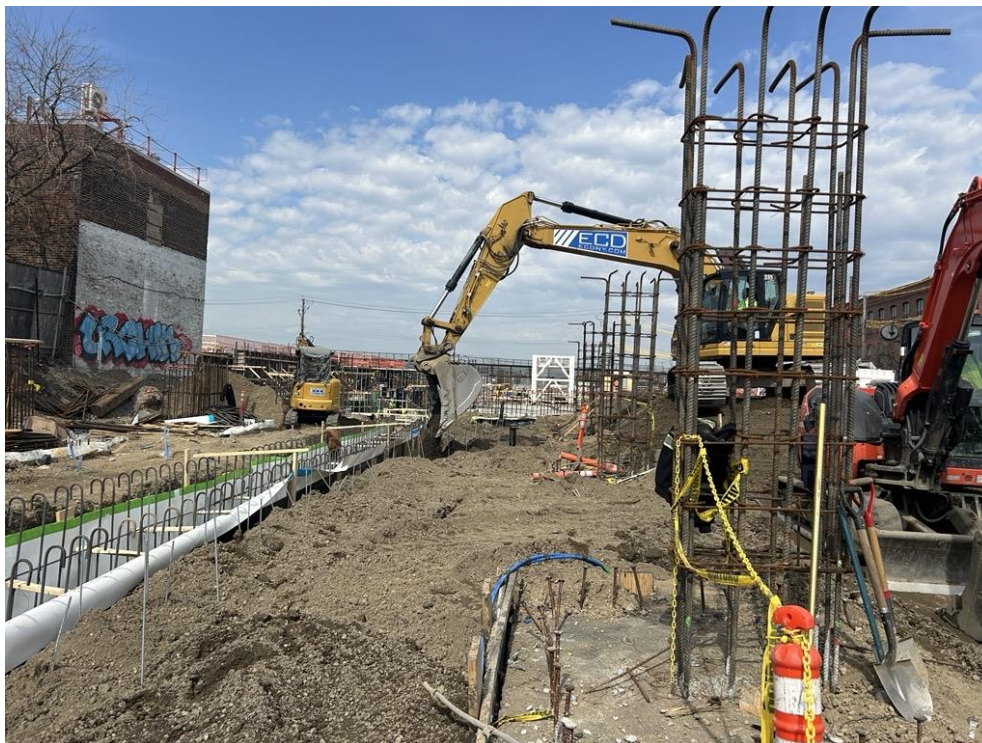
Photo 4: ECD backfilling with previously imported clean fill atop utility piping in the central part of the site (facing northwest)

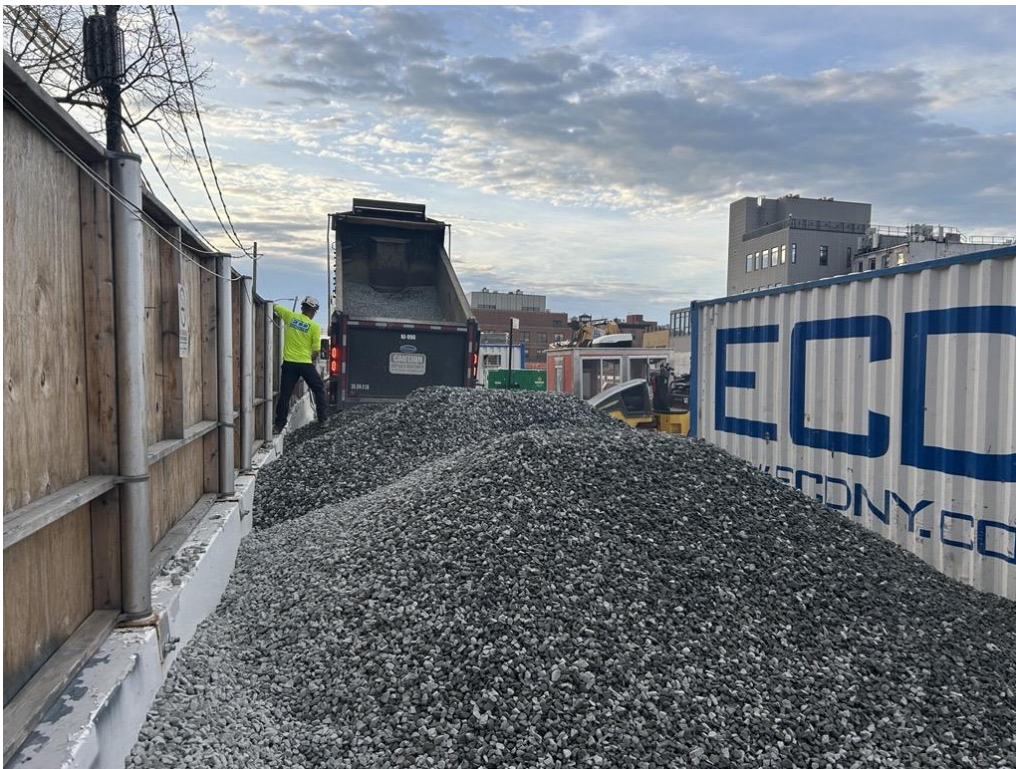
Photo 1: ECD importing ¾-inch virgin stone in the central part of the site (facing southeast)

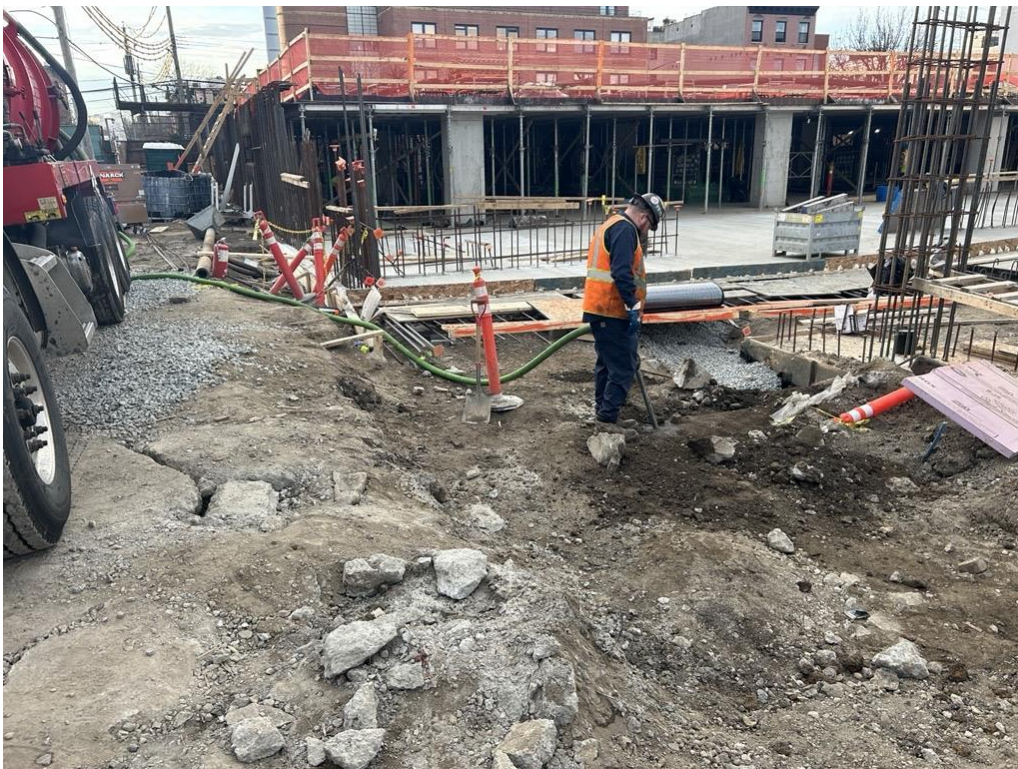
Photo 2: Arcwood extracting the contents of the steel tank for off-site disposal (facing south)

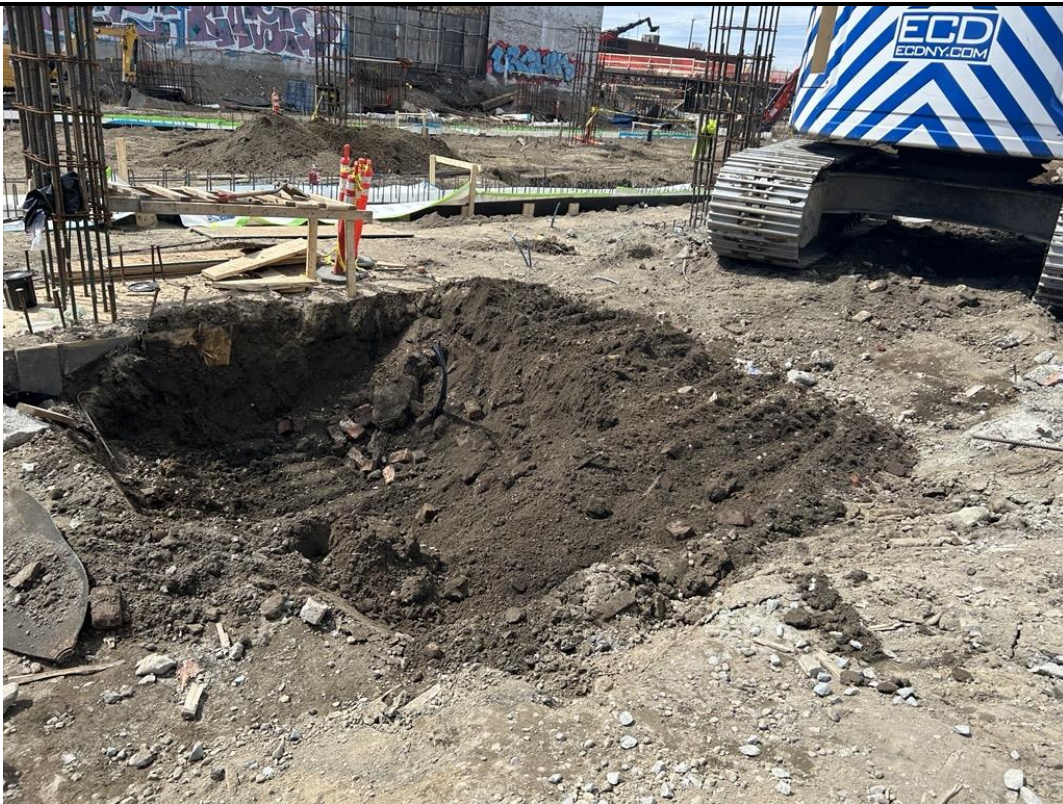
Photo 3: ECD excavating non-native fill beneath the base of the former steel tank in the southeastern part of the site (facing west)

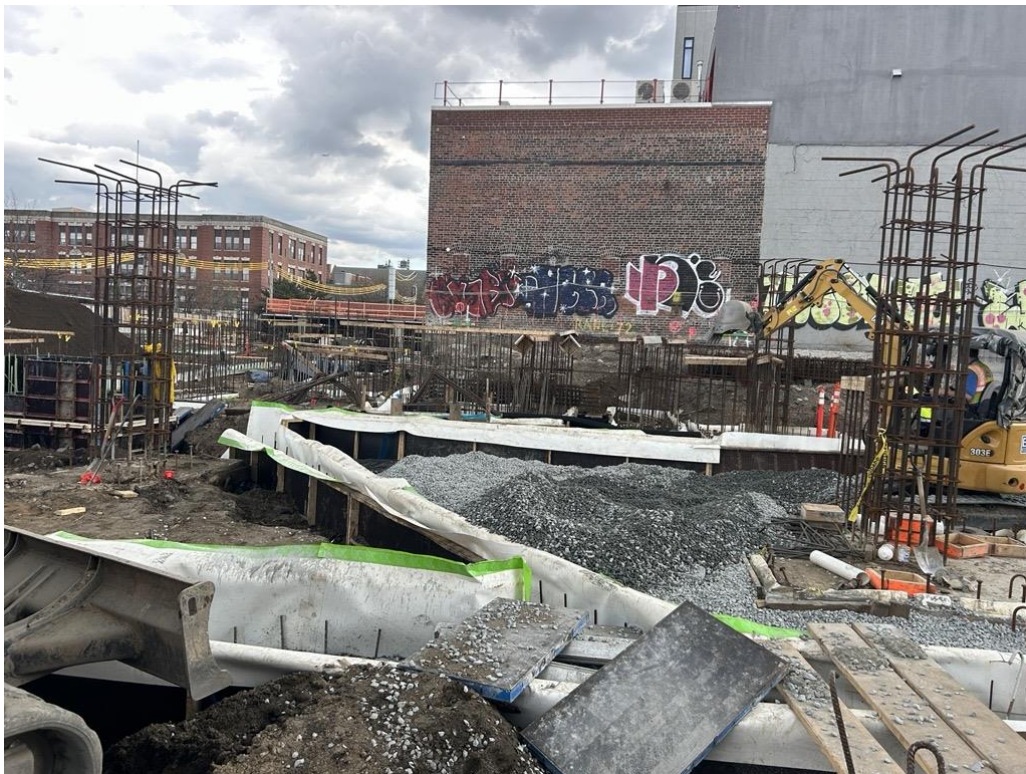
Photo 4: ECD backfilling SVE piping with previously imported ¾-inch stone in the western part of the site (facing east)

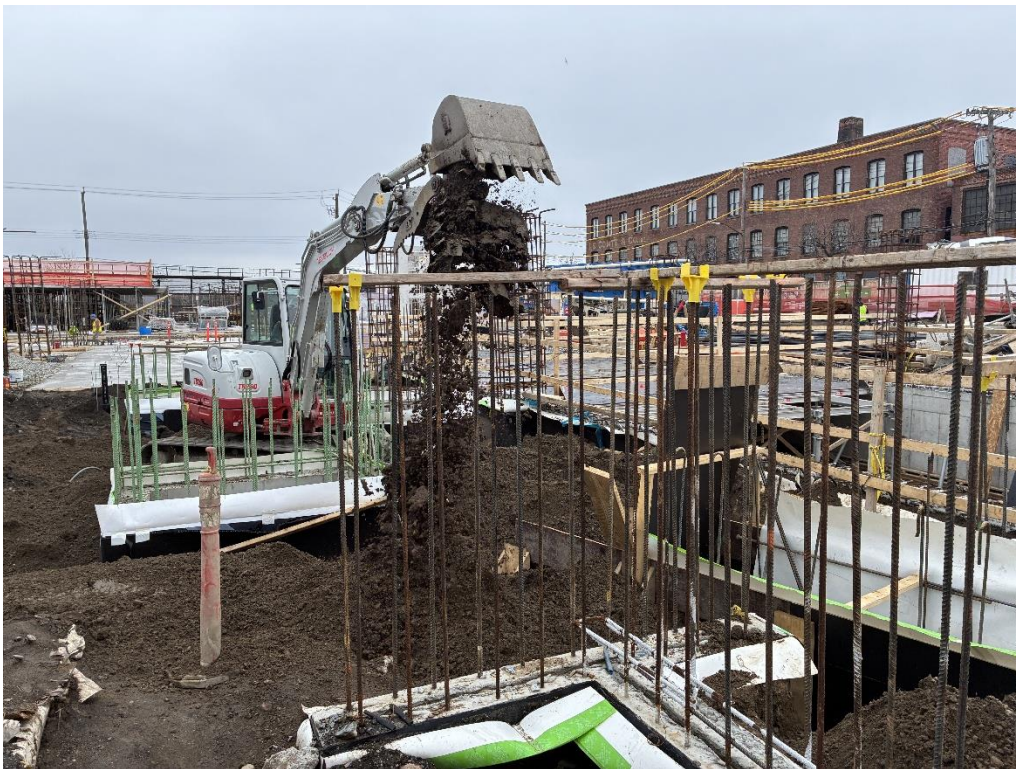
Photo 1: ECD backfilling with previously imported clean fill to surface grade around ConEd utility boxes in the western part of the site (facing north)

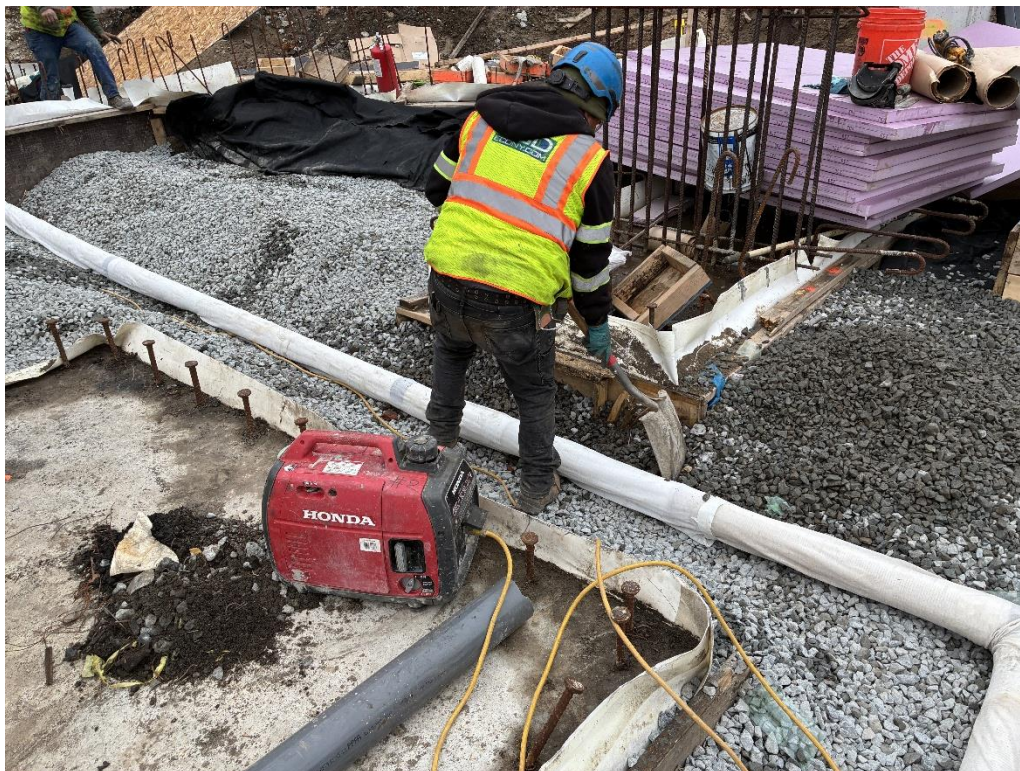
Photo 2: ECD installing the SSDS in the western part of the site (facing west)

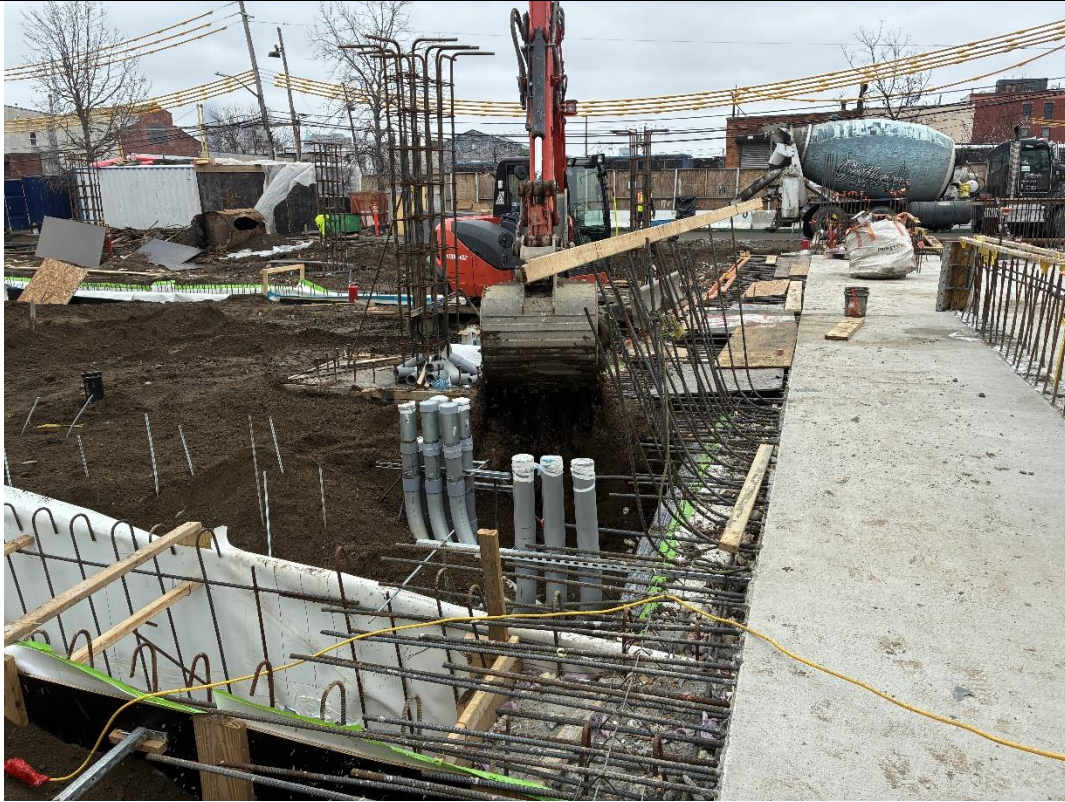
Photo 3: ECD backfilling a utility pipe trench with previously imported clean fill in the southern part of the site (facing east)

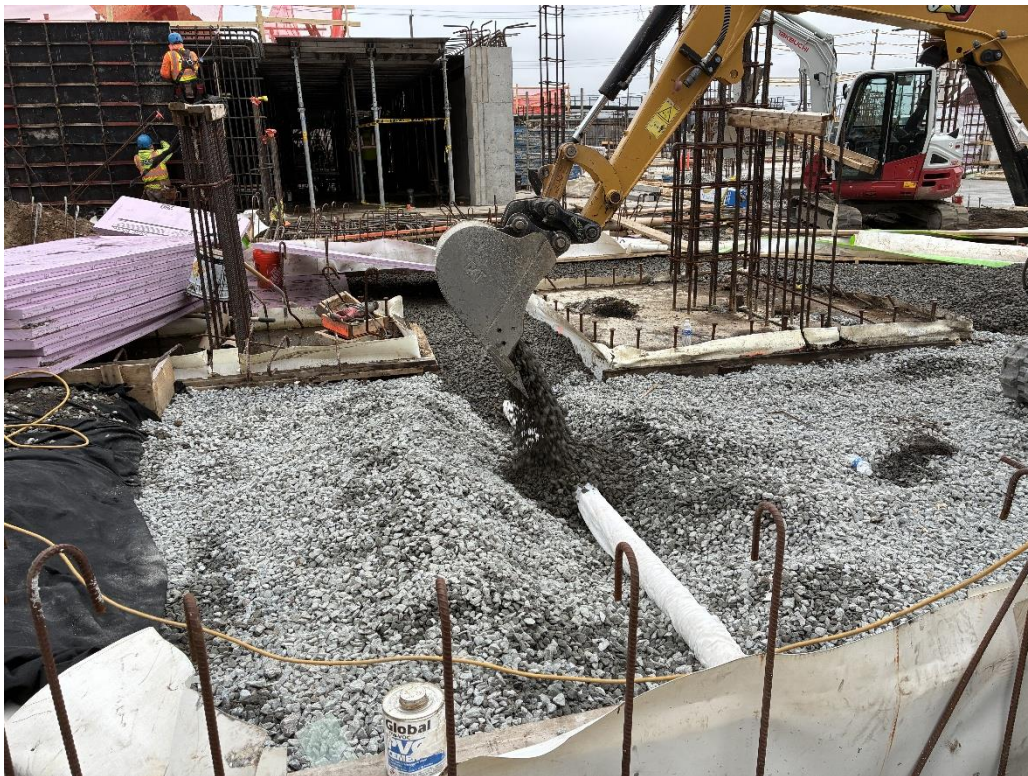
Photo 4: ECD backfilling SSDS piping with previously imported 3/4-inch stone in the western part of the site (facing north)

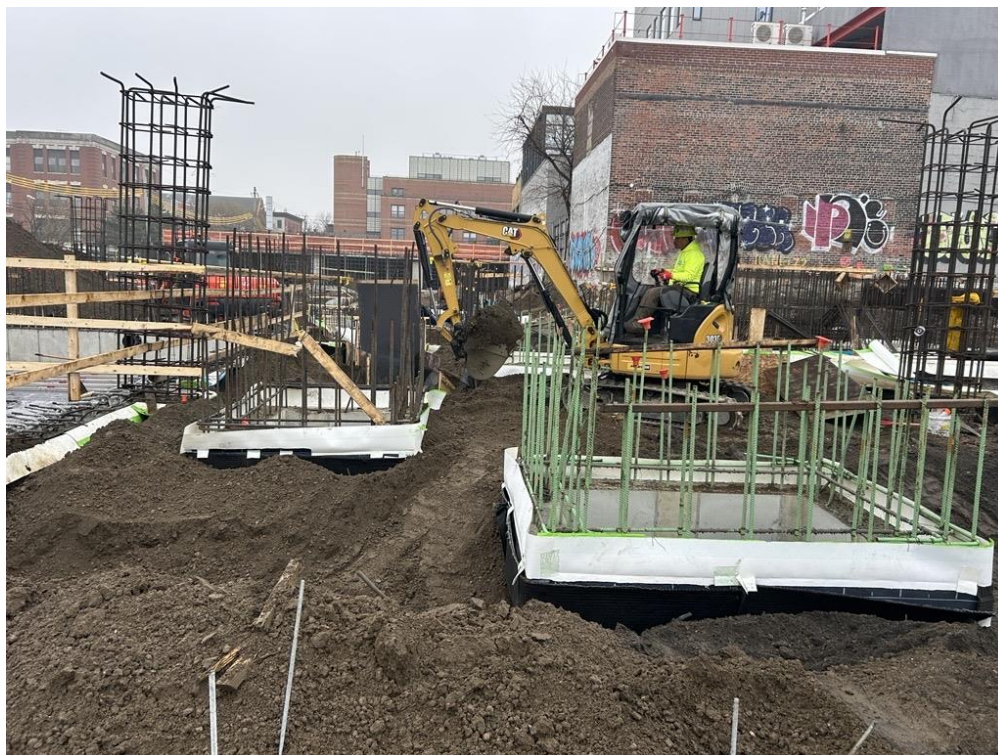
Photo 1: ECD backfilling with previously imported clean fill to surface grade around ConEd utility boxes in the western part of the site (facing north)

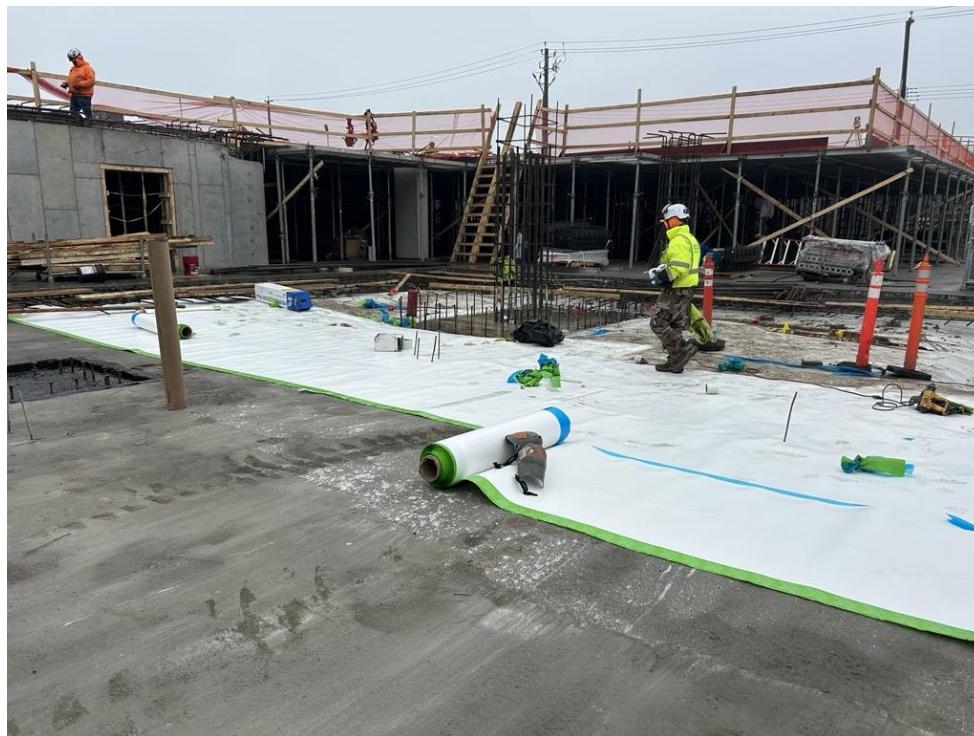
Photo 2: ECD installing Preprufe 300R Plus waterproofing/vapor barrier in the western part of the site (facing west)

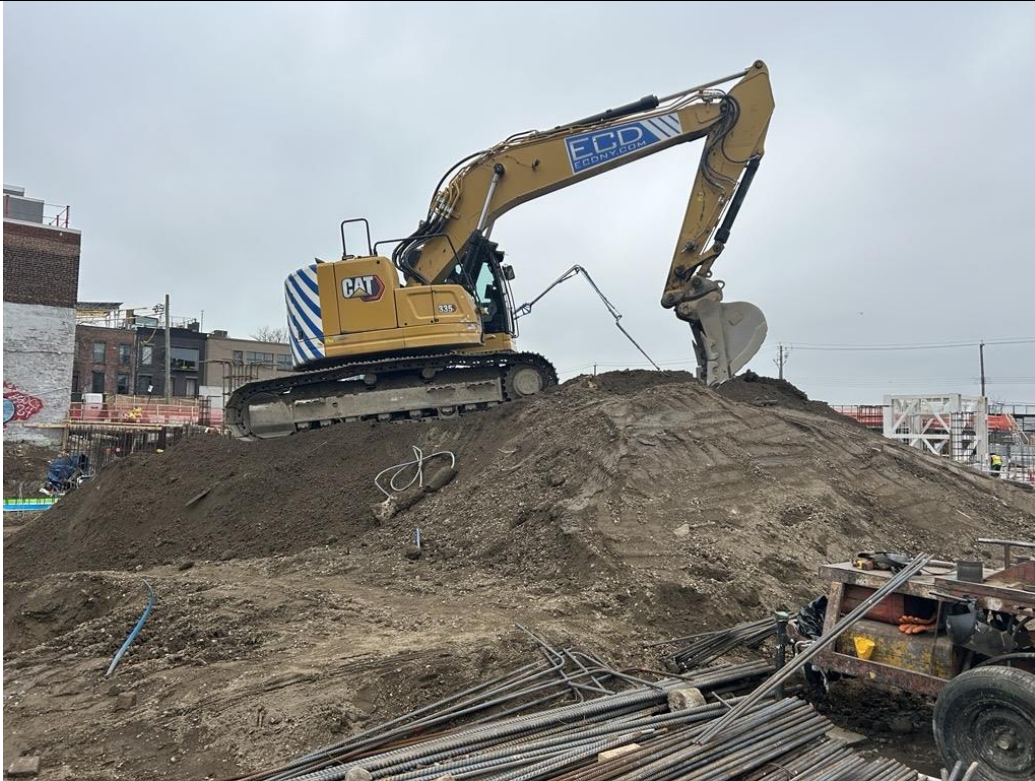
Photo 3: ECD stockpiling previously imported clean fill within the central part of the site (facing northwest)

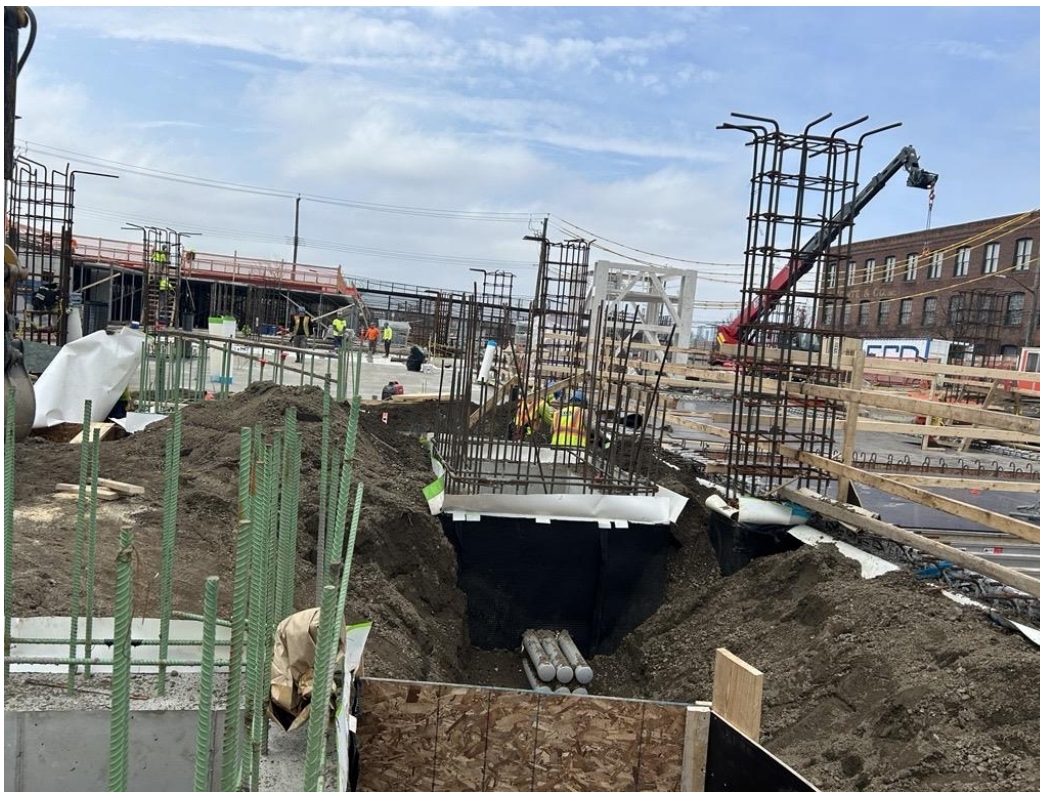
Photo 4: ECD installing utility piping in the central part of the site (facing north)
