LANGAN SITE OBSERVATION REPORT- Day 150

Cc: M. Burke, G. Nicholls, S. Knoop, N. Palumbo, L. Grose	By: Brayden Klein Langan Eng, Env, Surv, L.A. & Geo, DPC

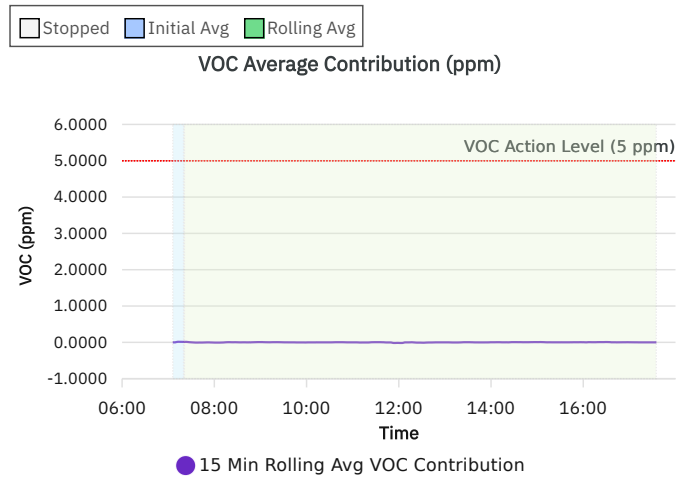
LANGAN SITE OBSERVATION REPORT- Day 151

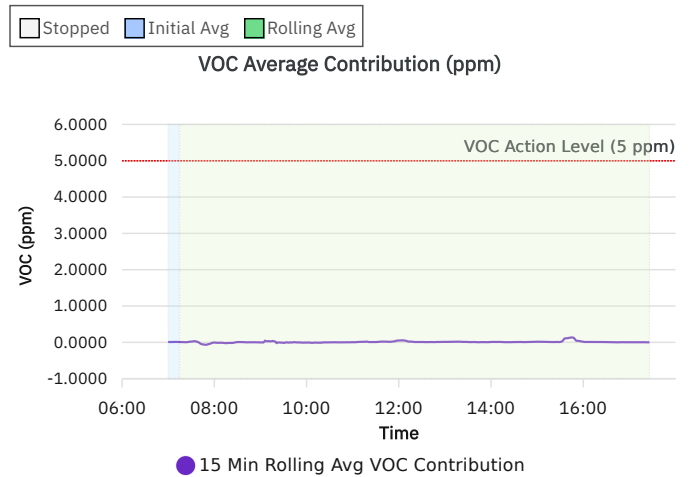
LANGAN SITE OBSERVATION REPORT- Day 154

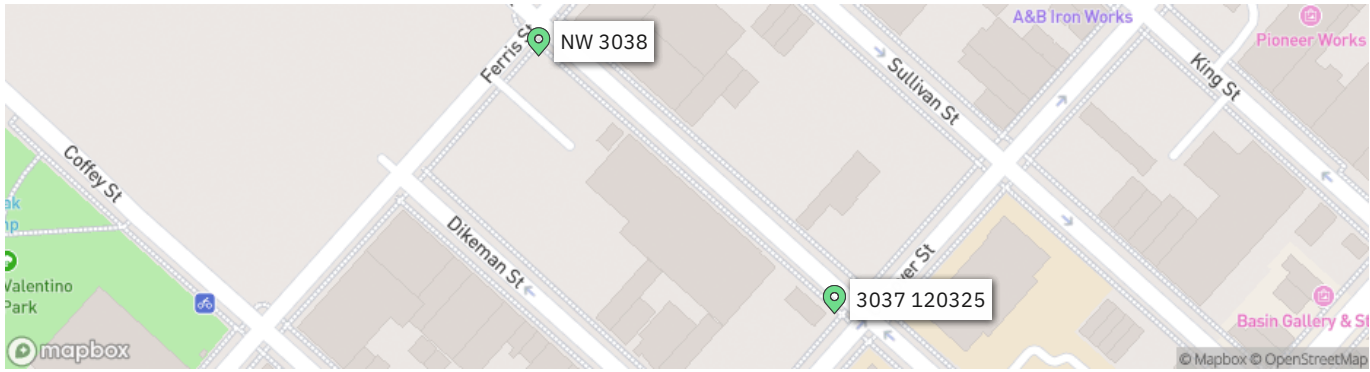
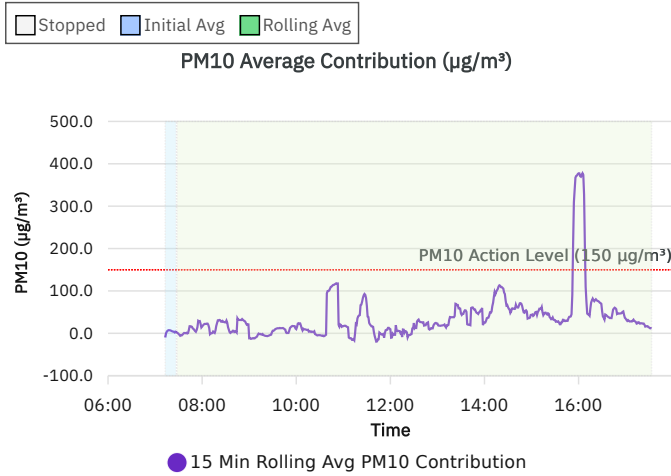
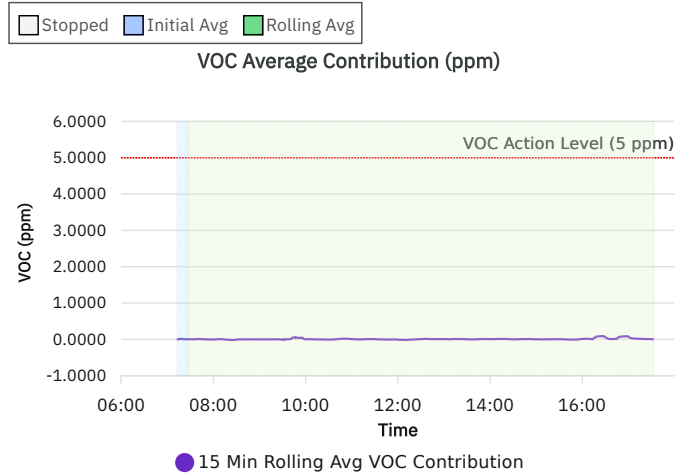
Daily Monitoring Summary	PM10 ($\mu\text{g}/\text{m}^3$)	Time	VOC (ppm)	Time
Min Contribution (15 min avg.) - 4/10/2026	-19.6	11:42	-0.0200	07:13
Max Contribution (15 min avg.) - 4/10/2026	377.6	16:05	0.0893	16:28
Daily Avg. Contribution (15 min avg.) - 4/10/2026	36.7	-	0.0080	-
