LANGAN SITE OBSERVATION REPORT- Day 155

PROJECT No.: 170452203	CLIENT: NYM 145 Wolcott, LLC 233 Broadway, 10 th Fl., New York, NY 10279	DATE: Mon., April 13, 2026
PROJECT: 145-165 Wolcott Street		WEATHER: Cloudy, 50 - 76°F Wind: ESE @ 0.5 – 4.8 mph
LOCATION: Brooklyn, New York		TIME: 6:45 am – 6:00 pm
SITE CODE: C224256		MONITOR: Brayden Klein

Langan was present to document remediation activities in accordance with the New York State Department of Environmental Conservation (NYSDEC)-approved July 22, 2025 Remedial Action Work Plan (RAWP) at the 145-165 Wolcott Street site in Brooklyn, New York (Site No. C224256).

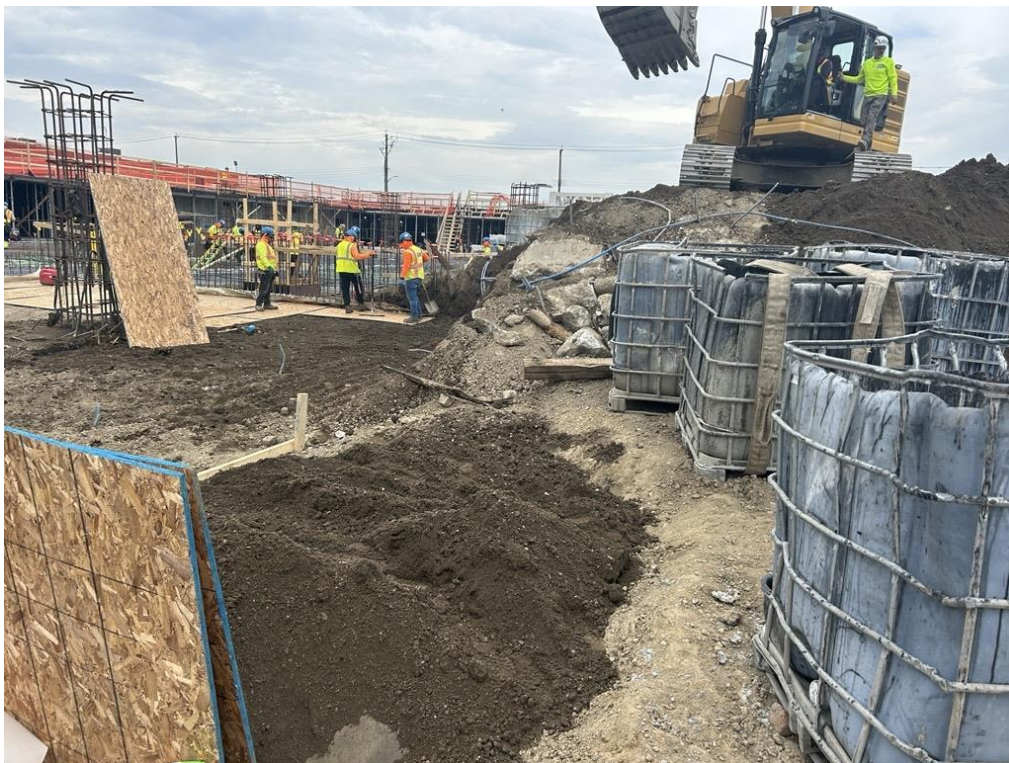
Photo 2: ECD backfilling previously imported clean fill in the central part of the site (facing west)

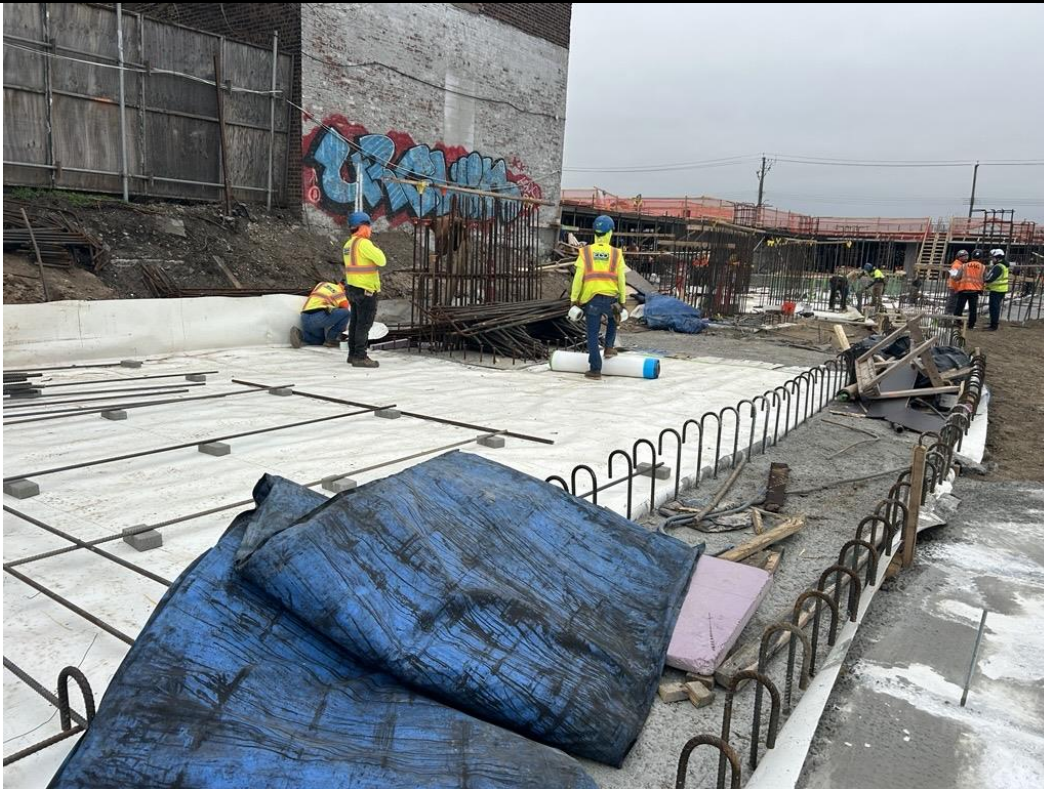
Photo 3: ECD installing Preprufe 300R Plus waterproofing / vapor barrier membrane in the central part of the site (facing northwest)

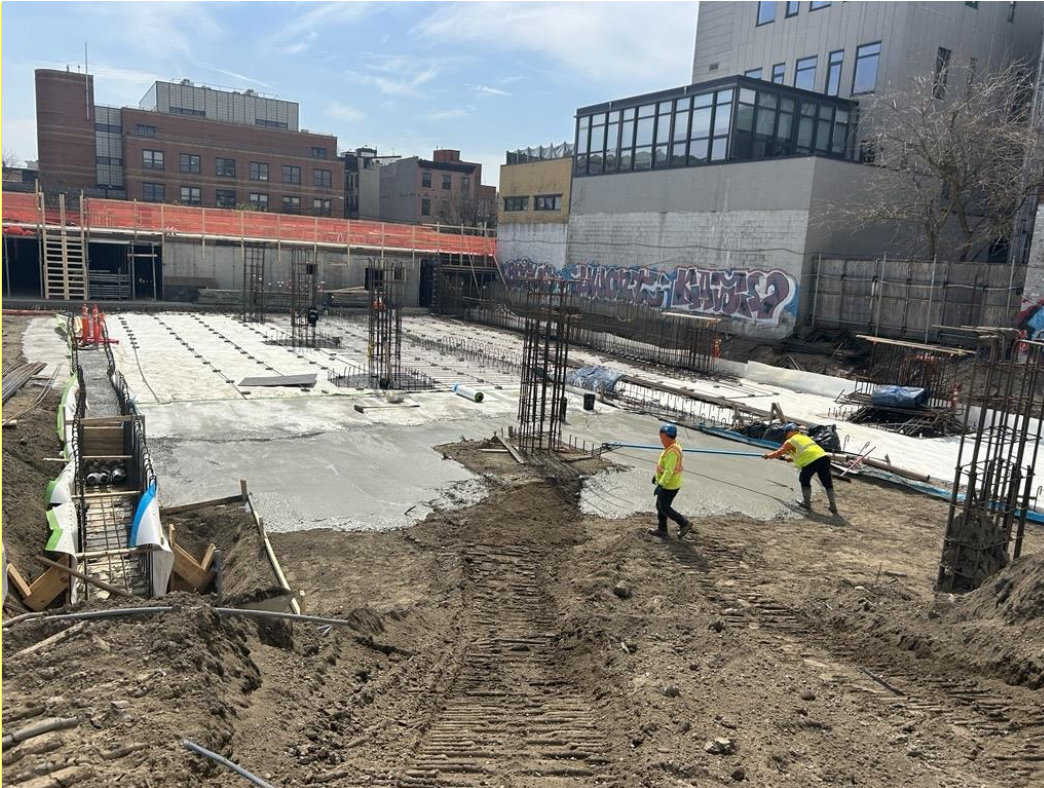
Photo 4: ECD pouring a 3-inch rat slab in the central part of the site (facing south)

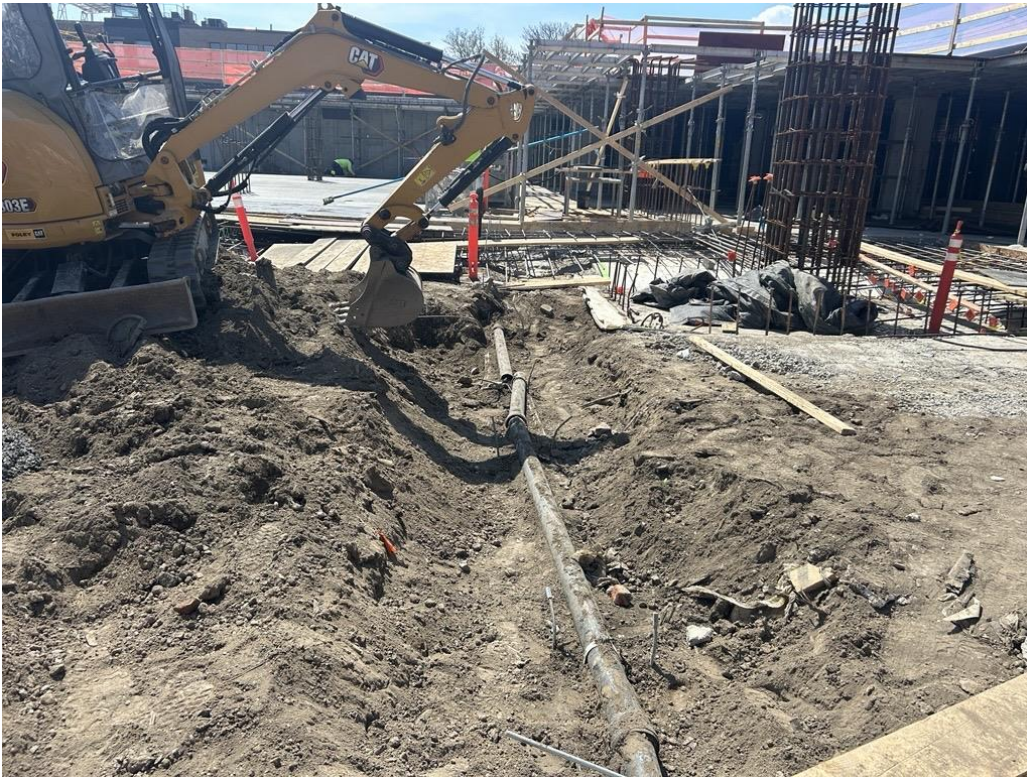
Photo 1: ECD excavating non-native fill for utility pipe installation in the northern part of the site (facing southwest)

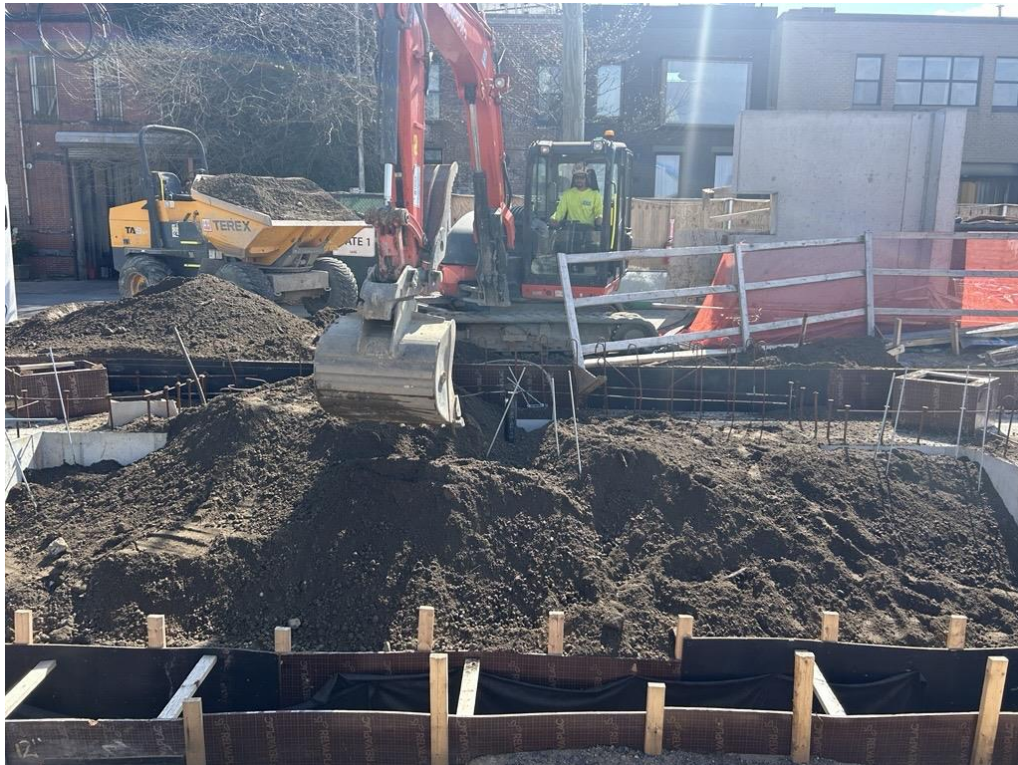
Photo 2: ECD backfilling previously imported clean fill in the western part of the site (facing west)

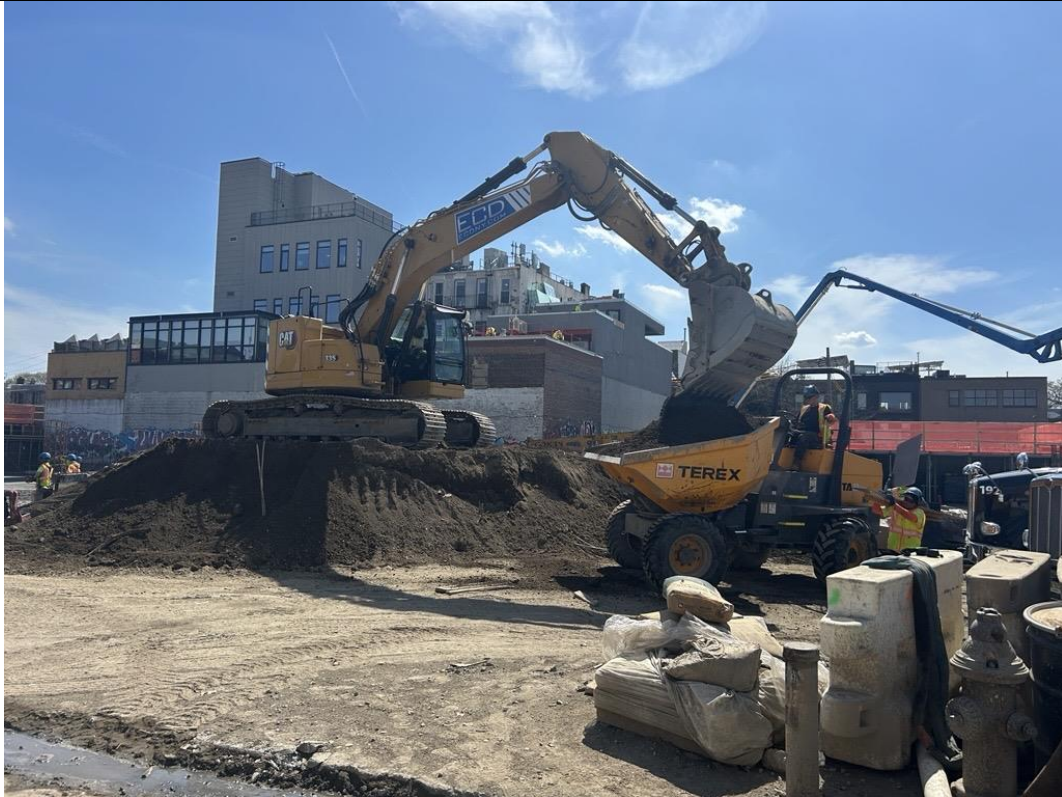
Photo 3: ECD relocating stockpiled imported clean fill from the eastern part of the site to the western part of the site for future backfill (facing south)

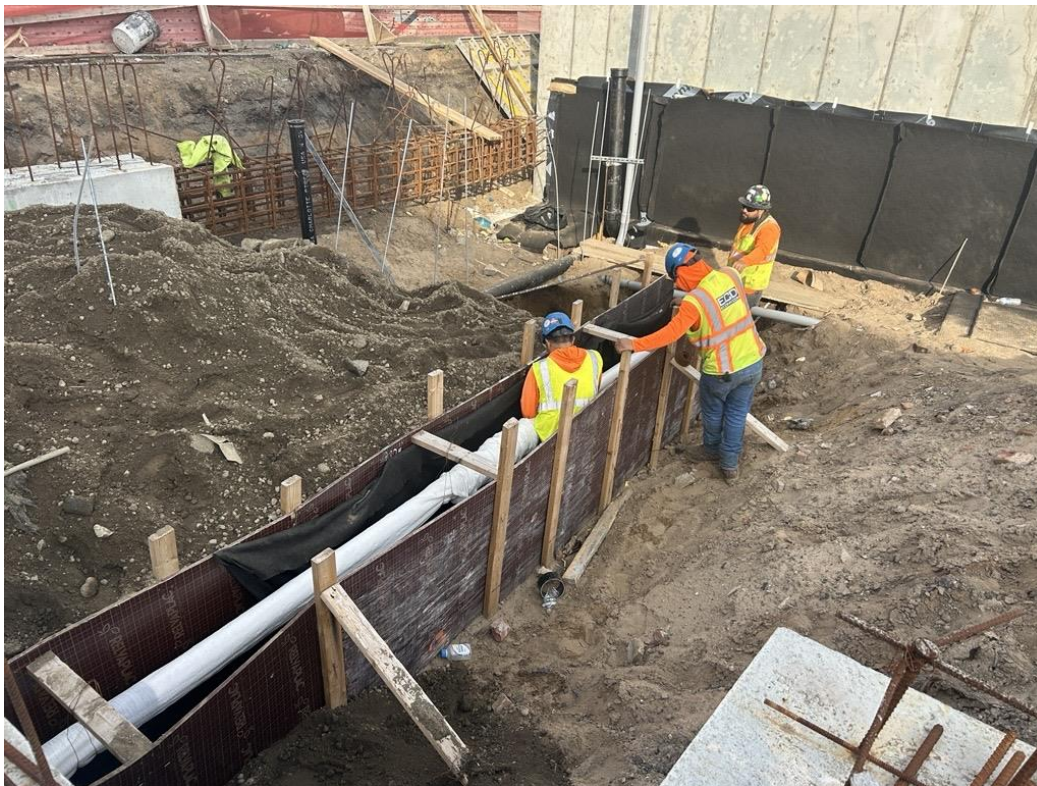
Photo 1: ECD installing SVE piping in the western part of the site (facing west)

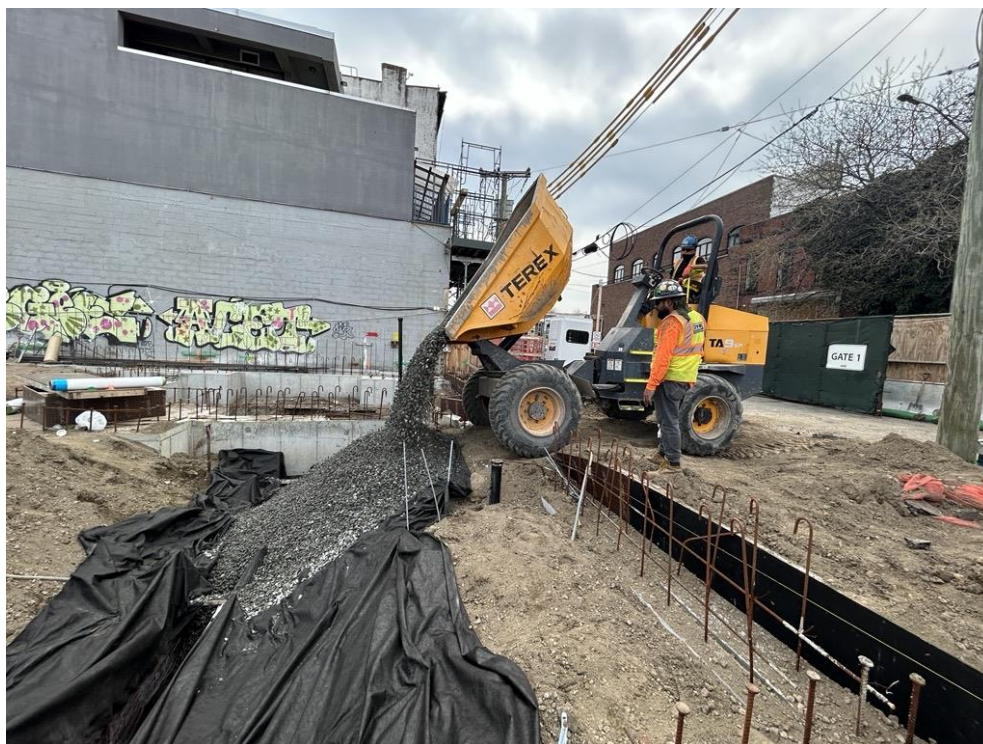
Photo 2: ECD backfilling $\frac{3}{4}$ -inch ASTM No.5 stone atop geotextile fabric in the western part of the site (facing south)

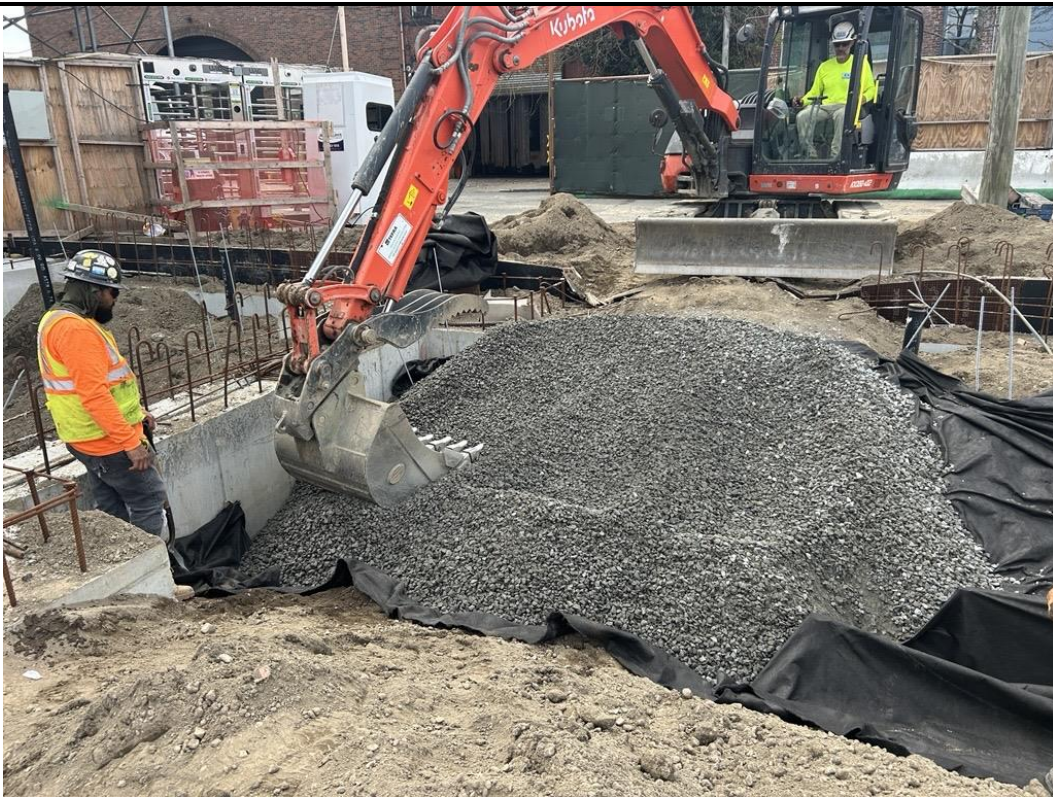
Photo 3: ECD backfilling with imported 3/4-inch ASTM No. 5 stone for the SVE system installation in the western part of the site (facing southwest)

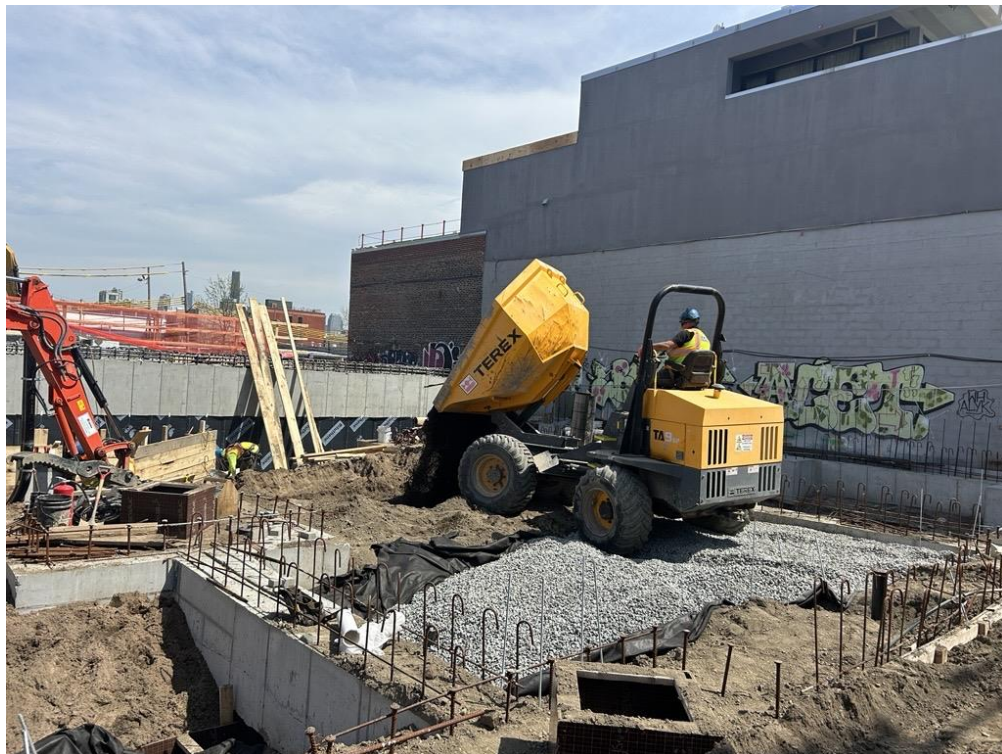
Photo 4: ECD stockpiling previously imported clean fill from the eastern part of the site in the western part of the site (facing east)

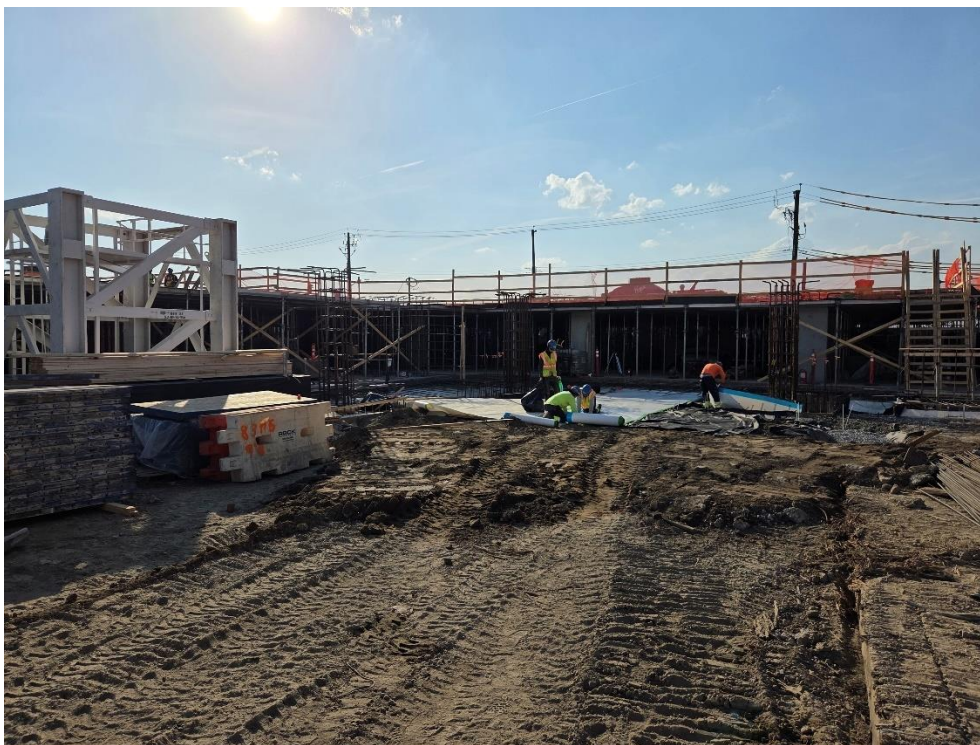
Photo 2: ECD installing Preprufe 300R Plus waterproofing/vapor barrier in the northern part of the site (facing west).

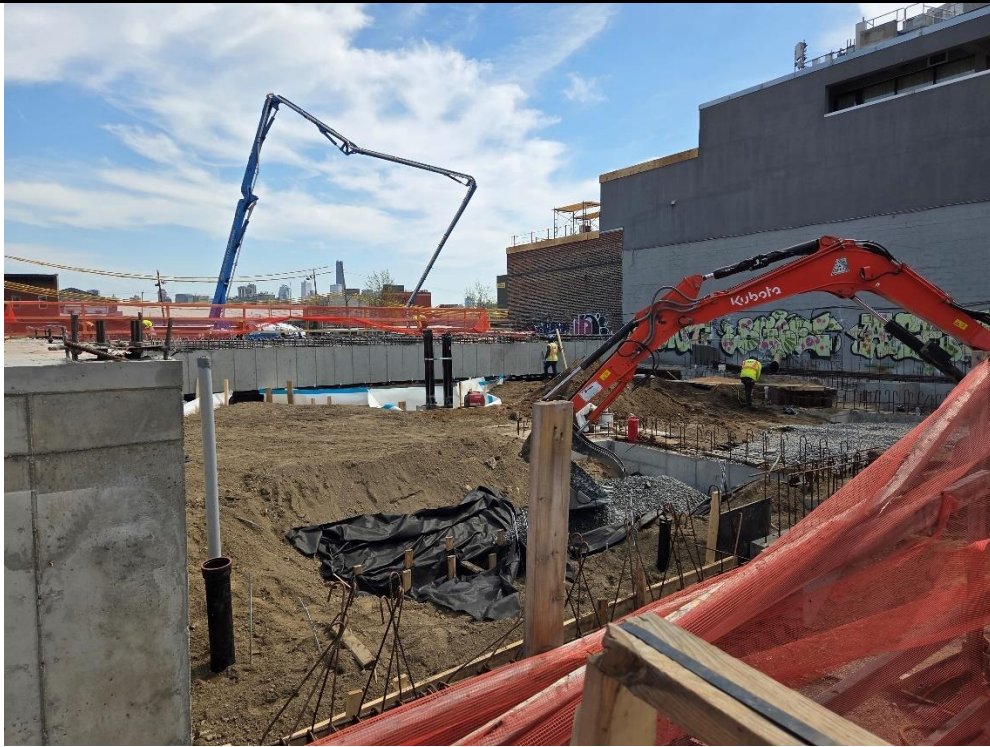
Photo 3: ECD backfilling with imported ¾-inch ASTM No. 5 stone for the SVE system installation in the western part of the site (facing east)

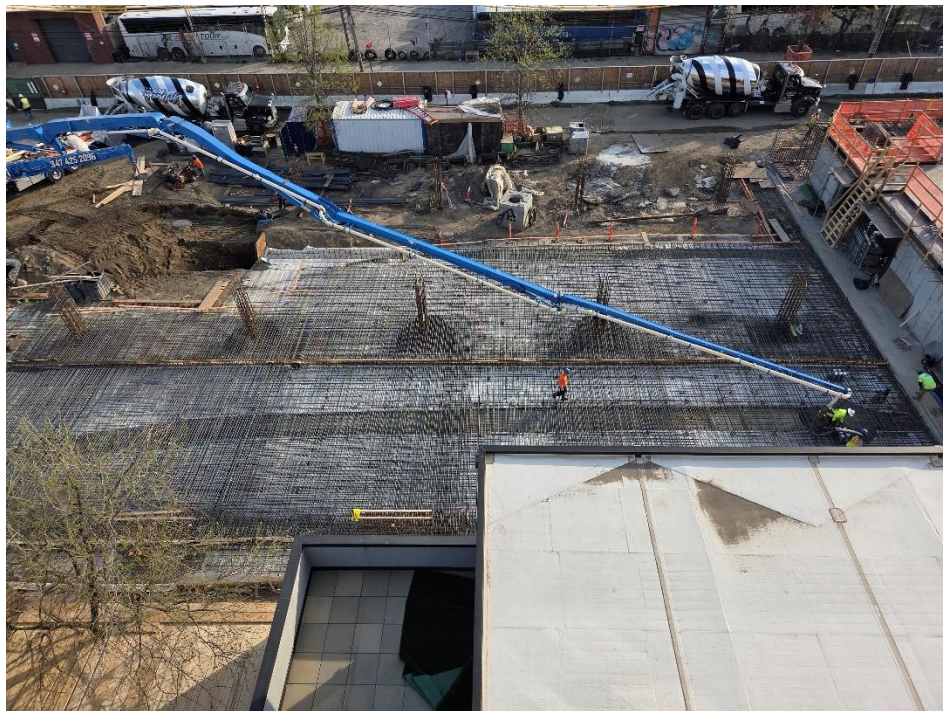
Photo 4: ECD pouring concrete in the central part of the site (facing down)

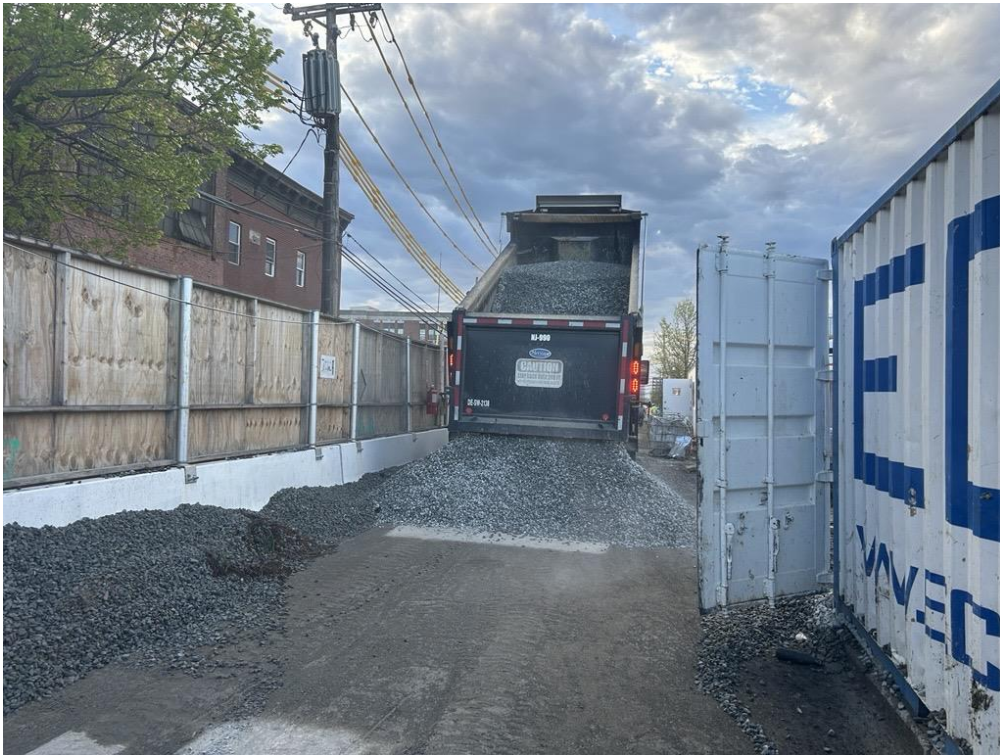
Photo 1: ECD importing approved ¾-inch ASTM No.5 stone in the eastern part of the site (facing southeast)

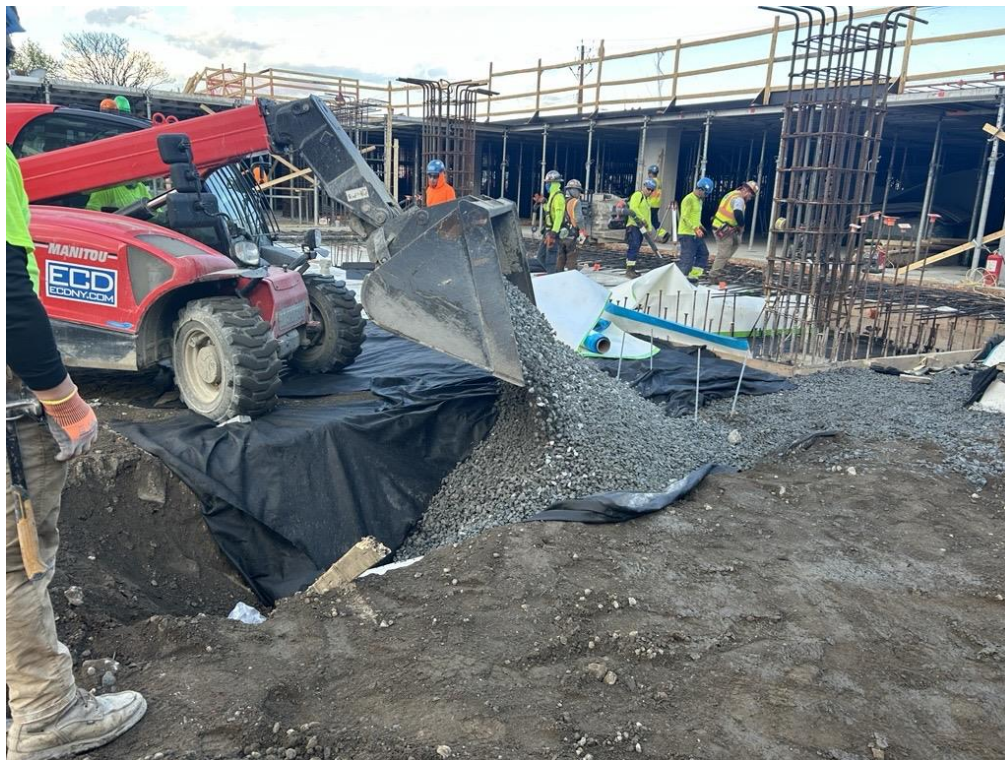
Photo 2: ECD backfilling with ¾-inch virgin stone (gas permeable aggregate) as the SVE system in the northern part of the site (facing west)

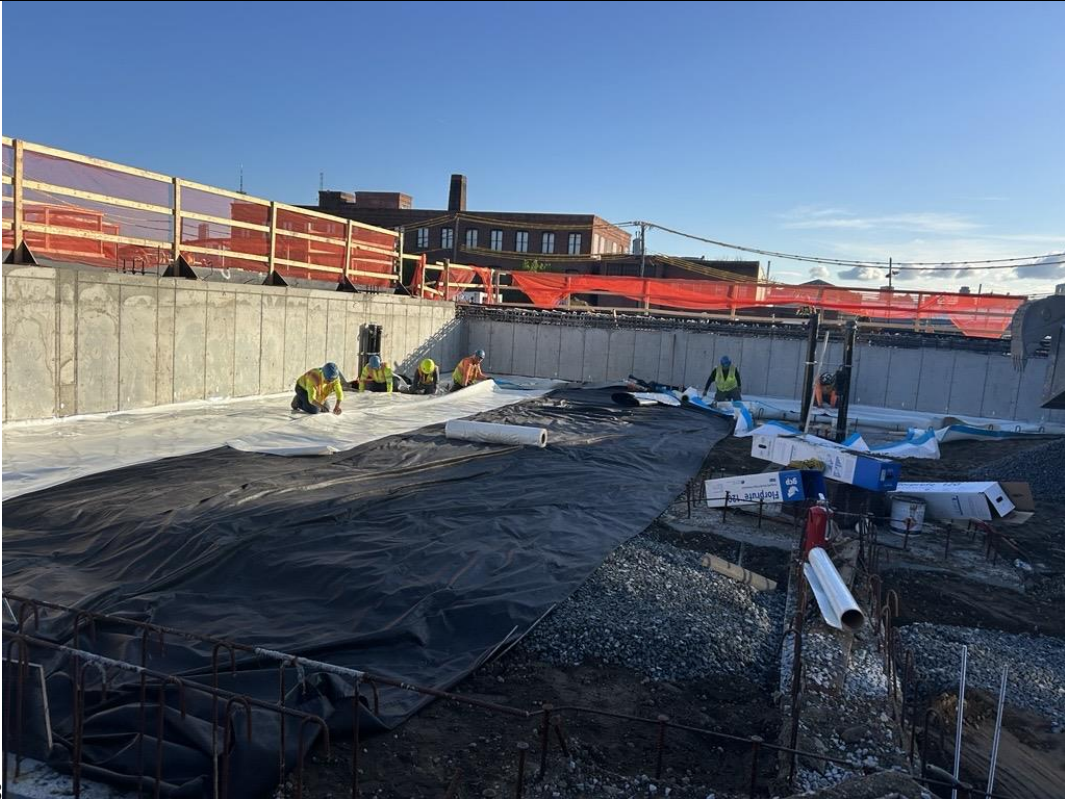
Photo 3: ECD installing Florprufe 120 waterproofing / vapor barrier in the western part of the site (facing north)

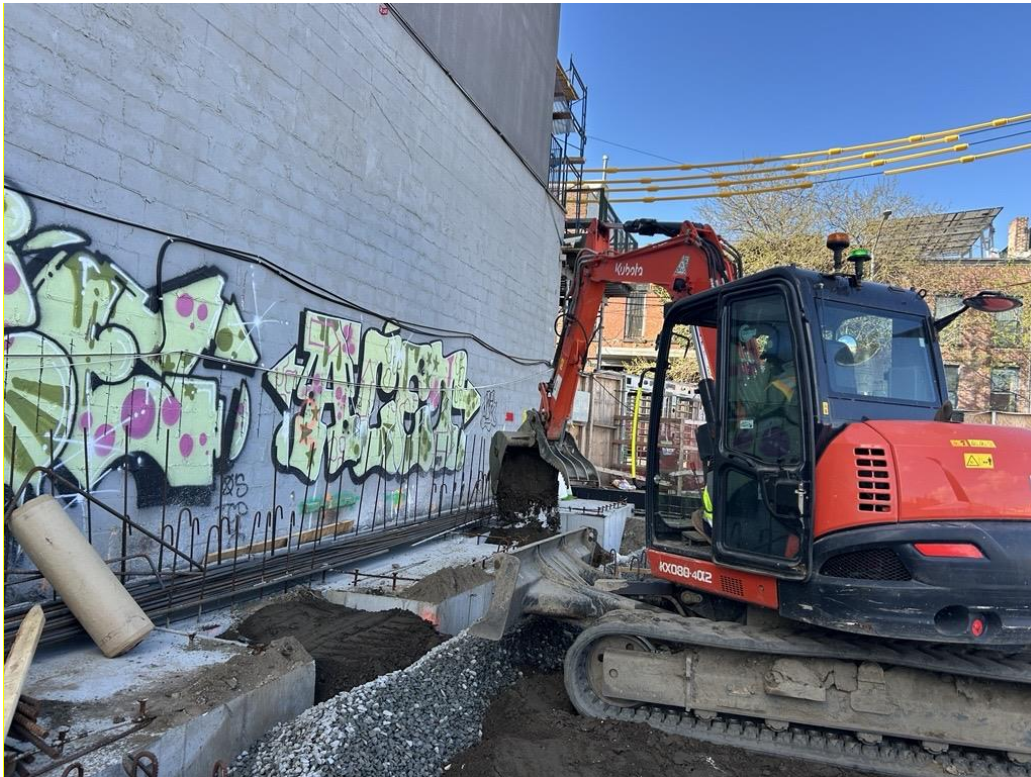
Photo 4: ECD backfilling with previously imported clean fill in the western part of the site (facing west)
