DAILY INSPECTION REPORT
Former NY Cleaning and Dyeing Off-Site Site No. C224264A

| Site Location: 376-378 Flushing Avenue, Brooklyn, NY | | | | | |

Site Plan and Proposed Investigation Locations

Former NY Cleaning and Dyeing Off-Site (Site #C224264A)
 376-378 Flushing Ave
 Brooklyn, New York

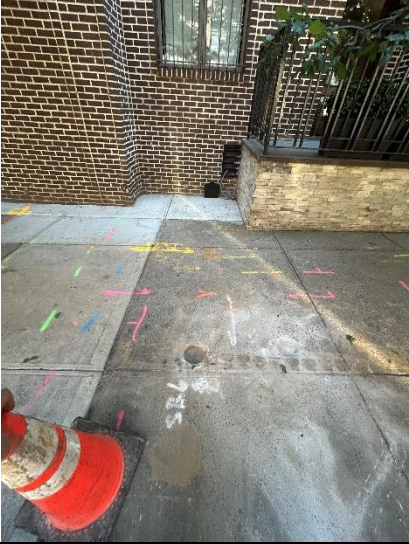
| Site Photographs (Descriptions Below) | |
|--|---|
| Boring SB-6 location relative to building and utility and GPR markout, before hand clearing. | Macrocores collected from SB-5 with grey-stained soils (13-19 ft bg) underlain by unstained silt layer (starting at 19 ft bg) |

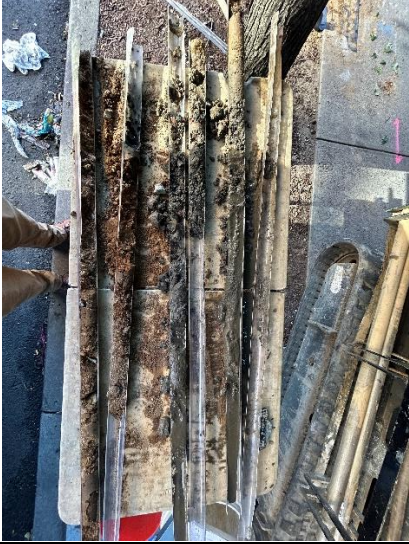
- Greatest impacts (max PID reading of 1375 ppm) observed at SB-5 at water table smear zone, 13-15 ft bg.
 - Soil samples collected for TCL VOCs+10, TCL SVOCs+20 laboratory analysis from SB-5 at and below contaminated smear zone: 13-15 ft bg. 20-24 ft bg (759 ppm), and 26-28 ft bg (10 ppm).

- All samples submitted to Pace of 5 day TAT so waste characterization can be completed before well install.
- Based on observations, monitoring wells are proposed for SB-3 (“clean edge” of plume, no impacts observed), SB-5 (highest PID readings observed), and SB-8 (across from LMW-01).

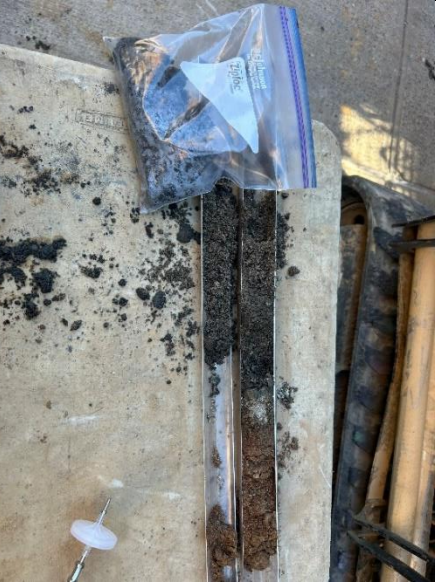
- One grab soil sample collected from each 5-foot macrocore of each boring composited into waste characterization sample.
 - Grab groundwater sample collected through a temporary well at SB-5 for waste characterization.

| Site Photographs (Descriptions Below) | |
|--|---|
| Composite sample | Location of SB-7 |
