Periodic Review Report

Chestnut Commons Atlantic Ave Site
NYSDEC BCP #C244276
110 Dinsmore Place
Brooklyn, New York

May 28, 2024

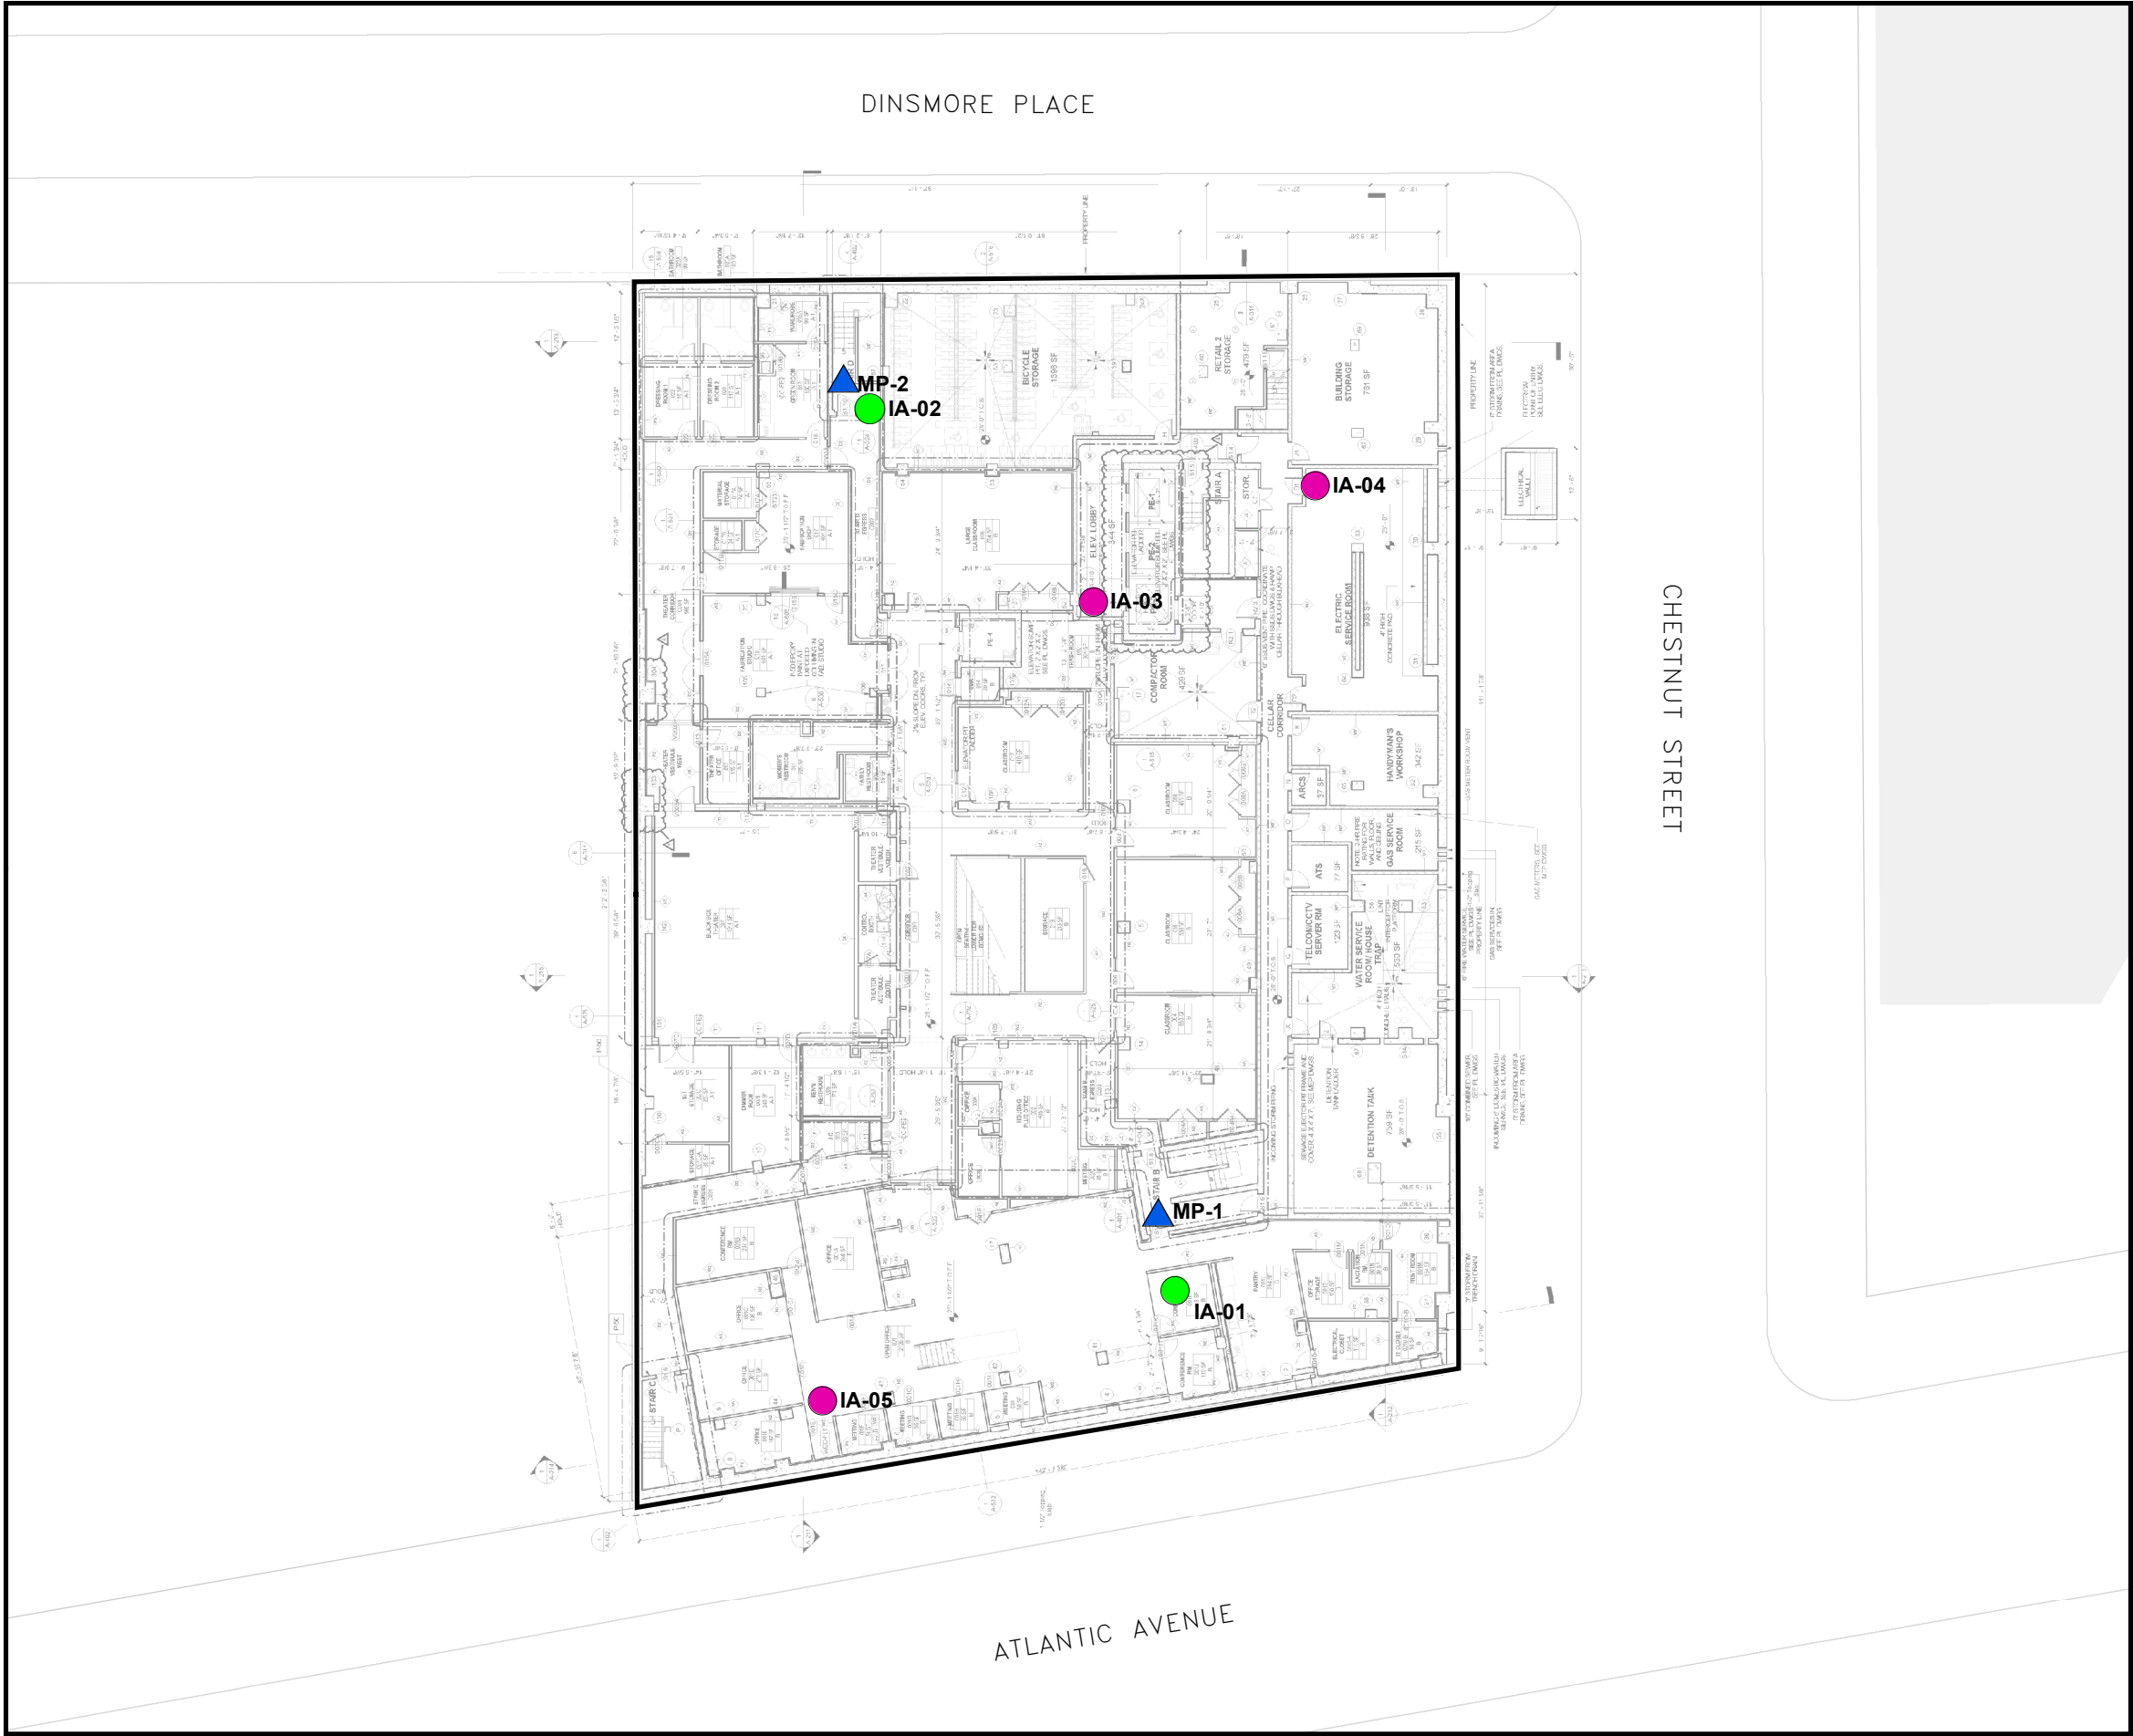
SOIL VAPOR AND INDOOR AIR SAMPLING LOCATIONS

The quarterly indoor air and sub-slab vapor sampling events on December 5, 2023, and March 20, 2024, indicated there were elevated concentrations of TCE in sub-slab vapor point MP-1. This resulted in these quarters having a monitor and mitigate recommendation, respectively. Vapor point MP-1 is located in the southeast portion of the Site and is the closest monitoring point to the Atlantic Chestnut Lots 1, 2, and 3, along the southwestern boundary of Lot 3. Based on groundwater flow and quality during Roux's Remedial Investigation and the reports and work plans prepared for the Atlantic Chestnut Lots 1, 2, and 3 BCP Sites, discussed in Section 2.7, it is likely that these BCP sites are the source of TCE in soil vapor.
