**1921 ATLANTIC AVENUE**

**BROOKLYN, NEW YORK**

# **Remedial Investigation Report**

June 2018

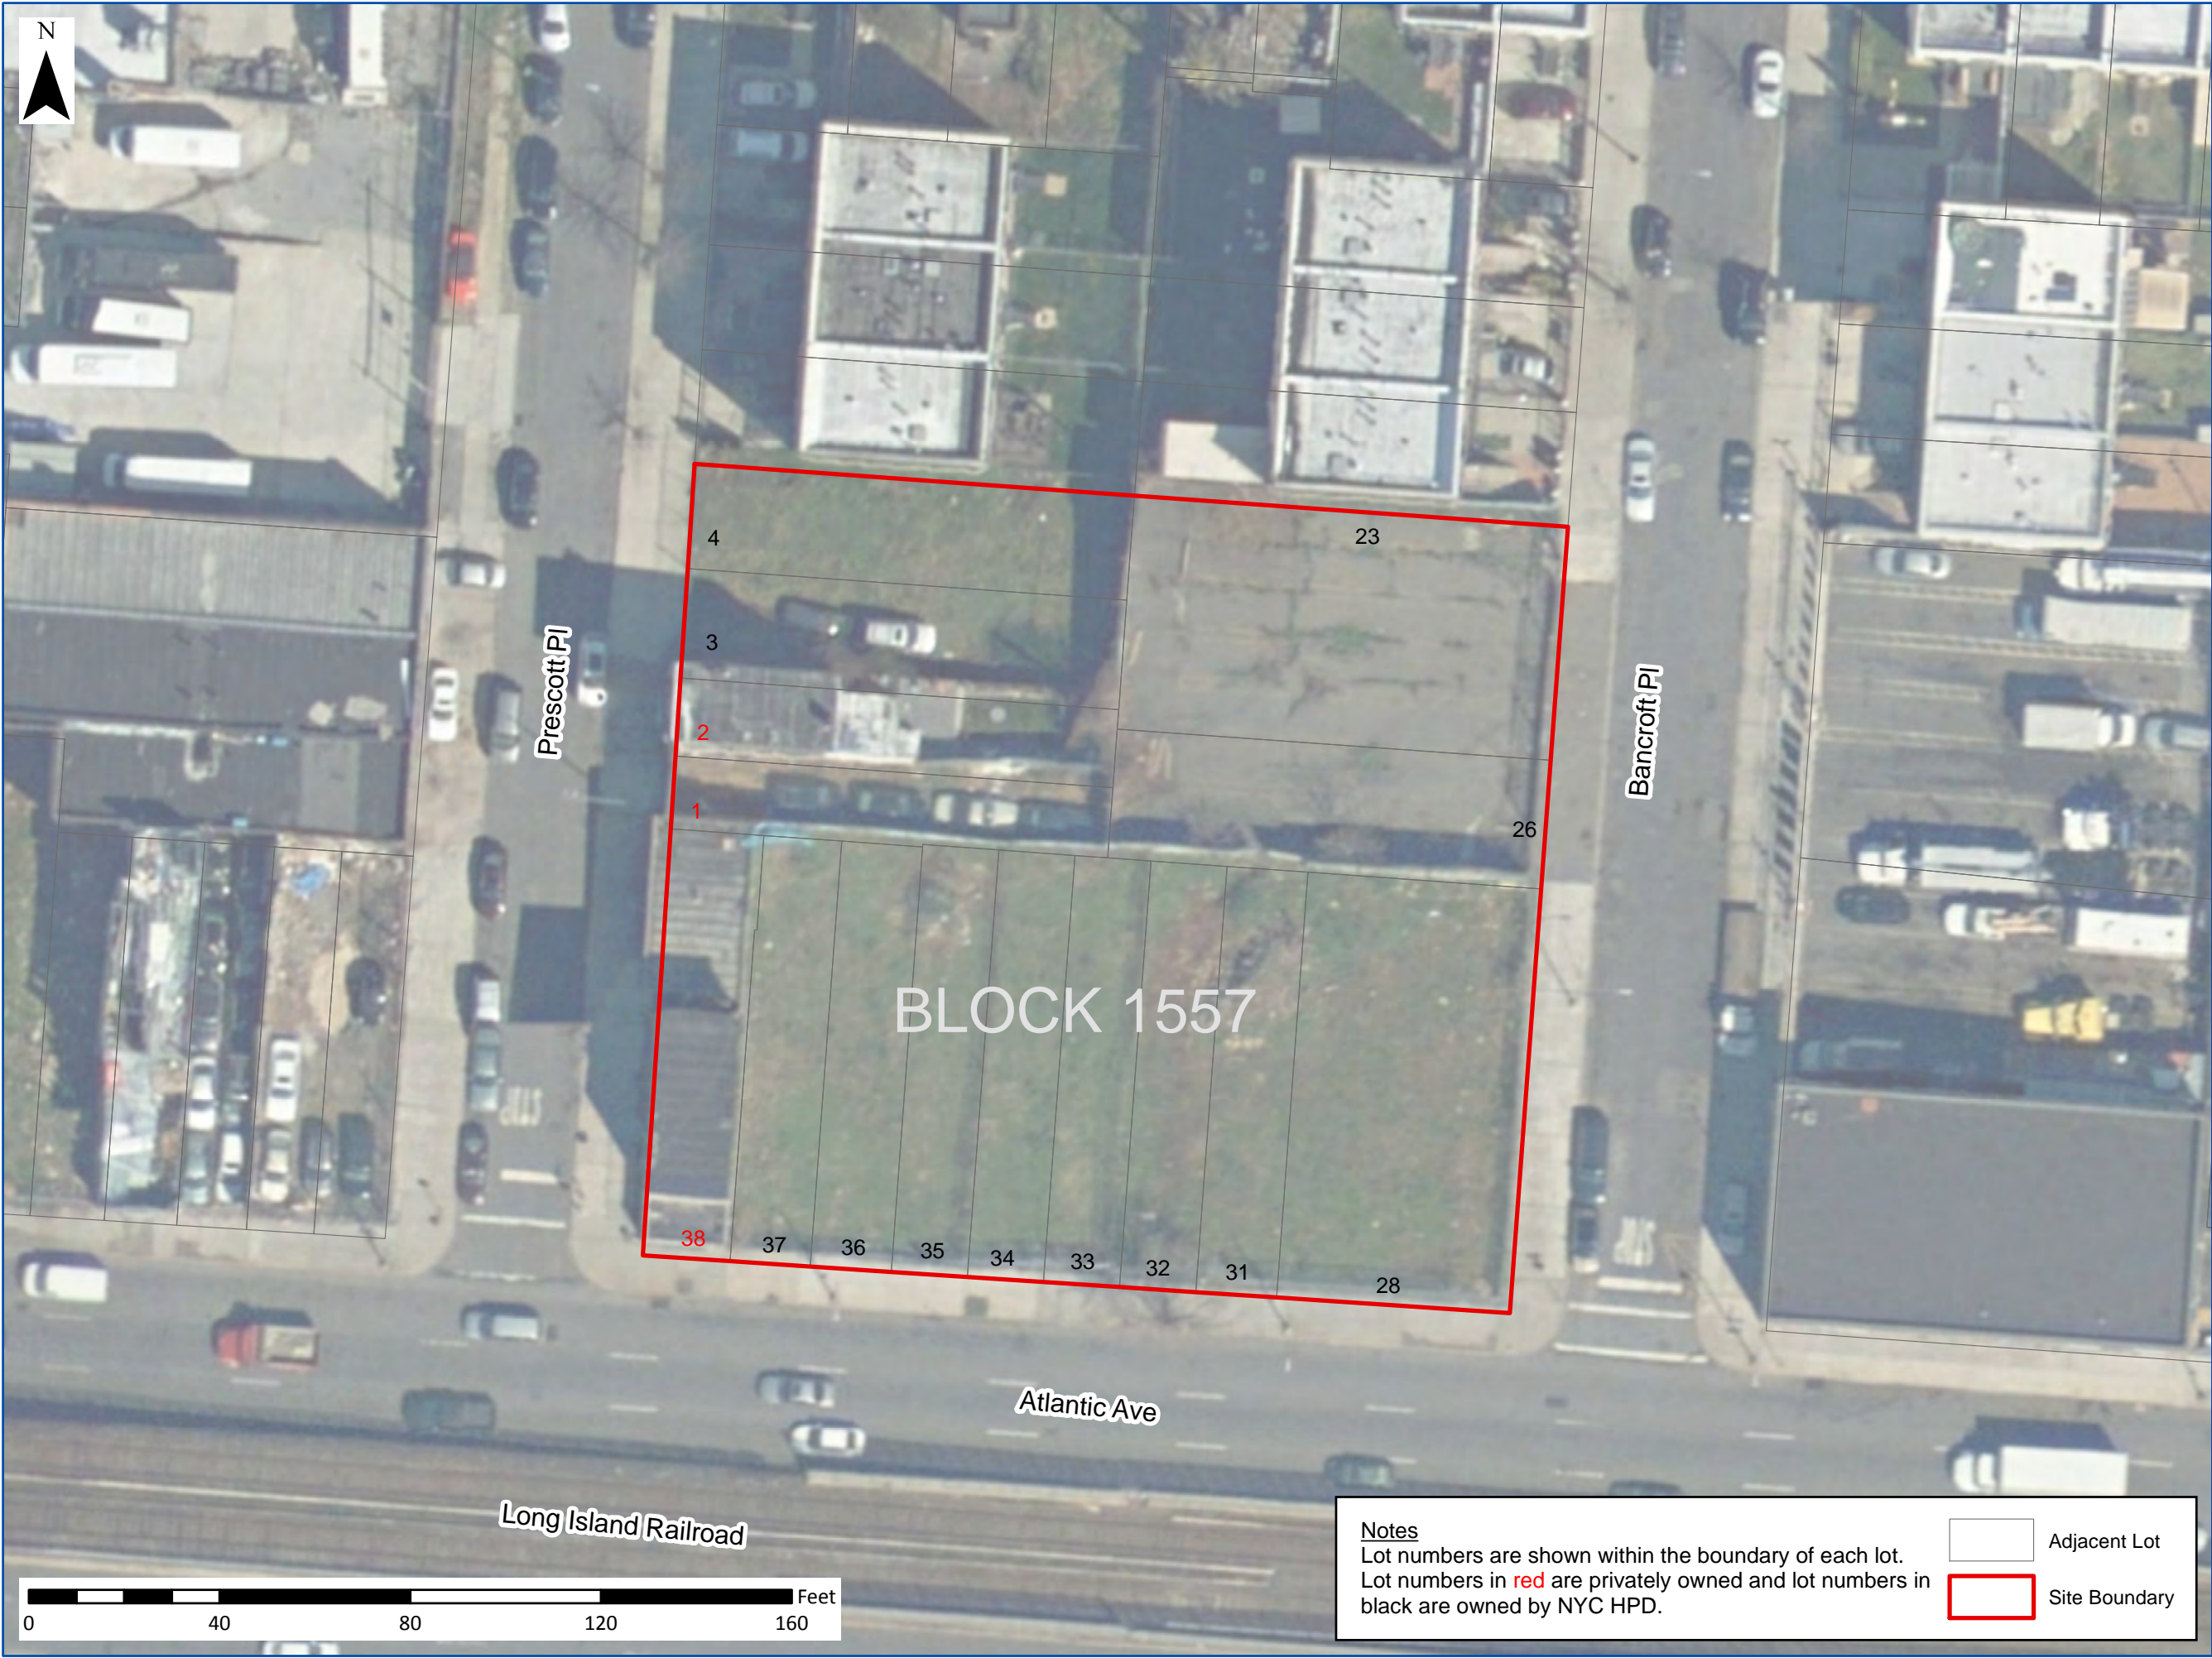
**Notes**  
Lot numbers are shown within the boundary of each lot.  
Lot numbers in **red** are privately owned. Lot numbers in black are owned by NYC HPD.

- Adjacent Lot
- Site Boundary
- Proposed Depth of Concrete Slab (12' bgs)
- Proposed Depth of Elevator Pit (17' bgs)

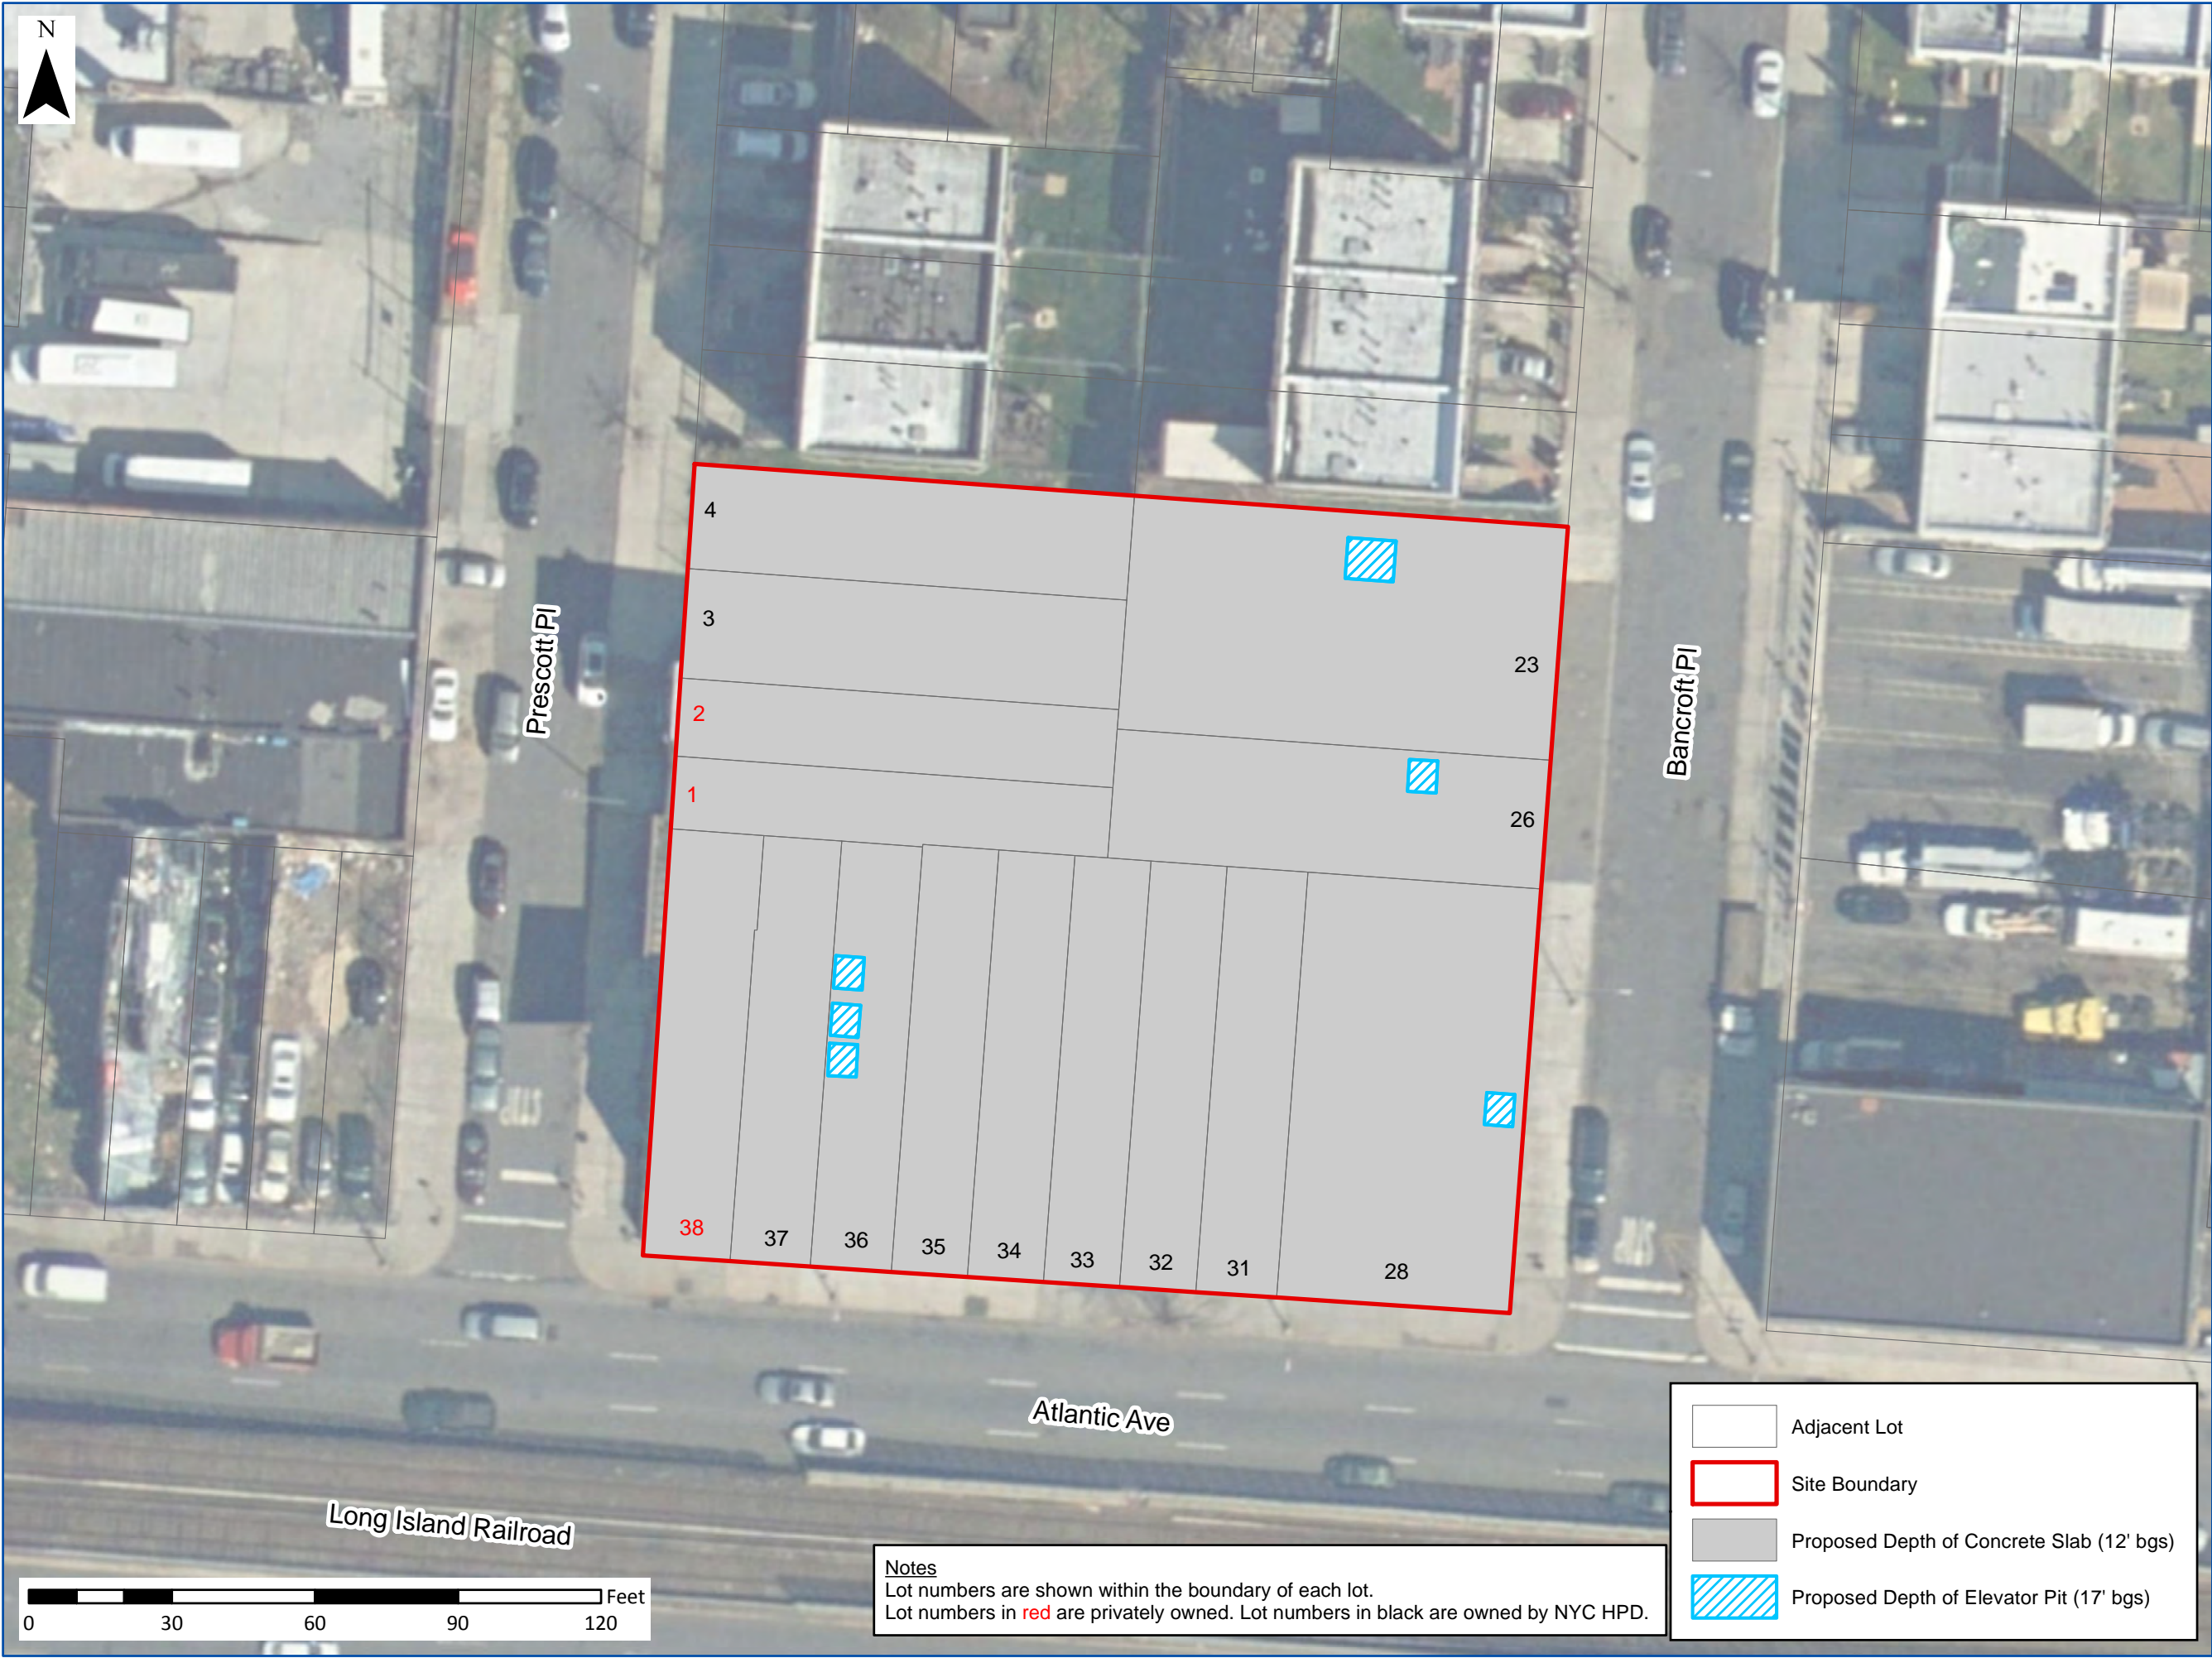
Existing buildings will be demolished as part of the site preparation activities and to perform remediation under the on-Site structures. The proposed future use of the Site will consist of the construction of a mixed-use fourteen story building with a cellar. The current zoning designation is M1-1/R7D (residential/commercial/manufacturing). The proposed use is consistent with existing zoning for the property. The buildings' cellars will be utilized for parking and mechanical equipment and storage. The first floor will be commercial retail space for a planned supermarket. The second through fourteenth floors will be residential space. The cellar space will encompass the entire site. The finished depth of the cellar foundations will be approximately 12 feet below sidewalk level. Elevator foundations will be at approximately 17

feet below sidewalk level. Excavation will occur across the entire site. An estimated 13,000 cubic yards of soil, approximately 8,500 yards of which exceeds applicable SCGs and will require special handling and off-site disposal, will be removed from the Site. Groundwater will not be encountered during the excavation for development.

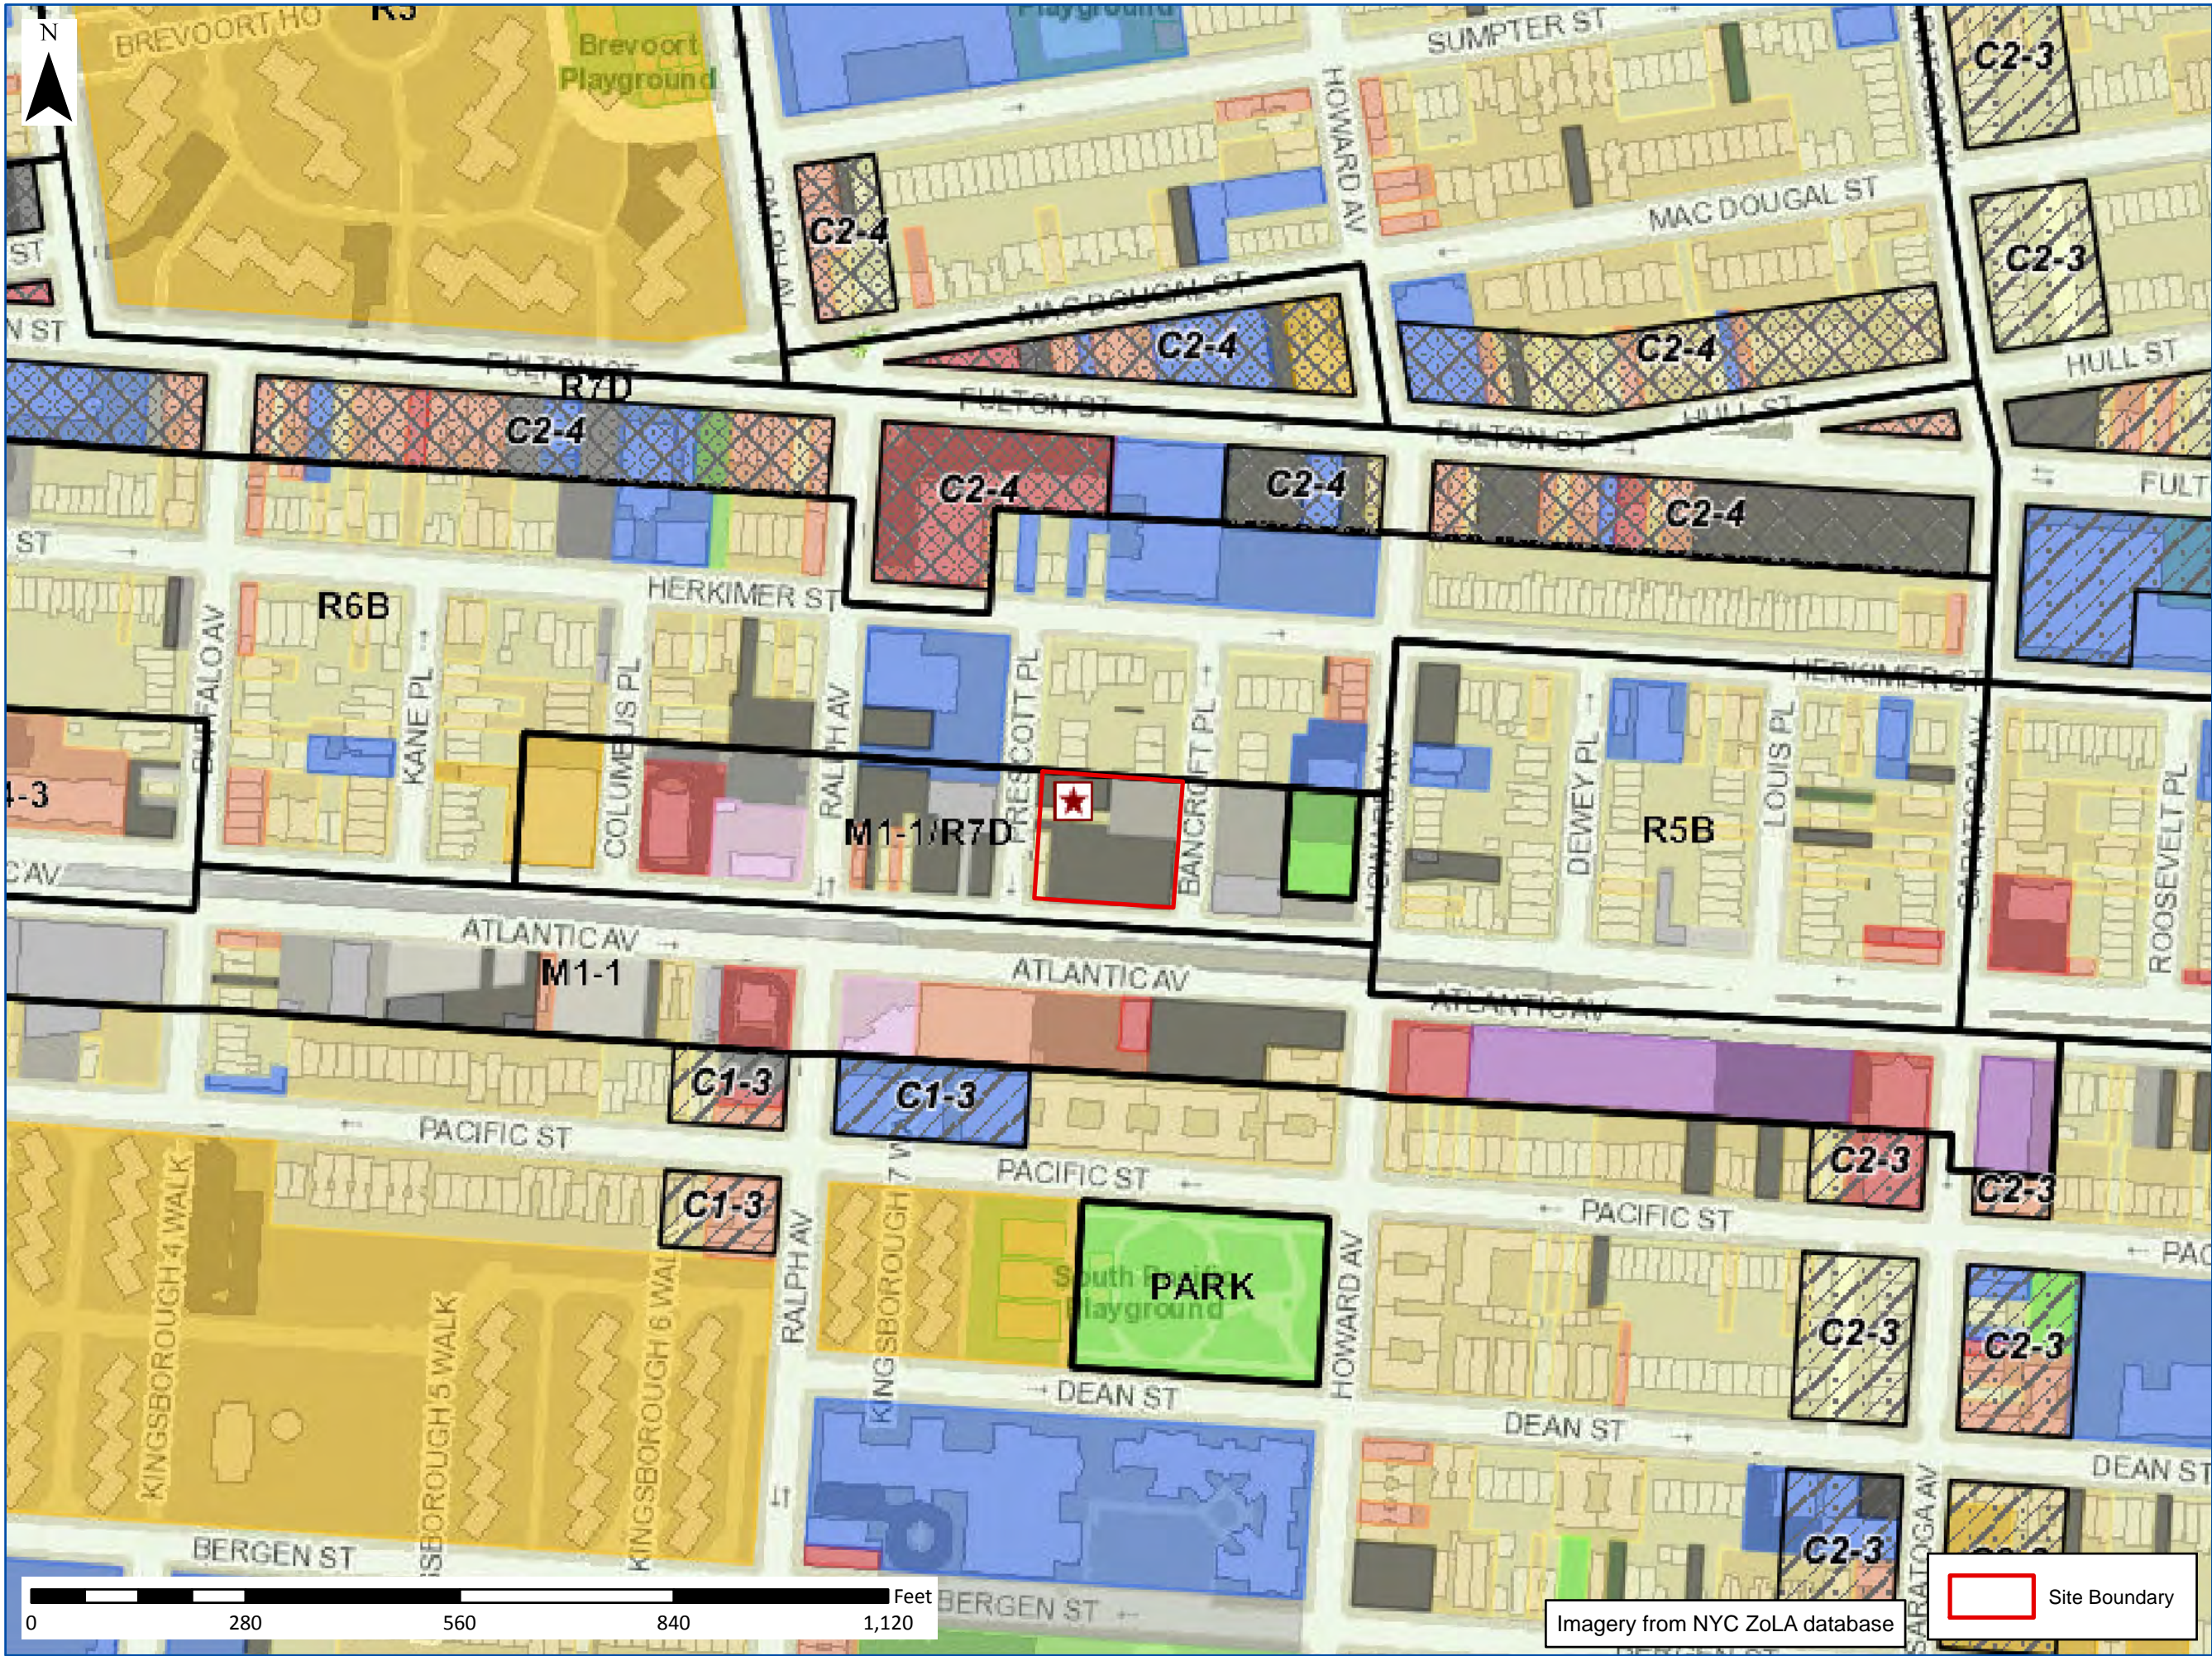
- Areas of Concern**  
AOC 1 - Gasoline  
AOC 2 - Fuel Oil  
AOC 3 - Debris Piles  
AOC 4 - Historic File (entire site)

- A gasoline underground storage tank is present in the garage on Lot 38.
- The presence of petroleum-related constituents in soil vapor samples indicates that the underground gasoline tank may have leaked; however, soil sample could not be collected from directly beneath the former UST.

- A fuel oil underground storage tank is present in the sidewalk adjacent to Lot 2.
- There is no evidence that the fuel oil UST has leaked; however, a sample could not be collected from directly beneath the former UST,
- Soil, structures, including the former UST, and related piping should be properly removed and disposed. to confirm that the applicable clean-up objectives are achieved
- A post-excavation documentation soil sample should be collected in the vicinity of AOC 2 to confirm that the applicable clean-up objectives are achieved.

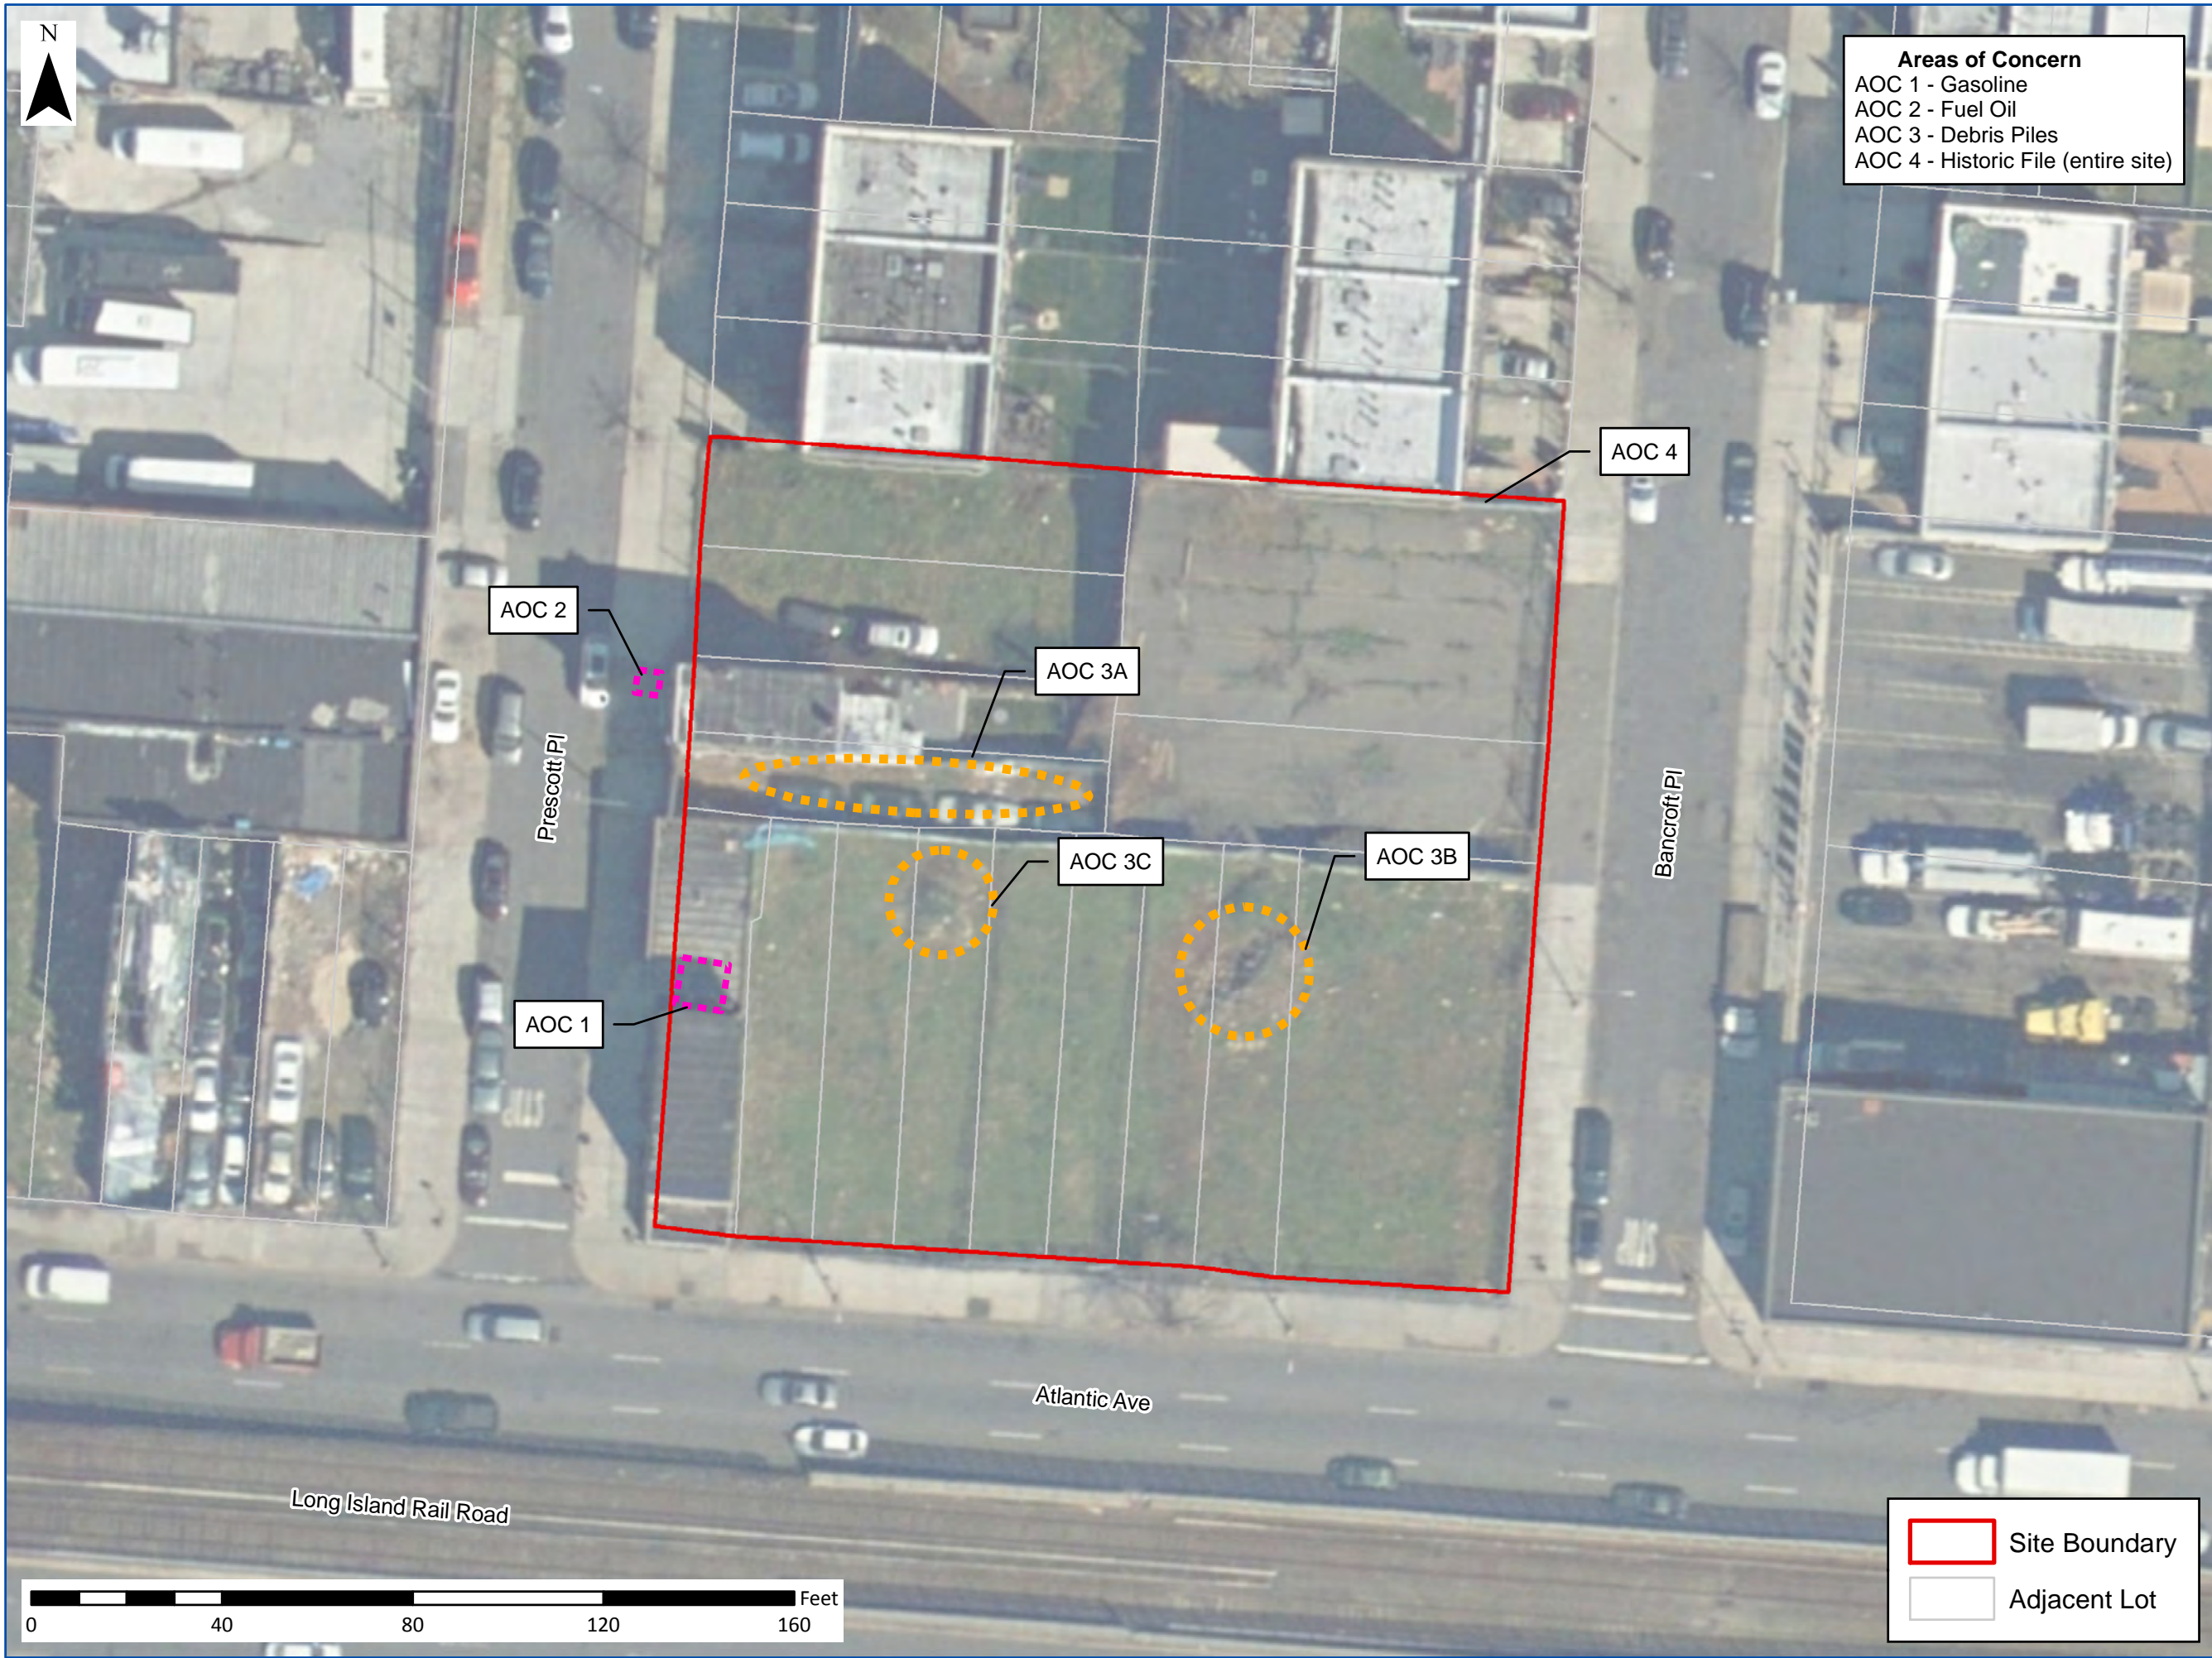
5

A subsurface metallic anomaly identified within the southern enclosed garage of Lot 38 during the February 2018 geophysical survey is consistent with the gas tank identified on Sanborn maps. Approximate dimensions of AOC 1 are 7 feet by 9 feet.

A subsurface metallic anomaly identified during the February 2018 geophysical survey beneath the sidewalk and outside the property line of Lot 2 is consistent with the location of a fuel oil tank fill port observed during the Phase I site inspection. Approximate dimensions of AOC 2 are 4 feet by 6 feet.

Extensive dumping consisting of vehicles in varying stages of disrepair as well as debris piles consisting of tires, construction debris, various containers of automotive fluids, and miscellaneous solid waste were observed on Lots 1, 32, 33, 35, 36. AOC 3 three consists of several debris piles which are identified as AOC 3a, AOC 3b, and AOC 3c. Approximate dimensions of AOC 3a on Lot 1 are 16 feet wide by 90 feet long. Approximate dimensions of AOC 3b on Lots 32 and 33 are 22 feet wide by 22 feet long. Approximate dimensions of AOC 3c on Lots 35 and 36 are 15 feet wide by 15 feet long.

The presence of contaminated historic fill material was observed throughout the Site to depths up to approximately 9 feet below grade. Approximate dimensions of AOC 4 are 180 feet long by 142 feet wide.
