# SUPPLEMENTAL REMEDIAL INVESTIGATION REPORT

**1921 ATLANTIC AVENUE  
Brooklyn, New York  
NYSDEC BCP Site No. C224279**

**Langan Engineering, Environmental, Surveying,  
Landscape Architecture and Geology, D.P.C.**

**April 2020  
100681201**

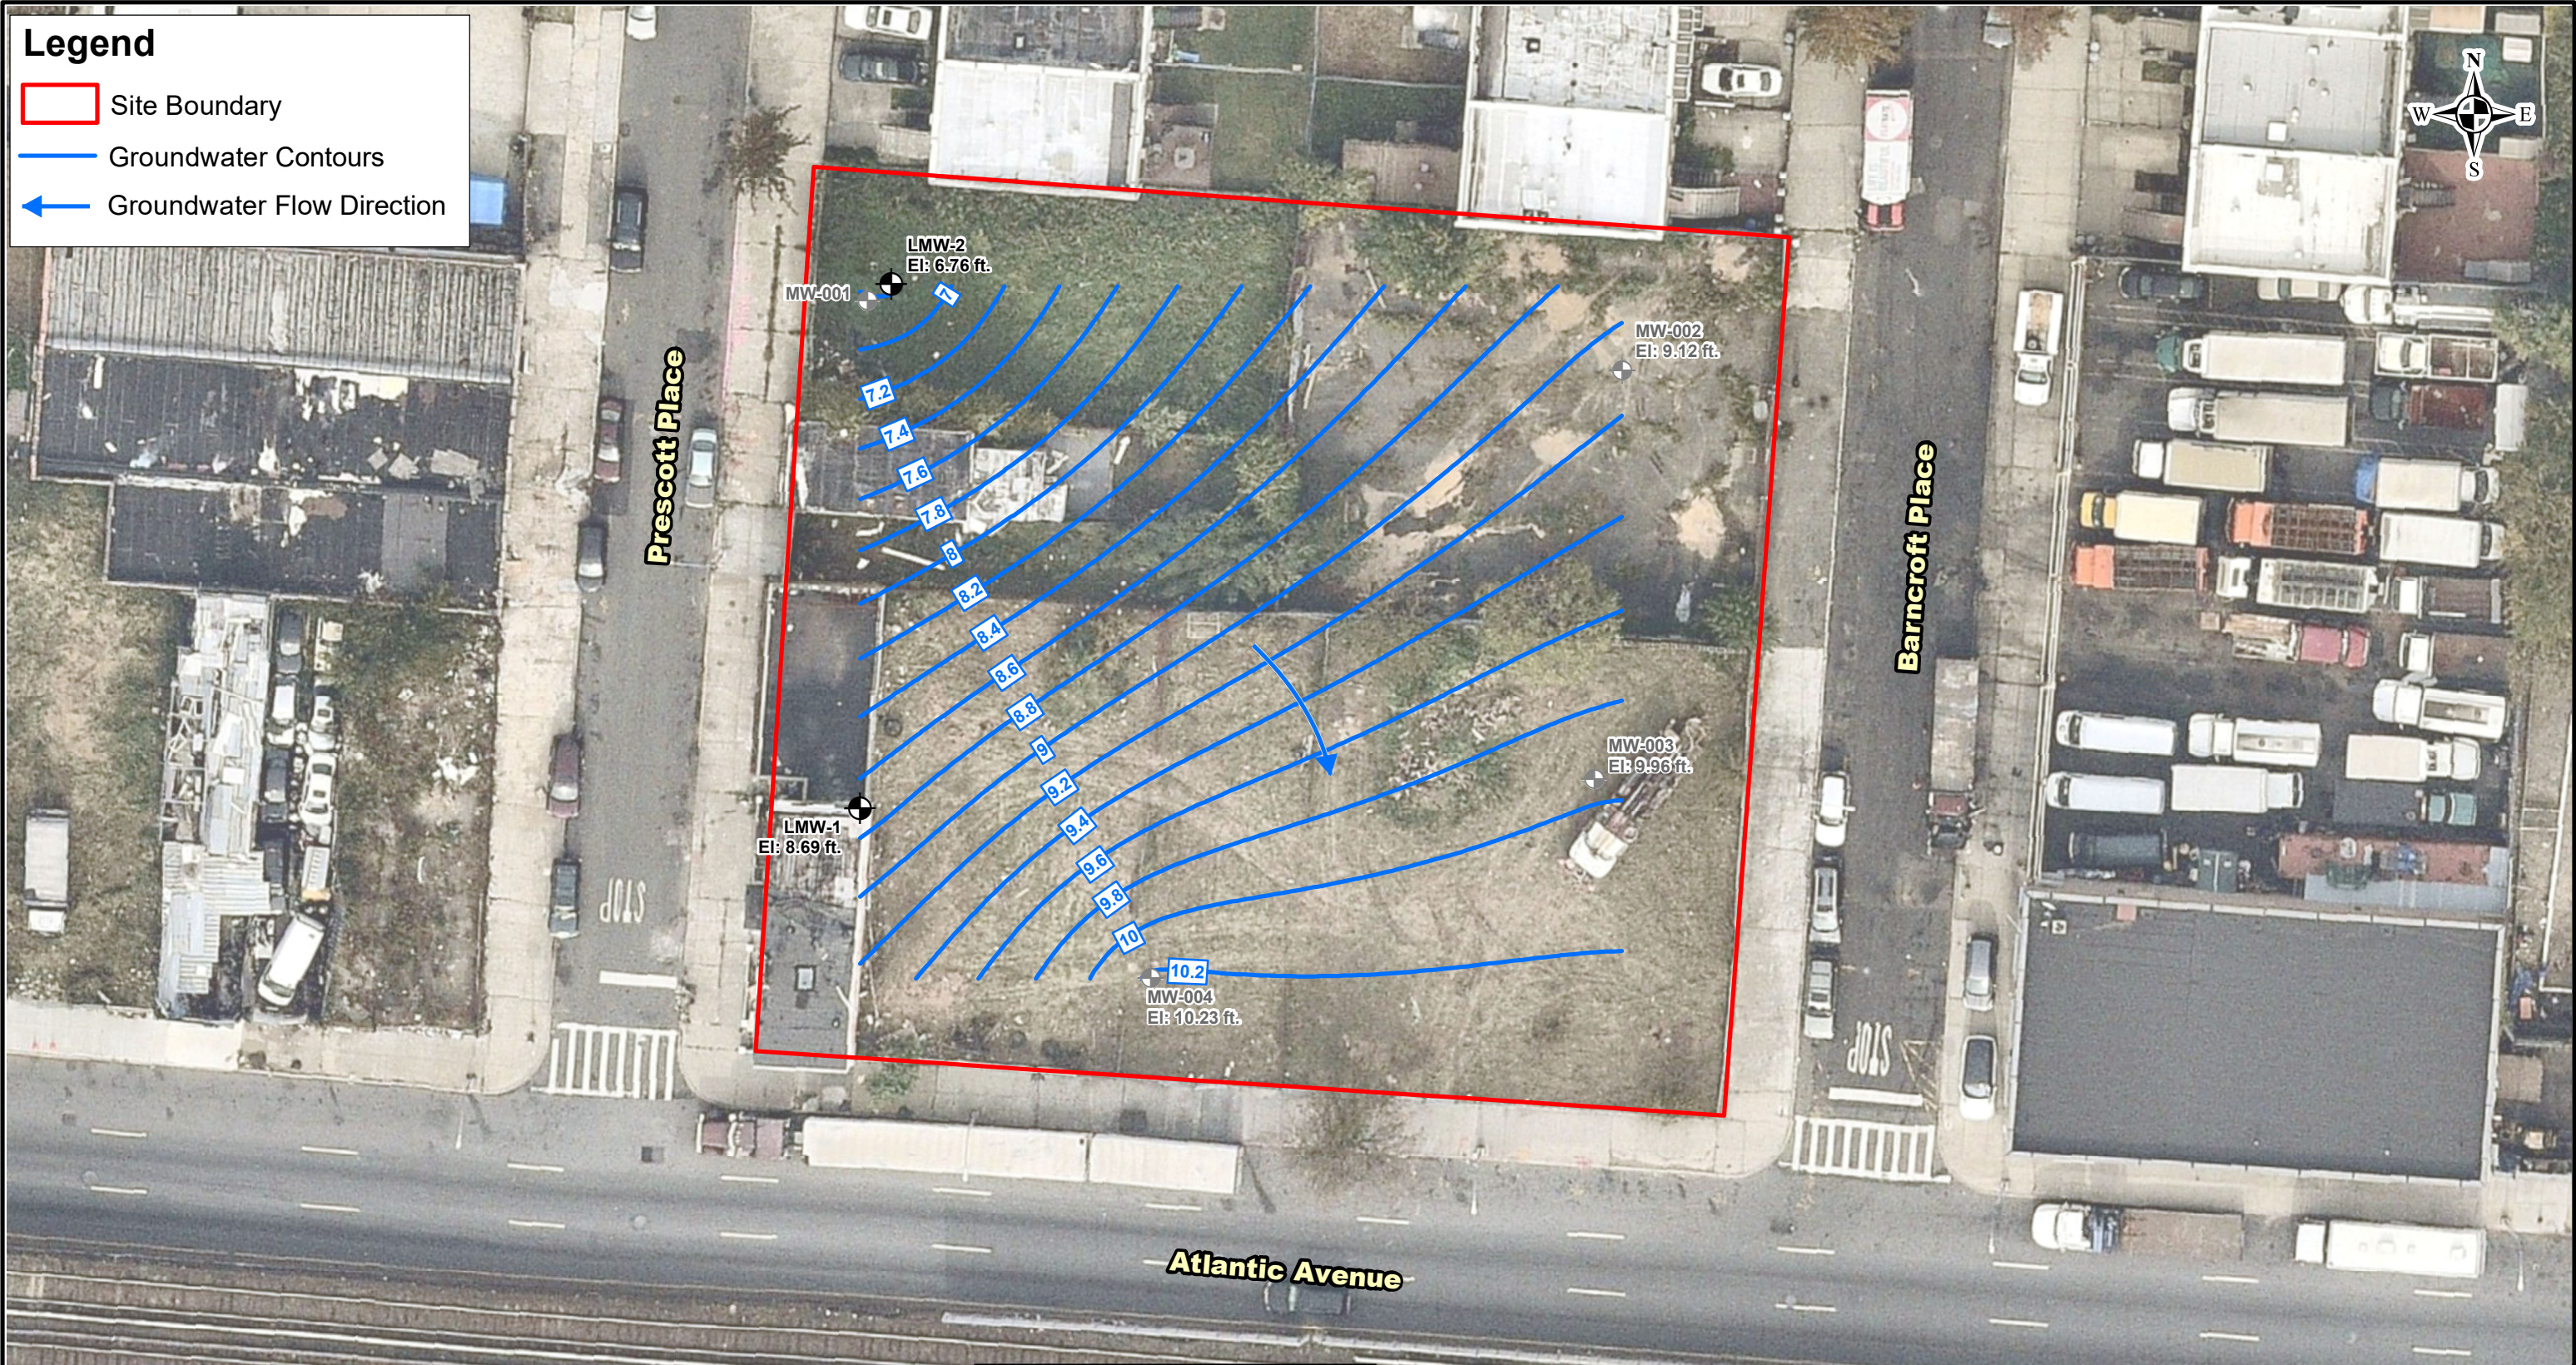
Groundwater was encountered in monitoring wells at depths ranging from 70.45 to 71.83 feet below ground surface during this investigation. Groundwater observations are consistent with those observed during the June 2018 Remedial Investigation by P.W. Grosser. Although Site topography gently slopes downward to the northwest, the groundwater flow direction was determined to be to the east-southeast based on measurements collected by P.W. Grosser in February 2018 and by Langan in March 2020. A potentiometric surface map is provided as Figure 3.

Groundwater Contours

Groundwater Flow Direction

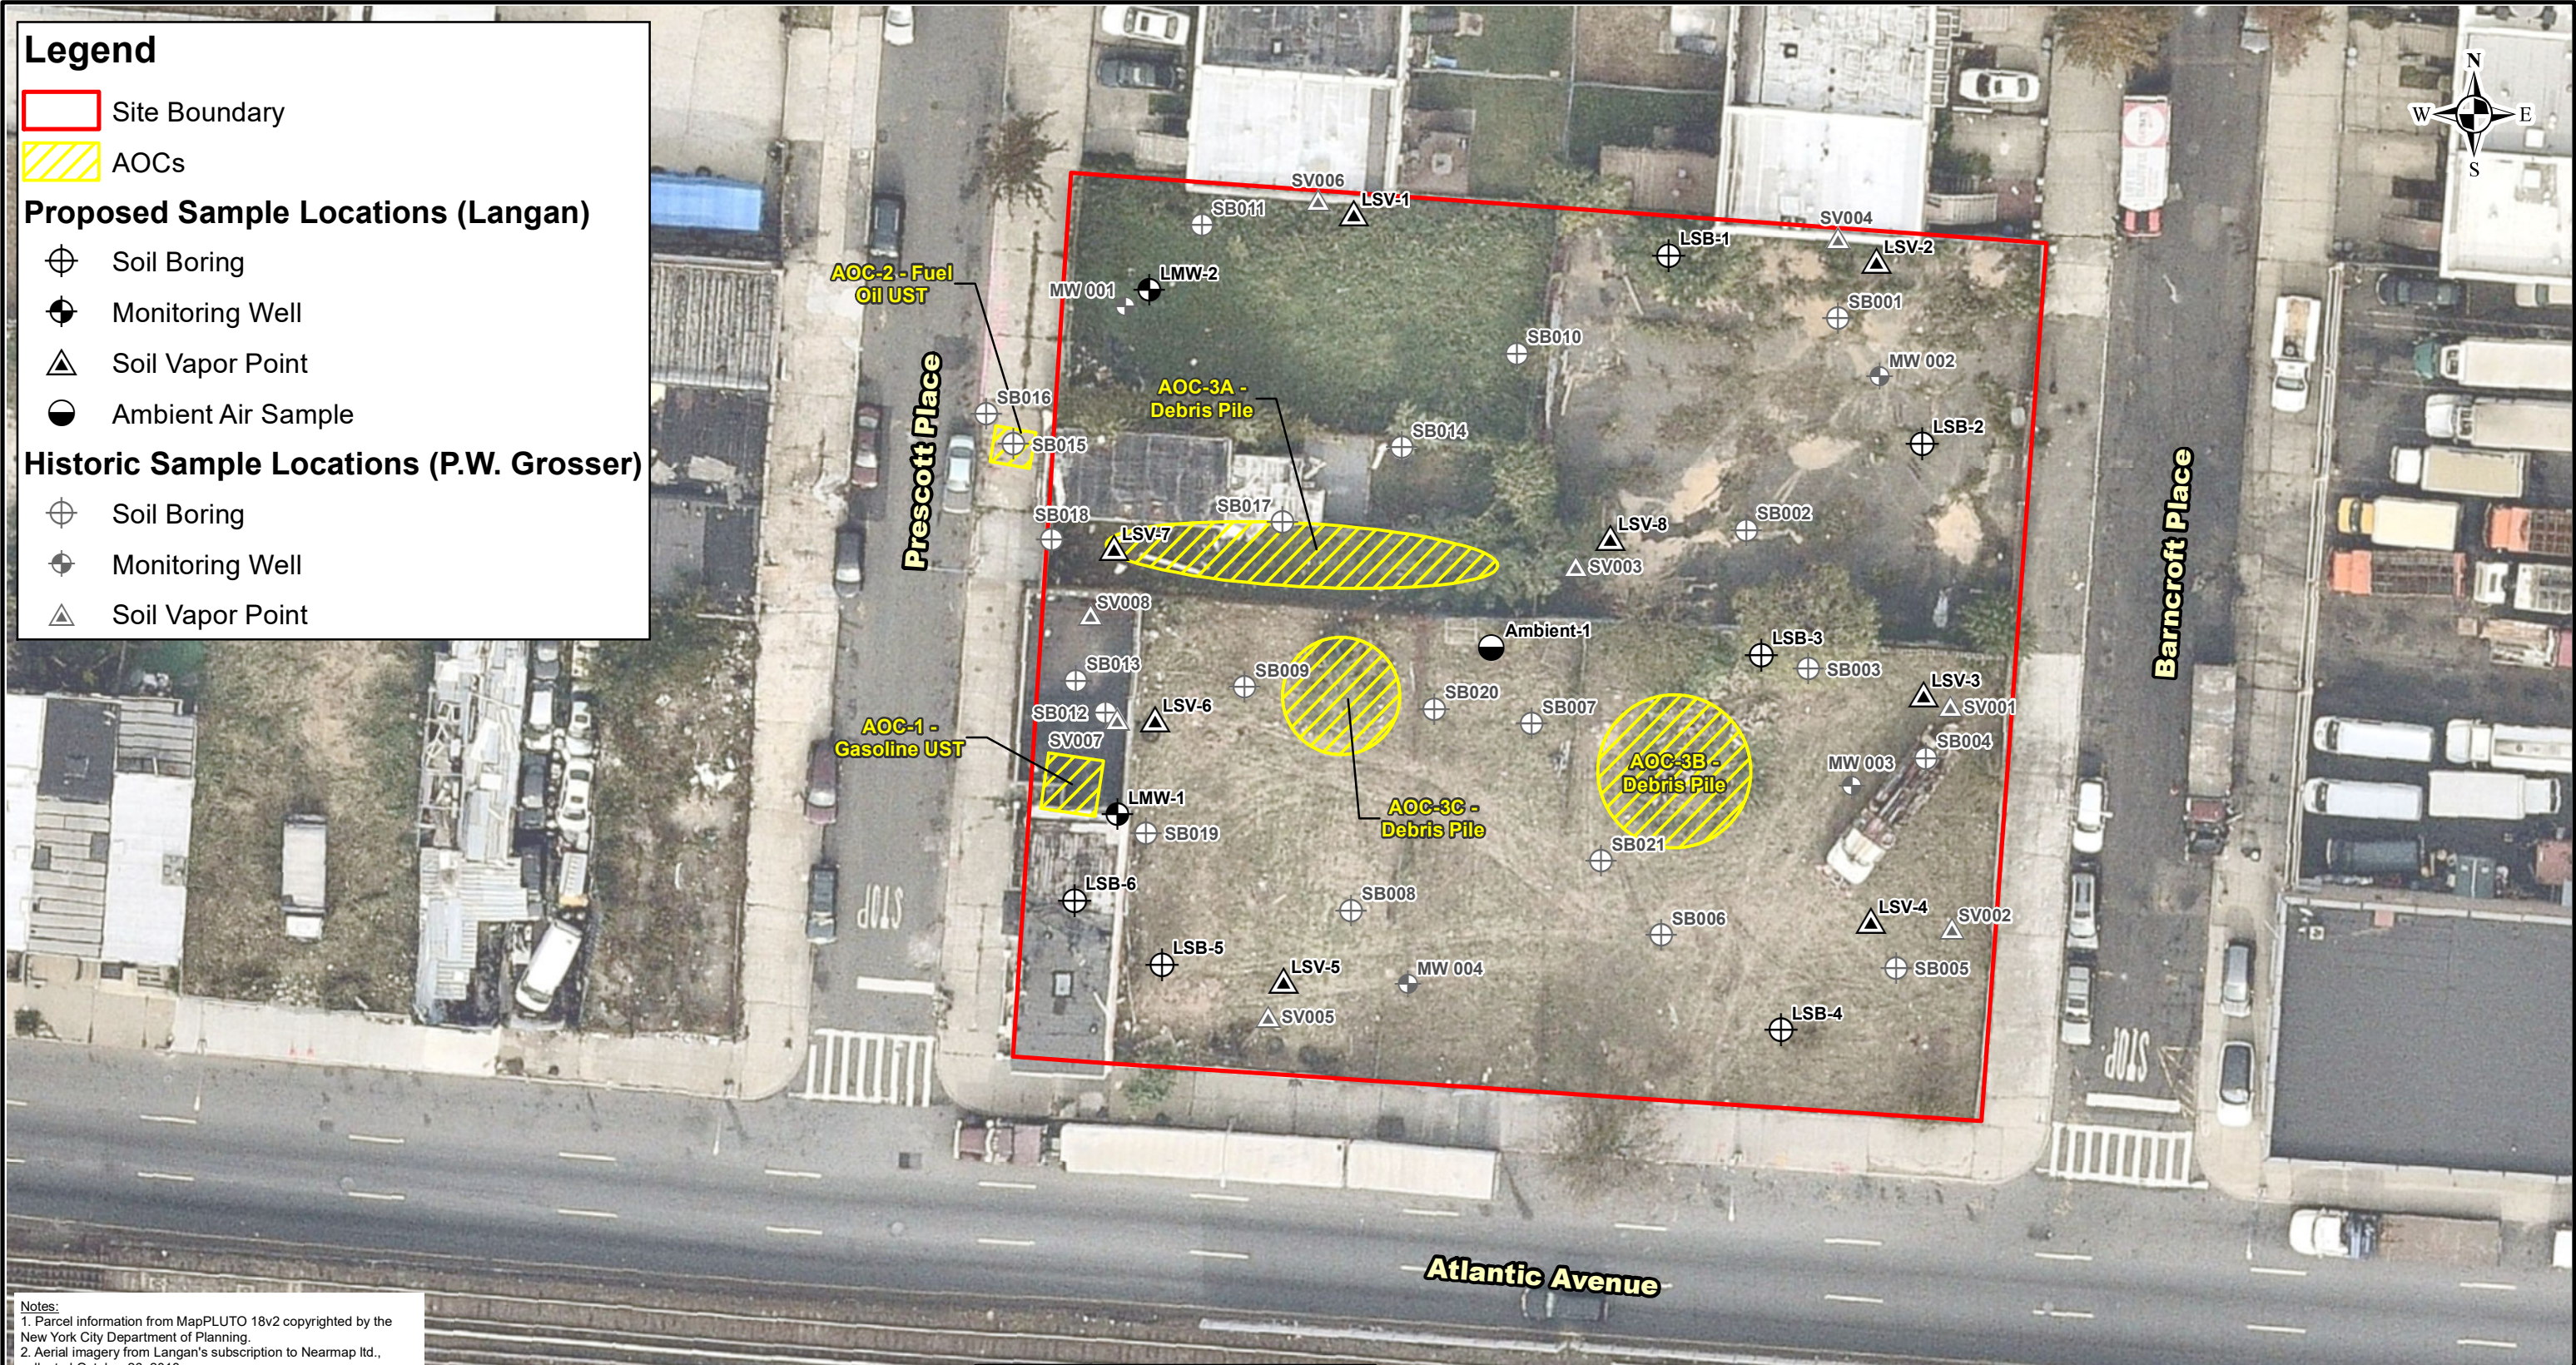
6. Langan sample locations are approximate and based on field measurements.  
7. Monitoring well MW-001, previously installed by P.W. Grosser, was determined to be damaged upon inspection and was replaced with LMW-2 during the SRI.

Prior to sampling, each soil vapor sampling point was tightness tested using the helium tracer gas method and purged at a flow rate of <200-ml per minute. No evidence of helium breakthrough (i.e., helium concentrations above 5%) was observed in any of the sample locations before sample collection. PID readings for VOCs collected from the purged soil vapor were measured at concentrations ranging from 120 ppb (LSV-6) to 1,535 ppb (LSV-6) during field screening of each location. Soil vapor sampling locations are shown on Figure 8 and soil vapor sampling field logs are provided in Appendix D.

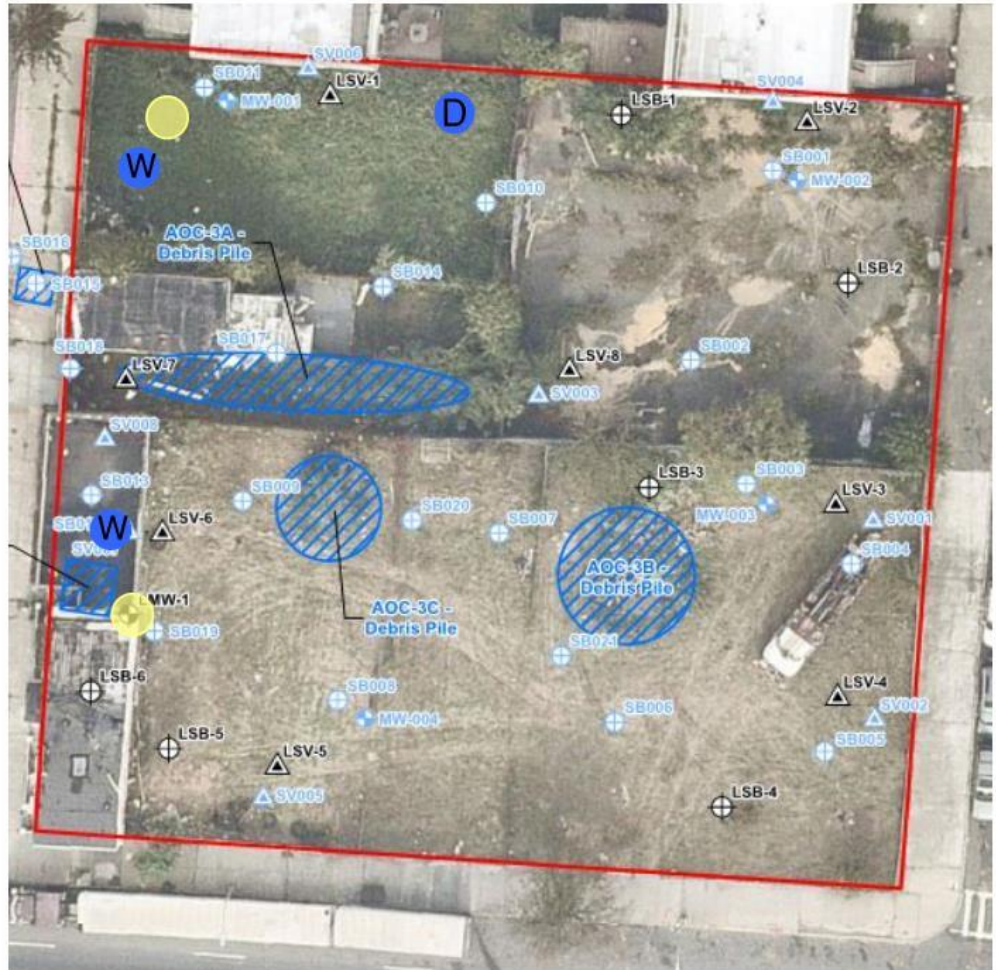
- Langan mobilized to the site with AARCO Environmental Services Corp. (AARCO), the environmental drilling contractor, and Hager-Richter Geoscience Inc. (Hager-Richter), the geophysical survey contractor.
- Hager-Richter conducted a geophysical survey throughout the site.
- AARCO used a Geoprobe Sonic drill rig to advance LMW-1 to 80 feet below ground surface (ft bgs). A 2-inch diameter PVC monitoring well (LMW-1) was installed to 80 ft bgs, with a screen from 65- to 80-ft bgs. No impacts were observed during installation of LMW-1.
- AARCO used a Geoprobe Sonic drill rig to advance LMW-2 to 77 ft bgs. AARCO will continue installation of LMW-2 on 17 March 2020. No impacts were observed during installation of LMW-2.

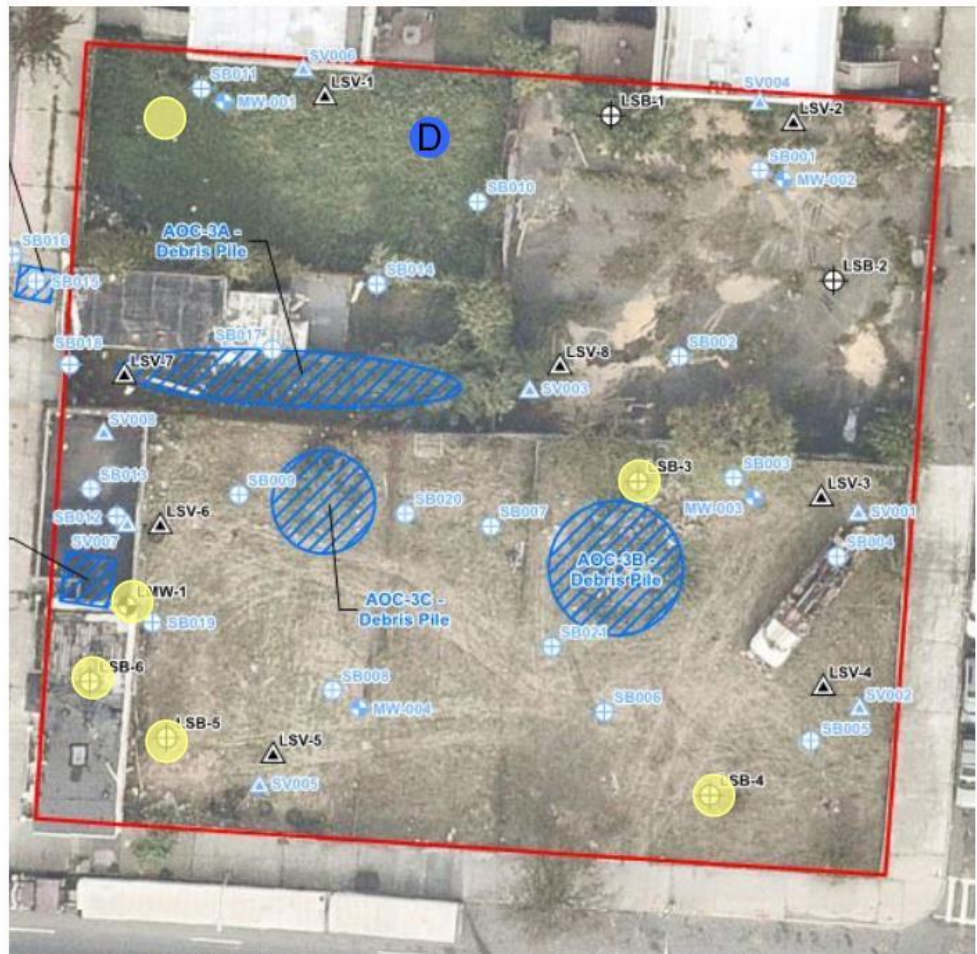
- AARCO installed a 2-inch diameter PVC monitoring well (LMW-2) to 77-feet below ground surface (ft bgs), with a screen from 62- to 77-ft bgs. No impacts were observed during installation of LMW-2.

- AARCO used a Geoprobe Sonic drill rig to advance soil borings LSB-3, LSB-4, and LSB-6 to 20 ft bgs and LSB-5 to 22 ft bgs. Two samples were collected from each boring, one from the observed historic fill layer and the second from the proposed development depth, for the following parameters: target compound list (TCL) volatile organic compounds (VOCs), TCL semi-volatile organic compounds (SVOCs), TCL pesticides, TCL polychlorinated biphenyls (PCBs), herbicides, target analyte list (TAL) metals, cyanide, hexavalent chromium, trivalent chromium, per- and polyfluoroalkyl substances (PFAS), and 1,4-dioxane. No impacts were observed during installation of soil borings LSB-3, LSB-4, LSB-5, and LSB-6.
