## SITE OBSERVATION REPORT

<b>PROJECT No.:</b> 170552901		<b>DATE:</b> Wednesday, November 9, 2022
<b>PROJECT:</b> 159 Boerum Street	<b>CLIENT:</b> SPG Boerum LLC	<b>WEATHER:</b> Partly Cloudy, 40-56 °F Wind: NNE @ 1.6-3.2 mph
<b>LOCATION:</b> Brooklyn, NY		<b>TIME:</b> 6:30 am to 5:15 pm
<b>CONTRACTOR:</b> SD Builders		<b>LANGAN REP. :</b> Lauren Roper
<b>CONTRACTOR'S EQUIPMENT:</b> Hitachi ZX 160LC Excavator Deere 300G Excavator Casagrande C9 Drill Rig	<b>PRESENT AT SITE:</b> Lauren Roper – Langan James Hsu – SD Builders - General Contractor Lucas Alvarez - Rise Concrete (Rise) – Foundation Contractor Able Siquij – Anel Queens Construction Inc. (Anel) – Drilling Contractor	
<b>OBSERVATIONS, DISCUSSIONS, TEST RESULTS, ETC.:</b> <p>Langan was present to observe environmental protocols in accordance with the New York State Department of Environmental Conservation (NYSDEC)-approved Remedial Action Work Plan (RAWP) for Brownfield Cleanup Program (BCP) site C224291 at 159 Boerum Street (Block 3071, Lot 40). Observed activities were as follows:</p> <p><b>Site Activities</b></p> <ul style="list-style-type: none"><li>• Anel used a Casagrande drill rig to install soldier piles along the s

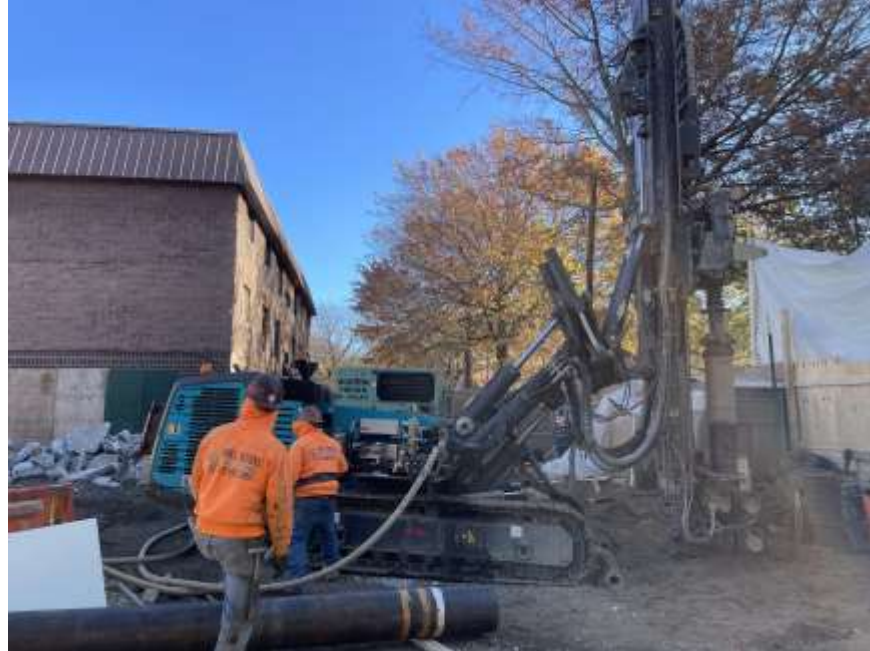
**Photo 1:** View of Anel installing soldier piles along the southern site boundary (facing east)..

- Anel will continue to install soldier piles along the southern site boundary.
- Rise will import recycled concrete aggregate (RCA) to the site for the temporary site ramp.

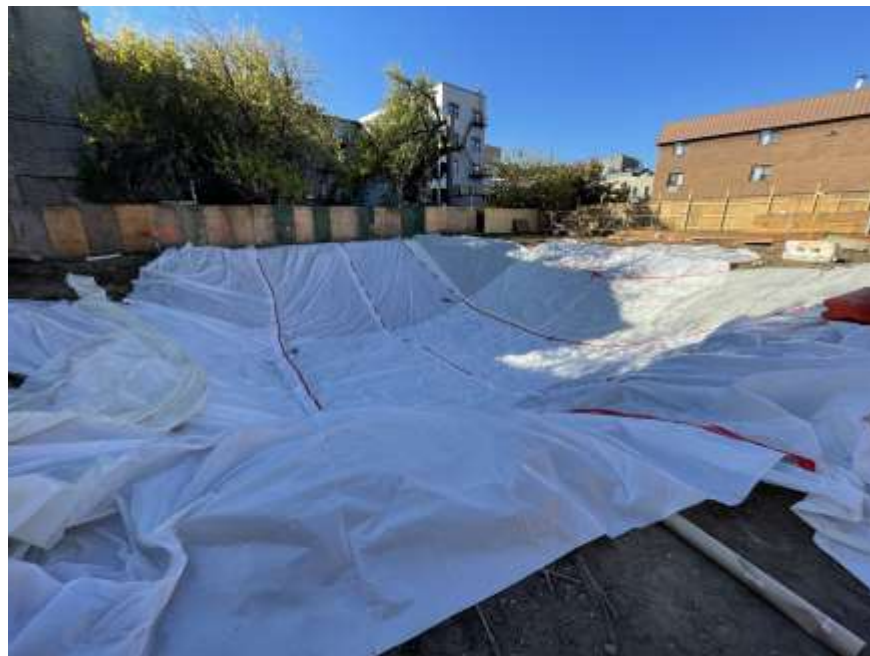
**Photo 2:** General view of the site at the end of the work day (facing northwest).
