SITE OBSERVATION REPORT

PROJECT No.: 170552901	CLIENT: SPG Boerum LLC	DATE: Thursday, November 10, 2022
PROJECT: 159 Boerum Street		WEATHER: Sunny, 48-66 °F Wind: WSW @ 0.6-4.4 mph
LOCATION: Brooklyn, NY		TIME: 6:30 am to 2:30 pm
CONTRACTOR: SD Builders		LANGAN REP. : Alex Nolan

Langan was present to observe environmental protocols in accordance with the New York State Department of Environmental Conservation (NYSDEC)-approved Remedial Action Work Plan (RAWP) for Brownfield Cleanup Program (BCP) site C224291 at 159 Boerum Street (Block 3071, Lot 40). Observed activities were as follows:

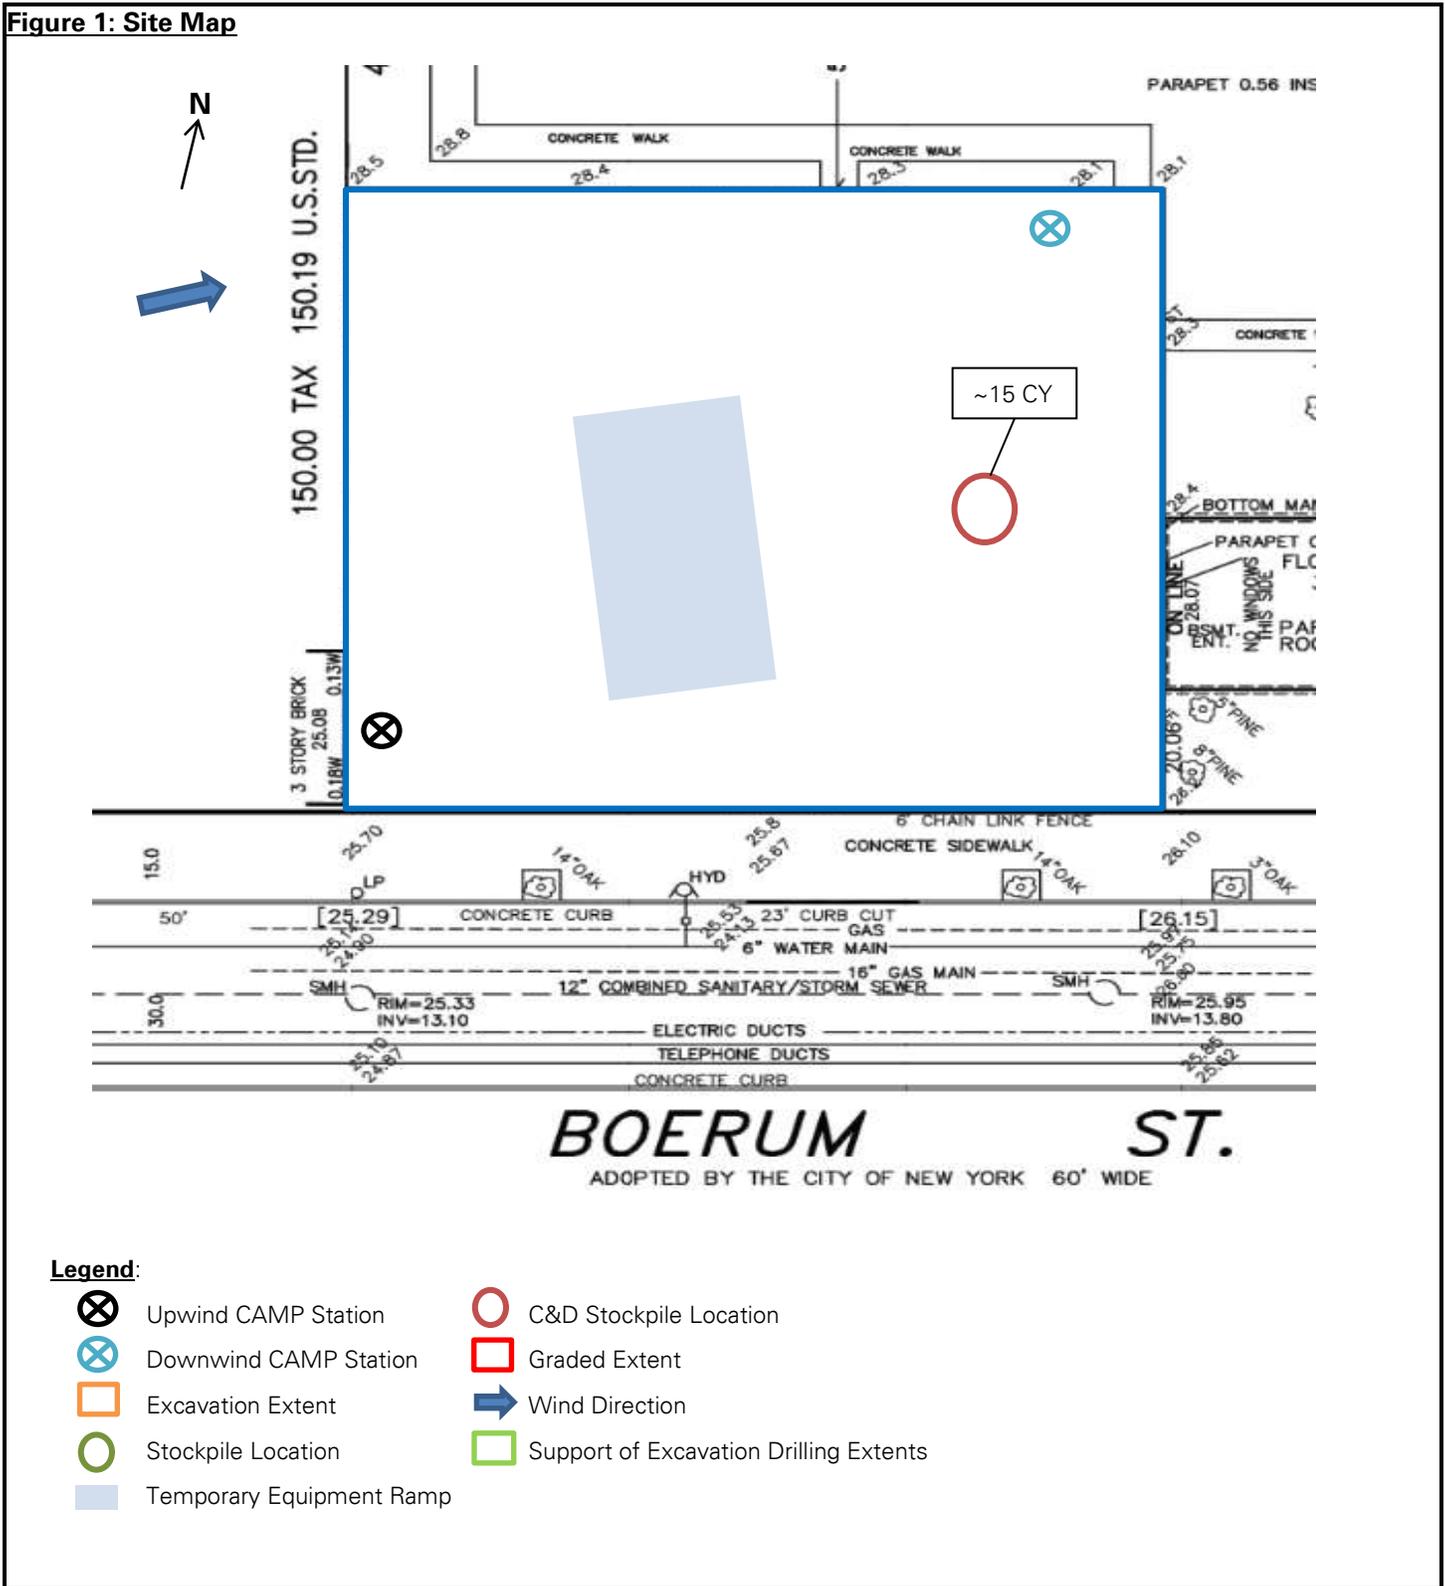
Figure 1: Site Map

- Rise placed about 300 cubic yards (CY) of ¾-inch recycled concrete aggregate (RCA) from the Allocco Recycling, Inc. facility in Brooklyn, New York in the central part of the site for construction of the temporary equipment ramp.

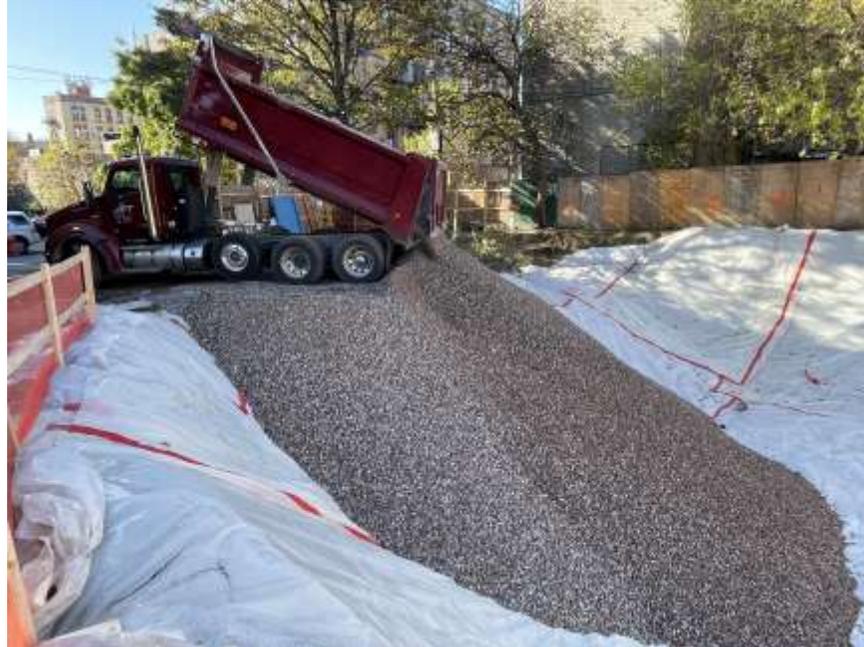
Photo 1: View of [Rise importing](#) 3/4-inch RCA [imported](#) for construction of the temporary equipment ramp in the central part of the site (facing southwest).

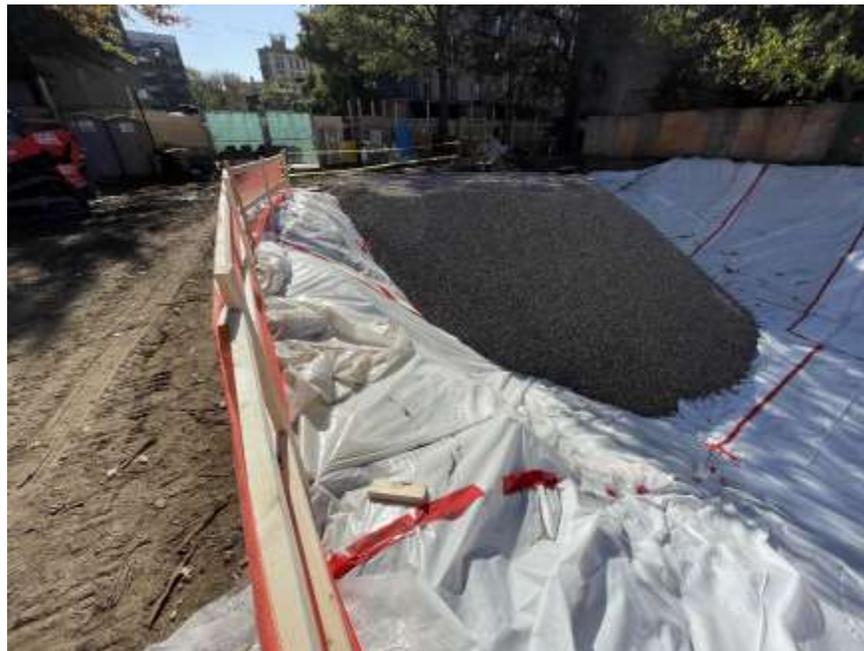
Photo 2: General view of the site at the end of the work day (facing southwest).
