## SITE OBSERVATION REPORT

<b>PROJECT No.:</b> 170552901  <b>PROJECT:</b> 159 Boerum Street  <b>LOCATION:</b> Brooklyn, NY	<b>CLIENT:</b> SPG Boerum LLC	<b>DATE:</b> Monday, November 14, 2022  <b>WEATHER:</b> Sunny, 38-47 °F Wind: NW @ 3.2-6.0 mph  <b>TIME:</b> 6:45 am to 5:30 pm
<b>CONTRACTOR:</b> SD Builders		<b>LANGAN REP. :</b> Lauren Roper
<b>CONTRACTOR'S EQUIPMENT:</b> Hitachi ZX 160LC Excavator Deere 300G Excavator Casagrande C9 Drill Rig Kubota SVL65-2 Skid Steer	<b>PRESENT AT SITE:</b> Lauren Roper – Langan James Hsu – SD Builders - General Contractor Lucas Alvarez – Rise Concrete (Rise) – Foundation Contractor Able Siquij – Anel Queens Construction Inc. (Anel) – Drilling Contractor	
<b>OBSERVATIONS, DISCUSSIONS, TEST RESULTS, ETC.:</b>  Langan was present to observe environmental protocols in accordance with the New York State Department of Environmental Conservation (NYSDEC)-approved Remedial Action Work Plan (RAWP) for Brownfield Cleanup Program (BCP) site C224291 at 159 Boerum Street (Block 3071, Lot 40). Observed activities were as follows:  <b>Site Activities</b> <ul style="list-style-type: none"> <li>• Rise placed about 200 cubic yards (CY) of ¾-inch recycled concr

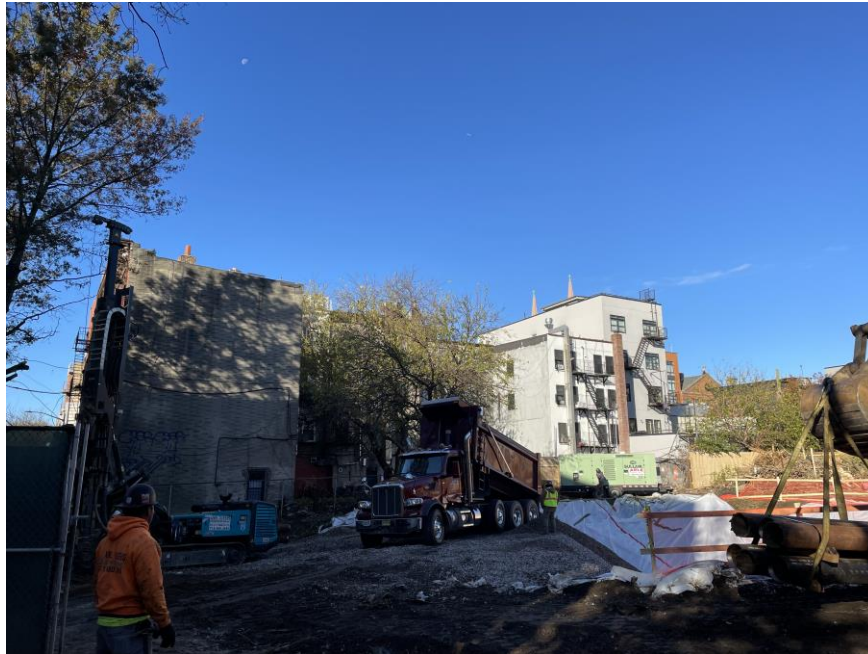
**Photo 1:** View of ¾-inch RCA imported for construction of the temporary equipment ramp in the central part of the site (facing northwest).

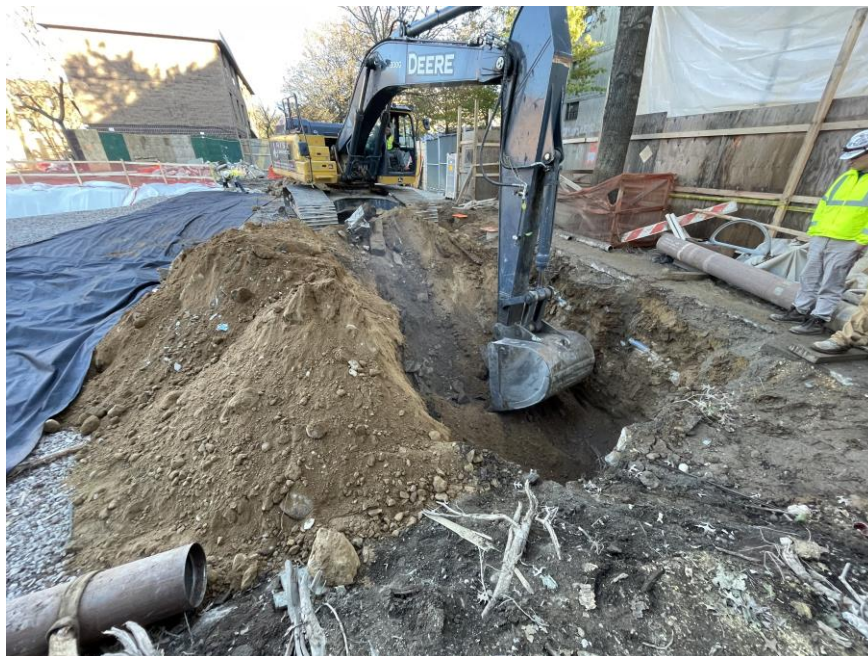
**Photo 2:** Rise excavating non-hazardous fill in the southwestern part of the site to remove subsurface obstructions (facing east).
