SITE OBSERVATION REPORT

PROJECT No.: 170552901 PROJECT: 159 Boerum Street LOCATION: Brooklyn, NY	CLIENT: SPG Boerum LLC	DATE: Monday, December 19, 2022 WEATHER: Clear, 31-38 °F Wind: WNW @ 4.0-7.1 mph TIME: 6:45 am to 6:00 pm
CONTRACTOR: SD Builders		LANGAN REP. : Lauren Roper
CONTRACTOR'S EQUIPMENT: Hitachi ZX 160LC Excavator Deere 300G Excavator Kubota SVL65-2 Skid Steer Deere 135G Excavator	PRESENT AT SITE: Lauren Roper – Langan Kevin Grey – SD Builders - General Contractor Lucas Alvarez - Rise Concrete (Rise) – Foundation Contractor	
OBSERVATIONS, DISCUSSIONS, TEST RESULTS, ETC.: Langan was present to observe environmental protocols in accordance with the New York State Department of Environmental Conservation (NYSDEC)-approved Remedial Action Work Plan (RAWP) for Brownfield Cleanup Program (BCP) site C224291 at 159 Boerum Street (Block 3071, Lot 40). Observed activities were as follows: Site Activities <ul style="list-style-type: none"> • Rise excavated two about 25-foot-long by 5-foot-wide areas to about 9 feet below grade surface (bgs) in the southeastern part of the site for support of excavation (SOE) installation. Excavated material consisted of non-hazardous fill and wa

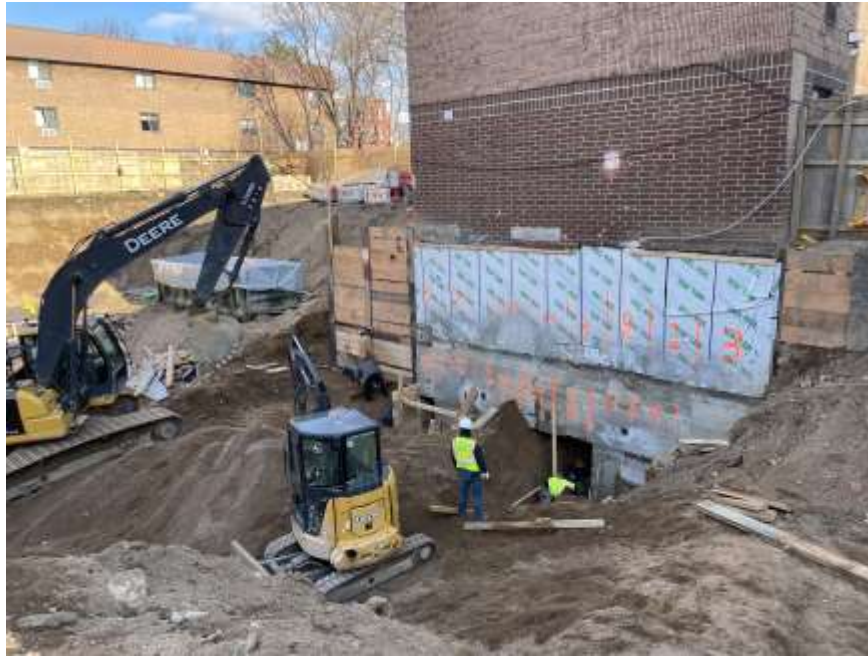
Photo 1: View of Rise excavating native soil for SOE underpinning installation (facing northeast).

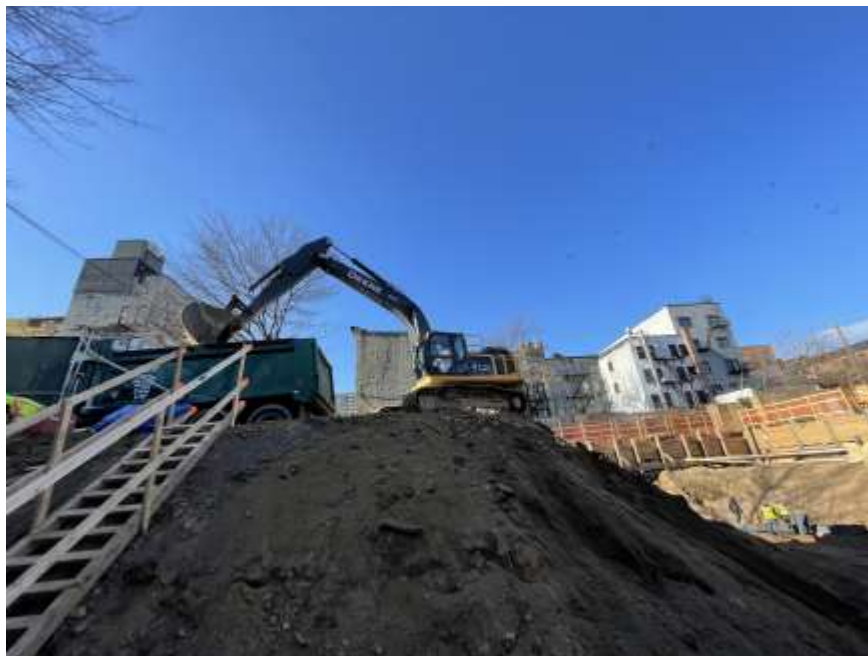
Photo 2: View of Rise live-loading non-hazardous fill/soil into permitted tri-axle trucks for off-site disposal (facing west).

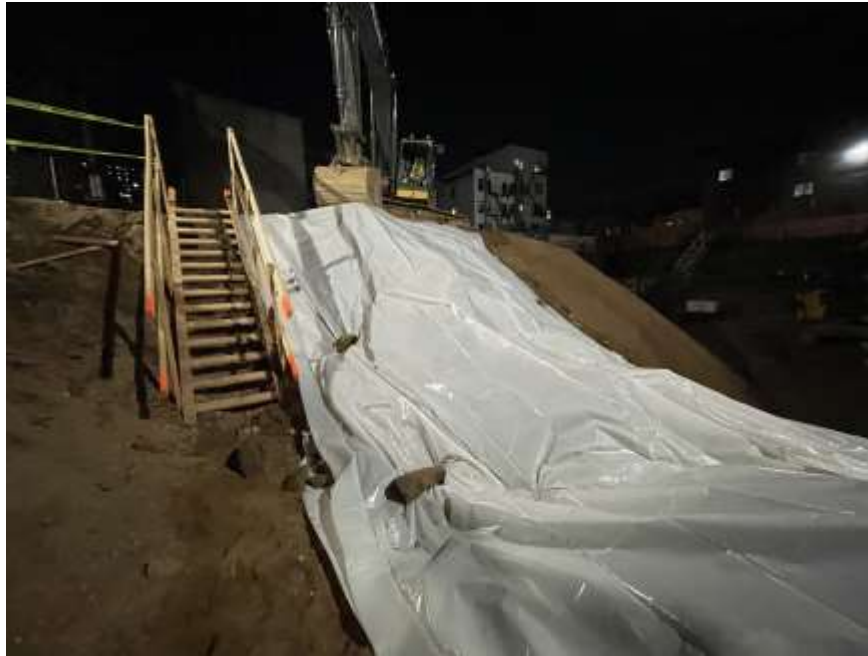
Photo 3: View of stockpiled hazardous lead contaminated soil on top of and covered with polyethylene sheeting in the southeastern part of the site (facing west).
