SITE OBSERVATION REPORT

PROJECT No.: 170552901 PROJECT: 159 Boerum Street LOCATION: Brooklyn, NY	CLIENT: SPG Boerum LLC	DATE: Tuesday, December 27, 2022 WEATHER: Clear, 27-37 °F Wind: W @ 2.7-4.5 mph TIME: 7:00 am to 5:00 pm
CONTRACTOR: SD Builders		LANGAN REP. : Lauren Roper
CONTRACTOR'S EQUIPMENT: Hitachi ZX 160LC Excavator Deere 300G Excavator Kubota SVL65-2 Skid Steer Deere 135G Excavator	PRESENT AT SITE: Lauren Roper – Langan James Hsu – SD Builders - General Contractor Lucas Alvarez - Rise Concrete (Rise) – Foundation Contractor	
OBSERVATIONS, DISCUSSIONS, TEST RESULTS, ETC.: Langan was present to observe environmental protocols in accordance with the New York State Department of Environmental Conservation (NYSDEC)-approved Remedial Action Work Plan (RAWP) for Brownfield Cleanup Program (BCP) site C224291 at 159 Boerum Street (Block 3071, Lot 40). Observed activities were as follows: Site Activities <ul style="list-style-type: none"> • Rise excavated three about 5-foot-long by 5-foot-wide areas to about 16 feet below grade surface (bgs) in the western and southwestern parts of the site for support of excavation (SOE) underpinning installation. Excavated material consisted of

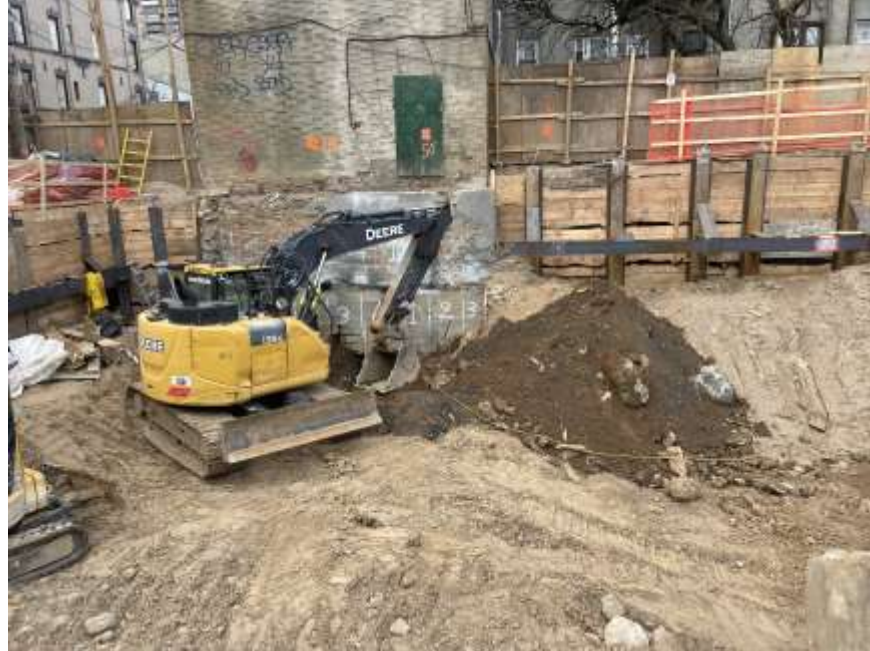
Photo 1: View of Rise excavating non-hazardous fill for SOE underpinning installation in the southwestern part of the site (facing west).

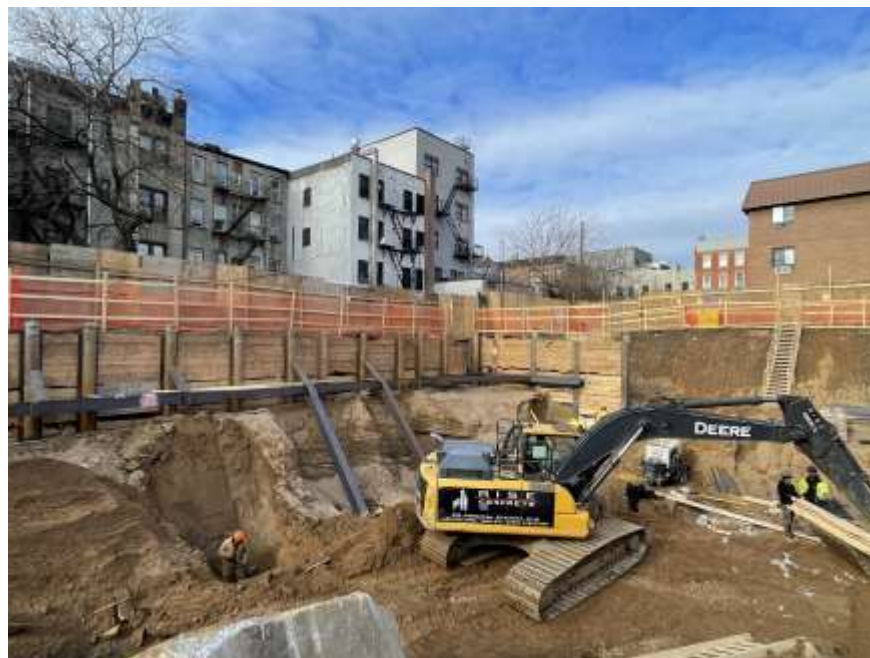
Photo 2: View of Rise grading native soil in the western part of the site (facing northwest).
