DAILY FIELD REPORT 001

Prepared By: LANGAN

BCP Project No: C224304 **Date:** June 29, 2021**Project Name:** 45 Commercial Street **Time:** 6:45 am to 2:30 pm**Consultant:** Langan Engineering, Environmental, Surveying, Landscape Architecture and Geology, D.P.C. (Langan)**Langan Field Personnel:**
Andrew Nesci**Construction Manager:** Monadnock Construction Inc. (MC)
Foundation Contractor: StructureTech New York, Inc. (STNY)
Soil Broker: Clean Earth LLC (CE)**Work Activities Performed:**

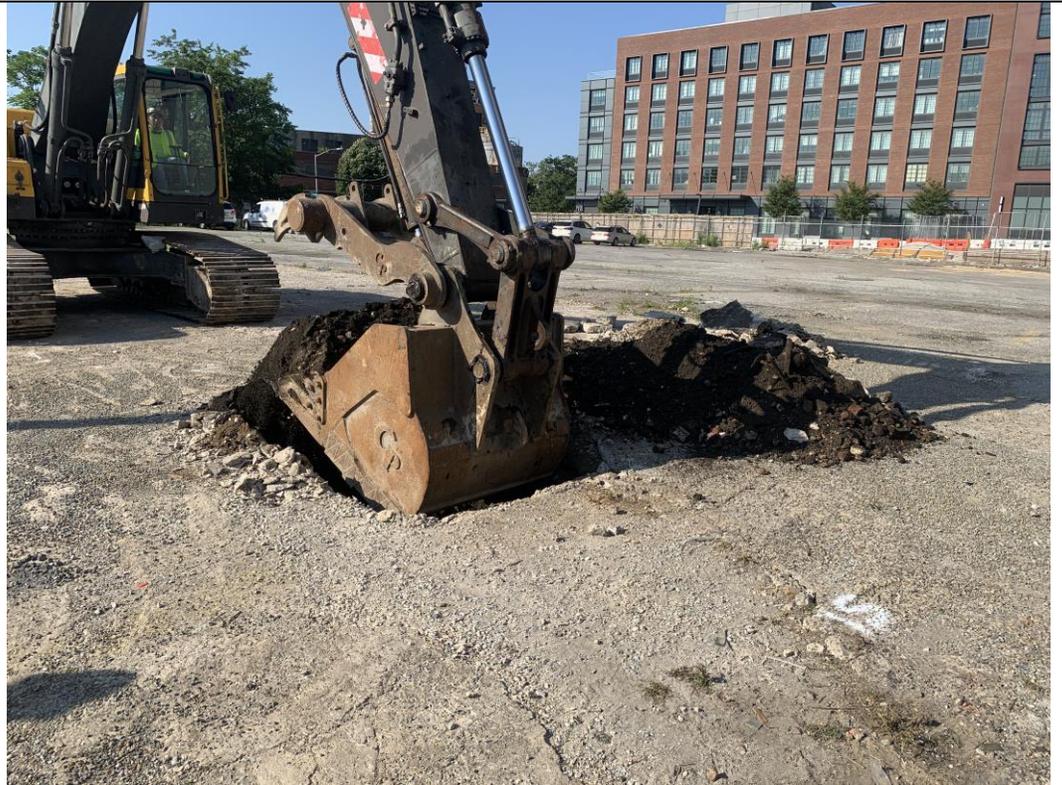
Photo 1:

View of STNY excavating a test pit at the LB17 hotspot, located in the northeastern part of the site (facing south).

- At LB17, four 10-foot step out test pits and four 20-foot step out test pits were excavated to a depth of 5 feet below grade surface (bgs) to the north, east, south, and west from the original boring location.

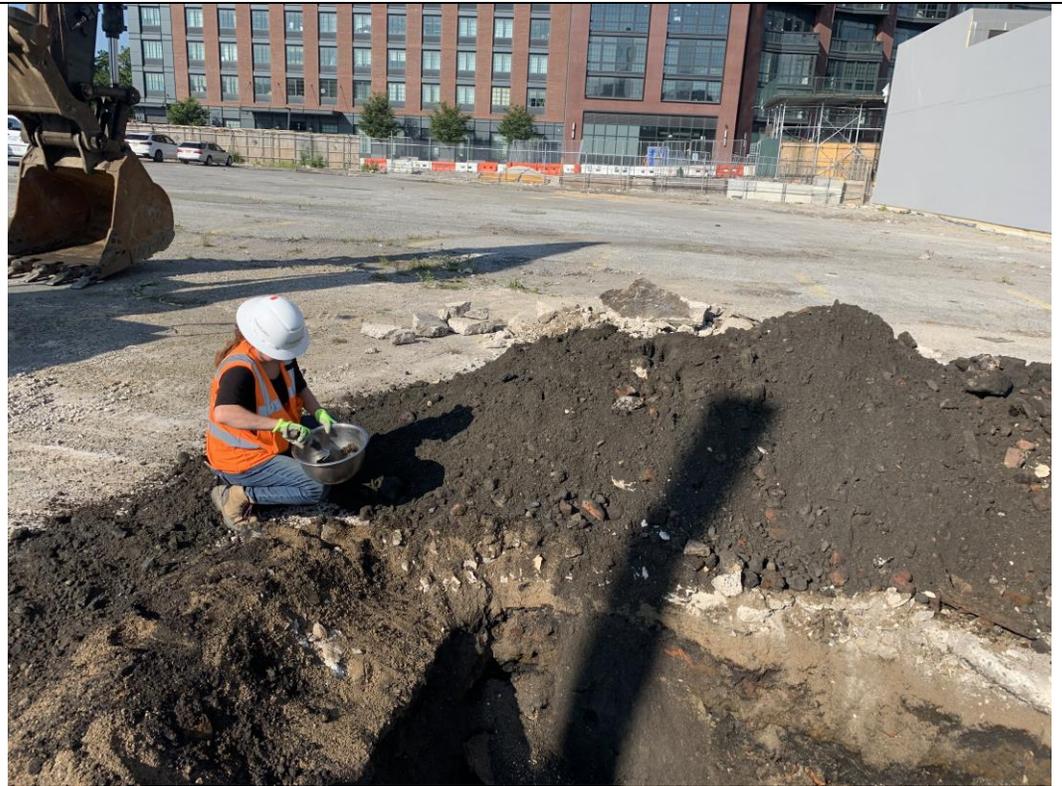
Photo 2:

View of CE collecting a soil sample at the LB17 hotspot, located in the northeastern part of the site (facing southwest).

- CE collected a total of 26 five-point composite samples to delineate hazardous lead hotspots, LB17, LB18, and LB22.
 - The soil samples were submitted to Eurofins Lancaster Laboratories, Inc. for laboratory analysis of total lead and Toxicity Characteristic Leaching Procedure (TCLP) lead.

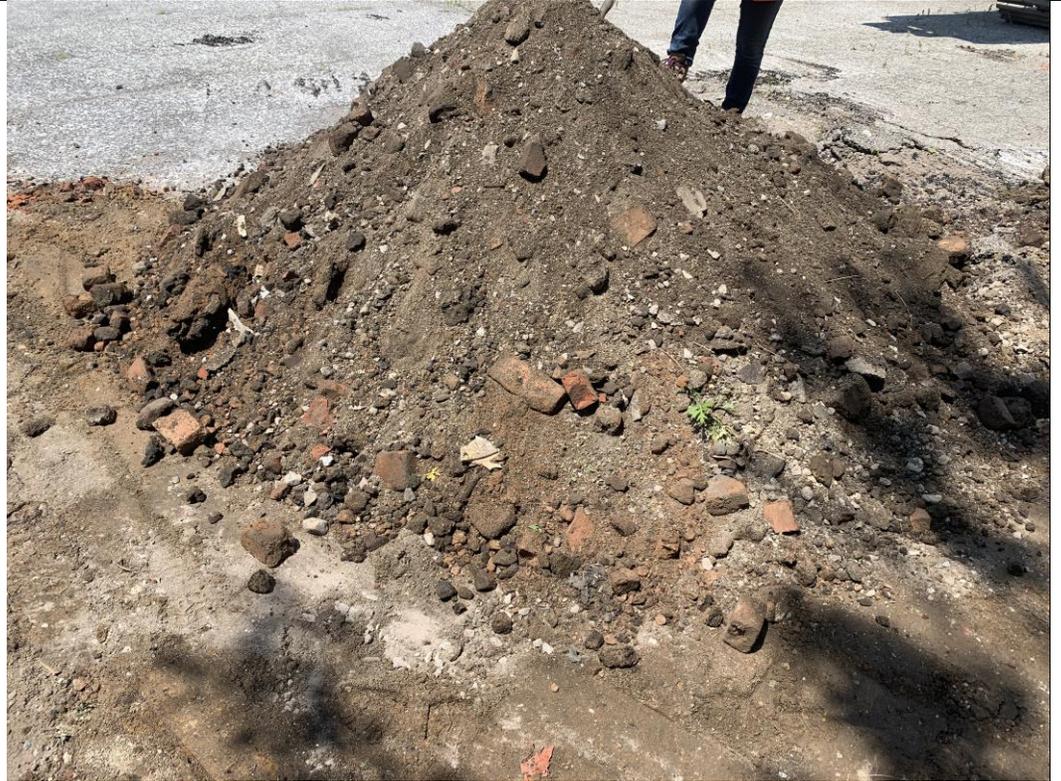
Photo 3:

View of historic fill materials at a LB18 hotspot test pit, located at the southern part of the site, prior to being returned to the excavation (facing northeast).

- At LB18, three 10-foot step out test pits and three 20-foot step out test pits were excavated to a depth of 3 feet from the north, east, and west of the original boring location. Step out test pits were not completed to the south of LB18 because of the proximity to the southern property boundary.

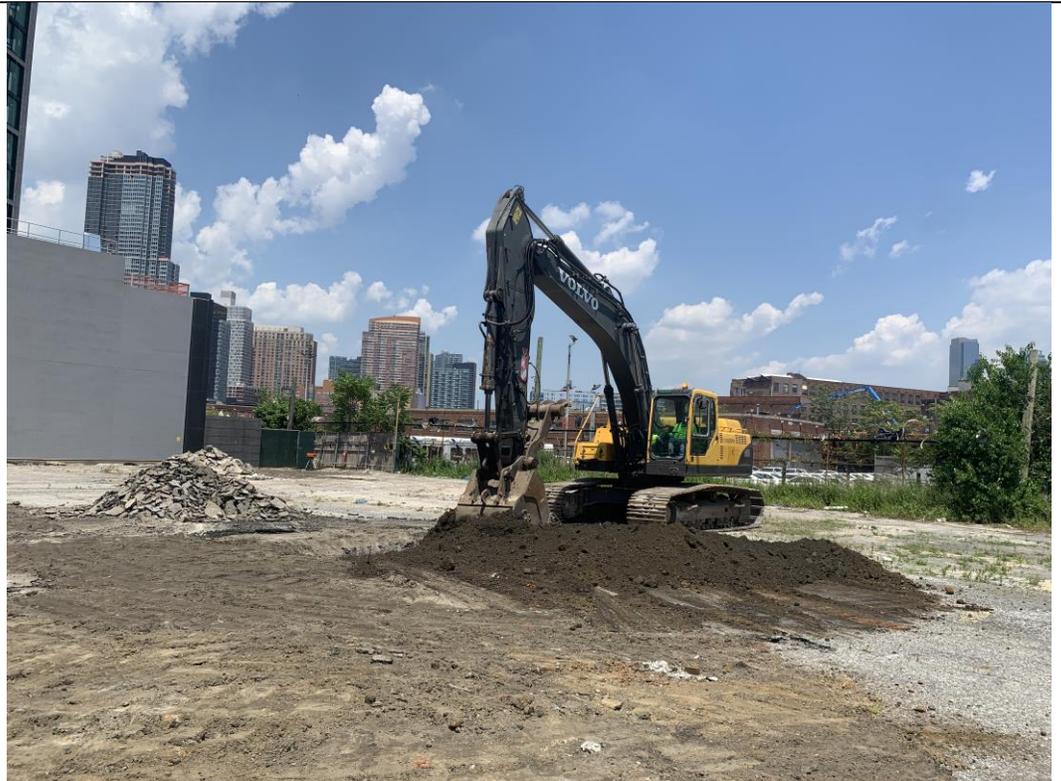
Photo 4:

View of STNY backfilling the test pit excavation at the LB22 hotspot, located in the central part of the site (facing northeast).

- At LB22, four 10-foot step out test pits and four 20-foot step out test pits were excavated to a depth of 5 feet bgs to the south and west and to a depth of 10 feet bgs to the north and east from the original boring location. The deeper test pits, excavated to 10 feet bgs, were advanced for vertical delineation of hazardous lead.
