DAILY FIELD REPORT 001		WEATHER	Snow		Rain		Overcast			Partly Cloudy		Sunny	х
Prepared By: LANGAN		TEMP.	< 32		32-50		50-70		-	70-85	Х	>85	Х
BCP Project No: C224304						Date: June 29, 2021							
Project Name:	Project Name: 45 Commercial Street					Time: 6:45 am to 2:30 pm							
Consultant: Langan Engineering, Environmental, Surveying, Landscape Architecture and Geology, D.P.C. (Langan)					_	•	Field F Nesci	Pers	onr	nel:			
	nager: Monadnock Construct ractor: StructureTech New ` Earth LLC (CE)

DAILY FIELD REPORT 002		WEATHER	Snow		Rain		Overcast		Partly Cloud		Sunny	×
Prepared By: LANGAN		TEMP.	< 32		32-50		50-70		70-85	>	>85	Х
BCP Project No:				Date : June 30, 20			021					
Project Name: 45 Commercial Street						Time: 6:45 am to 3:45 pm					15 pm	
Consultant: Langan Engineering, Environmental, Surveying, Landscape Architecture and Geology, D.P.C. (Langan)					Gabr	iel E	Enrique		sonnel : astro			
Construction Manager: Monadnock Construction Inc. (MC) Foundation Contractor: StructureTech New York, Inc. (STNY) Soil Broker: Clean Earth LLC (CE)					Andr	ew	Nesci

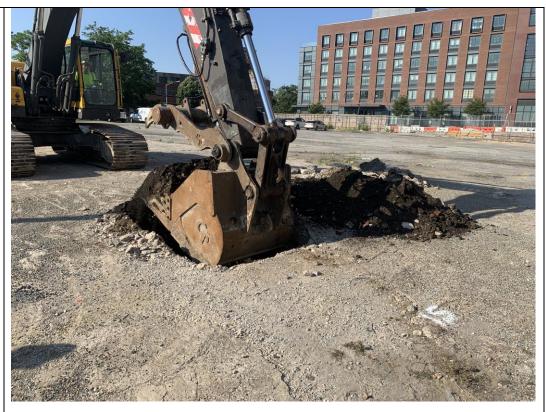
Photo 1:

View of STNY excavating a test pit at the LB17 hotspot, located in the northeastern part of the site (facing south).

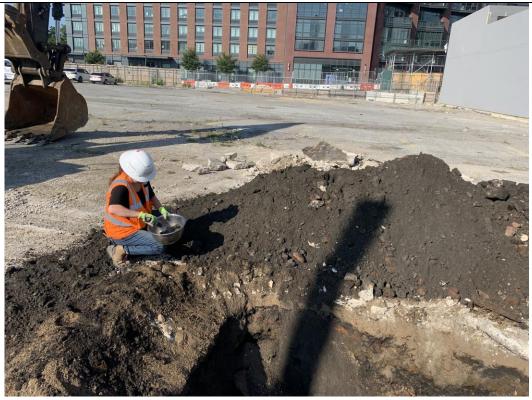
Photo 2:

View of CE collecting a soil sample at the LB17 hotspot, located in the northeastern part of the site (facing southwest).

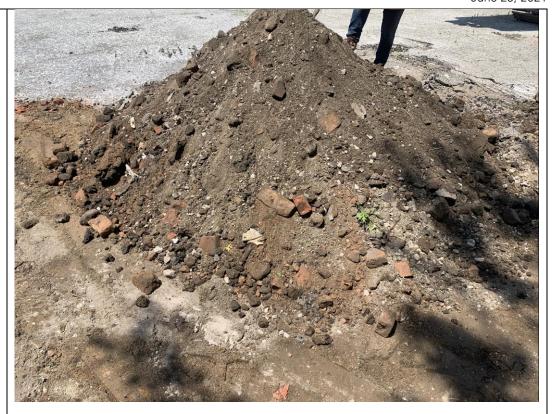
Photo 3:

View of historic fill materials at a LB18 hotspot test pit, located at the southern part of the site, prior to being returned to the excavation (facing northeast).

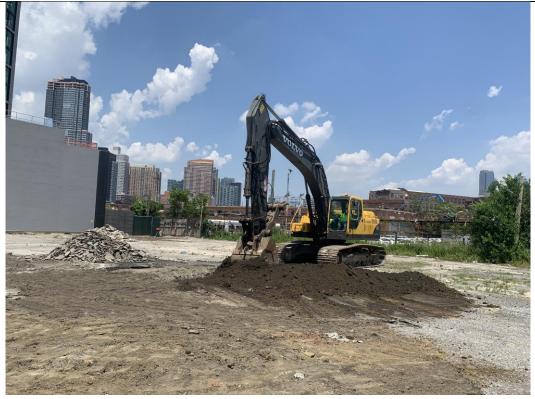
Photo 4:

View of STNY backfilling the test pit excavation at the LB22 hotspot, located in the central part of the site (facing northeast).

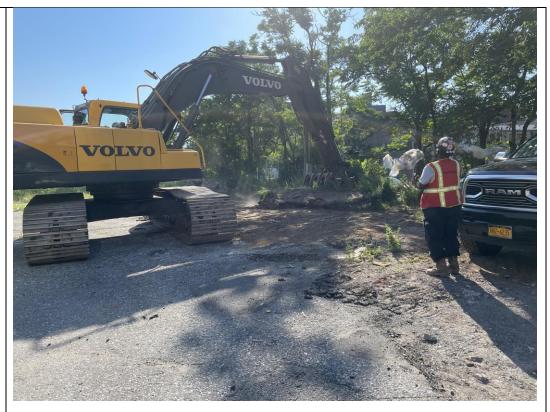
Photo 1:

View of STNY excavating a test pit at the LB18 hotspot, located in the southern part of the site (facing southeast).

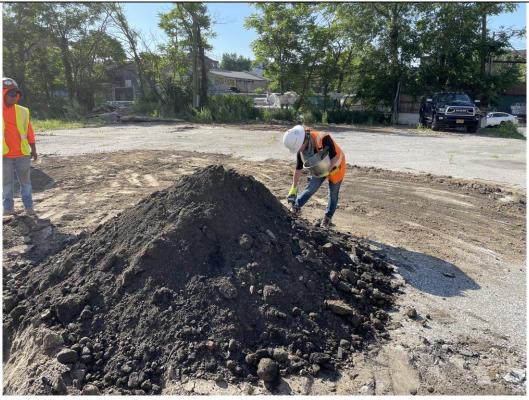
Photo 2:

View of CE collecting a soil sample at the LB22 hotspot, located in the central part of the site (facing south).

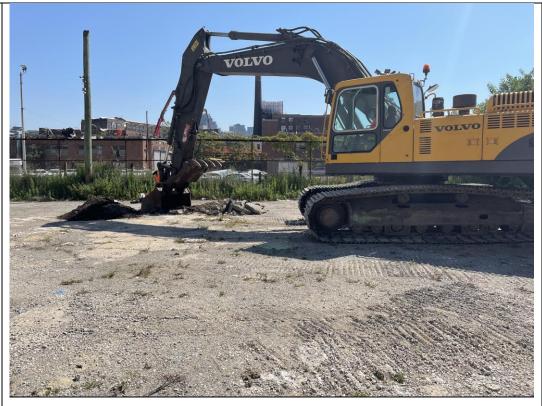
Photo 3:

View of STNY excavating a test pit in the eastern part of the site (facing east)

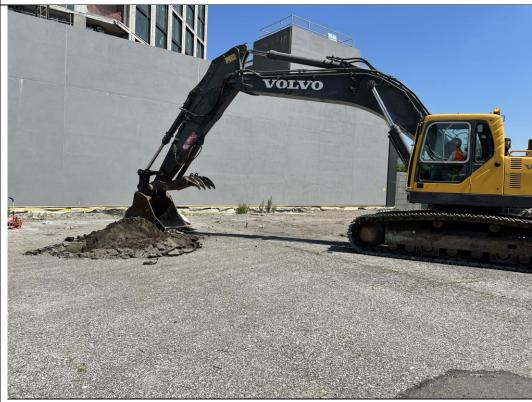
Photo 4:

View of STNY backfilling a test pit excavation in the north-central part of the site (facing northeast).
