**DAILY FIELD REPORT 006**

Prepared By: LANGAN

<b>BCP Project No:</b>	C224304	<b>Date:</b>	July 12, 2021
------------------------	---------	--------------	---------------

<b>Project Name:</b>	45 Commercial Street	<b>Time:</b>	6:45 am to 3:15 pm
----------------------	----------------------	--------------	--------------------

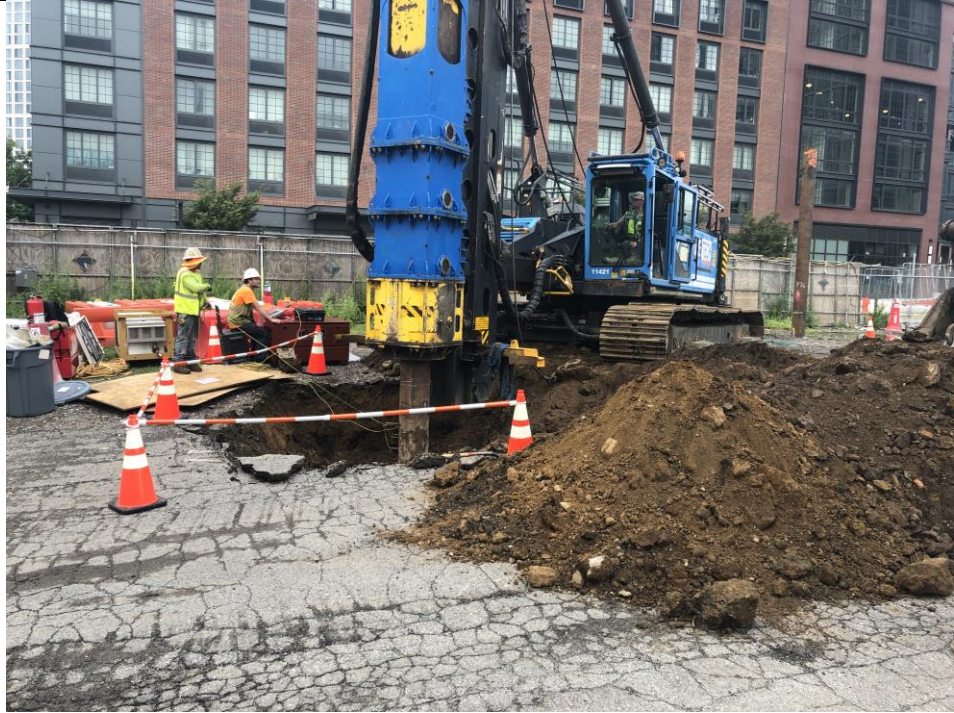
**Photo 1:**  
View of STNY advancing index pile 27 within waste characterization grid COMP H (facing west).

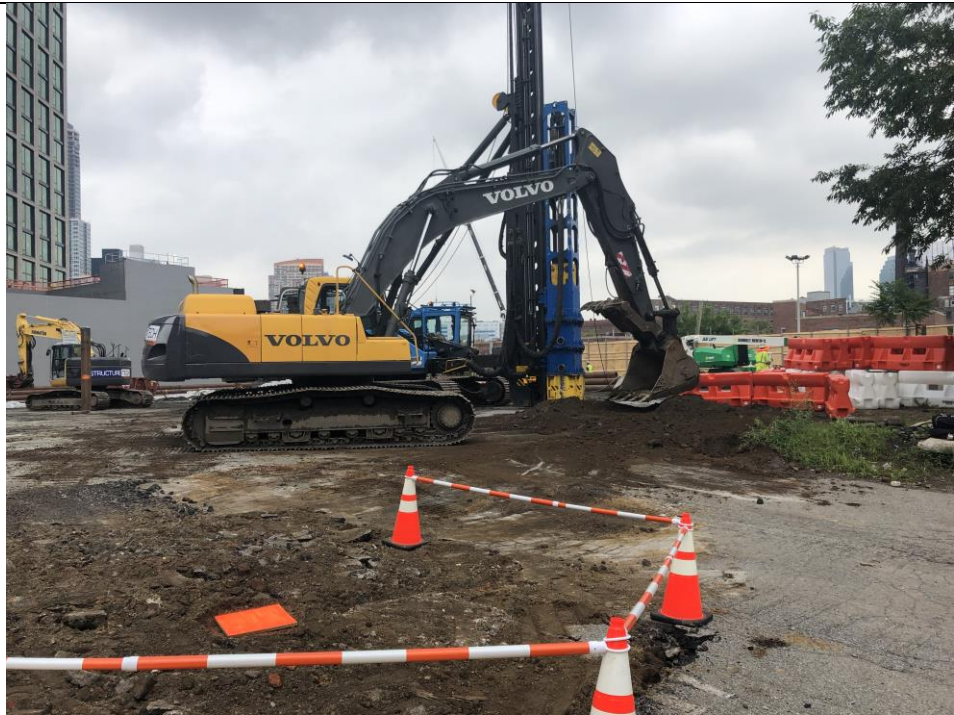
**Photo 2:**  
View of the STNY backfilling index pile 49 excavation within waste characterization grid COMP H (facing northeast).

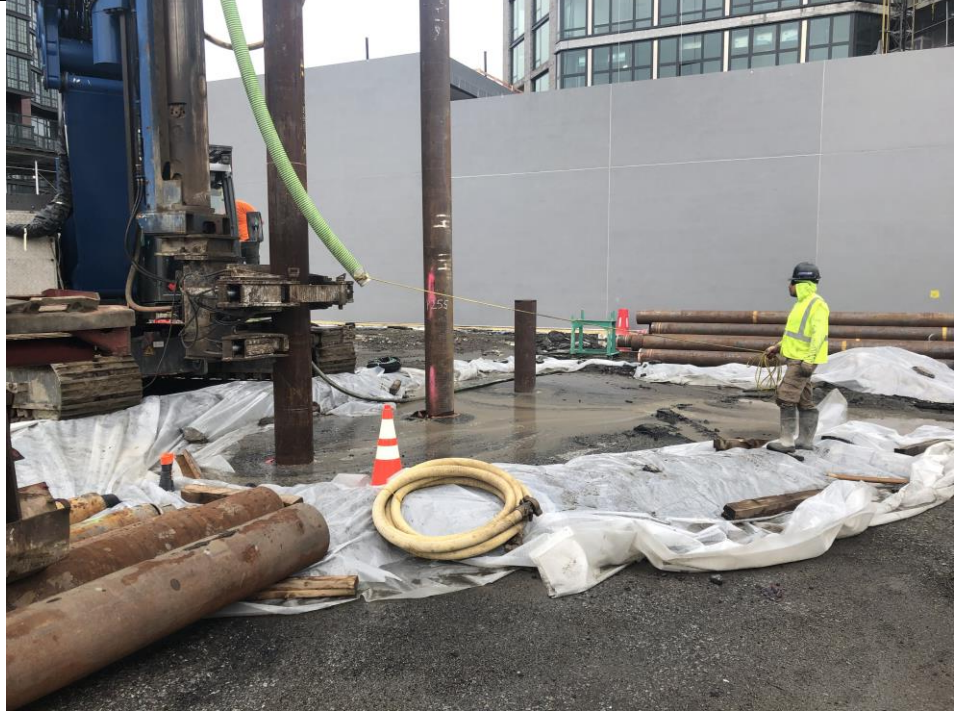
**Photo 3:**  
View of STNY advancing a reaction pile immediately south of index pile 255, within waste characterization grid COMP D (facing northwest).

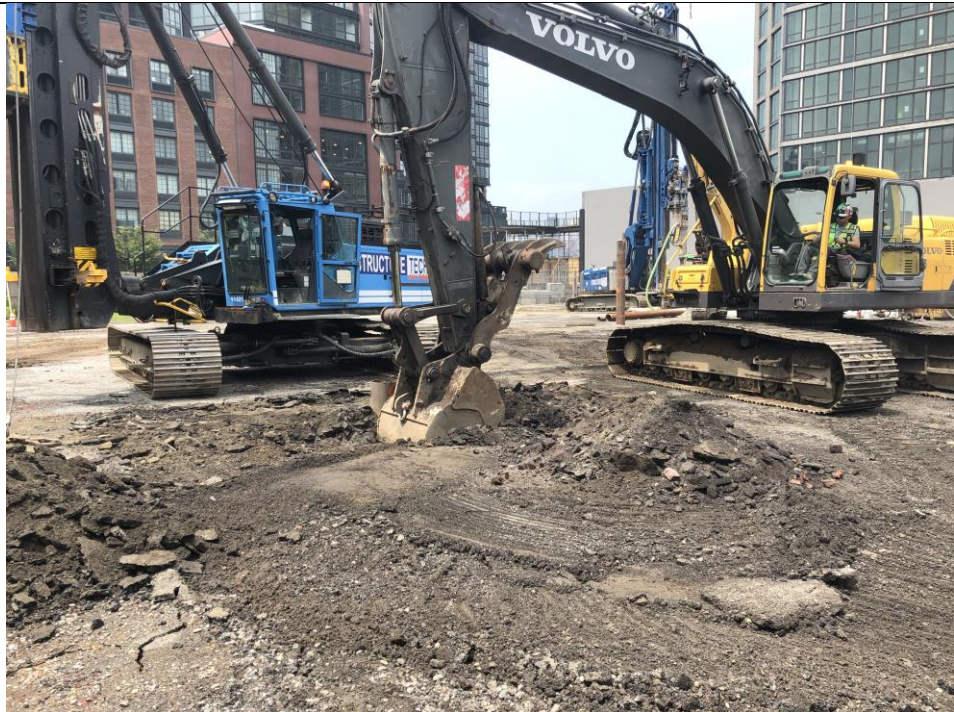
**Photo 4:**  
View of the STNY excavating within waste characterization grid COMP A to install structural pile 51 (facing northwest).

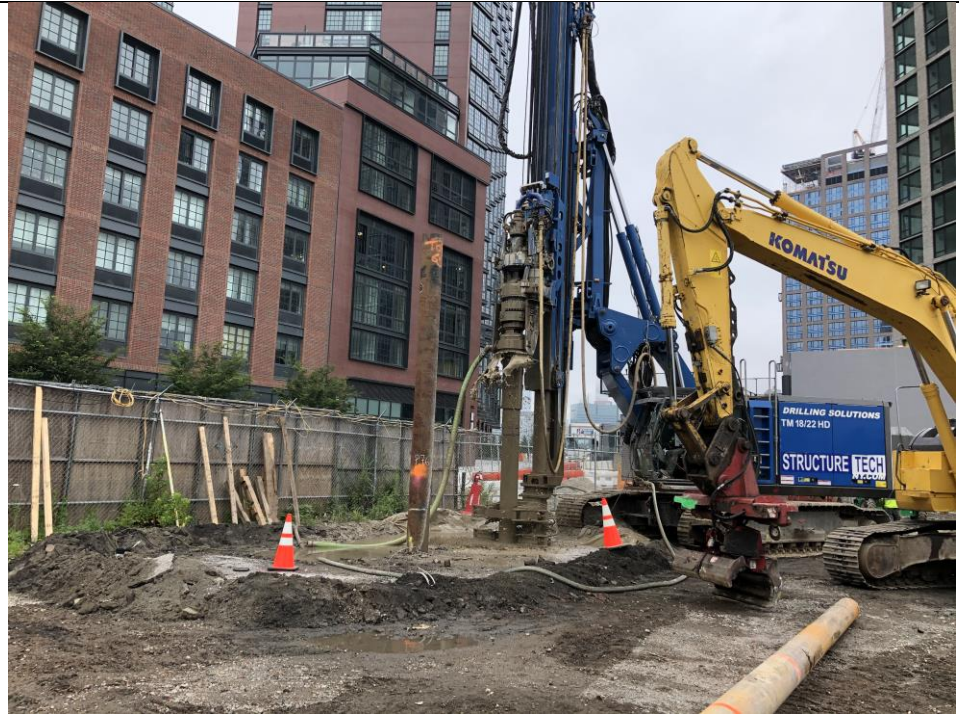
**Photo 1:**

View of STNY advancing a reaction pile north of structural pile 76 within waste characterization grid COMP G (facing northwest).

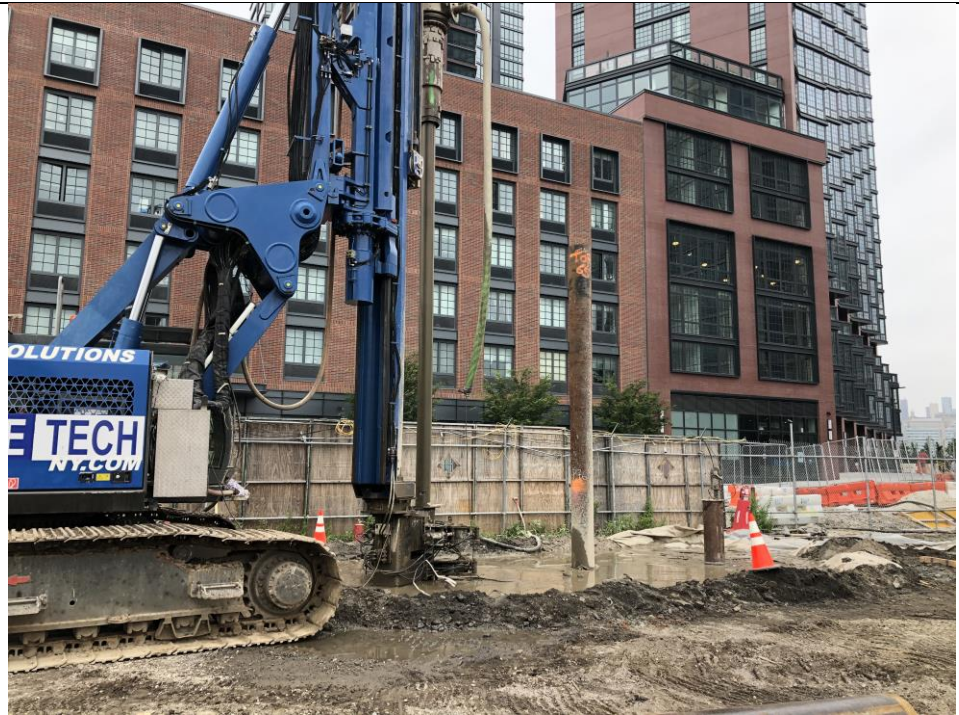
**Photo 2:**

View of STNY advancing a reaction pile south of structural pile 76 within waste characterization grid COMP G (facing northwest).

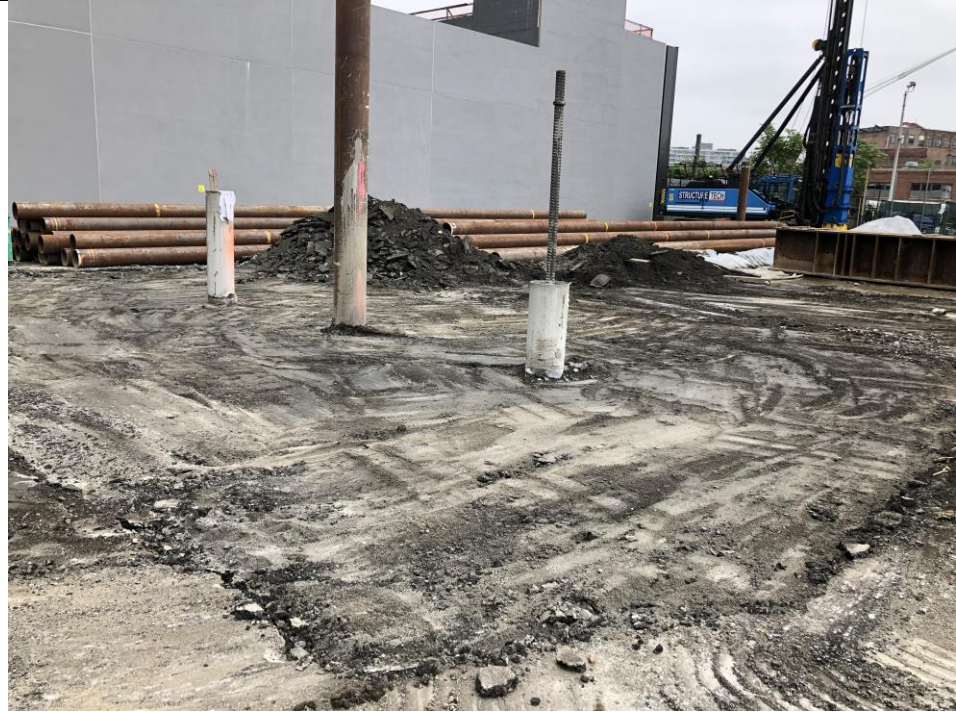
**Photo 3:**  
View of asphalt surface  
cover removal within waste  
characterization grids  
COMP D and COMP J  
North (facing northeast).

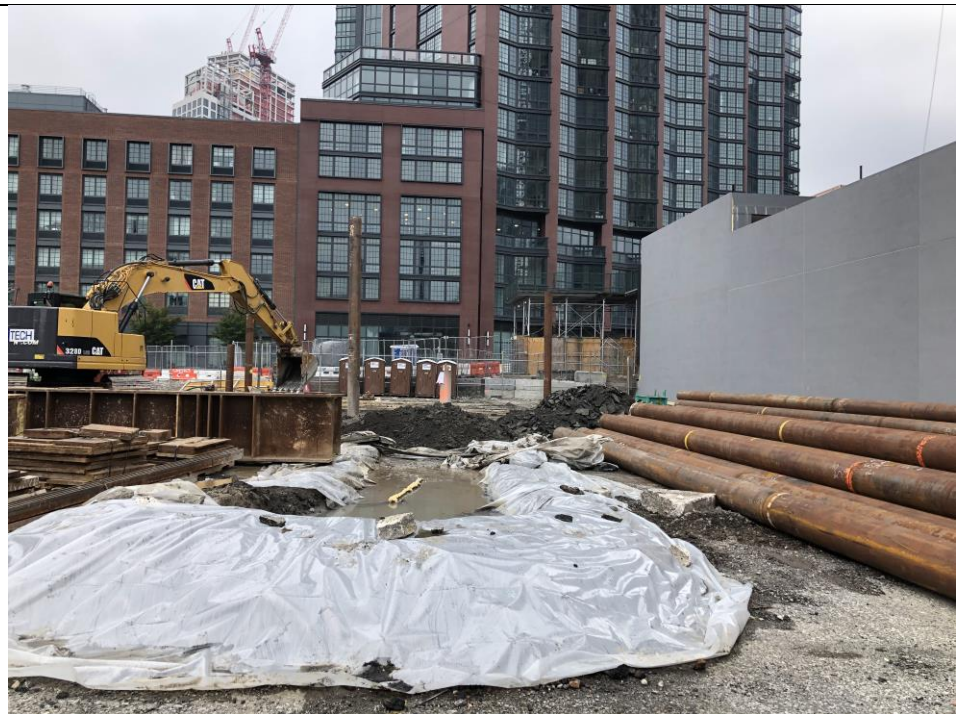
**Photo 4:**  
View of the soil stockpile  
located within COMP J  
North (facing west).

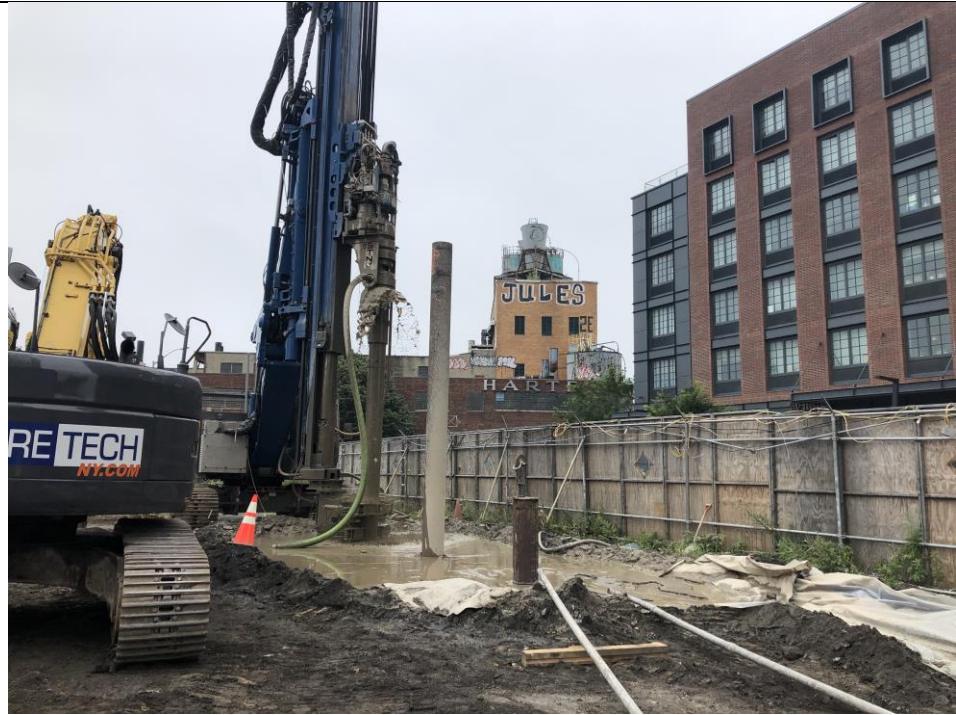
**Photo 1:**  
View of STNY advancing a reaction pile south of pile #76 in waste characterization grid COMP G (facing southwest).

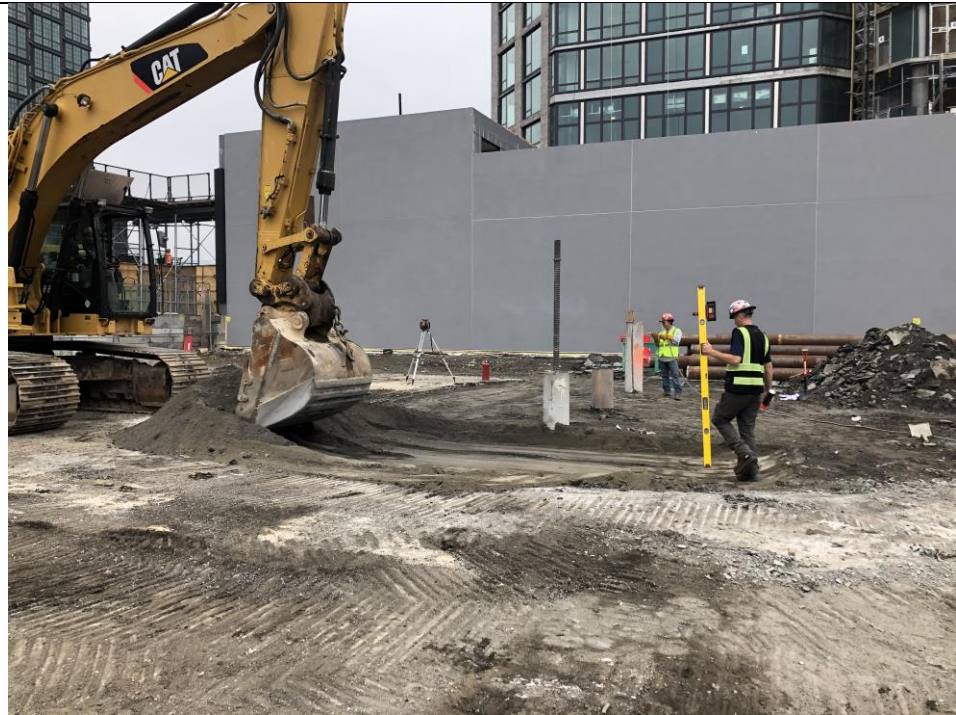
**Photo 2:**  
View of STNY excavating soil within waste characterization grid COMP D (0-5) in preparation for a load test (facing northwest).

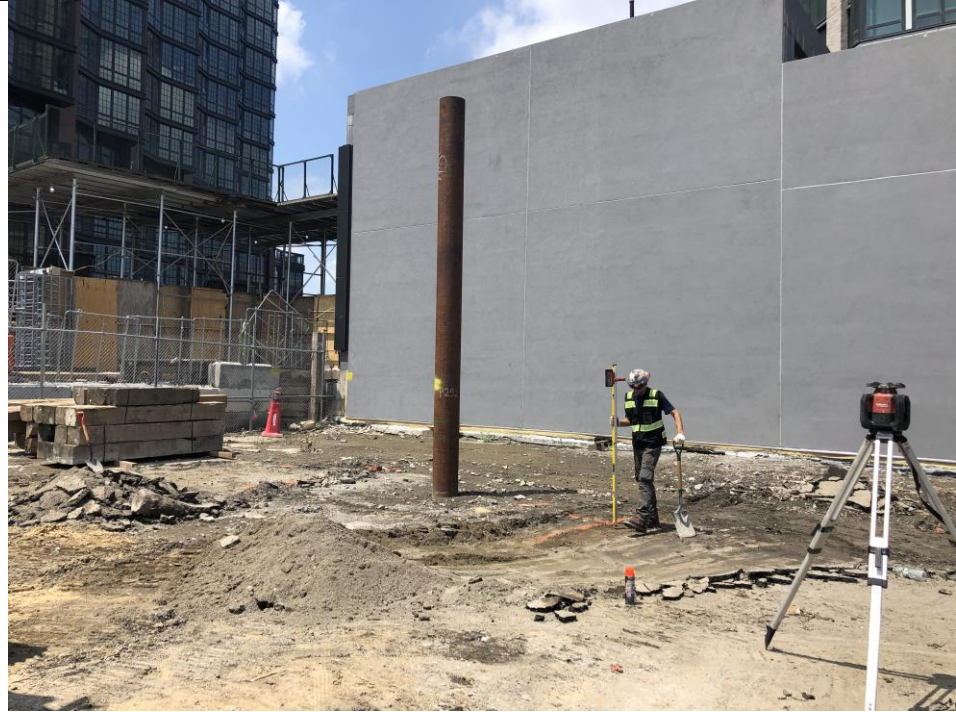
**Photo 3:**  
View of removed asphalt  
surface cover in waste  
characterization grid COMP  
E (facing northwest).

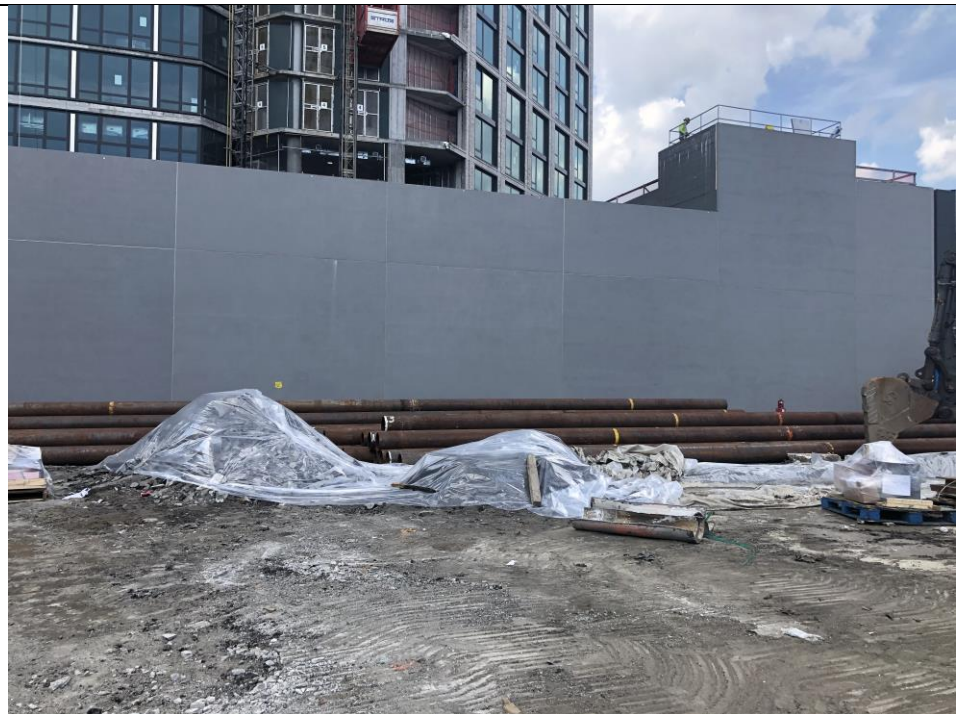
**Photo 4:**  
View of segregated soil and  
asphalt stockpiles covered  
with polyethylene sheeting  
located in COMP J North  
(facing north).

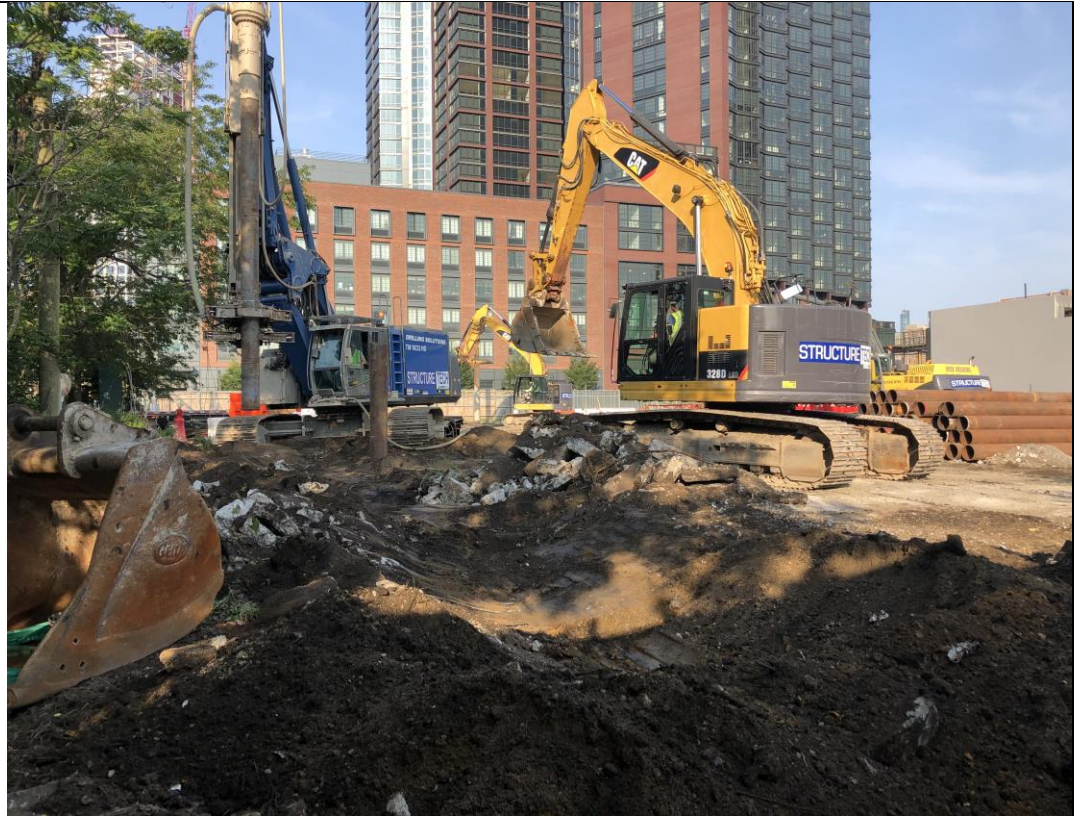
**Photo 1:**

View of STNY excavating a trench within waste characterization grids COMP A (0-5) and COMP K (0-5) (facing northwest).

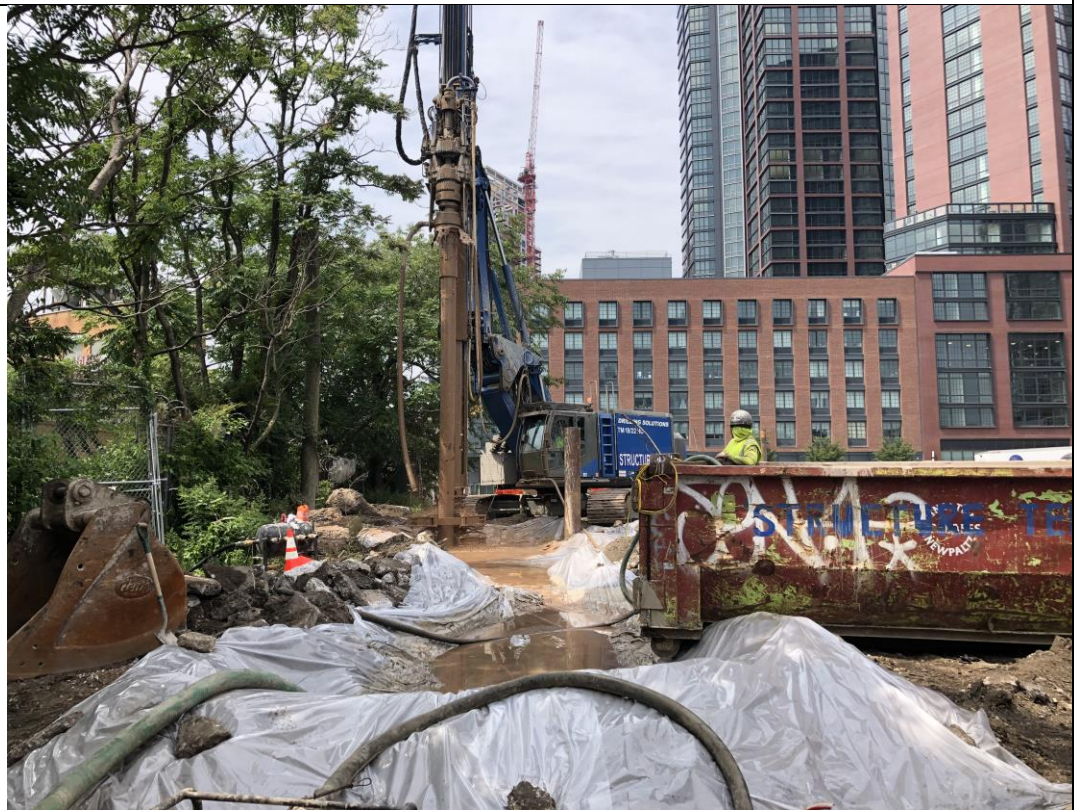
**Photo 2:**

View of STNY advancing a reaction pile south of pile #21 within waste characterization grid COMP A (facing west).

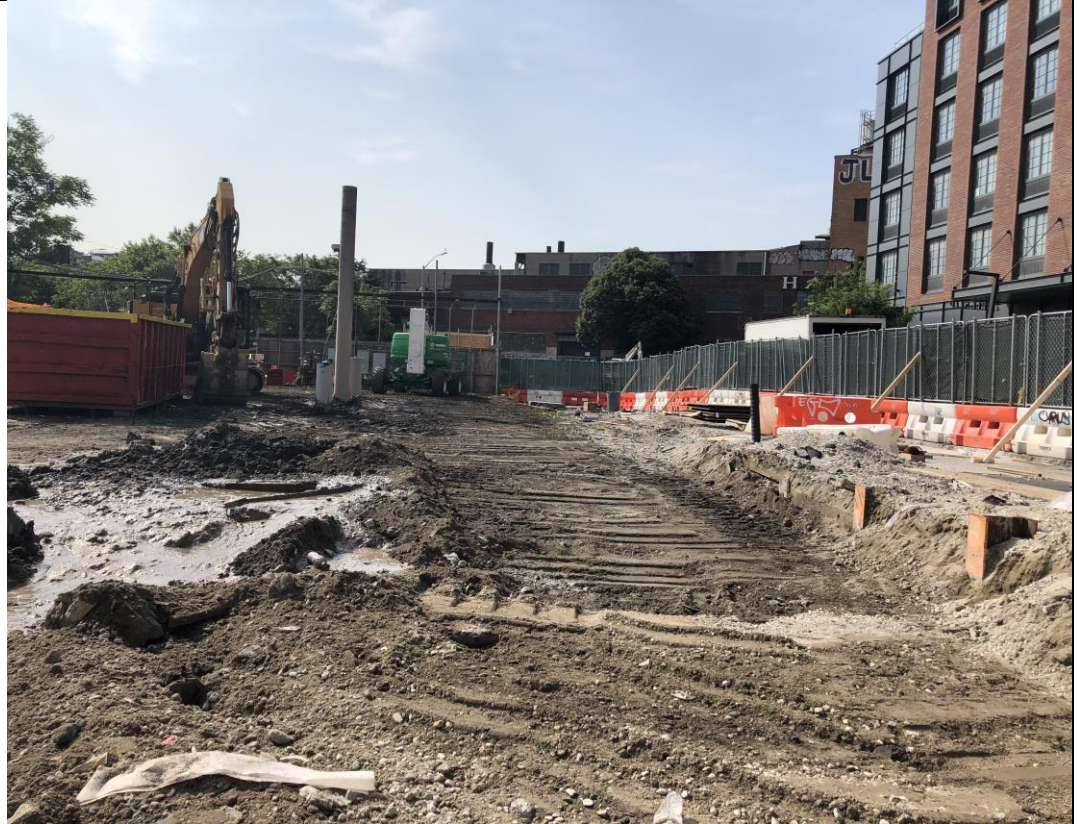
**Photo 3:**

View of the backfilled trench within waste characterization grid COMP G (facing south).

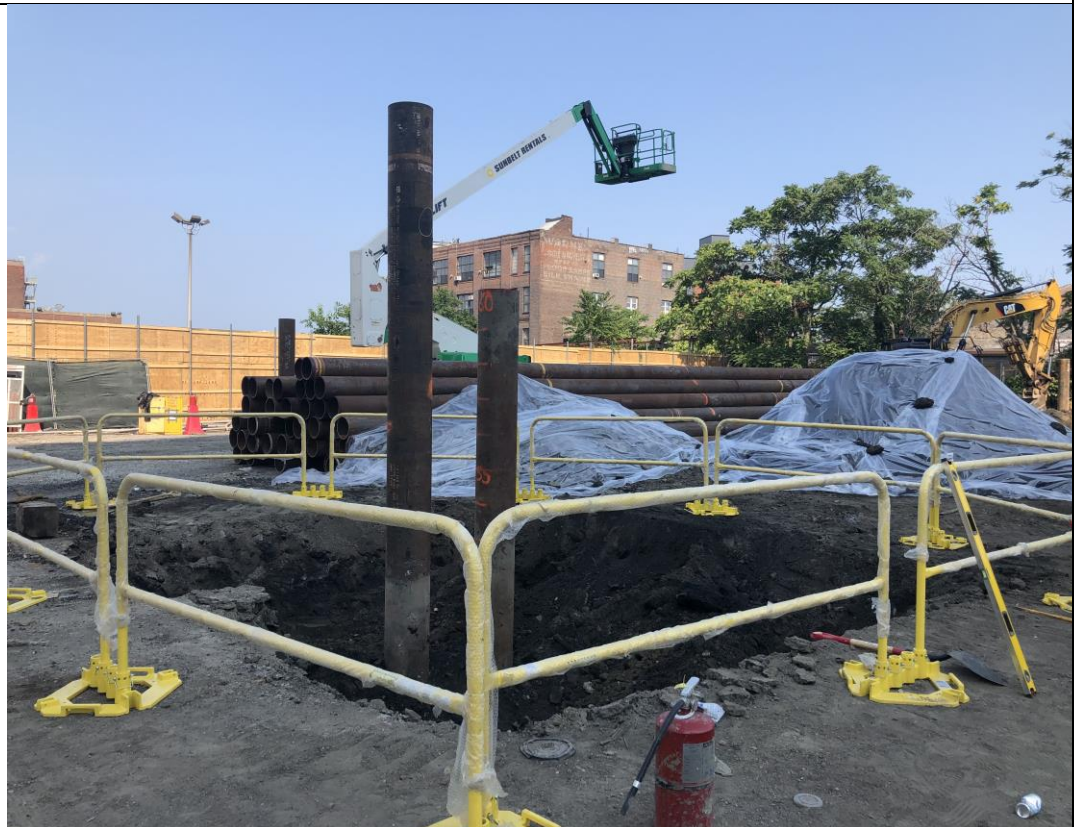
**Photo 4:**

View of excavated area around pile #215 and #216. C&D and soil stockpiles (covered with polyethylene sheeting) can be observed in the background (facing east)

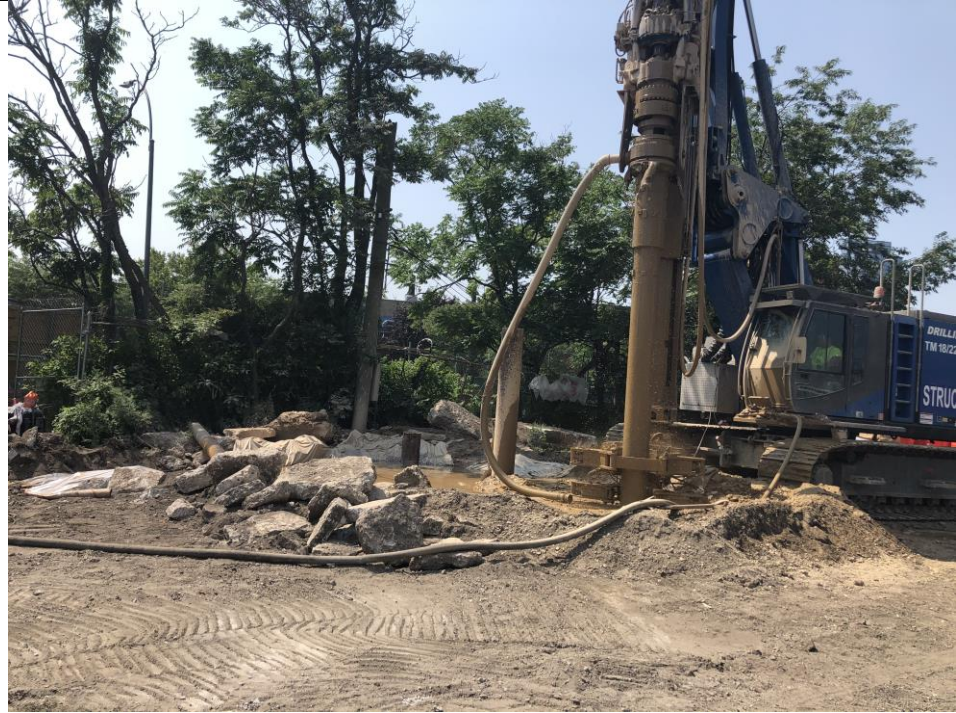
**Photo 1:**  
View of STNY advancing a reaction pile within waste characterization grid COMP A (facing south)

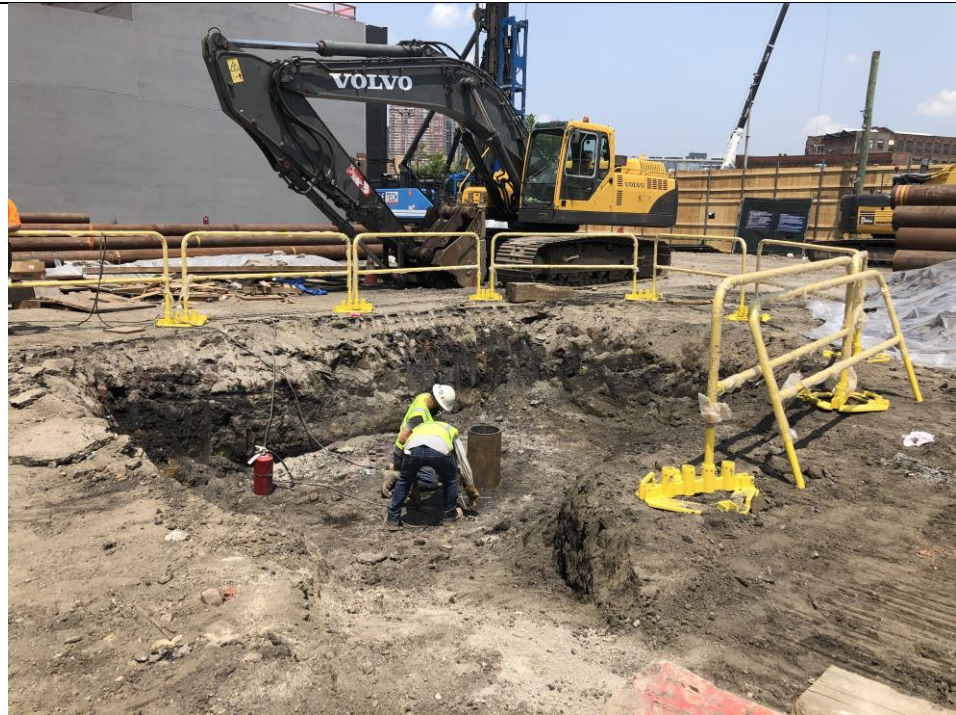
**Photo 2:**  
View of the excavated area around pile #215 and #216 within waste characterization grids COMP B (0-5), COMP C (0-5), and COMP D (0-5) (facing northeast)

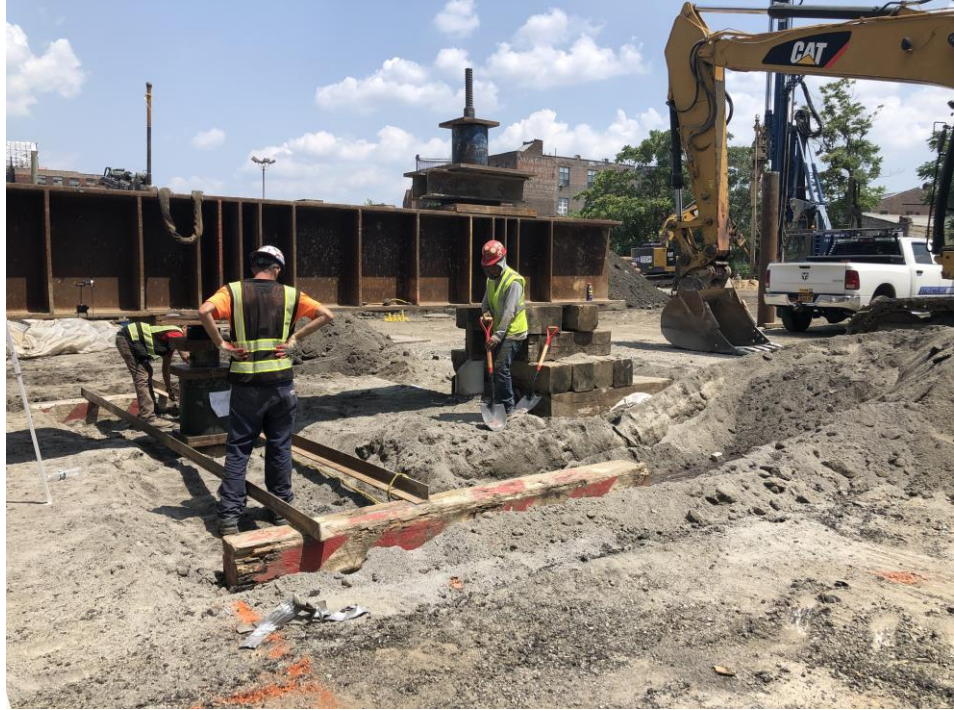
**Photo 3:**  
View of excavated L-shaped area around pile #255 within waste characterization grid COMP D (0-5) (facing southeast)

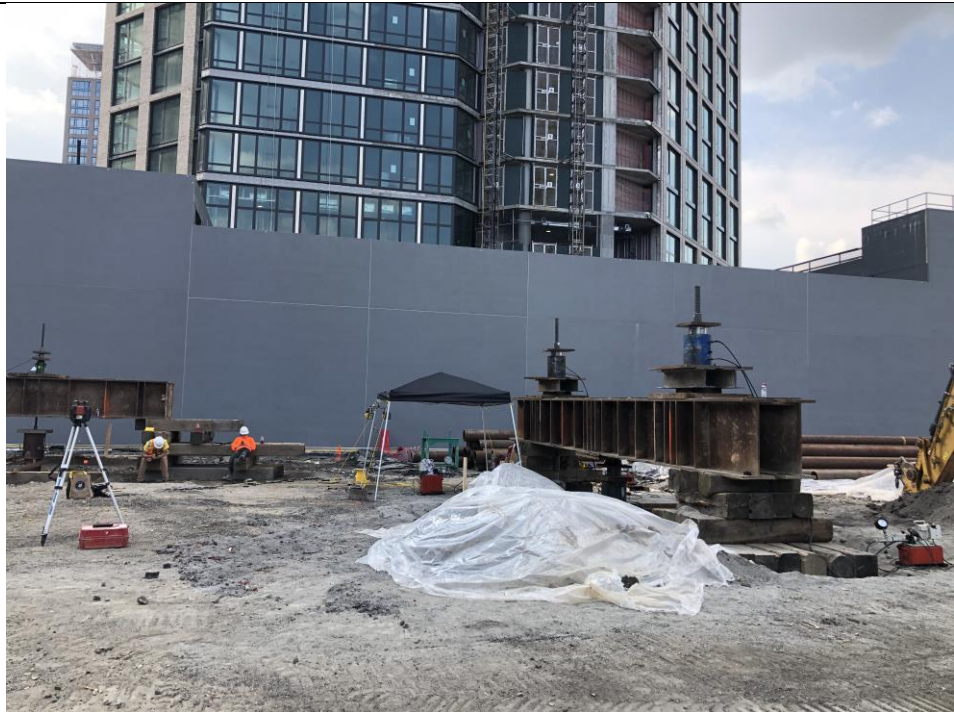
**Photo 4:**  
View of excavated area around pile #255 within waste characterization grid COMP D (0-5). Soil stockpile (covered with polyethylene sheeting) can be observed in the foreground (facing north)
