DAILY FIELD REPORT 073 Prepared By: LANGAN		WEATHER	Snow		Rain		Overca	ast		Partly Cloudy	х	Sunny	×
		ТЕМР.	< 32		32-50		50-70		Х	70-85		>85	
BCP Project No: C224304					Date: October 18					ber 18,	, 2021		
Project Name: 45 Commercial Street					Time: 6:45 am to 3:15 pm					5 pm			
Consultant: Langan Engineering, Environmental, Surveying, Landscape Architecture and Geology, D.P.C. (Langan)				_	•	Field F oper	Pers	sor	nnel:				
Construction Manager: Monadnock Construction Inc. (MC) Foundation Contractor: StructureTech New York, Inc. (STNY) Soil Broker: Clean Earth, Inc. (CE)

DAILY FIELD REPORT 074 Prepared By: LANGAN		WEATHER	Snow		Rain		Overca	ast		Partly Cloudy		Sunny	х
		TEMP.	< 32		32-50		50-70		Х	70-85		>85	
BCP Project No: C224304				Date: October 1				ber 19,	9, 2021				
Project Name: 45 Commercial Street					Time: 6:45 am to 3:15 pr					5 pm			
Consultant: Langan Engineering, Environmental, Surveying, Landscape Architecture and Geology, D.P.C. (Langan)				Lang Laure		Field F oper	Pers	or	nnel:				
Construction Manager: Monadnock Construction Inc. (MC) Foundation Contractor: StructureTech New York, Inc. (STNY) Soil Broker: Clean Earth, Inc. (CE)

DAILY FIELD REPORT 076 Pre

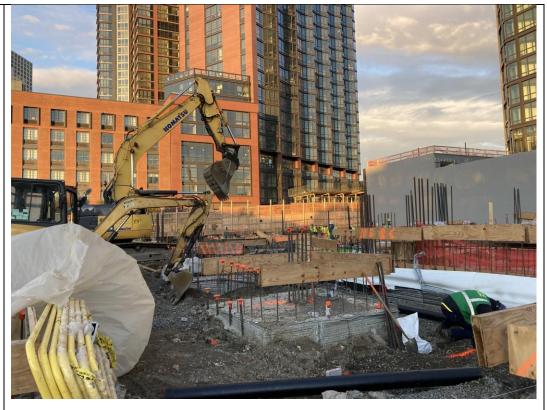
Photo 1:

General view of the site (facing west).

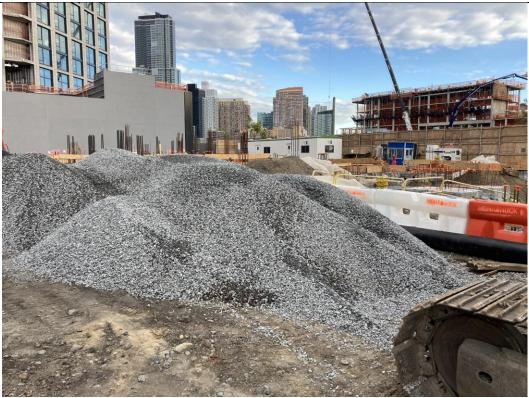
Photo 2:

View of imported 0.75-inch stone stockpile located in waste characterization grid COMP J North (facing northeast).

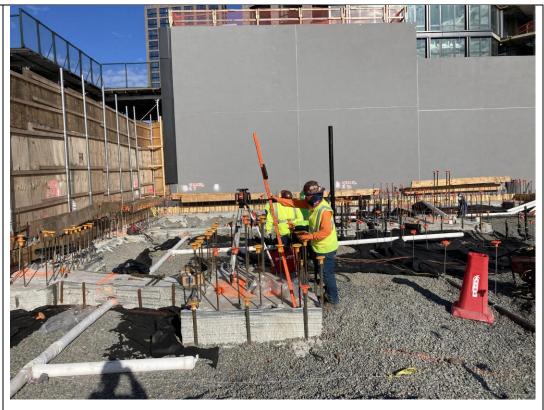
- STNY installed sub-membrane depressurization (SMD) system components in accordance with the design documents.
 - Non-woven, geotextile fabric (Mirafi 140N) was placed over an about 110-foot-long by 60-foot-wide compacted/flattened area in waste characterization grids COMP E and COMP F to isolate the SMD system from subgrade fines.

View of STNY installing geotextile fabric for the SMD system in waste characterization grdi COMP E (facing north).

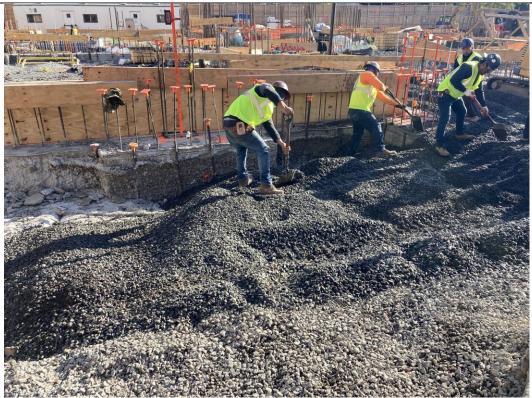
Photo 4:

- A minimum 8-inch-thick layer of 0.75-inch virgin stone was placed in an about 60-foot-long by 50-foot-wide area in waste characterization grid COMP E above the geotextile fabric to install the gas permeable aggregate layer.

View of STNY backfilling with imported 0.75-inch stone for the SMD aggregate layer in waste characterization grid COMP E (facing east).

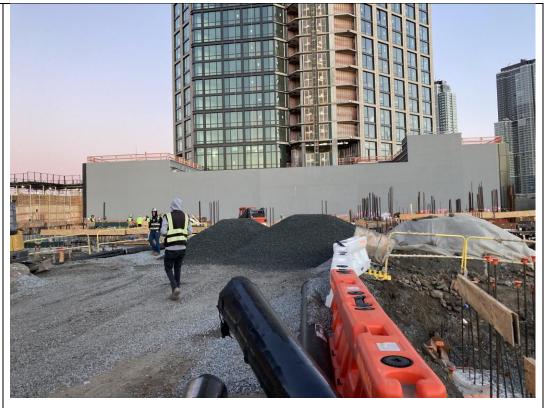
Photo 1:

General view of the site (facing north).

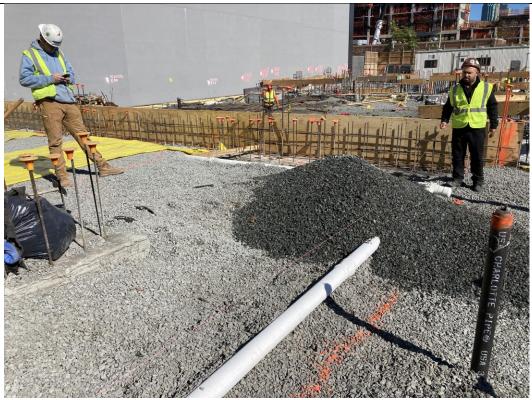
Photo 2:

View of STNY installing SMD piping and aggregate layer in waste characterization COMP E (facing northeast).

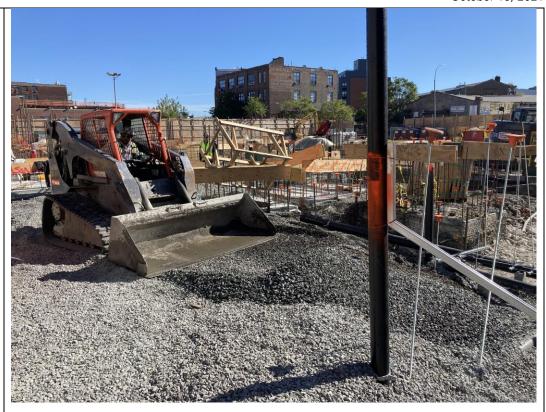
- STNY installed sub-membrane depressurization (SMD) system components in accordance with the design documents.
 - A minimum 8-inch-thick layer of 0.75-inch virgin stone was placed in an about 60-foot-long by 50-foot-wide area in waste characterization grid COMP F above previously installed geotextile fabric to install the gas permeable aggregate layer.

View of STNY installing the SMD aggregate layer in waste characterization grid COMP F (facing southeast).

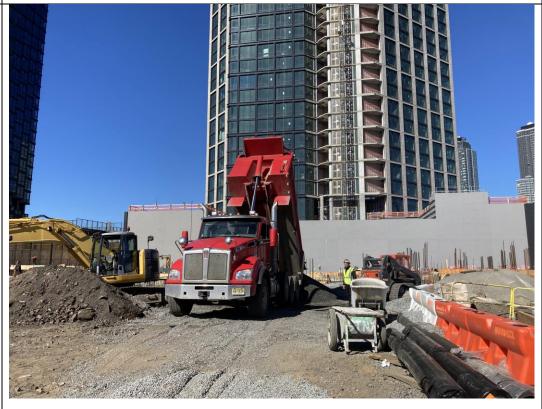
Photo 4:

View of a truck importing 0.75 inch virgin stone from Tilcon – Mt. Hope Quarry (facing north).

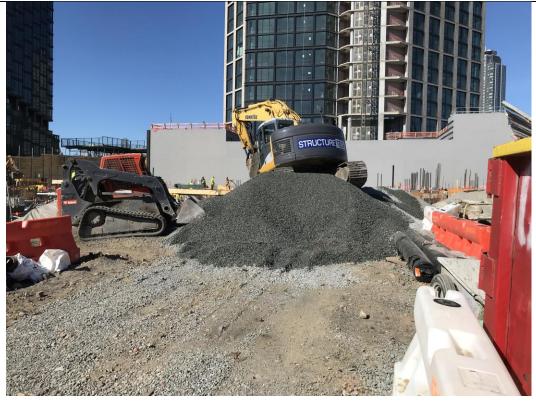
Photo 1:

View of imported 0.75-inch stone stockpile in waste characterization grid COMP J South (facing north).

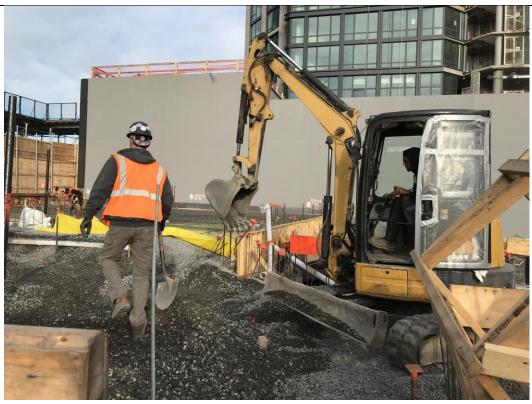
Photo 2:

- An about 63-foot-long by 60-foot wide area in waste characterization grids COMP D, COMP F, and COMP G from a maximum depth of 5 feet bgs (from original site grade) to about original site grade to raise the site to final grade in preparation for pouring of the concrete slab.

View of STNY backfilling in COMP D and COMP F with imported 0.75-inch stone (facing north).

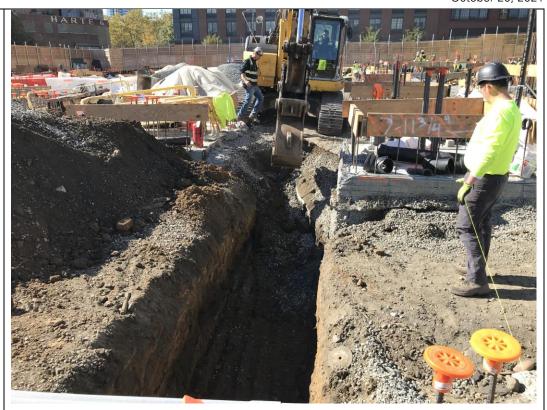
- STNY excavated an about 40-foot-long by 6-foot-wide area to 4 feet bgs (below grade surface) (from original site grade) in waste characterization grid COMP B (0-5) for the installation of plumbing piping. Excavated material consisted of non-native soil that did not exhibit signs of chemical- or petroleum-like contamination and was stockpiled in waste characterization grid COMP B.

View of STNY excavating in waste characterization grid COMP B (0-5) for utility piping installation (facing west).

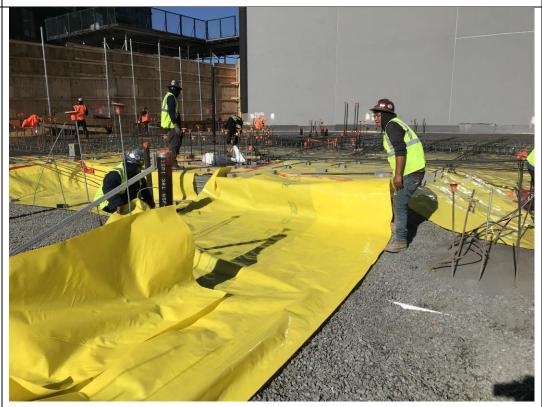
Photo 4:

- STNY placed vapor barrier (Stego® Wrap 20 Mil) in an about 60-foot-long by 55-foot-wide area above the gas permeable aggregate layer in waste characterization grids COMP F and COMP G. Vapor barrier seams were set with at least 6-inches of overlap and sealed with Stego® Tape. Vapor barrier installation documentation is to verify general conformance with specifications and contract documents. No rips, tears, or holes were observed during the installation.

View of STNY installing vapor barrier in waste characterization grid COMP F (facing northwest).

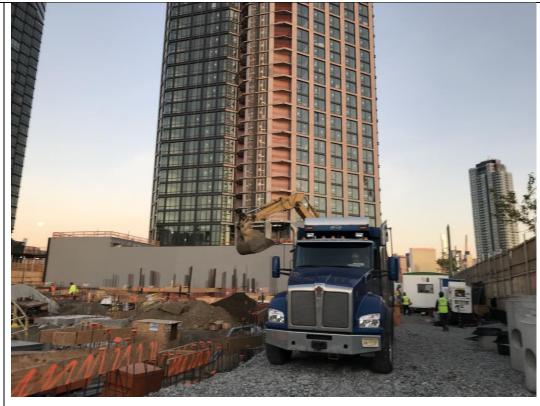
Photo 1:

- STNY loaded a truck with soil stockpiles³ in waste characterization grid COMP B for off-site disposal to the Clean Earth of Bethlehem (CEPA) facility located in Bethlehem, Pennsylvania.

View of STNY loading a truck with soil for off-site disposal to the CEPA facility (facing north).

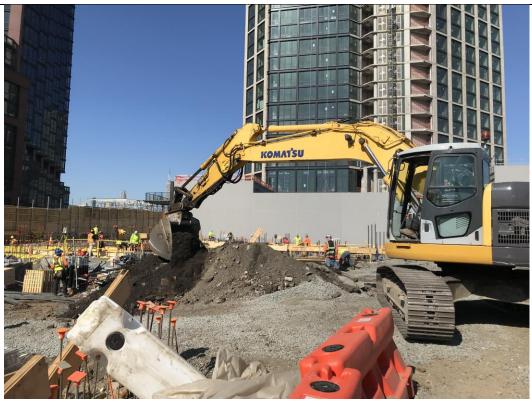
Photo 2:

View of STNY relocating a stockpile from waste characterization grid COMP J South to waste characterization grid COMP G (facing north).

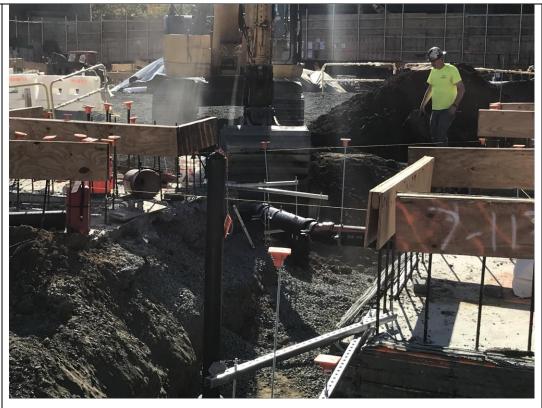
View of STNY excavating in waste characterization grid COMP B for plumbing utility piping (facing west).

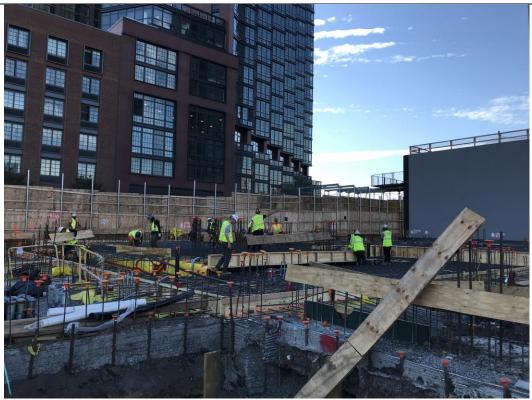
Photo 4:

- STNY continued installing vapor barrier membrane (Stego® Wrap 20 Mil) in an about 60-foot-long by 55-foot-wide area above the gas permeable aggregate layer in waste characterization grids COMP F and COMP G. Vapor barrier seams were set with at least 6-inches of overlap and sealed with Stego® Tape. Vapor Barrier installation documentation is to verify general conformance with specifications and contract documents. No rips, tears, or holes were observed during the installation.

View of vapor barrier installation in waste characterization grids COMP E and COMP F (facing northwest).

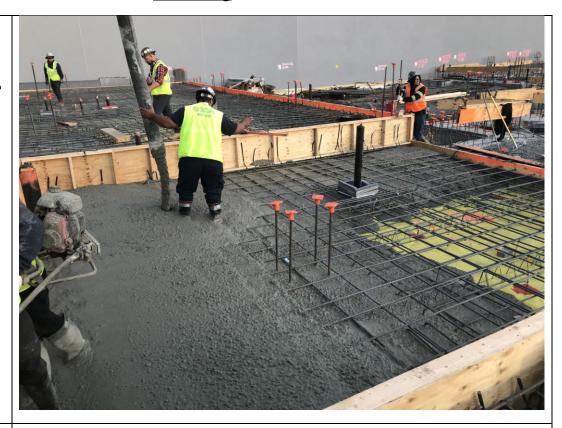
Photo 1:

- STNY poured concrete for the building foundation slab in an about 105-foot-long by 60-foot-wide area in waste characterization grids COMP E and COMP F.

View of STNY pouring concrete for the foundation slab in waste characterization grid COMP E (facing northeast).

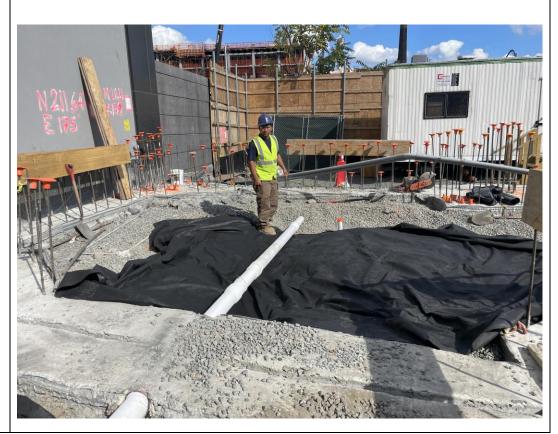
Photo 2:

- STNY installed sub-membrane depressurization (SMD) system components in accordance with the design documents.
 - Non-woven, geotextile fabric (Mirafi 140N) was placed over an about 60-foot-long by 37-footwide area in waste characterization grid COMP C to isolate the SMD system from subgrade fines.

View of STNY installing geotextile fabric and perforated PVC pipe in waste characterization grid COMP C for the SMD system (facing east).

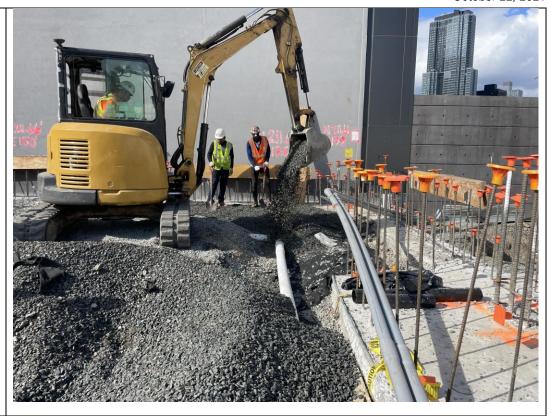
- A minimum 8-inch-thick layer of 0.75-inch virgin stone was placed in an about 60-foot-long by 37-foot-wide area in waste characterization grid COMP C above the geotextile fabric for the gas permeable aggregate layer.

View of STNY backfilling with 0.75-inch stone for the SMD system aggregate layer in waste characterization grid COMP C (facing north).

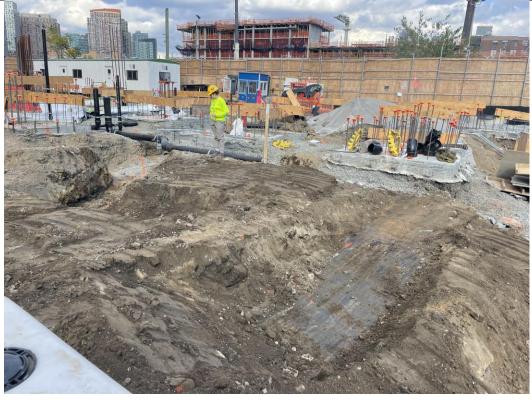
Photo 4:

- STNY excavated an about 10-foot-long by 3-foot-wide area to a depth of 1 foot below grade surface (bgs) to uncover existing plumbing piping in waste characterization grid COMP-B. Excavated material consisted of non-native soil, did not exhibit signs of chemical- or petroleum-like contamination and was added to an existing stockpile¹ in waste characterization grid COMP J South.

View of excavated area in waste characterization grid COMP B for plumbing installation (facing east).
