DAILY FIELD REPORT 098

BCP Project No:	C224304	Date:	November 22, 2021
------------------------	---------	--------------	-------------------

Project Name:	45 Commercial Street	Time:	5:45 am to 3:45 pm
----------------------	----------------------	--------------	--------------------

DAILY FIELD REPORT 099

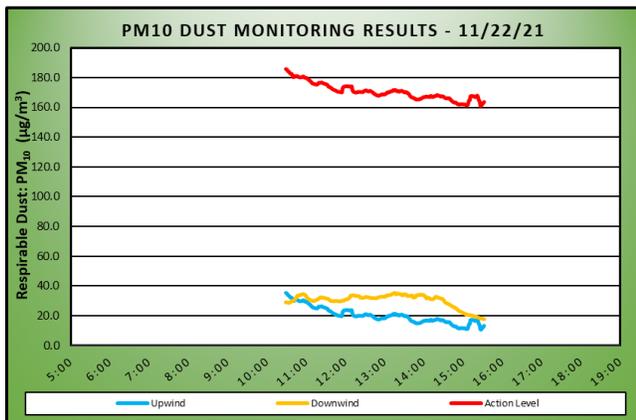
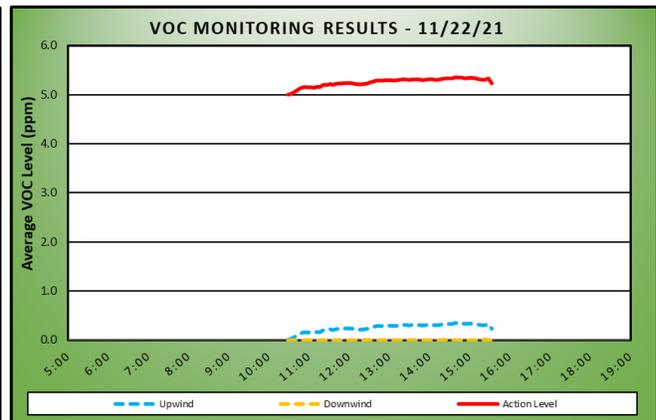
Data was not collected until 10:14 AM due to inclement weather. No particulate or organic vapor exceedances at the downwind station were encountered. The daily Community Air Monitoring Program (CAMP) monitoring results are also presented in the following charts:

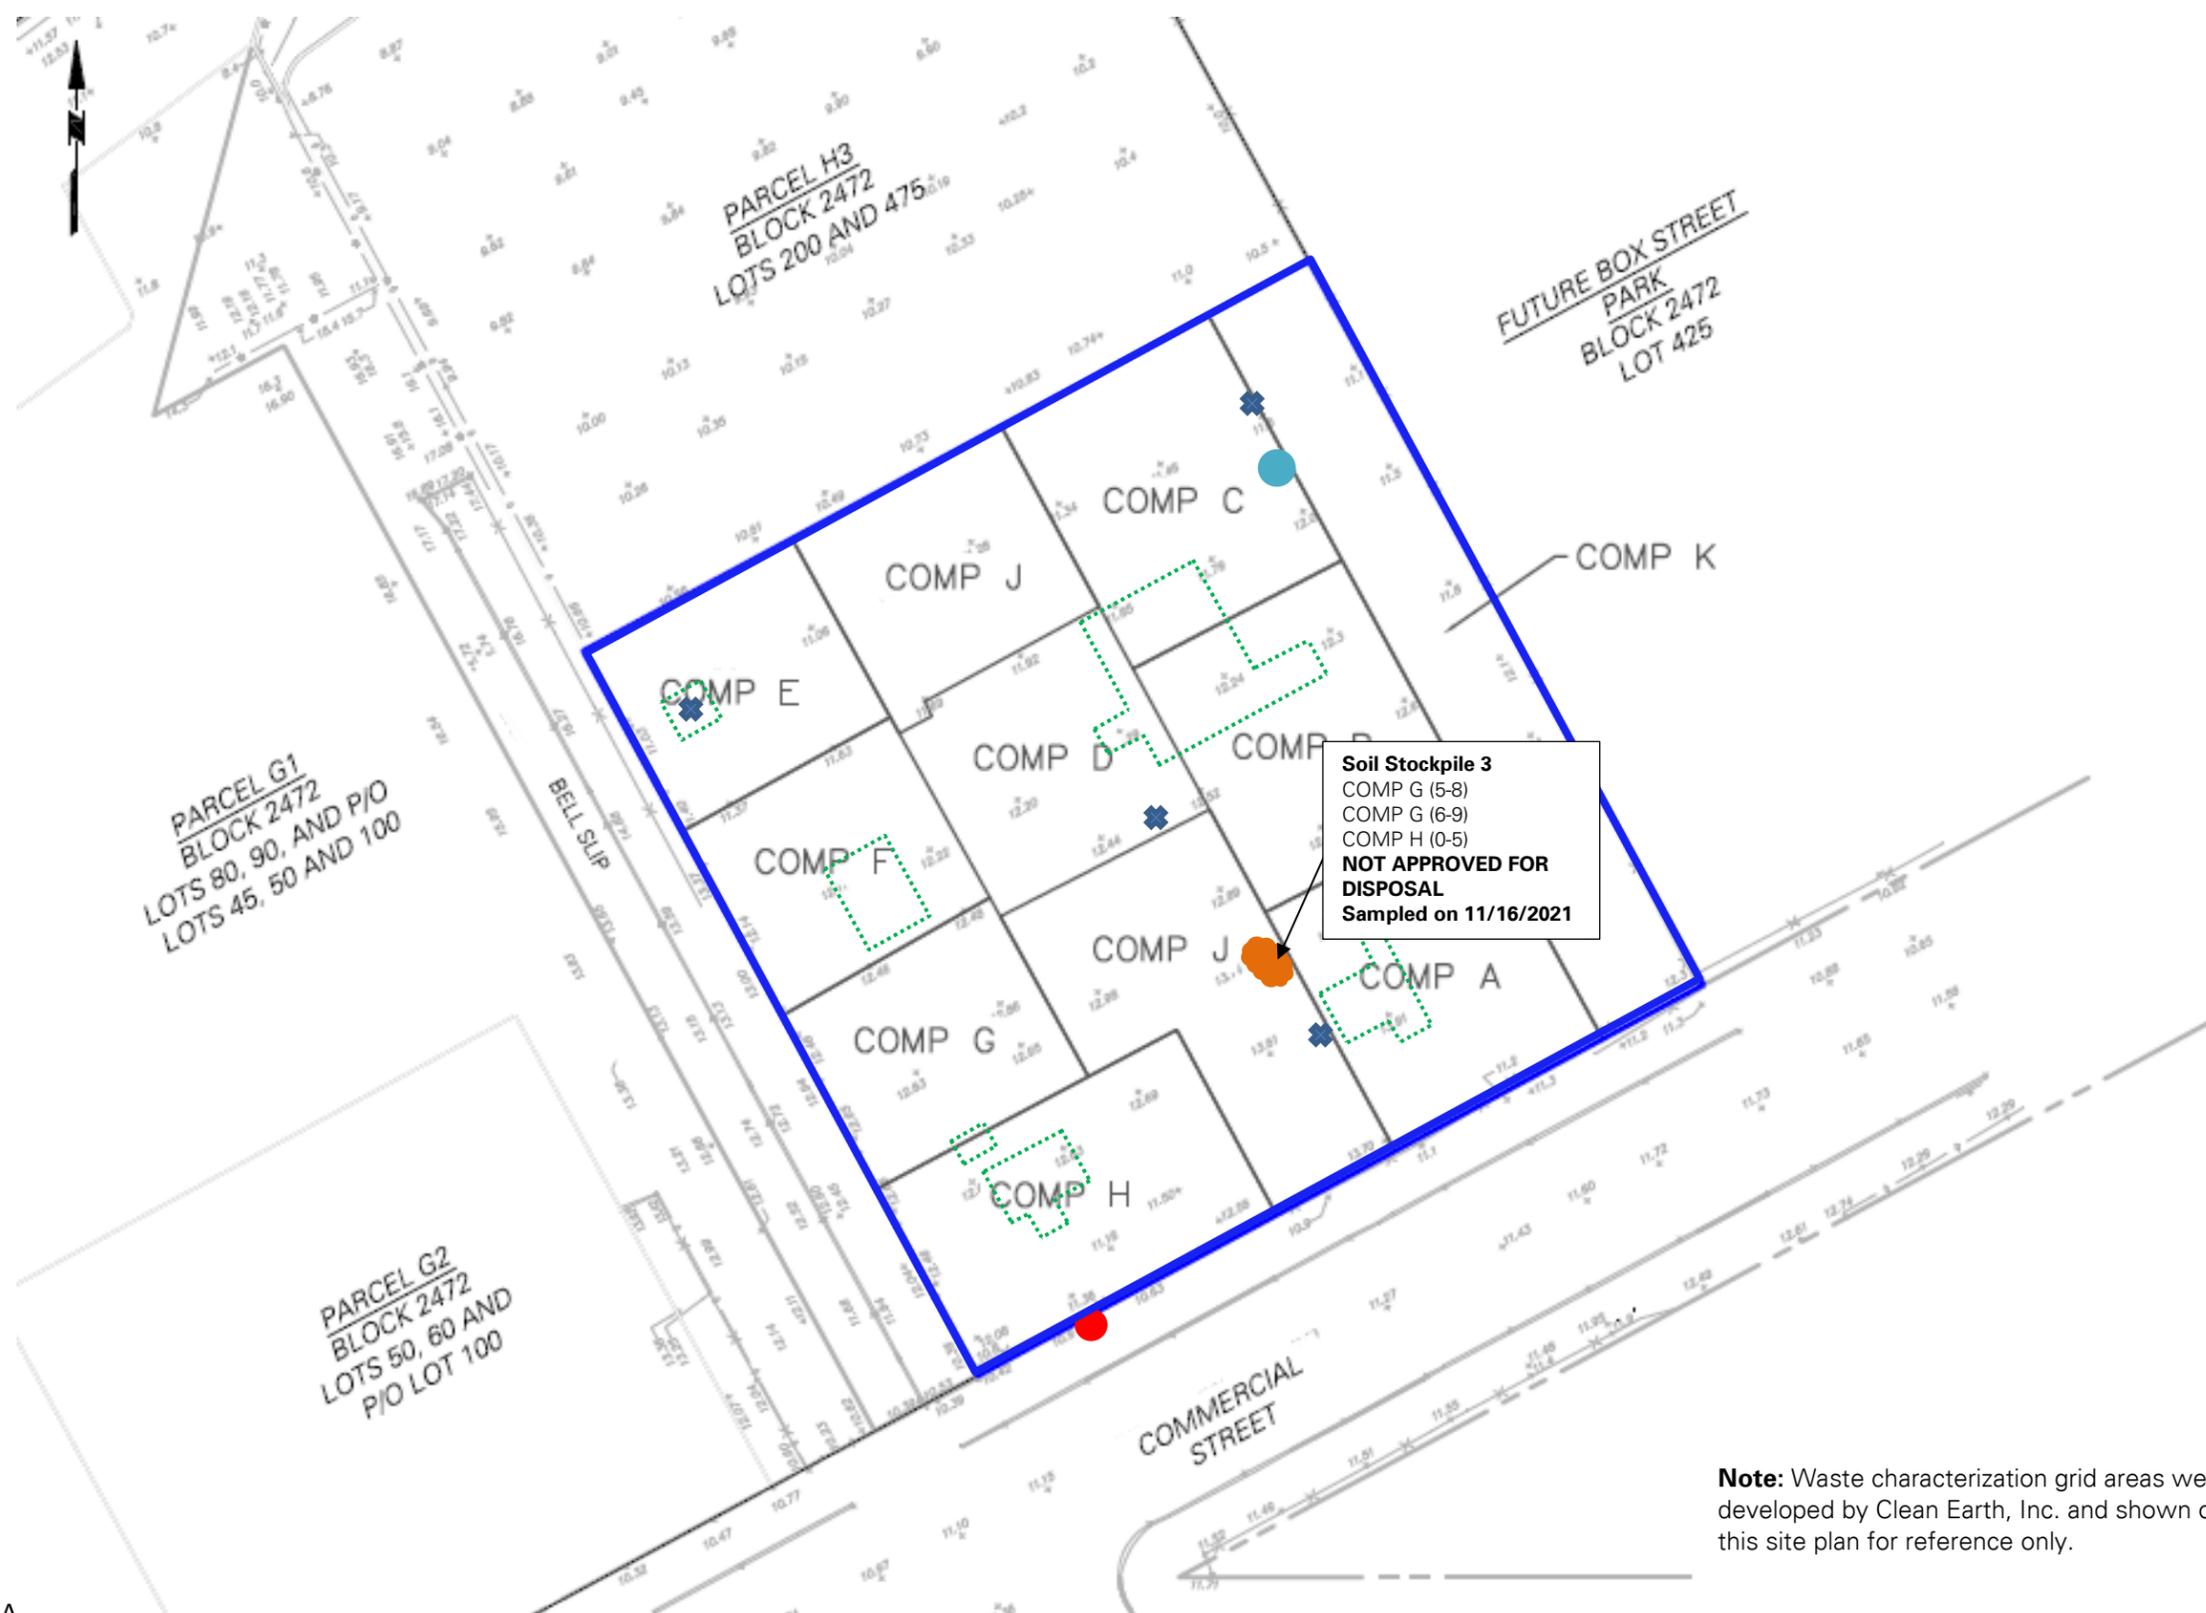
SITE PLAN

- STNY loaded trucks with soil¹ stockpiled in waste characterization grid COMP J South for off-site disposal to the Clean Earth of Carteret (CEC) facility located in Carteret, NJ.
- STNY repaired small tears (less than 1 inch wide) that were created when rebar was installed in waste characterization grids COMP G and COMP H. Tears were repaired using vapor barrier membrane (Stego® Wrap 20 Mil) and Stego® Tape.

- The following soil/fill was exported from the site:
 - Four loads of non-native soil was transported to the CEC facility located in Carteret, NJ
- No material was imported to the site.

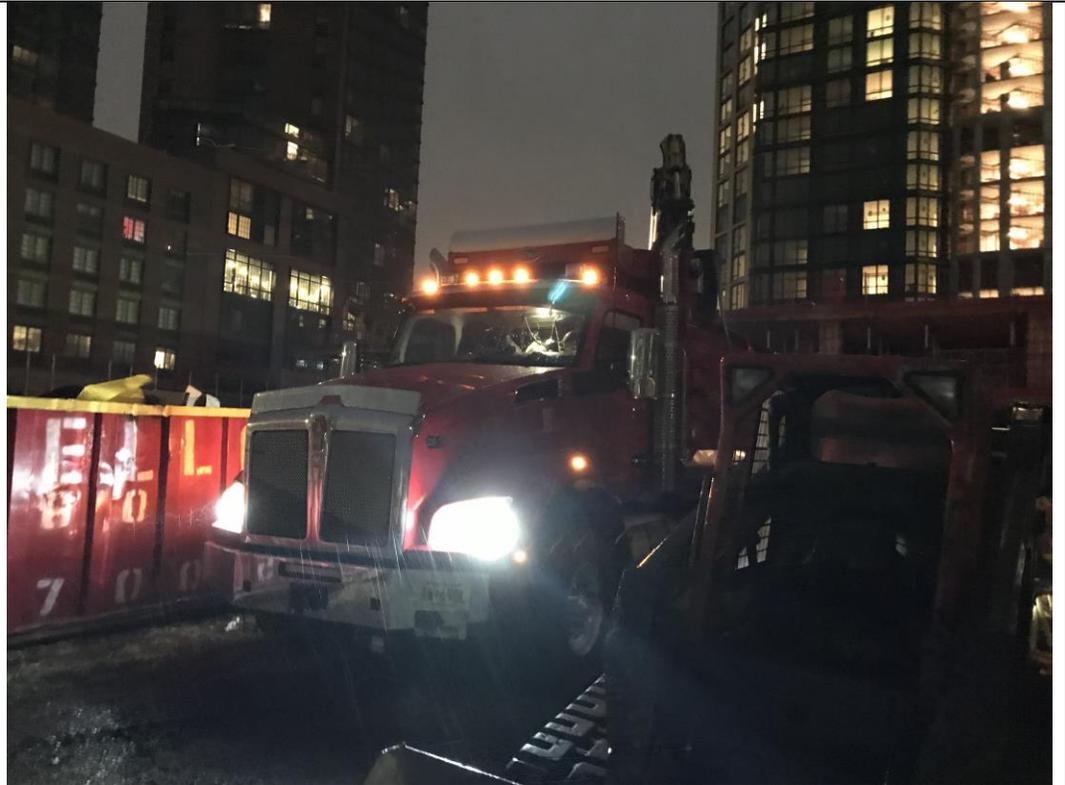
Photo 1:
View of STNY loading a truck with soil for off-site disposal to the CEC facility (facing northwest)

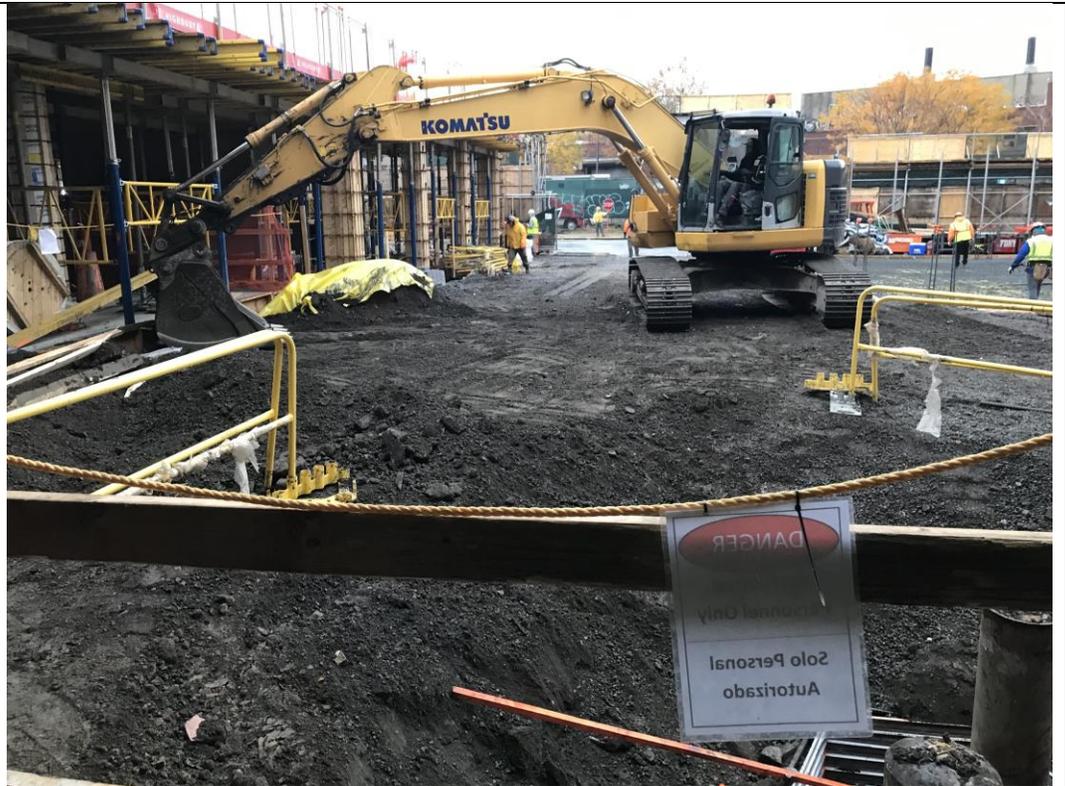
Photo 2:
View of COMP J south after the soil stockpile¹ was exported off site (facing south)

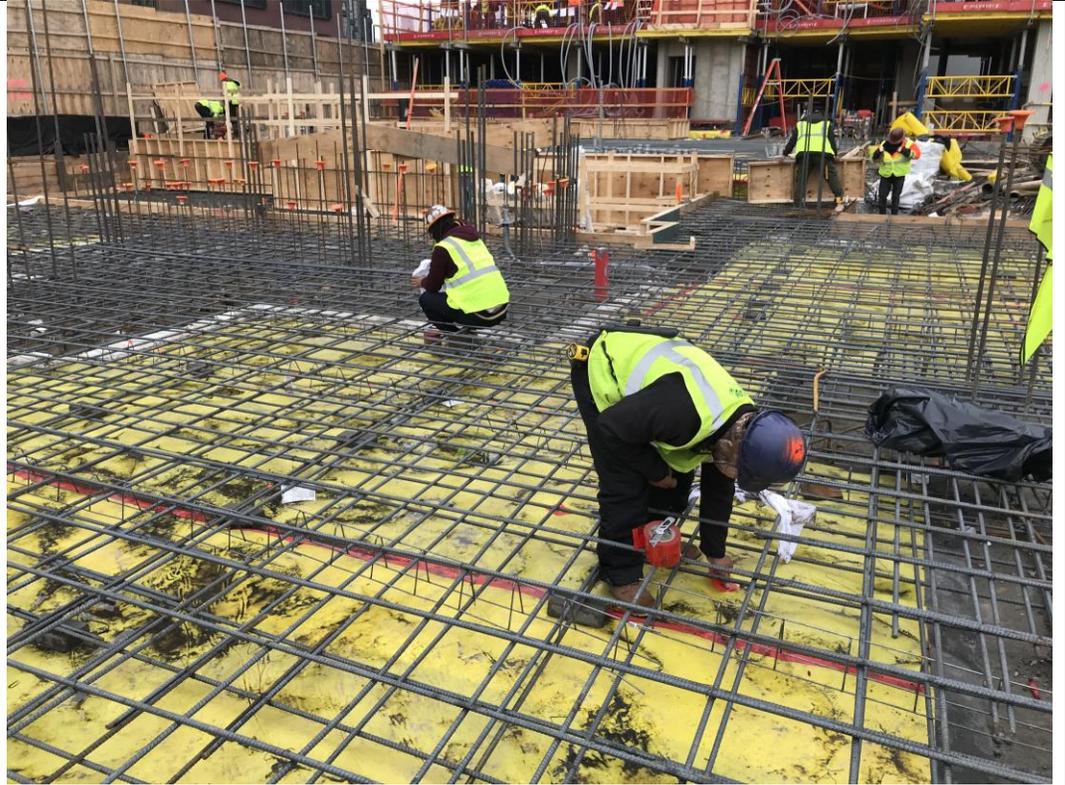
Photo 3:
View of STNY repairing
small tears in the vapor
barrier membrane (Stego®
Wrap 20 Mil) (facing north)

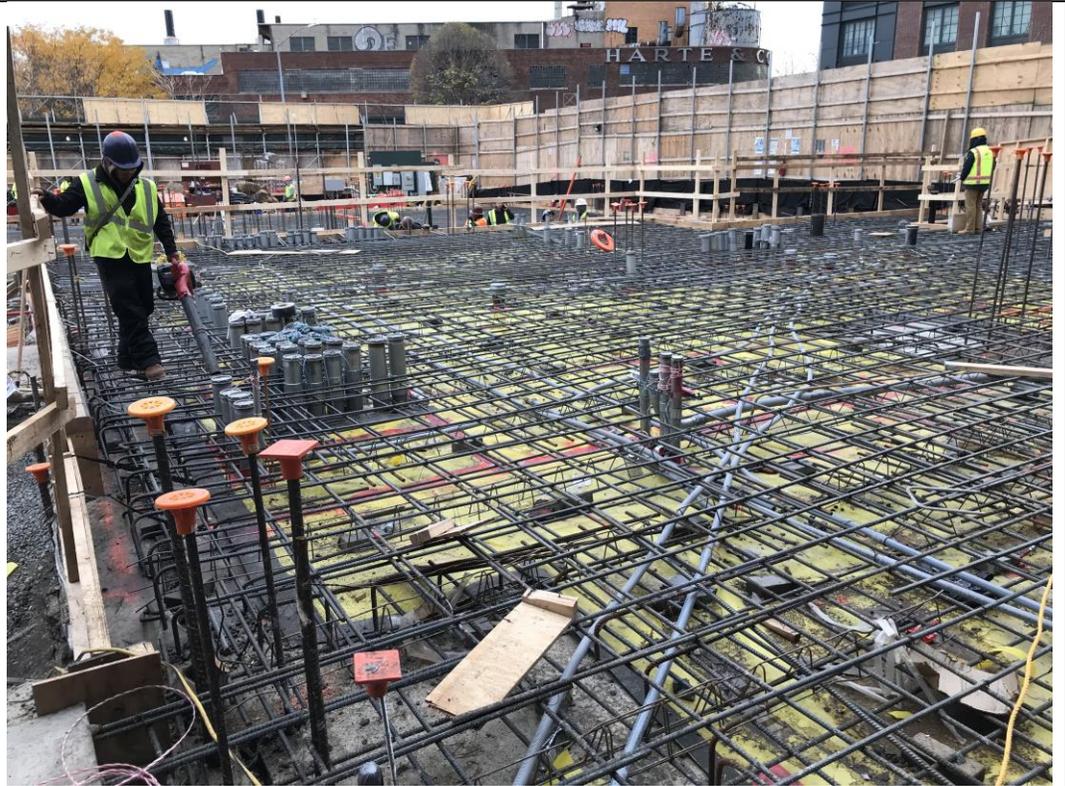
Photo 4:
View of STNY cleaning the
vapor barrier membrane
(facing south)

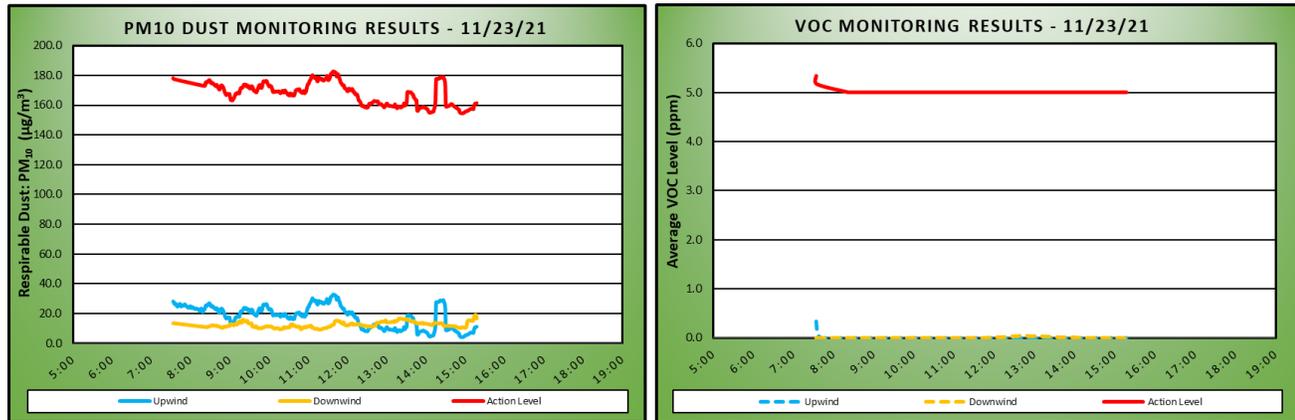
No data was collected from the downwind station from 7:36 am until 8:07 am due to the battery getting unplugged from the station while work was performed near the station, the station was reconnected at 8:06 am. No particulate or organic vapor exceedances at the downwind station were encountered. The daily Community Air Monitoring Program (CAMP) monitoring results are also presented in the following charts:

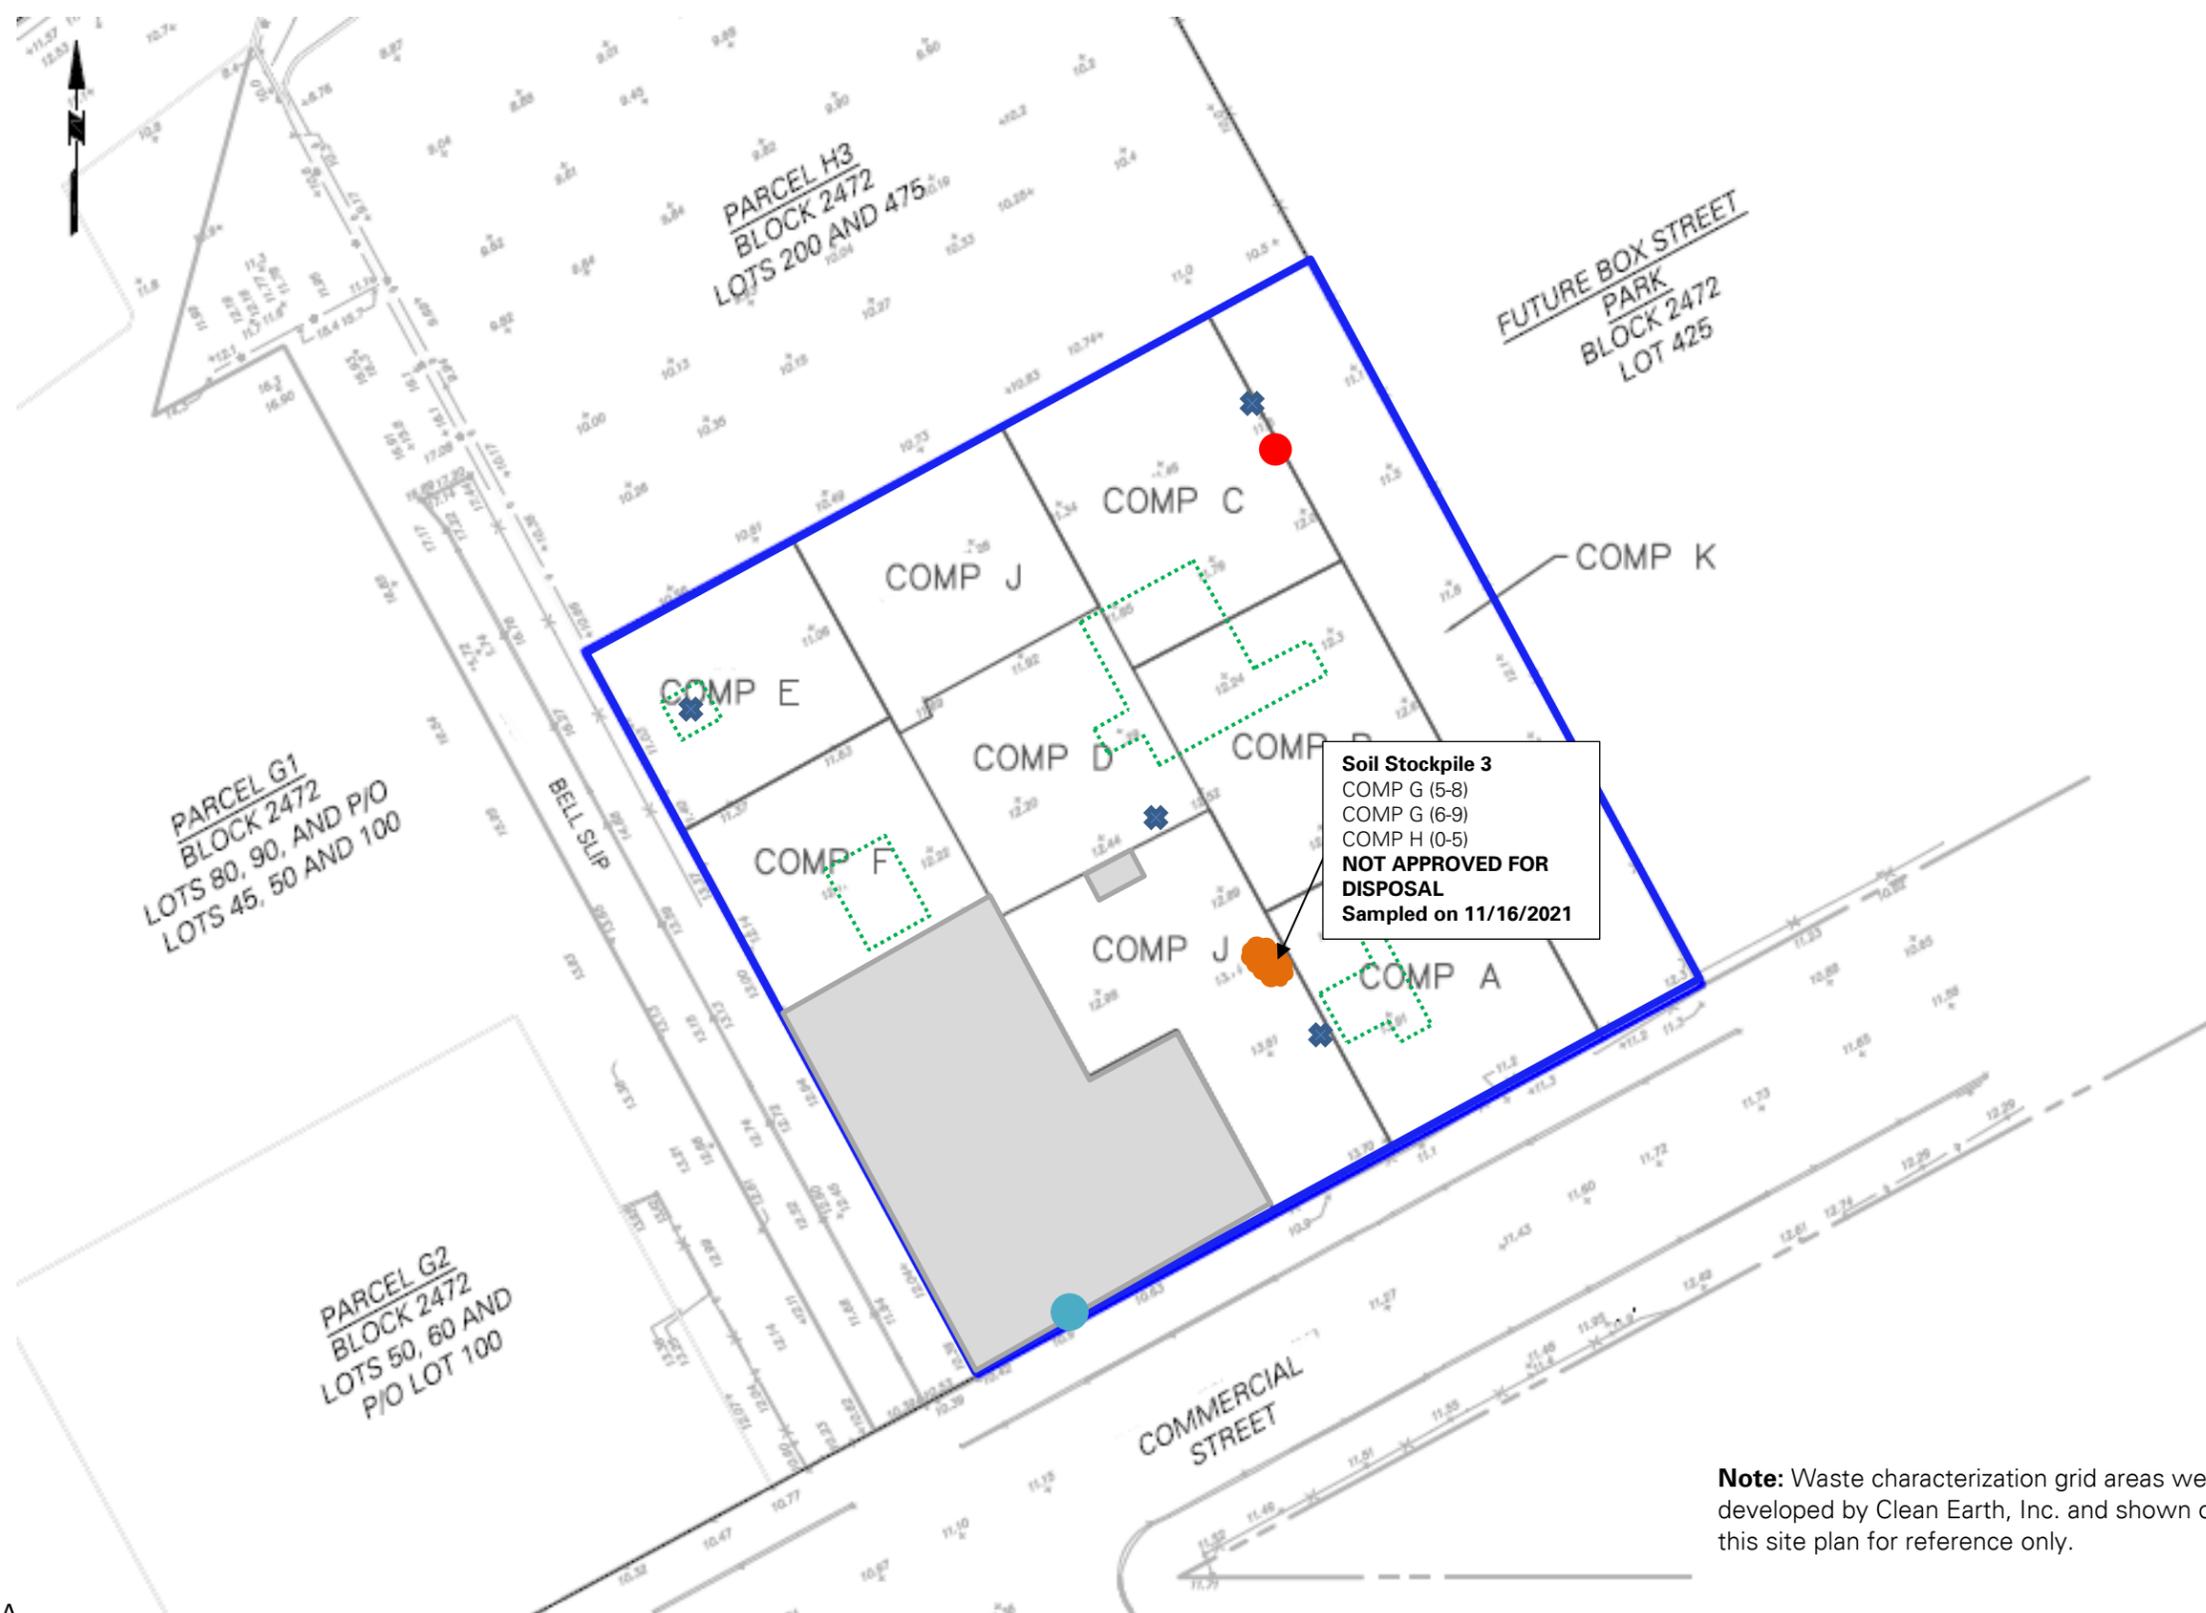
SITE PLAN

- STNY sealed pipe penetrations through the vapor barrier membrane in waste characterization grid COMP G using vapor barrier membrane (Stego ® Wrap 20 Mil) and Stego® Tape.
- STNY poured concrete for the building foundation slab in waste characterization grids COMP H and COMP G.
- STNY poured concrete for the hoist bed in waste characterization grid COMP J South.

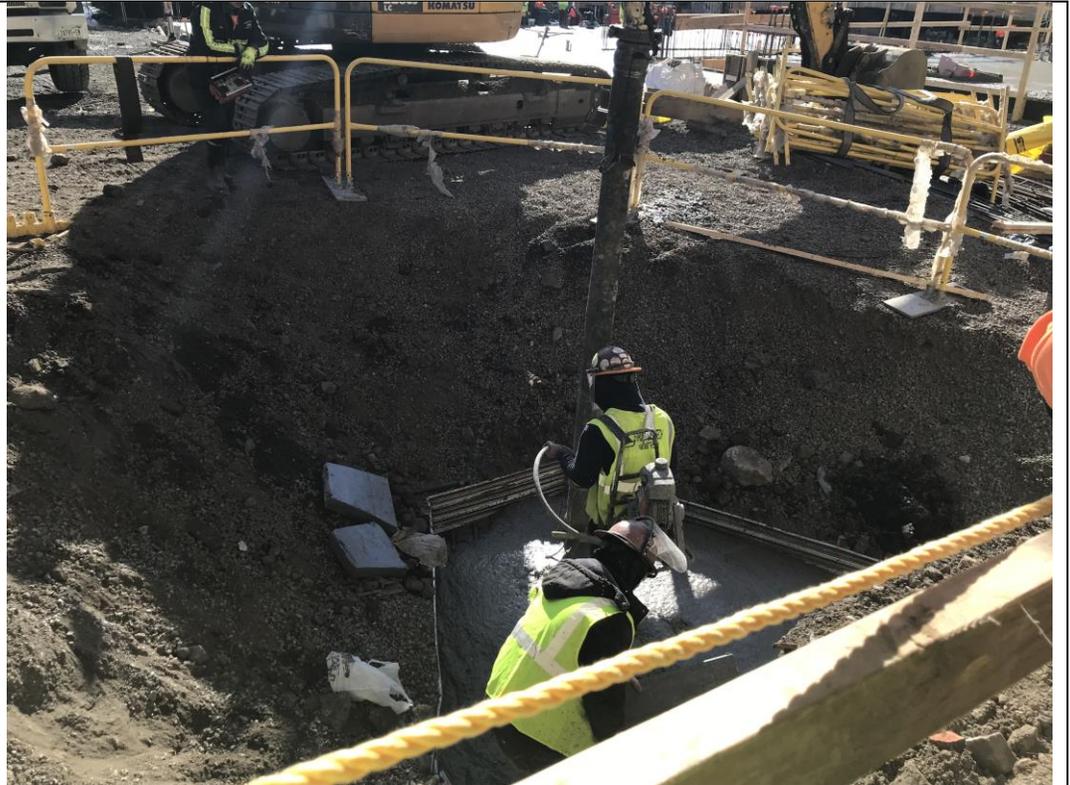
Photo 1:

View of STNY pouring concrete for the hoist bed in waste characterization grid COMP J South (facing northwest)

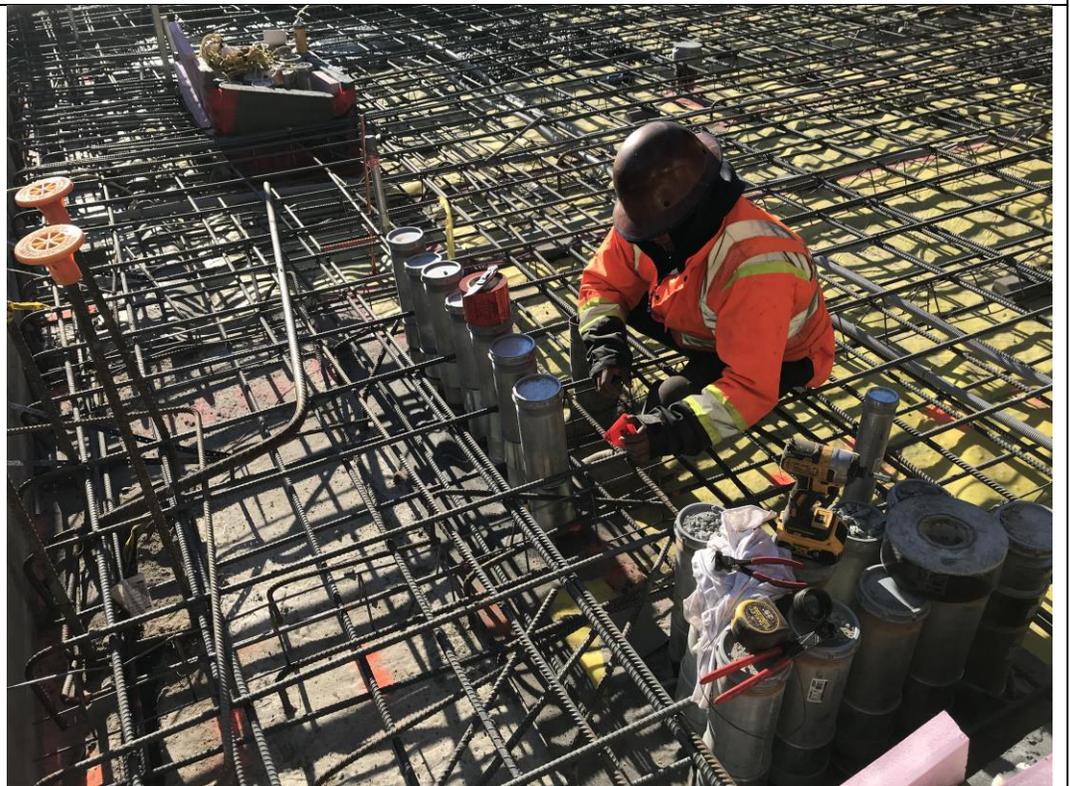
Photo 2:

View of STNY sealing pipe penetrations through the vapor barrier membrane (Stego® Wrap 20 Mil) before concrete pour in waste characterization grid COMP G (facing southwest)

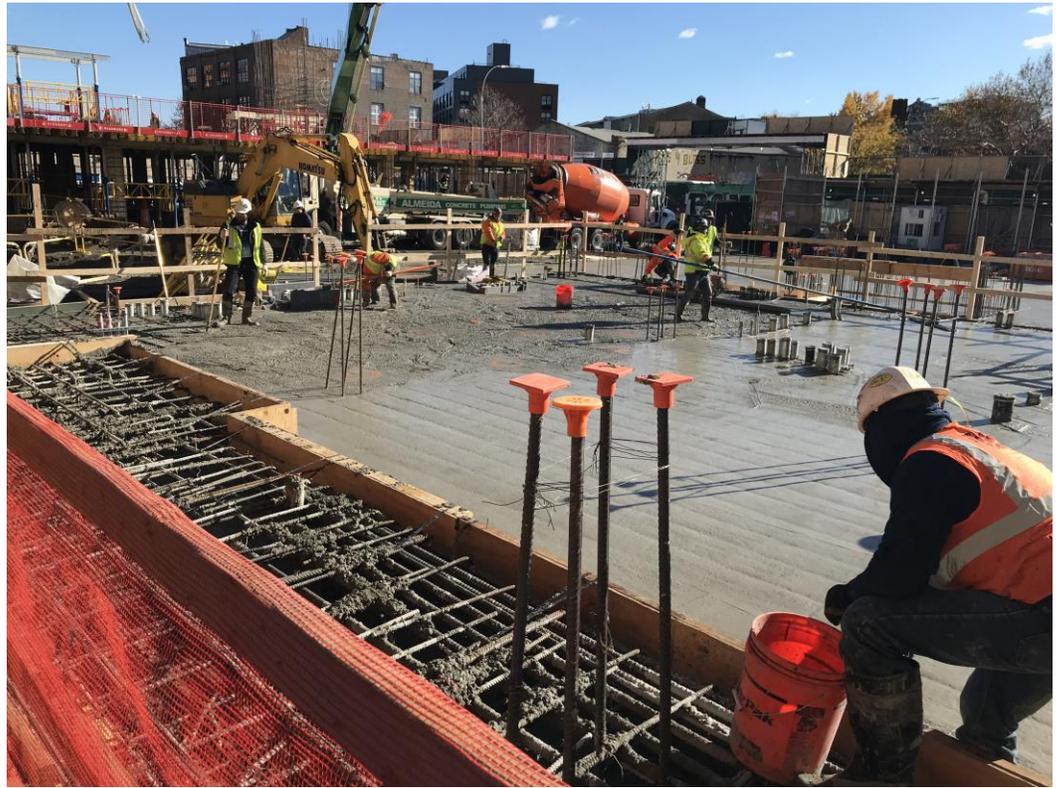
Photo 3:

View of STNY pouring concrete for foundation slab in waste characterization grid COMP G (facing southeast).

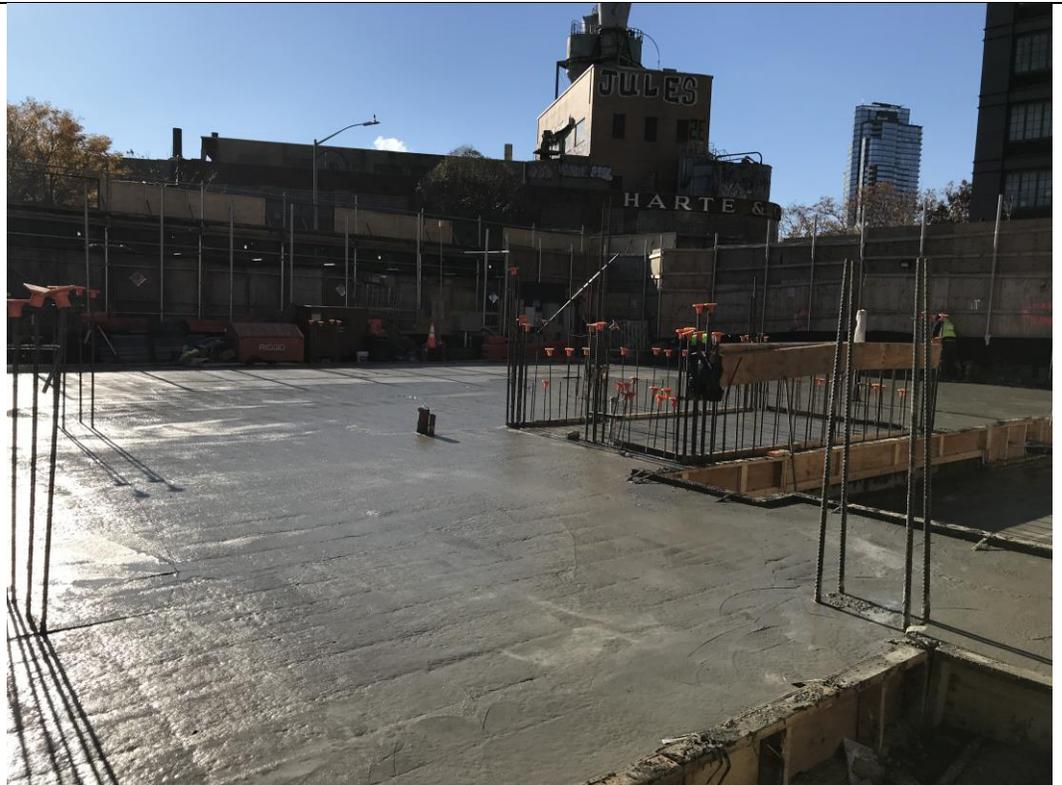
Photo 4:

View of poured foundation slab concrete in waste characterization grid COMP H (facing northwest)

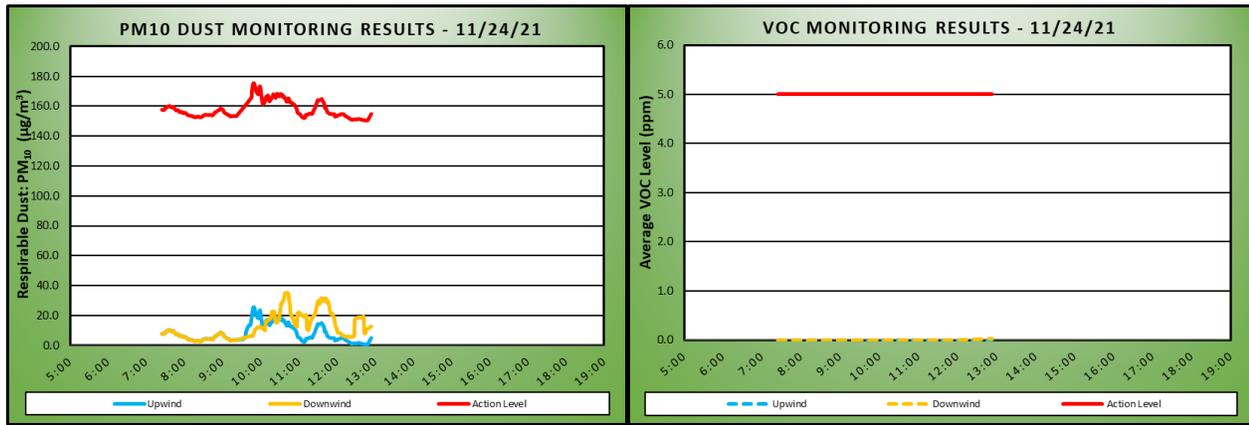
No particulate or organic vapor exceedances at the downwind station were encountered. The daily Community Air Monitoring Program (CAMP) monitoring results are also presented in the following charts:

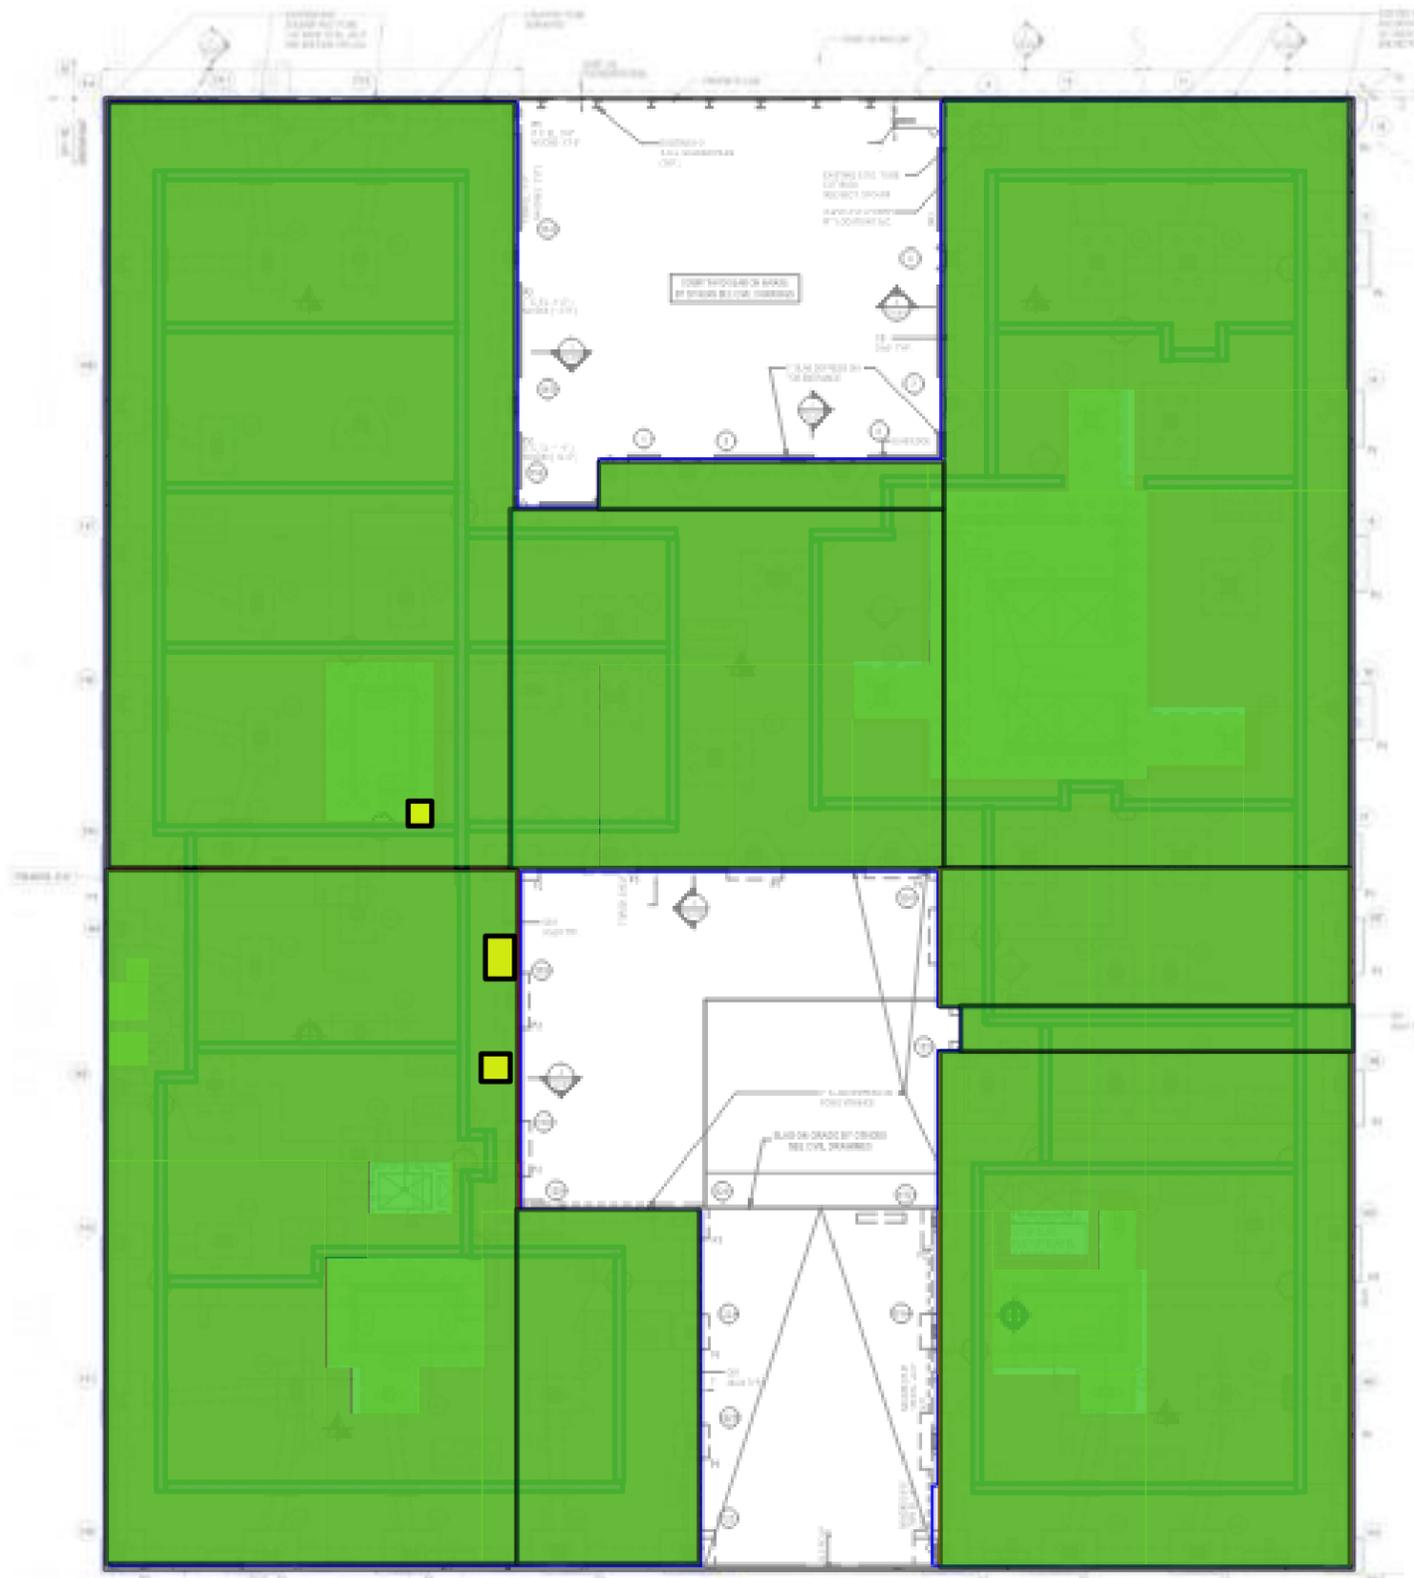
WATERPROOFING/VAPOR BARRIER AND SMD INSTALLATION MAP

Concrete Foundation Slab Poured

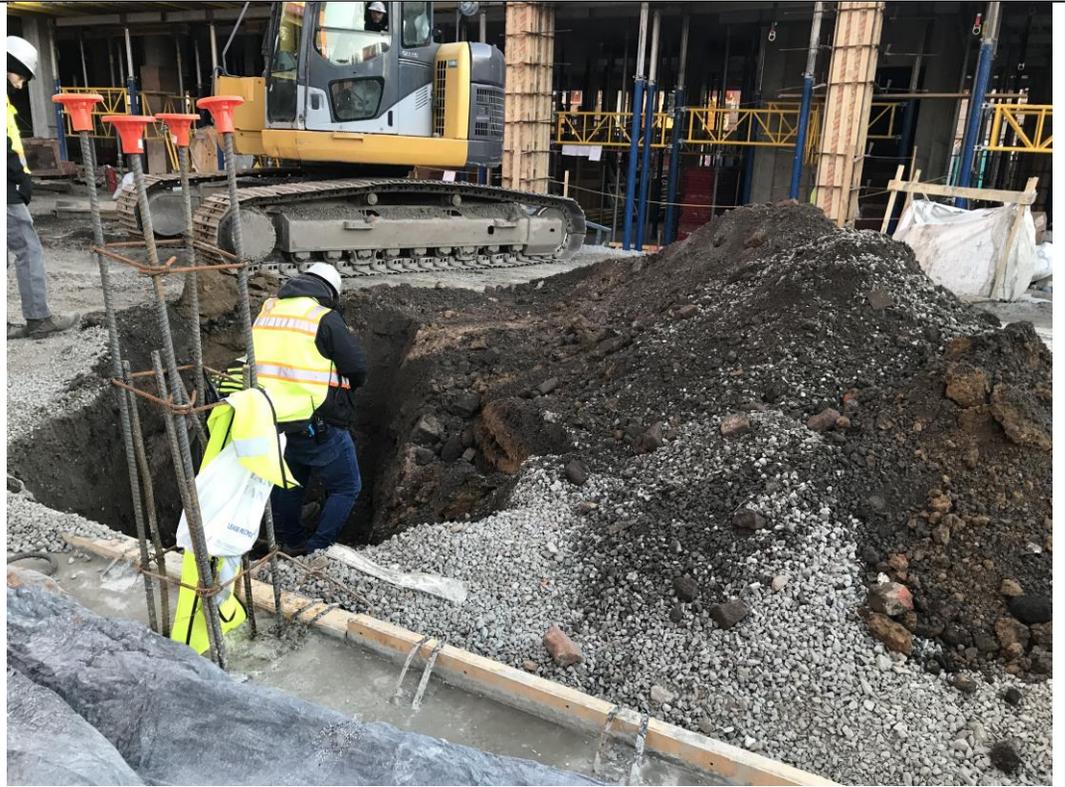
Photo 1:

- STNY excavated the following areas of the site.
 - An about 12-foot-long by 2-foot-wide area to a maximum depth of 5 foot below grade surface (bgs) to repair utility piping in waste characterization grid COMP J South. Excavated material consisted of imported 0.75-inch stone and non-native soil that did not exhibit signs of chemical- or petroleum-like contamination. Imported stone and soil were not comingled and were temporarily stockpiled adjacent to the excavation. Following the utility repair, the excavated stone and soil were used to backfill the trench in the same locations and depths they were excavated from.

View of STNY excavating in waste characterization grid COMP J South to repair utility pipes (facing northeast).

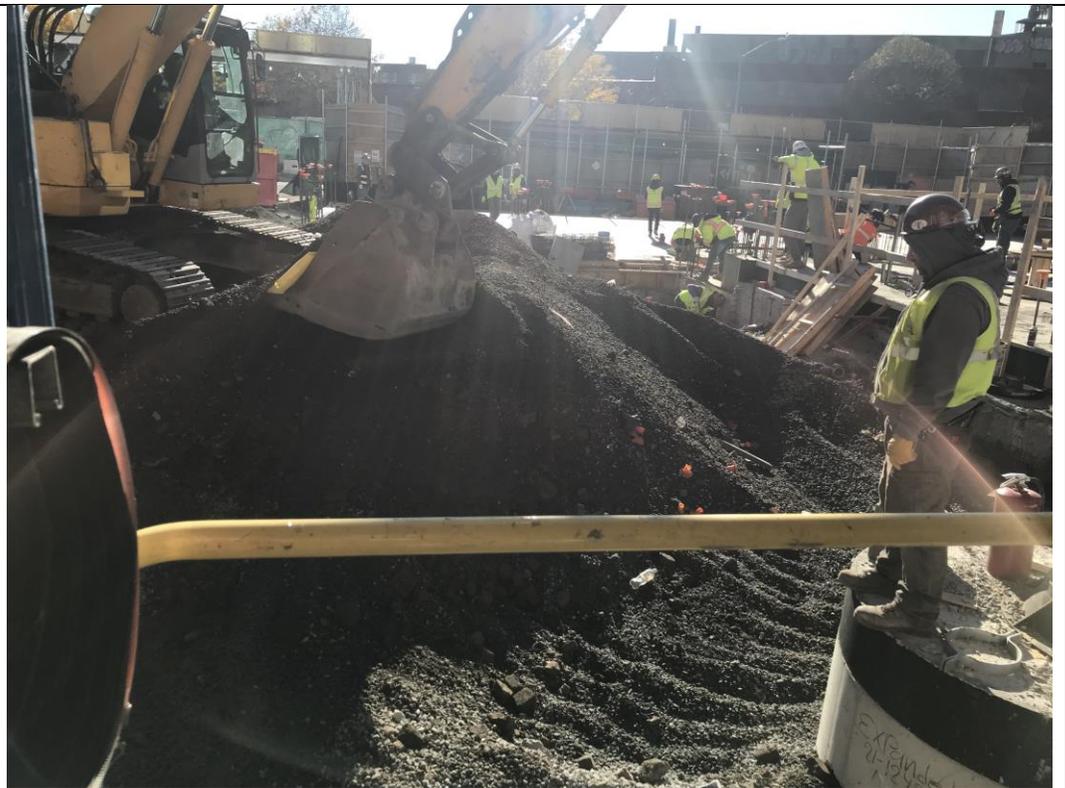
Photo 2:

- An about 25-foot-long by 17-foot-wide area to a maximum depth of 5 feet bgs to install plumbing utilities in waste characterization grid COMP J South. Excavated material consisted of imported 0.75-inch stone that did not exhibit signs of chemical- or petroleum-like contamination. The 0.75-inch stone was stockpiled adjacent to the excavation in waste characterization grid COMP J South in preparation for future backfill on-site.

View of STNY excavating in waste characterization grid COMP J South to install plumbing utilities (facing south).

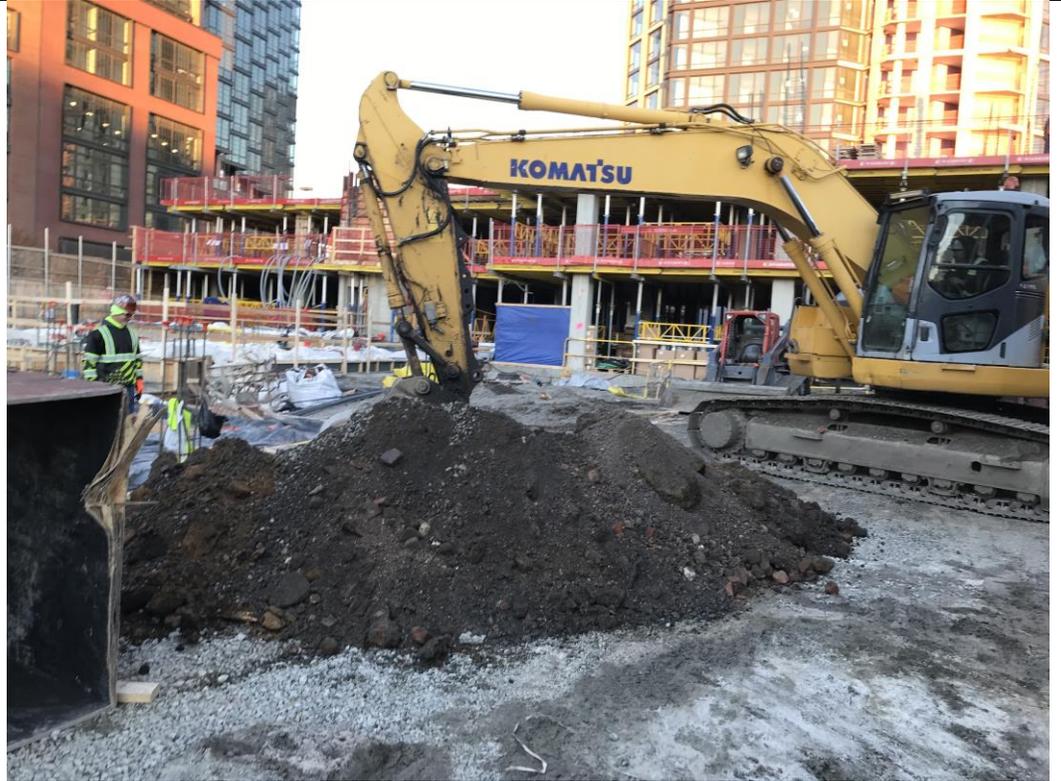
Photo 3:

View of excavated non-native soil stockpiled in waste characterization COMP J South (facing north).

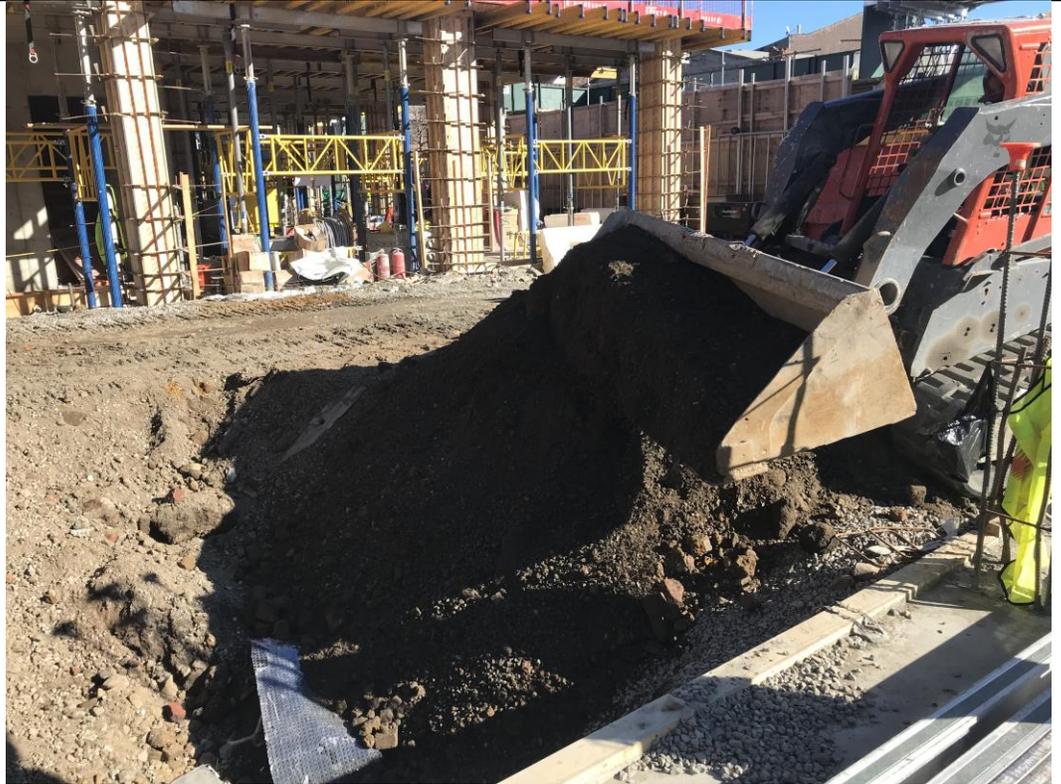
Photo 4:

View of STNY backfilling the utility excavation in waste characterization grid COMP J South (facing southeast).
