**DAILY FIELD REPORT 101**

<b>BCP Project No:</b>	C224304	<b>Date:</b>	November 29, 2021
------------------------	---------	--------------	-------------------

<b>Project Name:</b>	45 Commercial Street	<b>Time:</b>	6:30 am to 3:45 pm
----------------------	----------------------	--------------	--------------------

<b>Consultant:</b> Langan Engineering, Environmental, Surveying, Landscape Architecture and Geology, D.P.C. (Langan)	<b>Langan Field Personnel:</b> Yaskira Mota
<b>Construction Manager:</b> Monadnock Construction Inc. (MC)	
<b>Foundation Contractor:</b> StructureTech New York, Inc. (STNY) <b>Soil Broker:</b> Clean Earth, Inc. (CE)

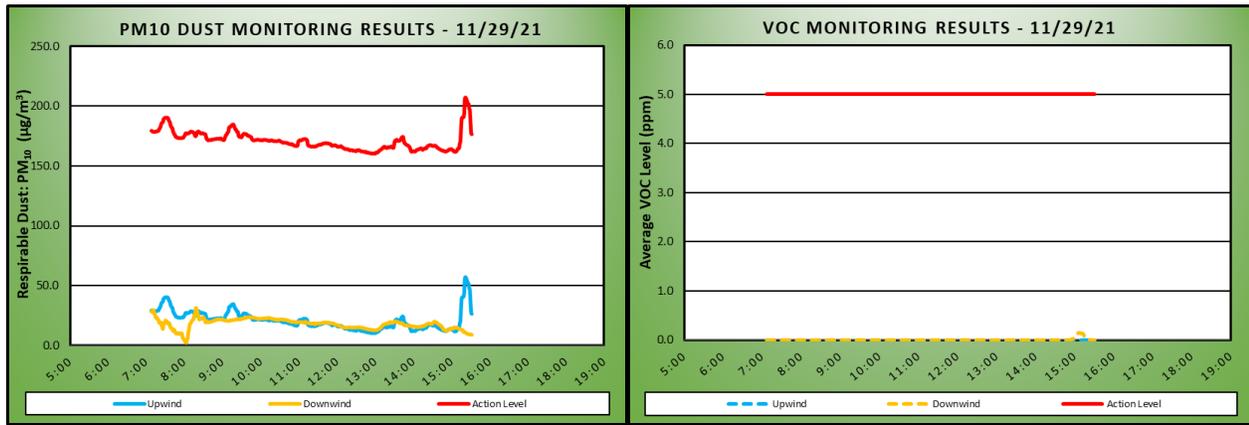
No particulate or organic vapor exceedances at the downwind station were encountered. The daily Community Air Monitoring Program (CAMP) monitoring results are also presented in the following charts:

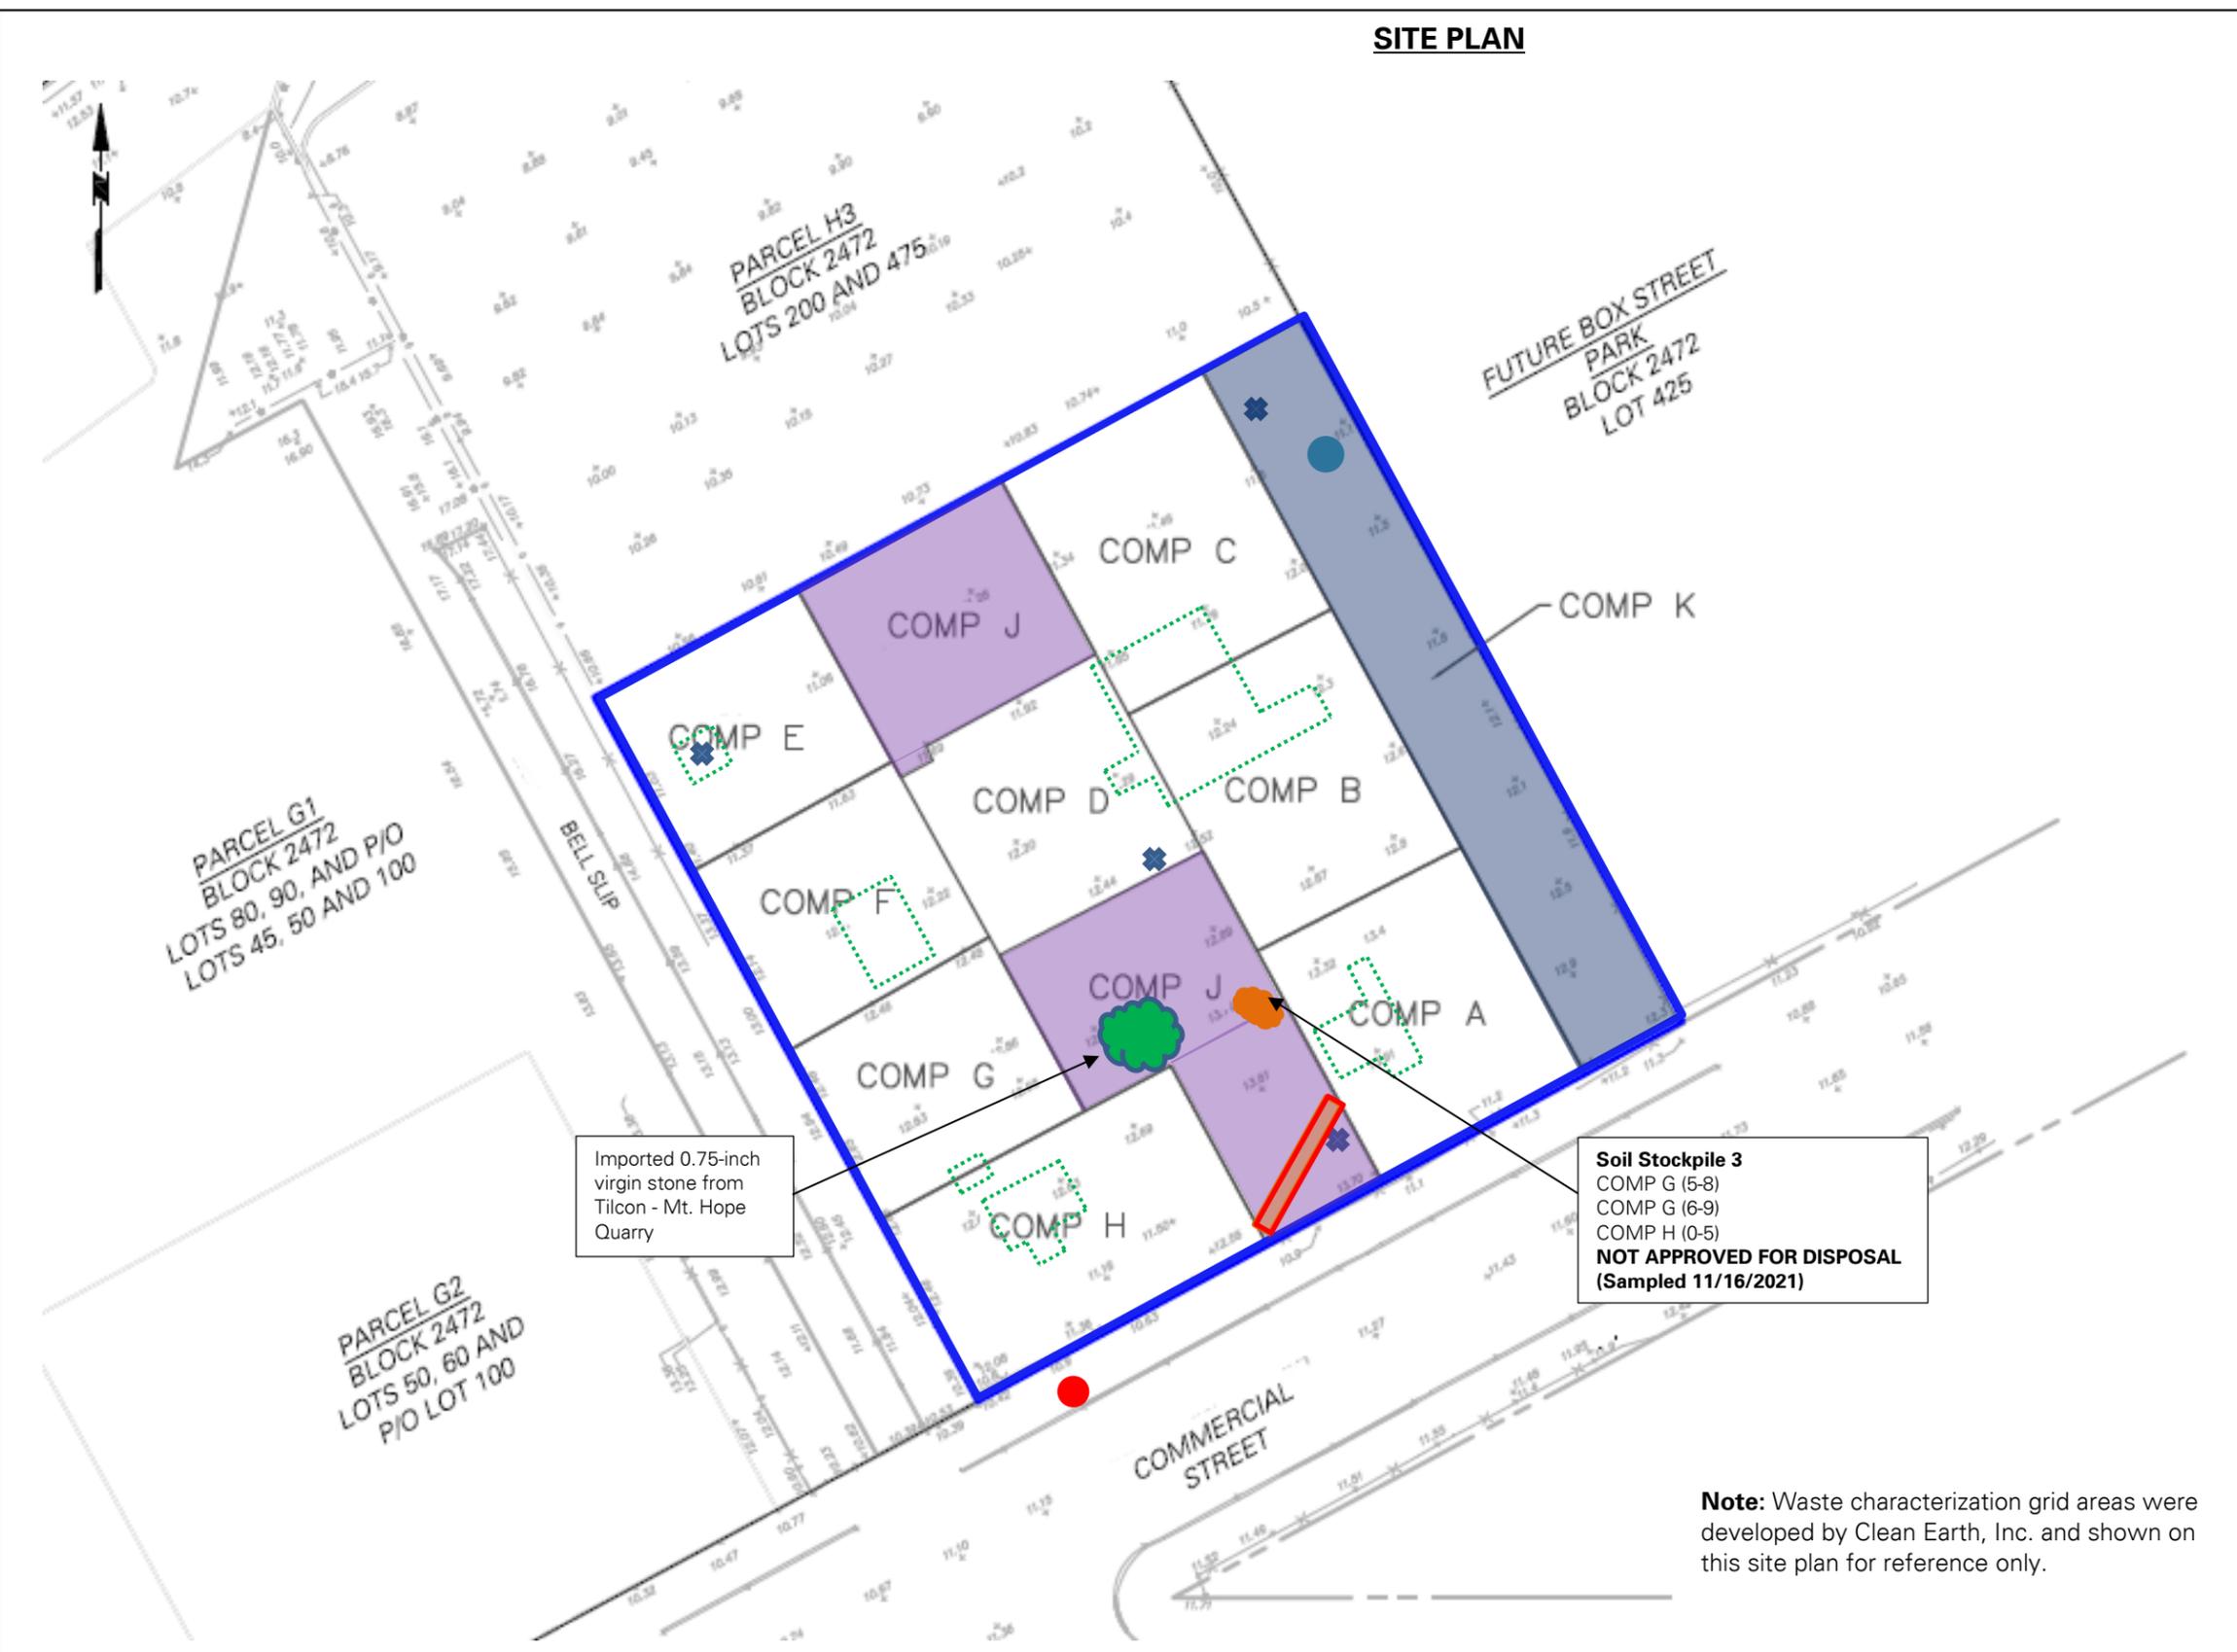
**SITE PLAN**

Imported 0.75-inch virgin stone from Tilcon - Mt. Hope Quarry

**Soil Stockpile 3**  
 COMP G (5-8)  
 COMP G (6-9)  
 COMP H (0-5)  
**NOT APPROVED FOR DISPOSAL**  
 (Sampled 11/16/2021)

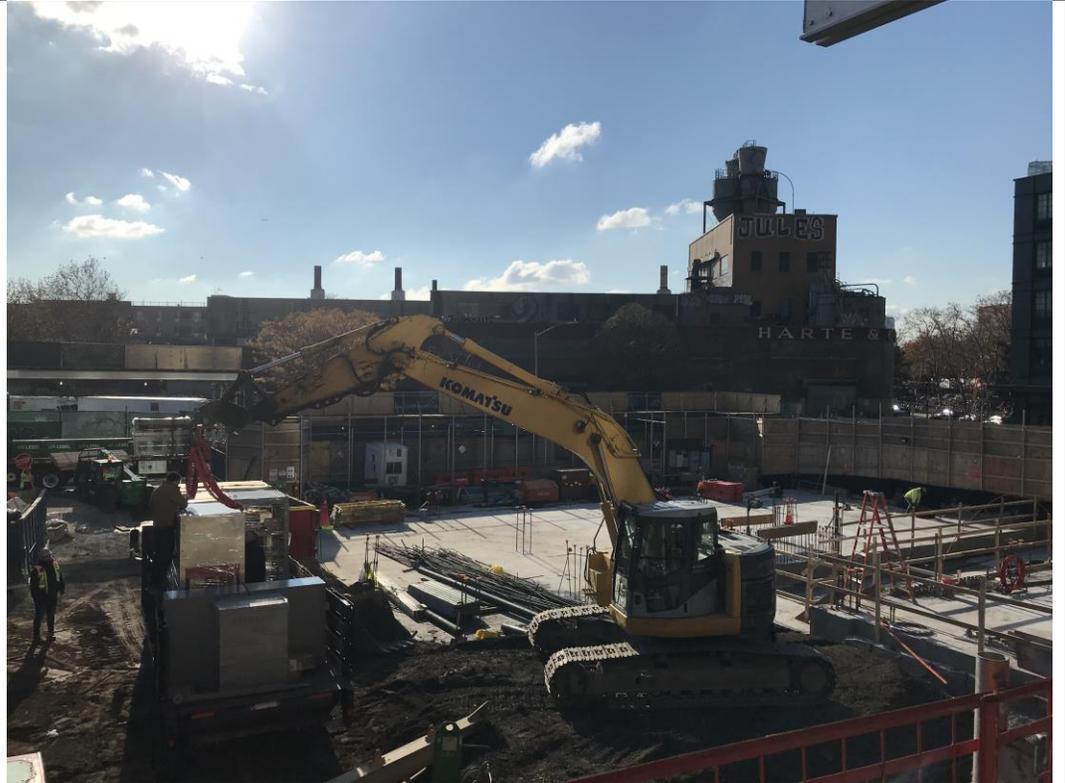
**Photo 1:**

General view of the site  
(facing southwest).

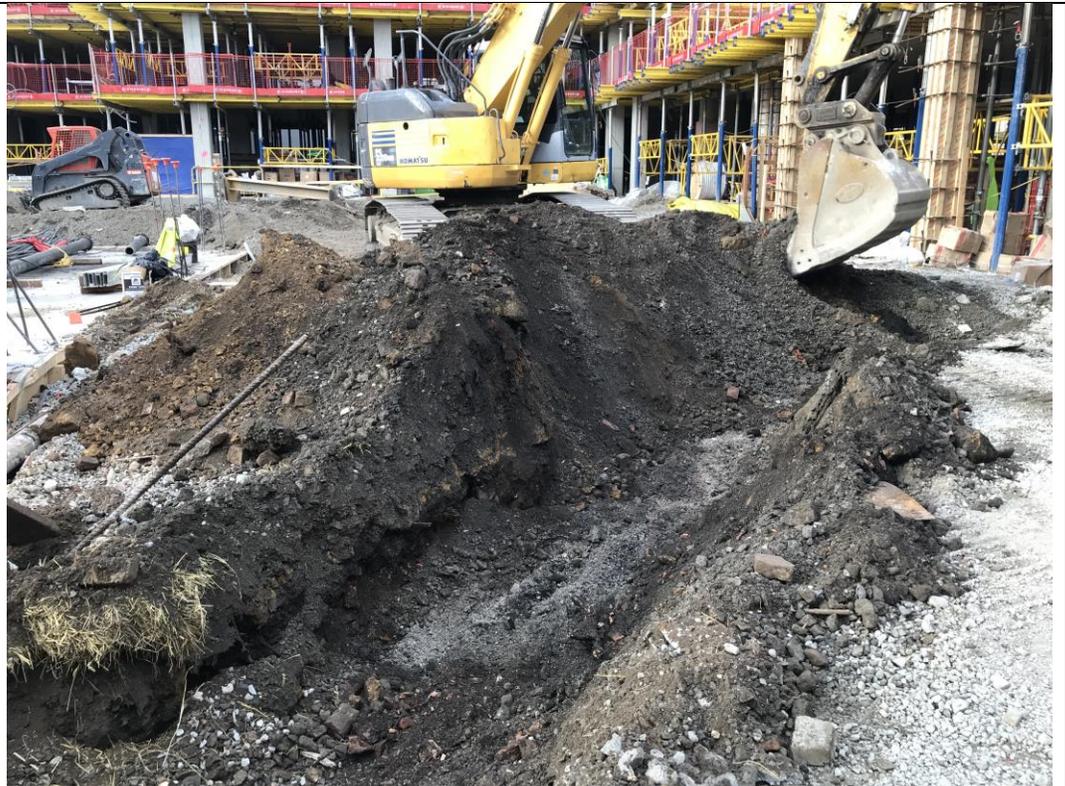
**Photo 2:**

View of STNY excavating in  
waste characterization grid  
COMP J South to install a  
temporary utility pipe  
(facing north).

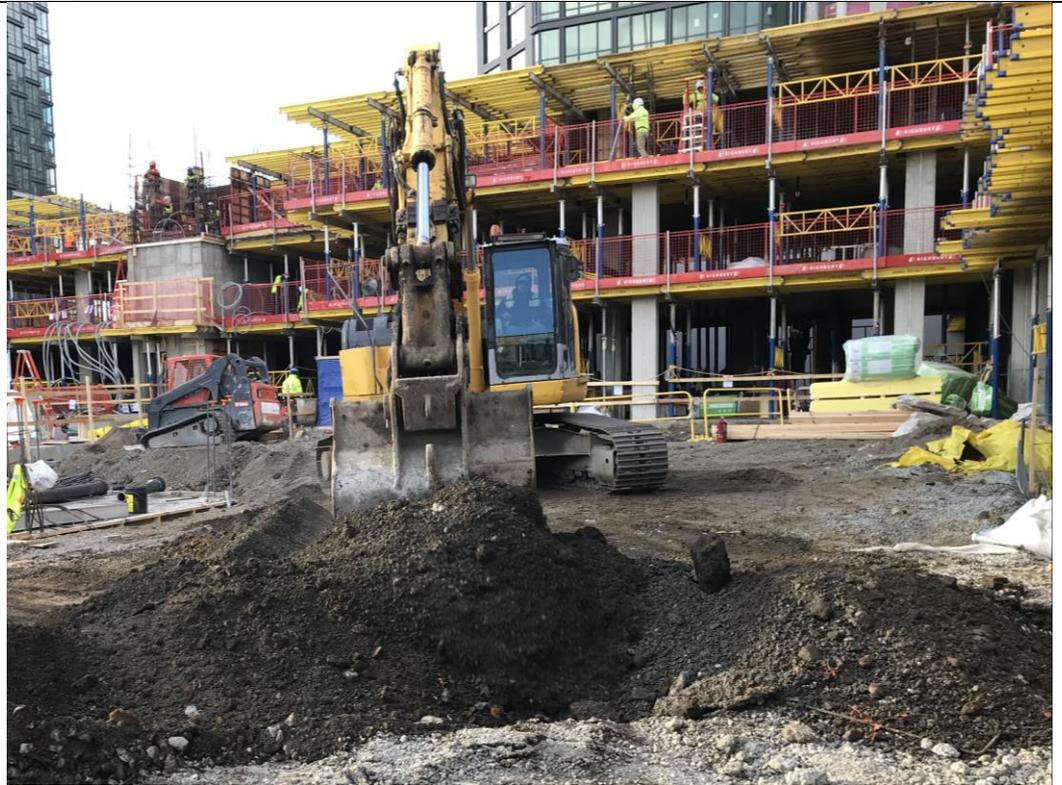
**Photo 3:**

View of STNY backfilling the utility excavation in waste characterization grid COMP J South (facing north).

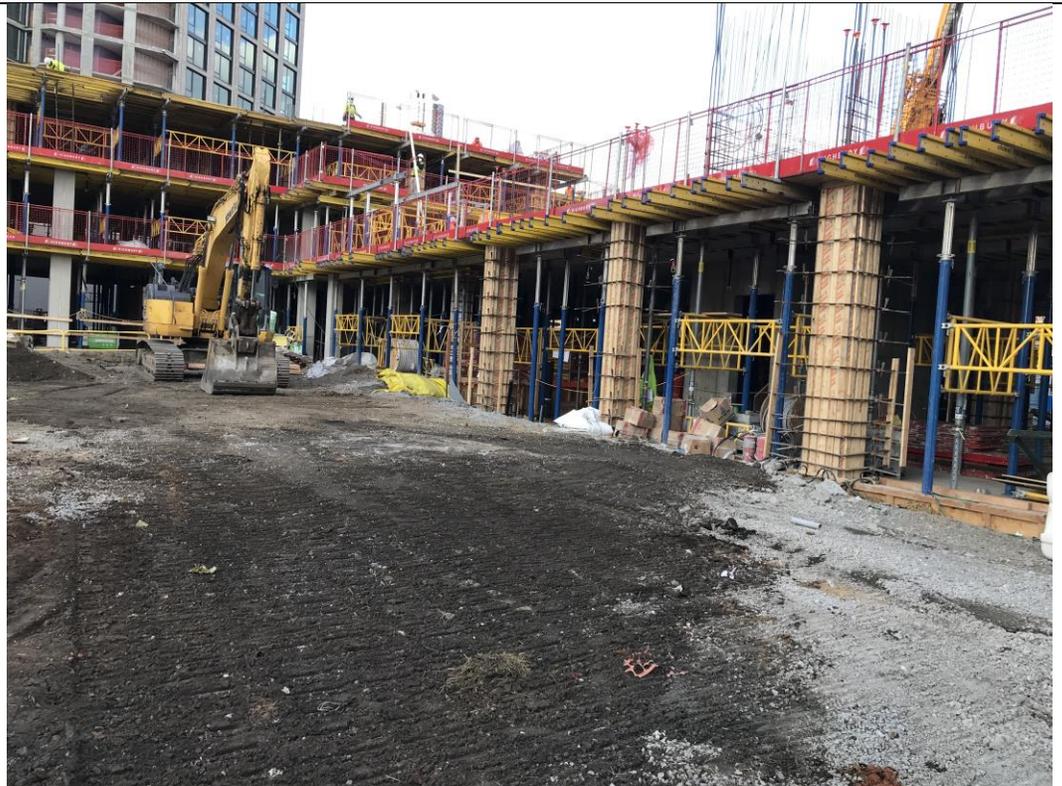
**Photo 4:**

View of waste characterization grid COMP J South at the end of the day (facing northwest).

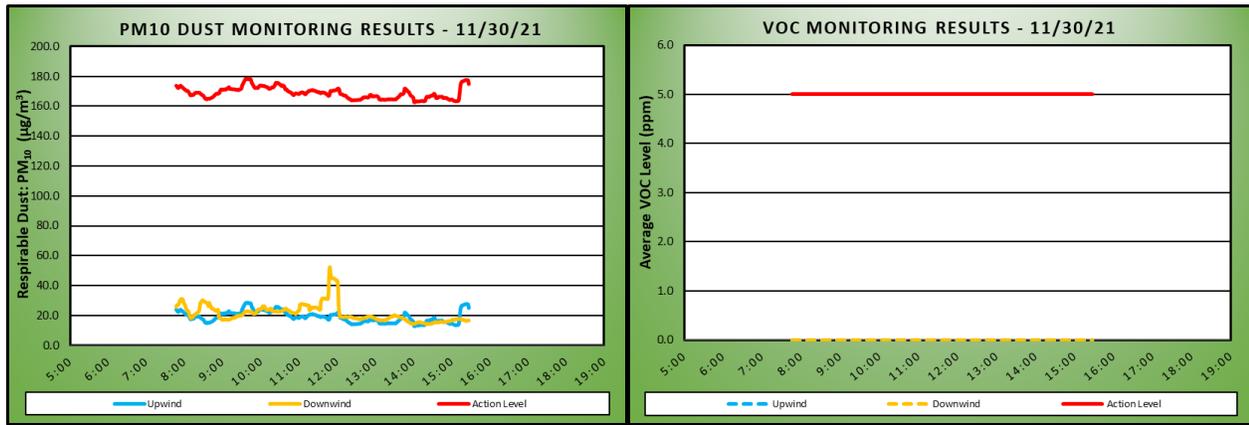
No particulate or organic vapor exceedances at the downwind station were encountered. The daily Community Air Monitoring Program (CAMP) monitoring results are also presented in the following charts:

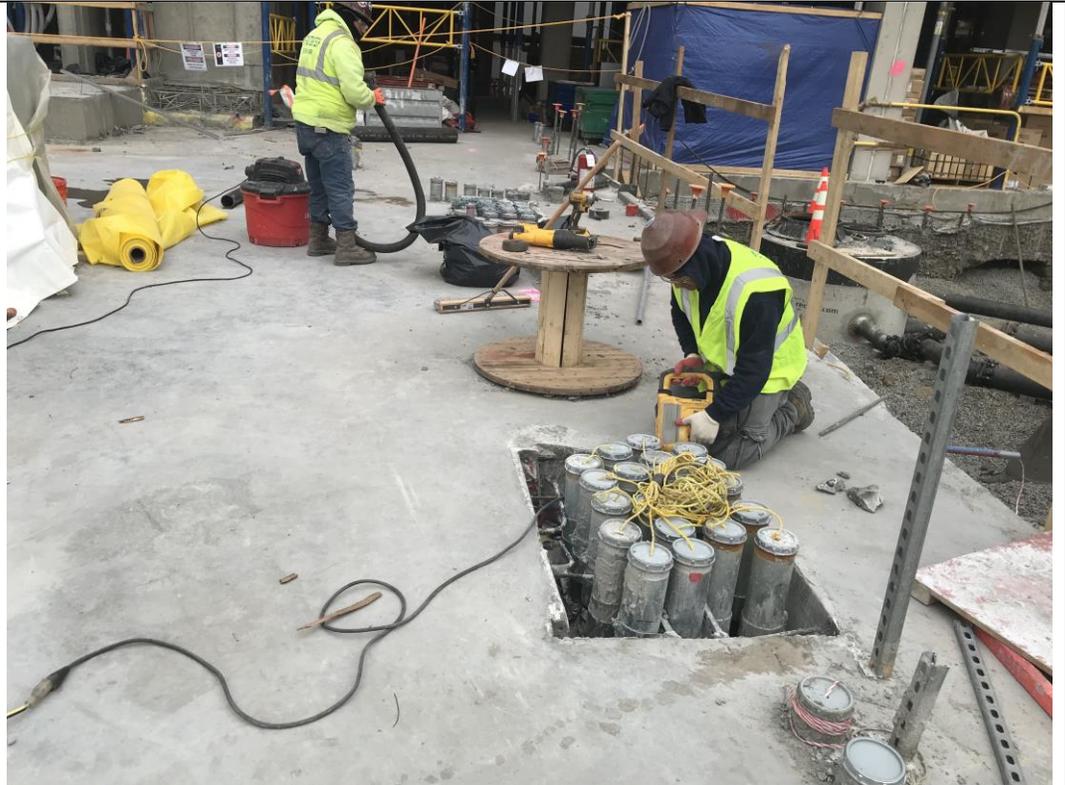
**Photo 1:**  
View of STNY preparing utility piping penetrations for liquid membrane application in waste characterization grid COMP G (facing north).

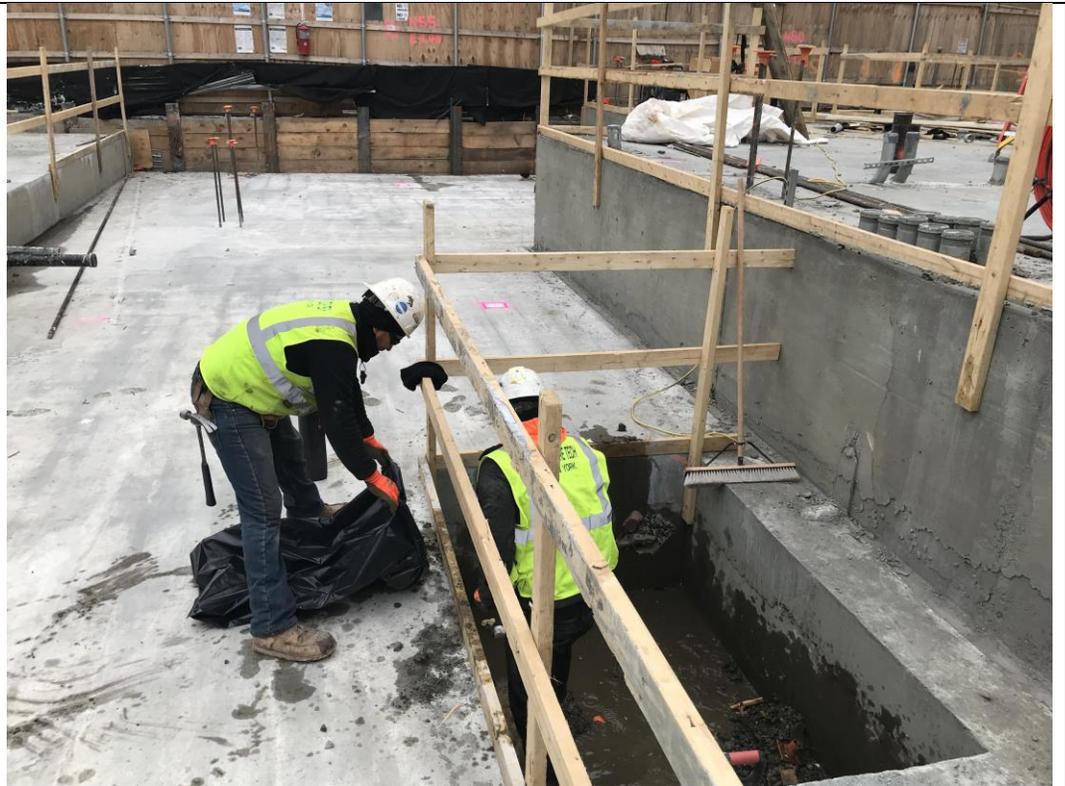
**Photo 2:**  
View of STNY cleaning a sewer ejector pit in waste characterization grids COMP H and COMP G (facing west).

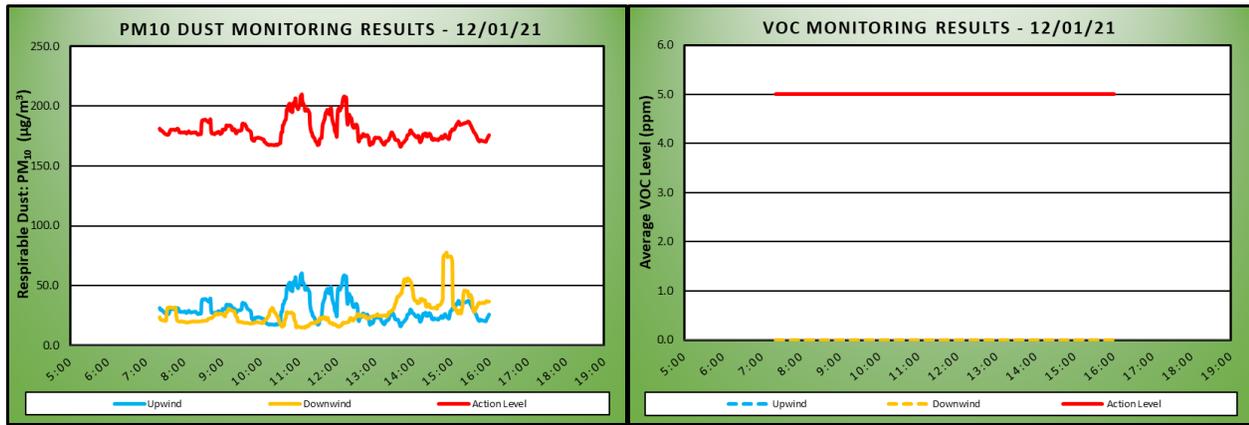
No particulate or organic vapor exceedances at the downwind station were encountered. The daily Community Air Monitoring Program (CAMP) monitoring results are also presented in the following charts:

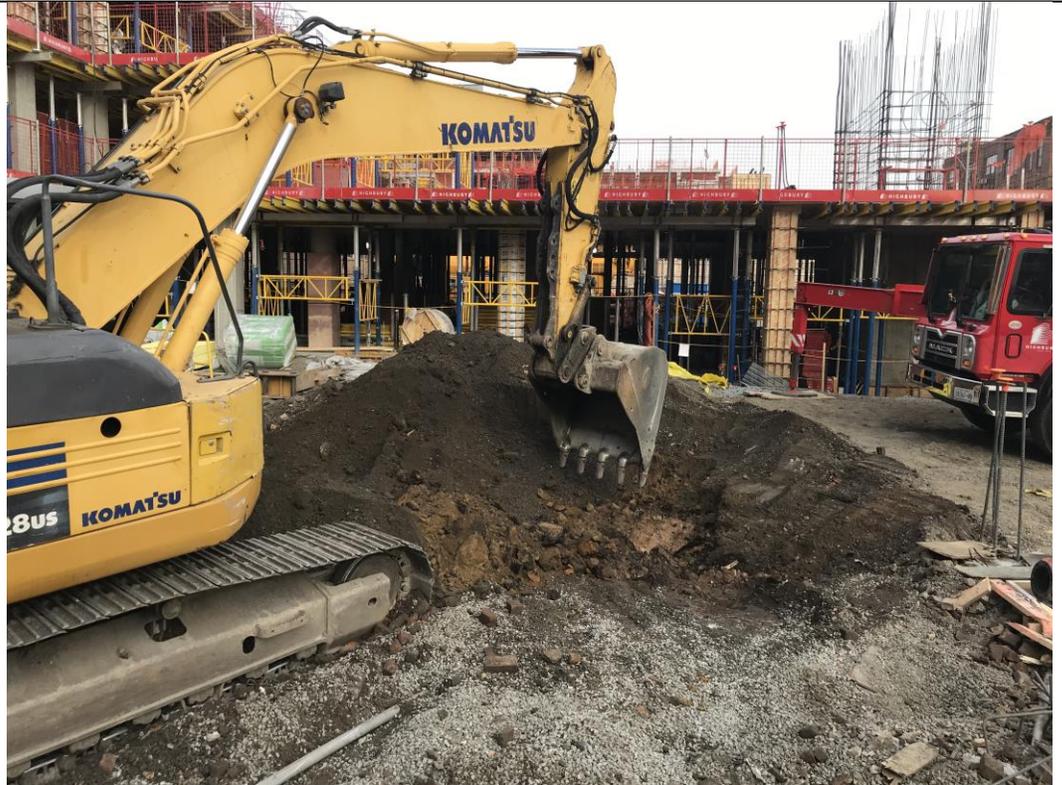
**Photo 1:**  
View of STNY grading an area in waste characterization grid COMP J South (facing north).

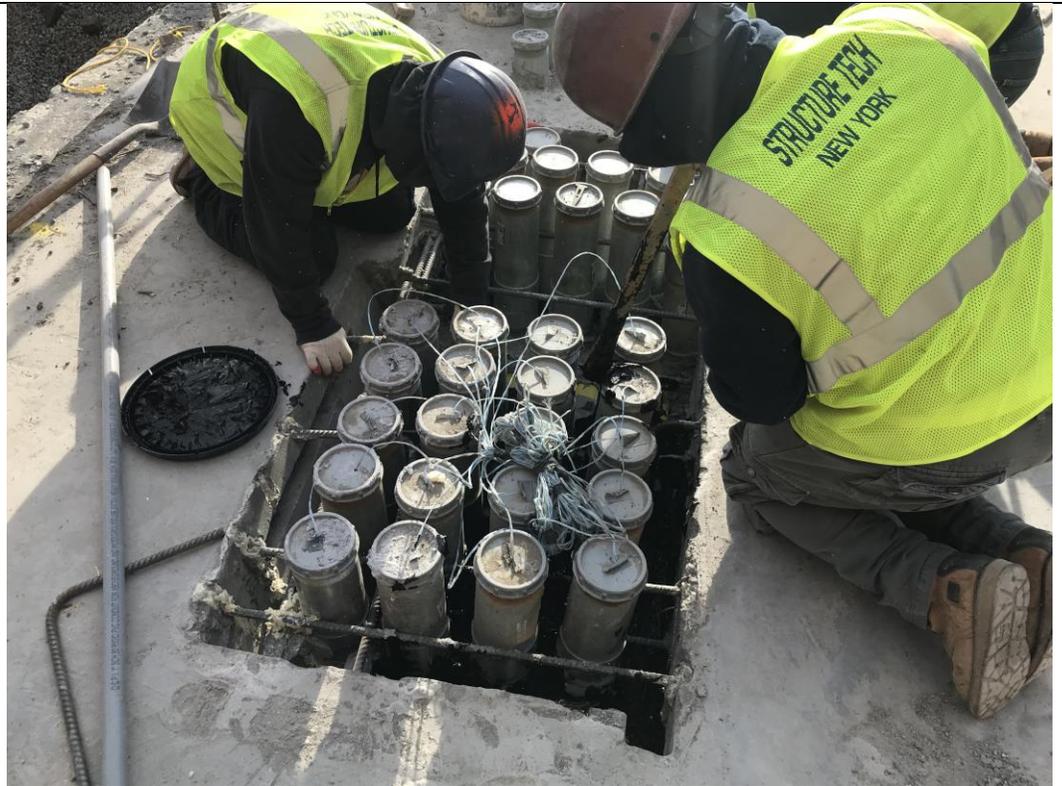
- STNY sealed vapor barrier utility pipe penetrations at two locations in waste characterization grid COMP G using Stego® Mastic.
- Highbury poured concrete for the building foundation slab at two utility pipe penetrations in waste characterization grid COMP G.

**Photo 2:**  
View of STNY sealing vapor barrier penetrations using Stego® Mastic in waste characterization grid COMP G (facing south).

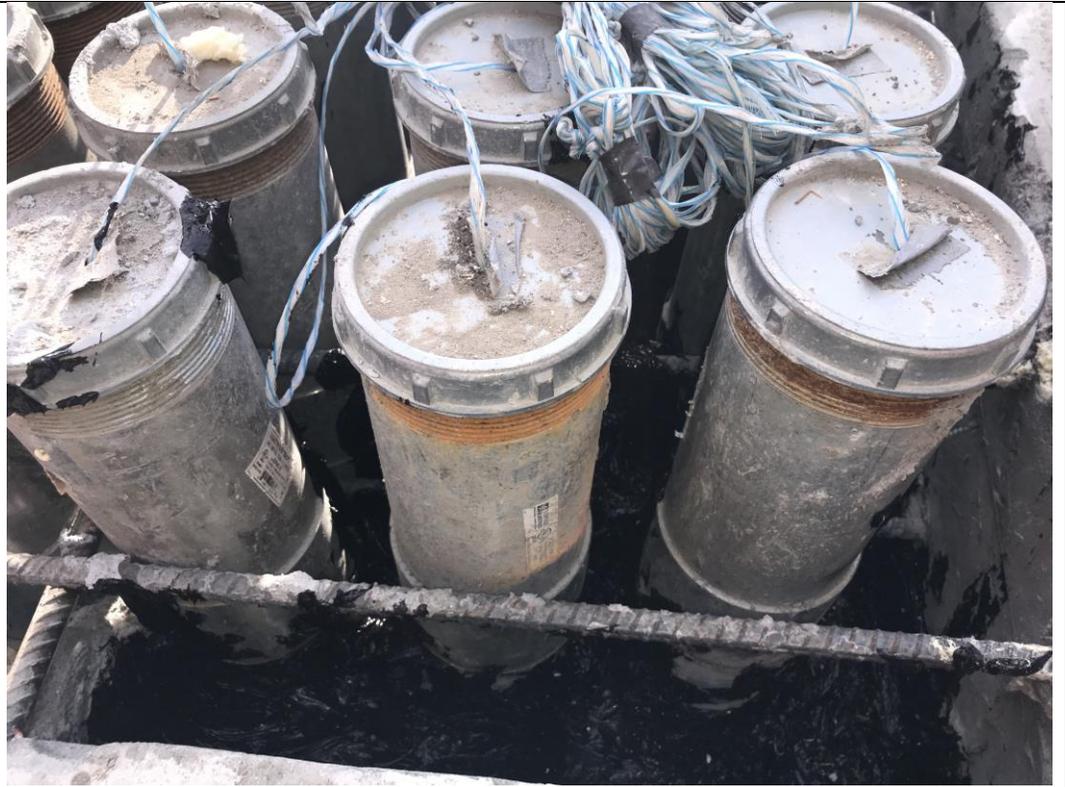
**Photo 3:**

View of sealed vapor barrier penetrations in waste characterization grid COMP G (facing south).

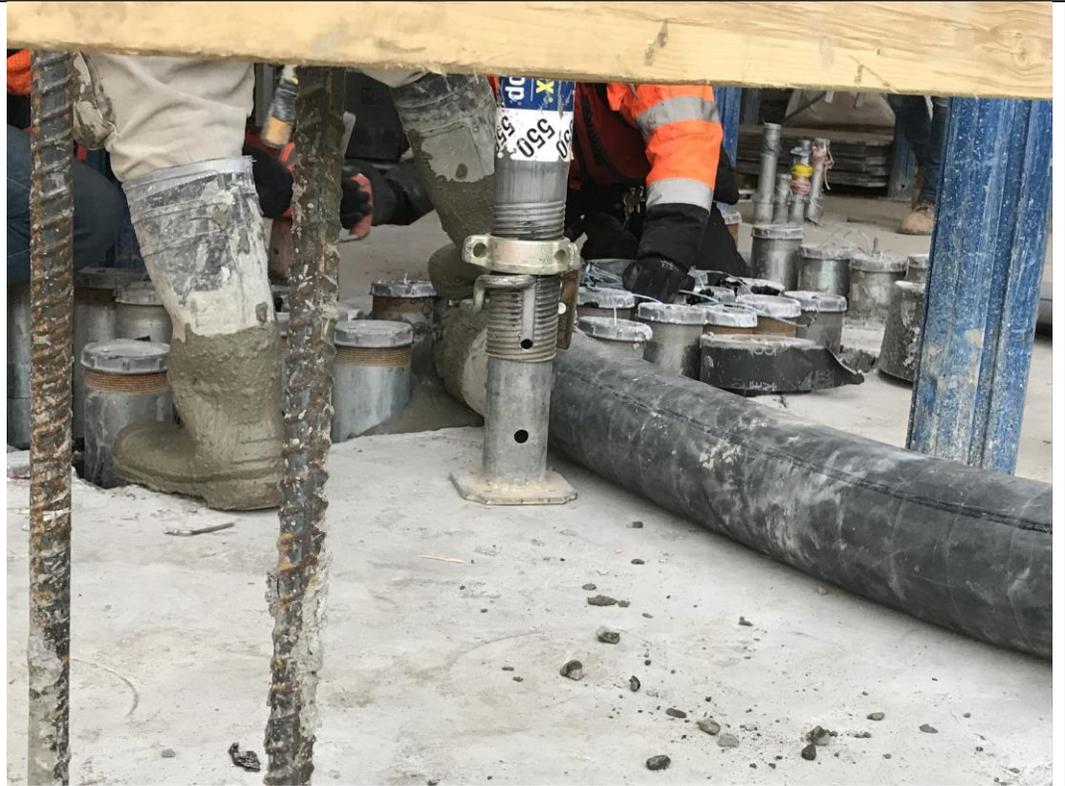
**Photo 4:**

View of Highbury pouring concrete at utility penetrations in waste characterization grid COMP G (facing west).

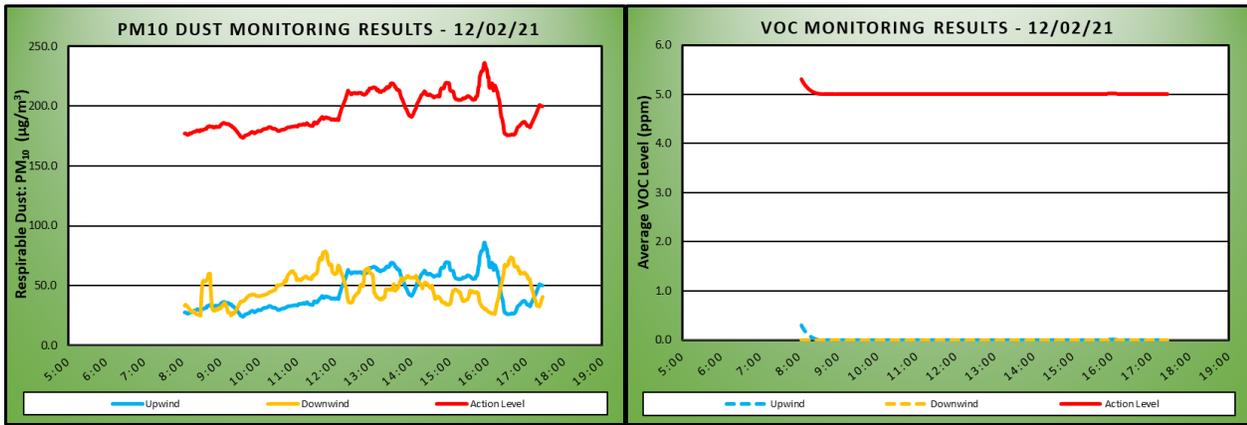
No particulate or organic vapor exceedances at the downwind station were encountered. The daily Community Air Monitoring Program (CAMP) monitoring results are also presented in the following charts:

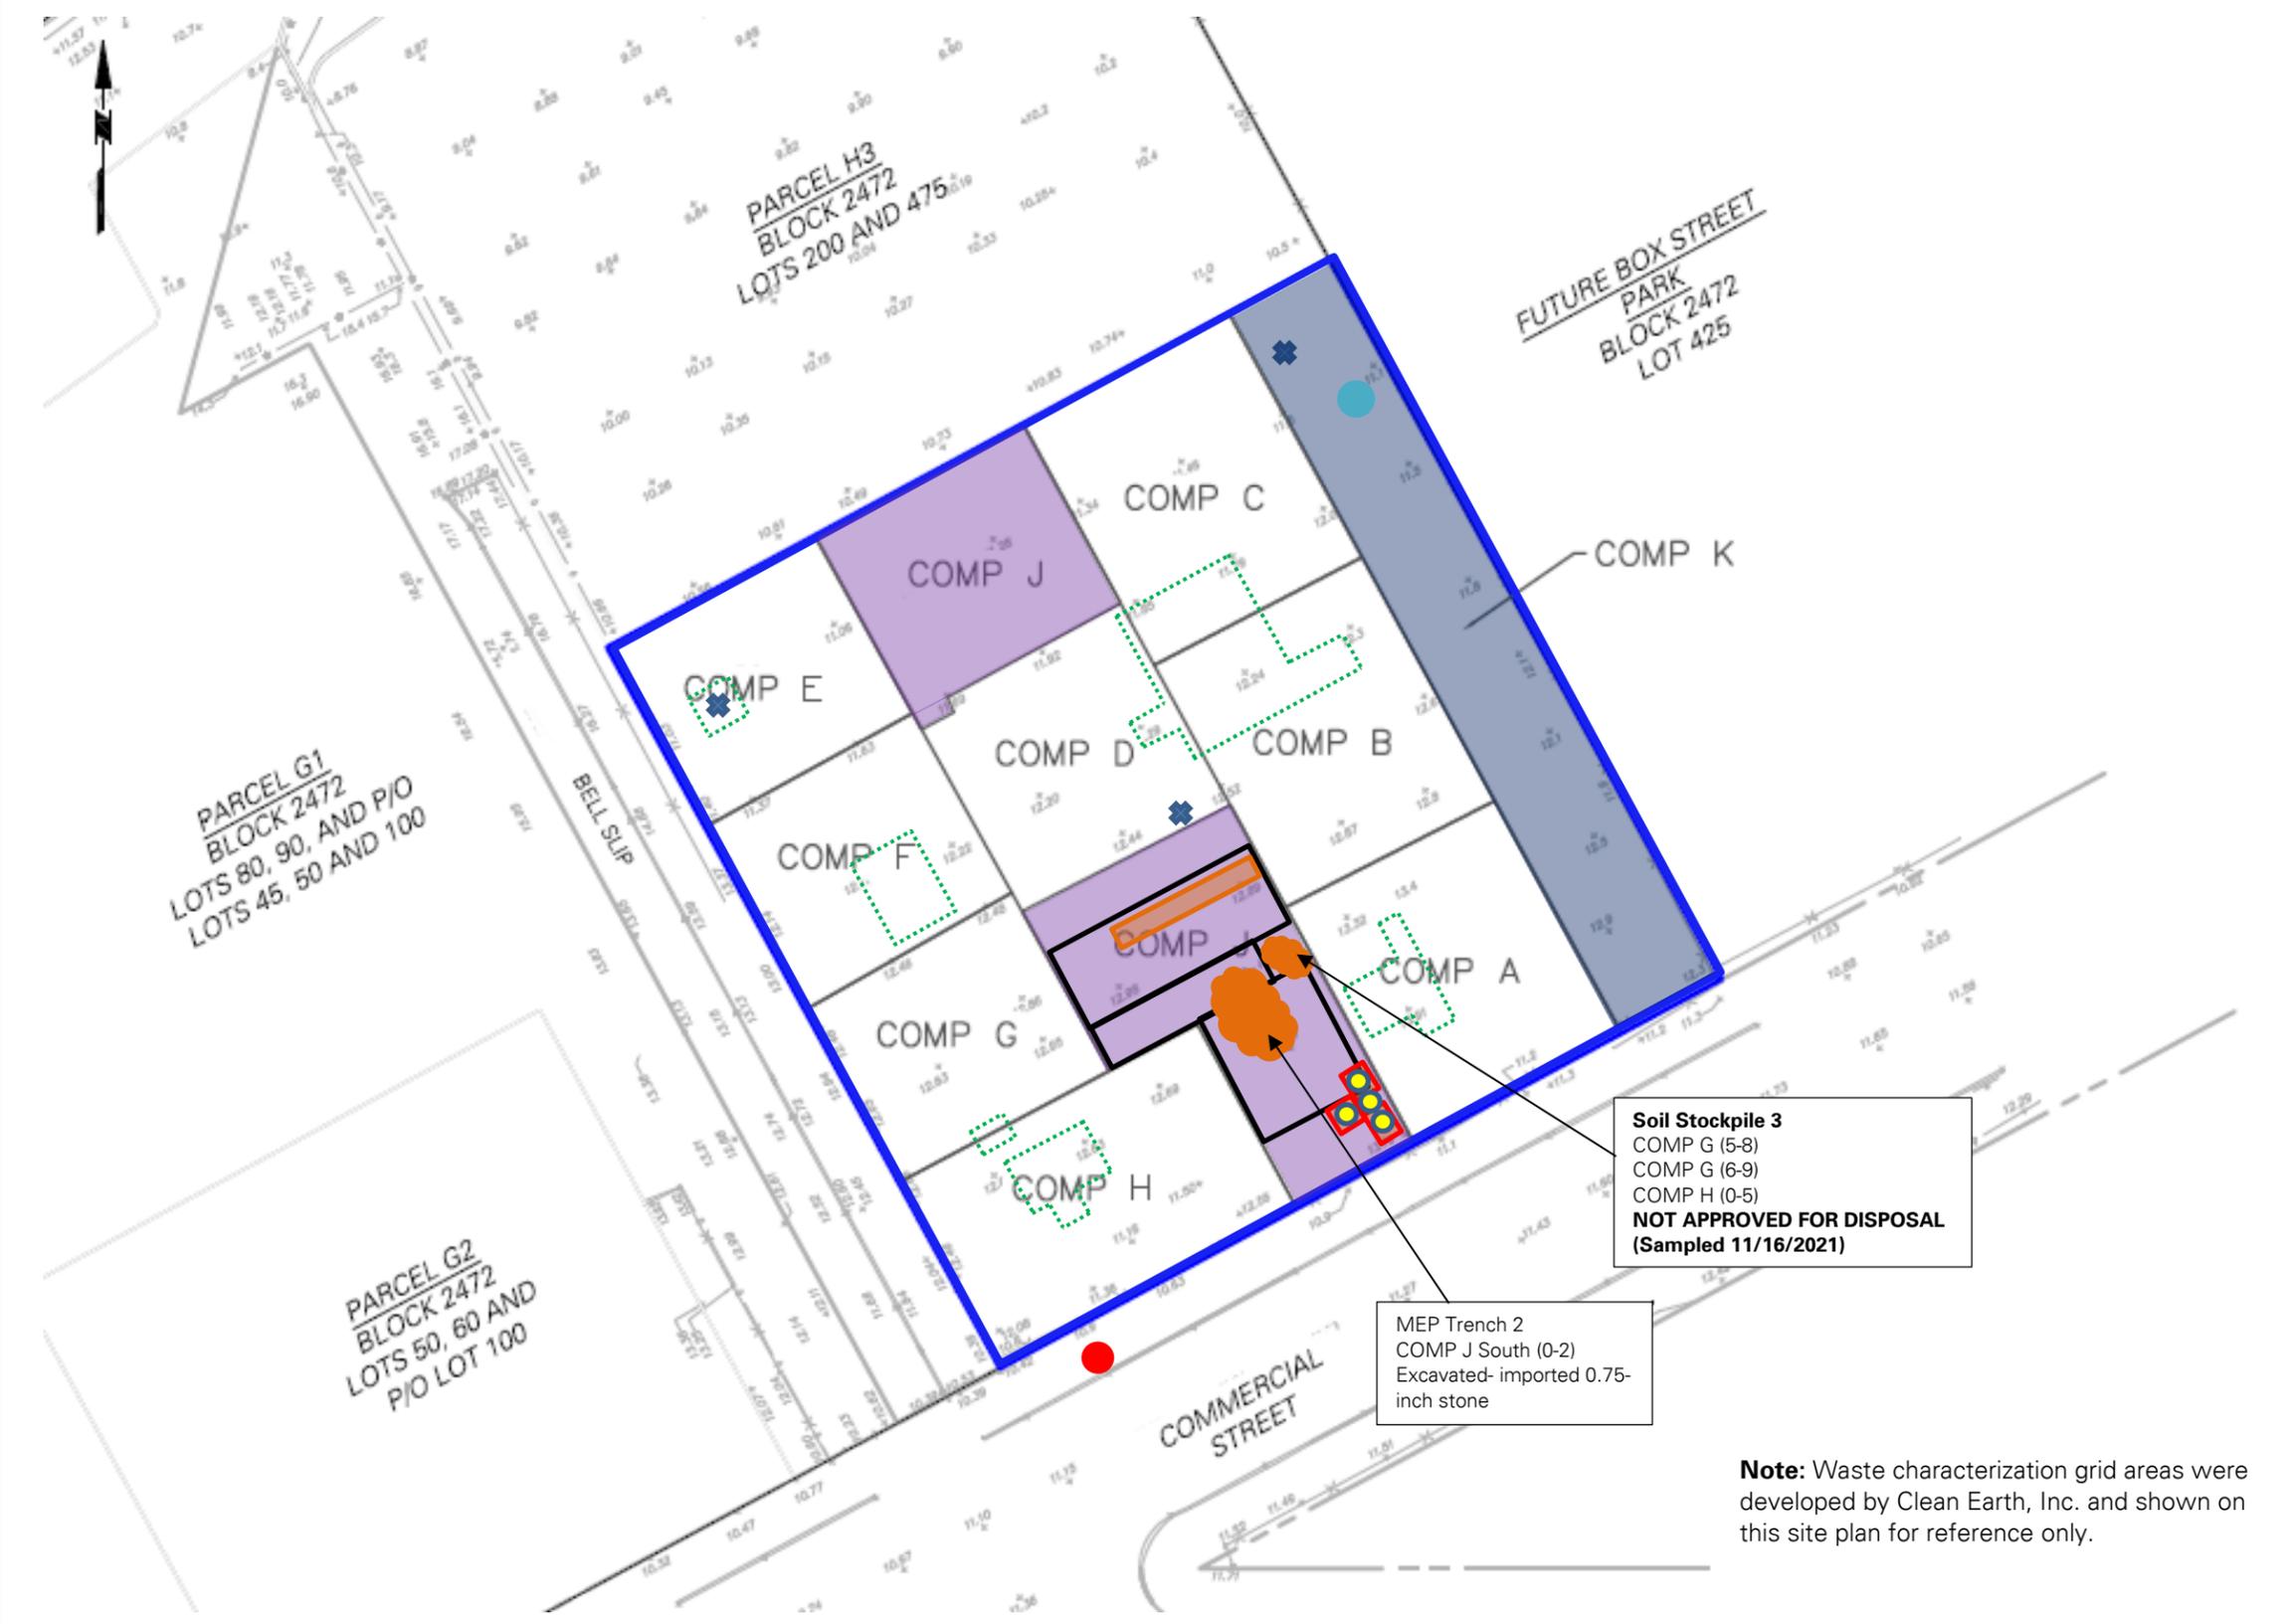
**SITE PLAN**

**Soil Stockpile 3**  
 COMP G (5-8)  
 COMP G (6-9)  
 COMP H (0-5)  
**NOT APPROVED FOR DISPOSAL**  
 (Sampled 11/16/2021)

MEP Trench 2  
 COMP J South (0-2)  
 Excavated- imported 0.75-  
 inch stone

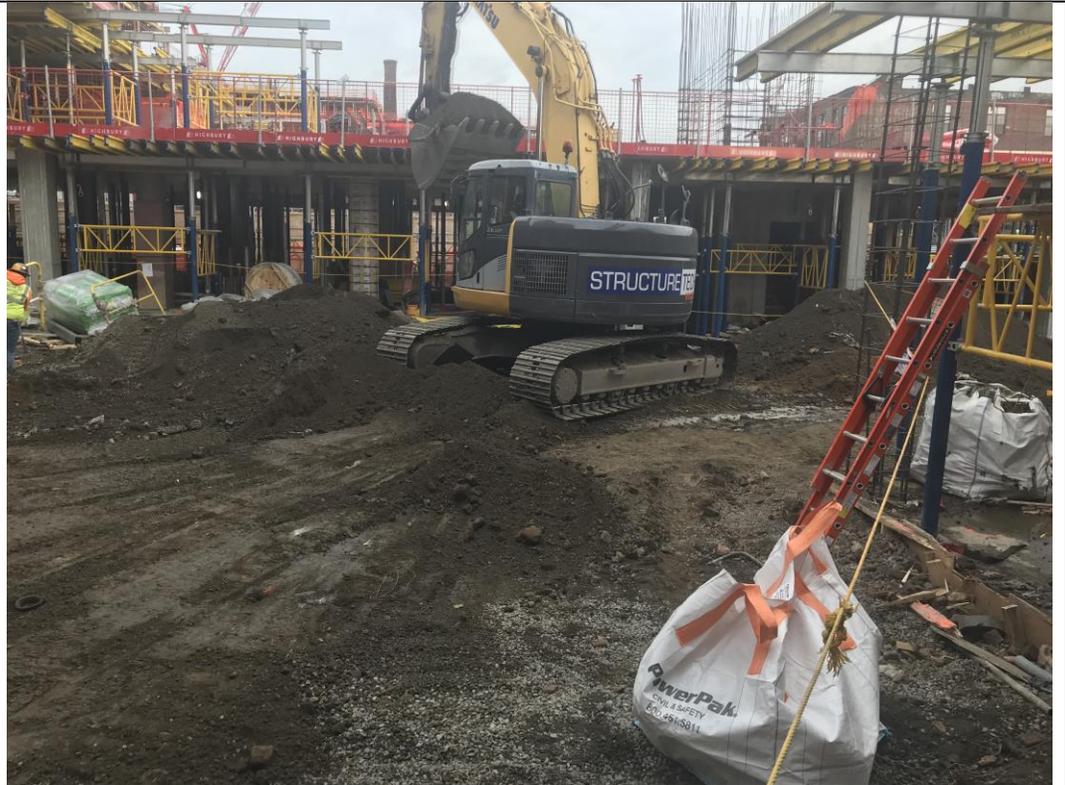
**Photo 1:**

View of STNY regrading in waste characterization grid COMP J South (facing east).

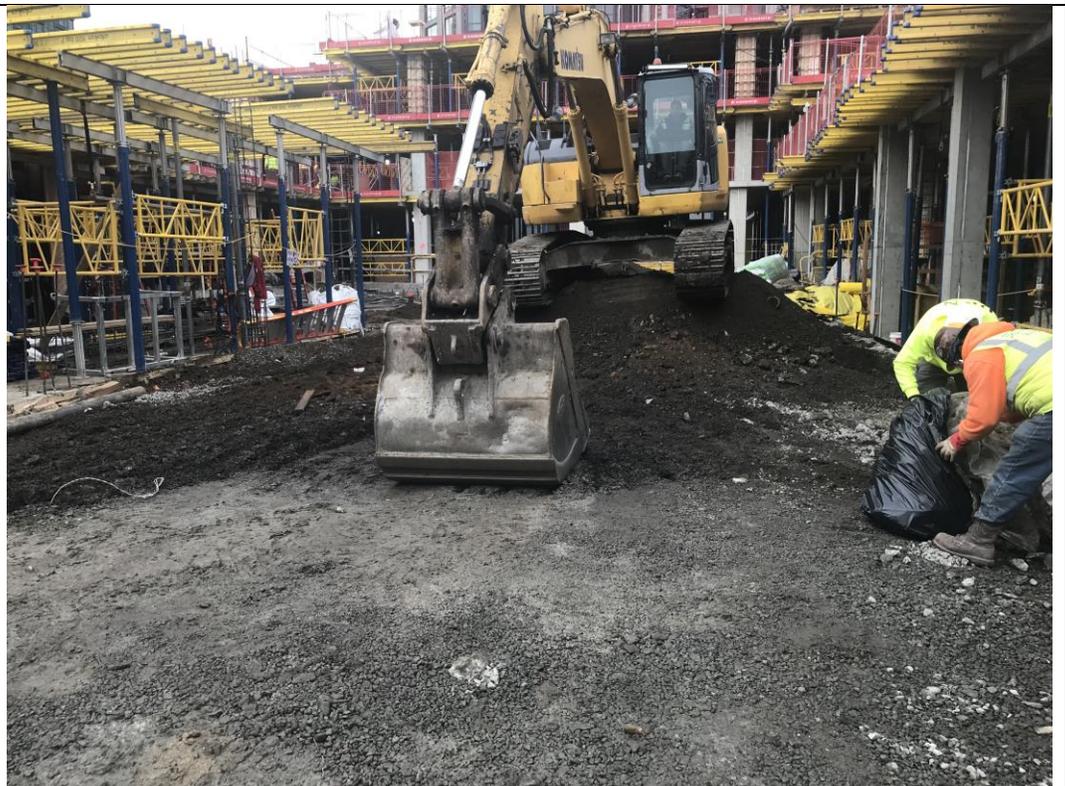
**Photo 2:**

View of STNY regrading in waste characterization grid COMP J South (facing north).

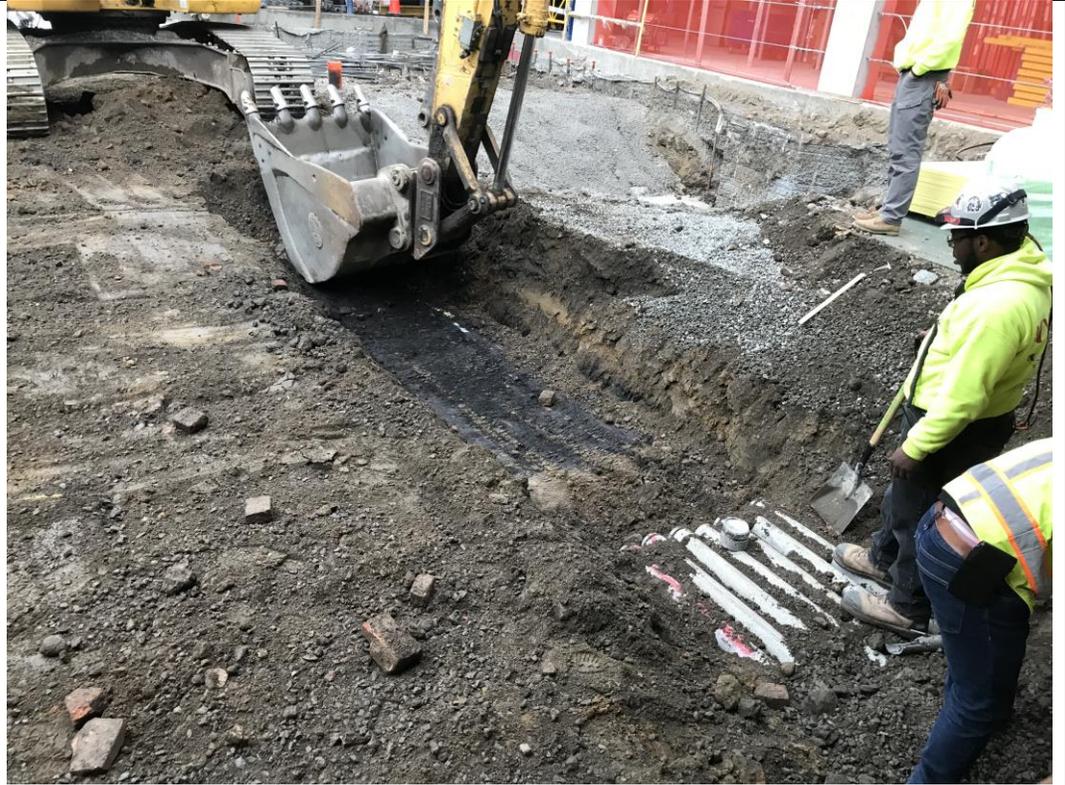
**Photo 3:**

View of STNY excavating in waste characterization grid COMP J South for electric utility piping installation (facing southwest).

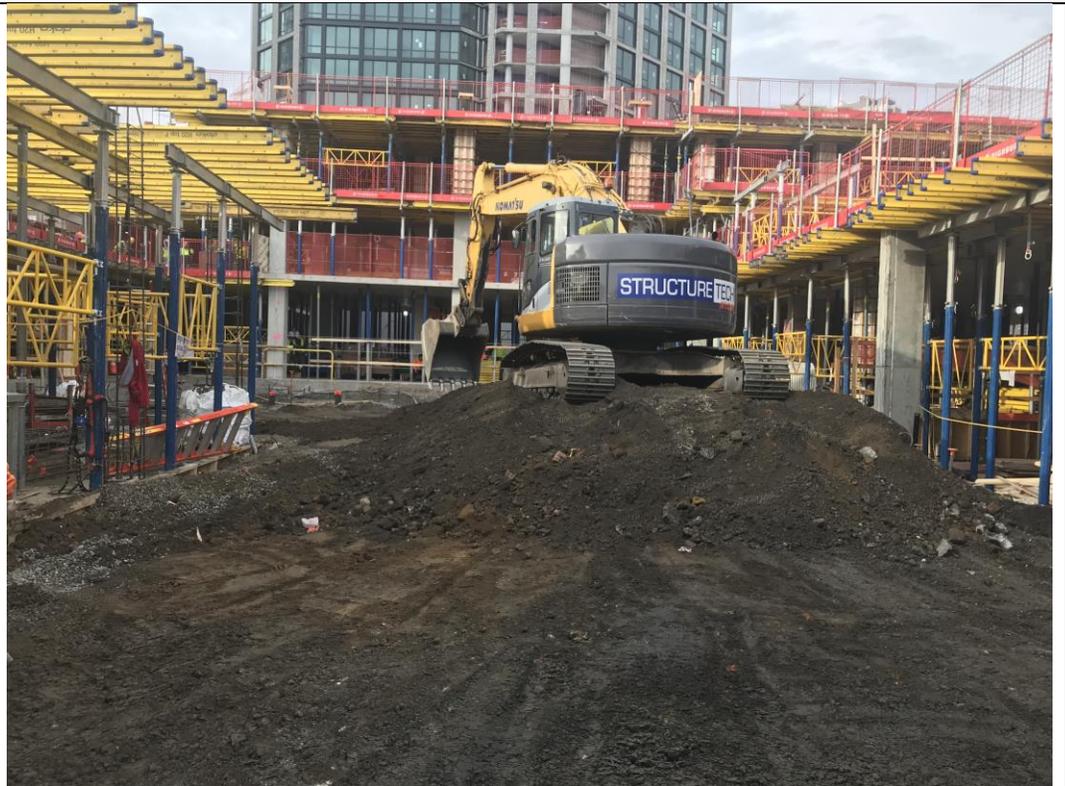
**Photo 4:**

General view of the site (facing north)

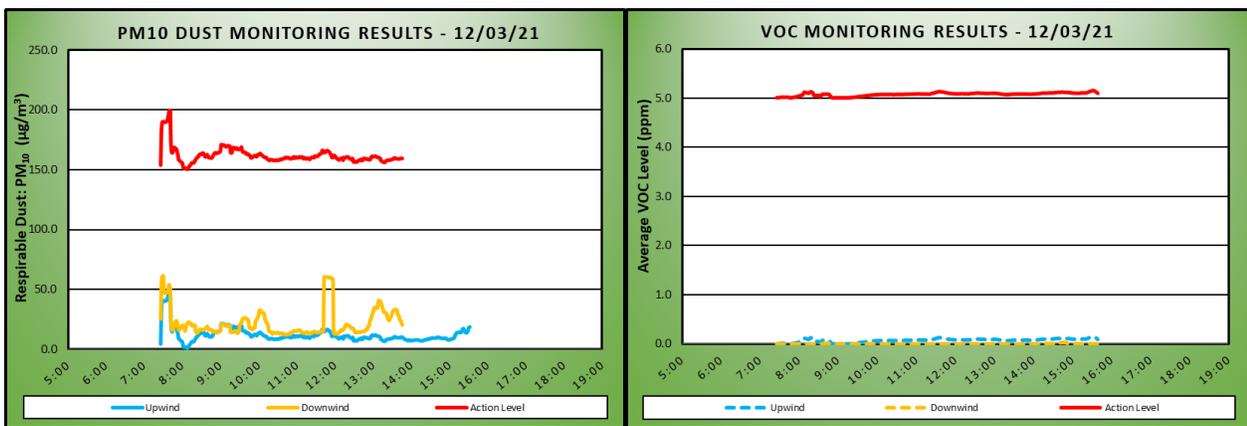
Particulate data was not collected at the downwind station after 13:47 due to a connectivity issue. The manufacturer was contacted and the issue will be resolved the following day. No particulate or organic vapor exceedances at the downwind station were encountered. The daily Community Air Monitoring Program (CAMP) monitoring results are also presented in the following charts:
