**DAILY FIELD REPORT 101**

<b>BCP Project No:</b>	C224304	<b>Date:</b>	November 29, 2021
------------------------	---------	--------------	-------------------

<b>Project Name:</b>	45 Commercial Street	<b>Time:</b>	6:30 am to 3:45 pm
----------------------	----------------------	--------------	--------------------

<b>Consultant:</b> Langan Engineering, Environmental, Surveying, Landscape Architecture and Geology, D.P.C. (Langan)	<b>Langan Field Personnel:</b> Yaskira Mota
<b>Construction Manager:</b> Monadnock Construction Inc. (MC)	
<b>Foundation Contractor:</b> StructureTech New York, Inc. (STNY) <b>Soil Broker:</b> Clean Earth, Inc. (CE)

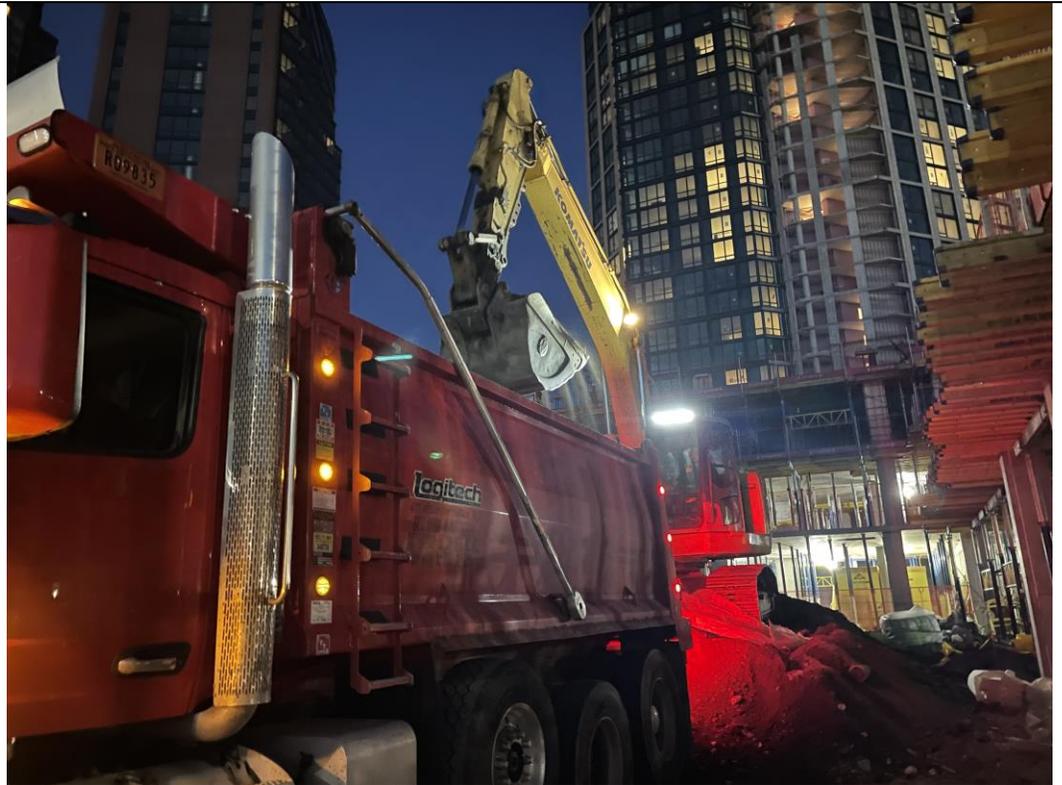
**Photo 1:**

View of STNY loading a truck with soil for off-site disposal to the CEC facility (facing north).

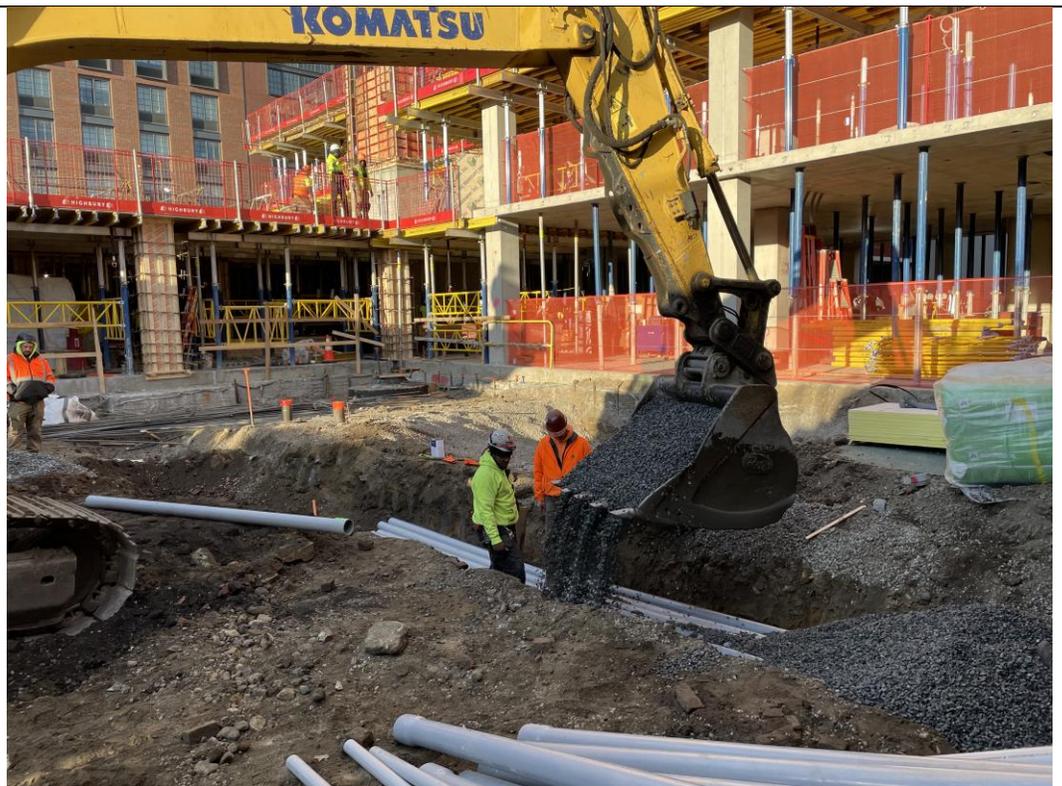
**Photo 2:**

View of STNY backfilling the electrical utility excavation with 0.75-inch stone in waste characterization grid COMP J South (facing northwest).

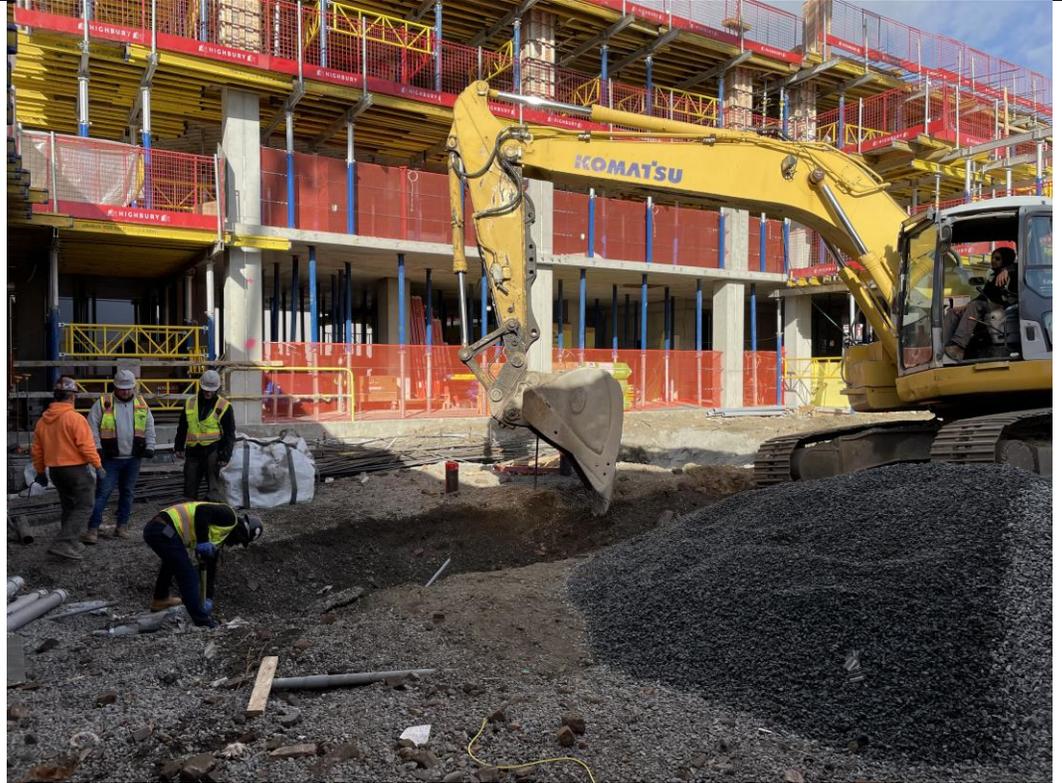
**Photo 3:**

View of STNY excavating for electrical utility piping installation in waste characterization grid COMP J South (facing north).

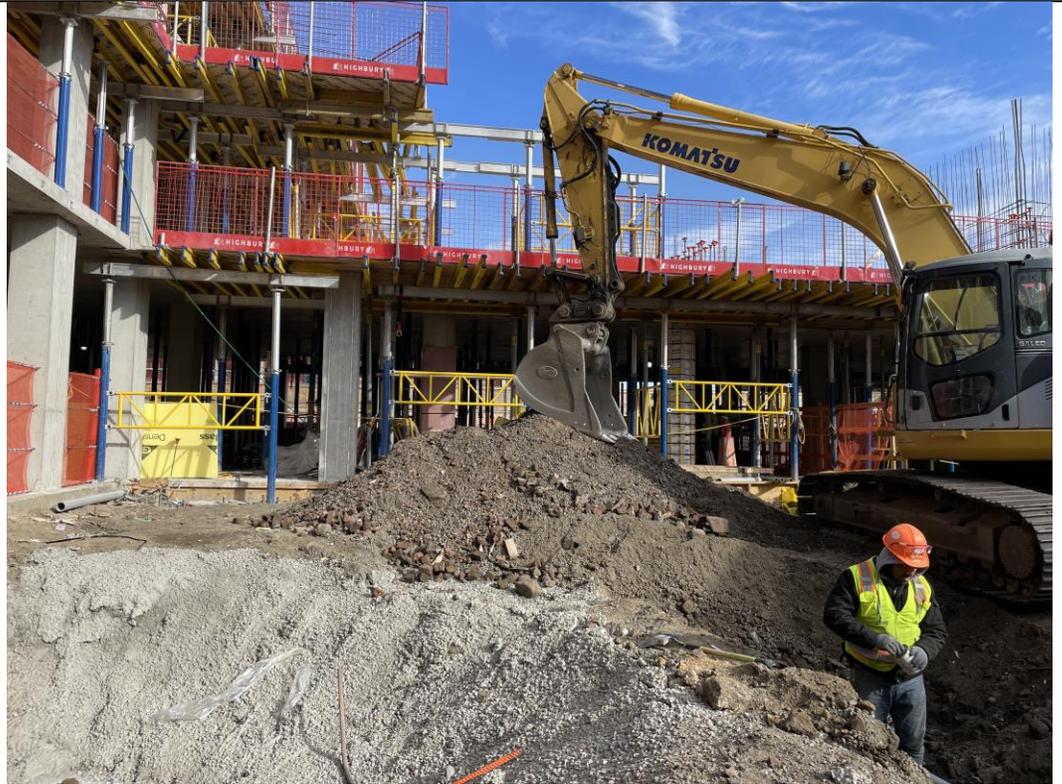
**Photo 4:**

View of STNY relocating a soil stockpile within waste characterization grid COMP J South (facing east)
