**DAILY FIELD REPORT 108**

<b>BCP Project No:</b>	C224304	<b>Date:</b>	August 22, 2022
------------------------	---------	--------------	-----------------

<b>Project Name:</b>	45 Commercial Street	<b>Time:</b>	6:30 am to 3:30 pm
----------------------	----------------------	--------------	--------------------

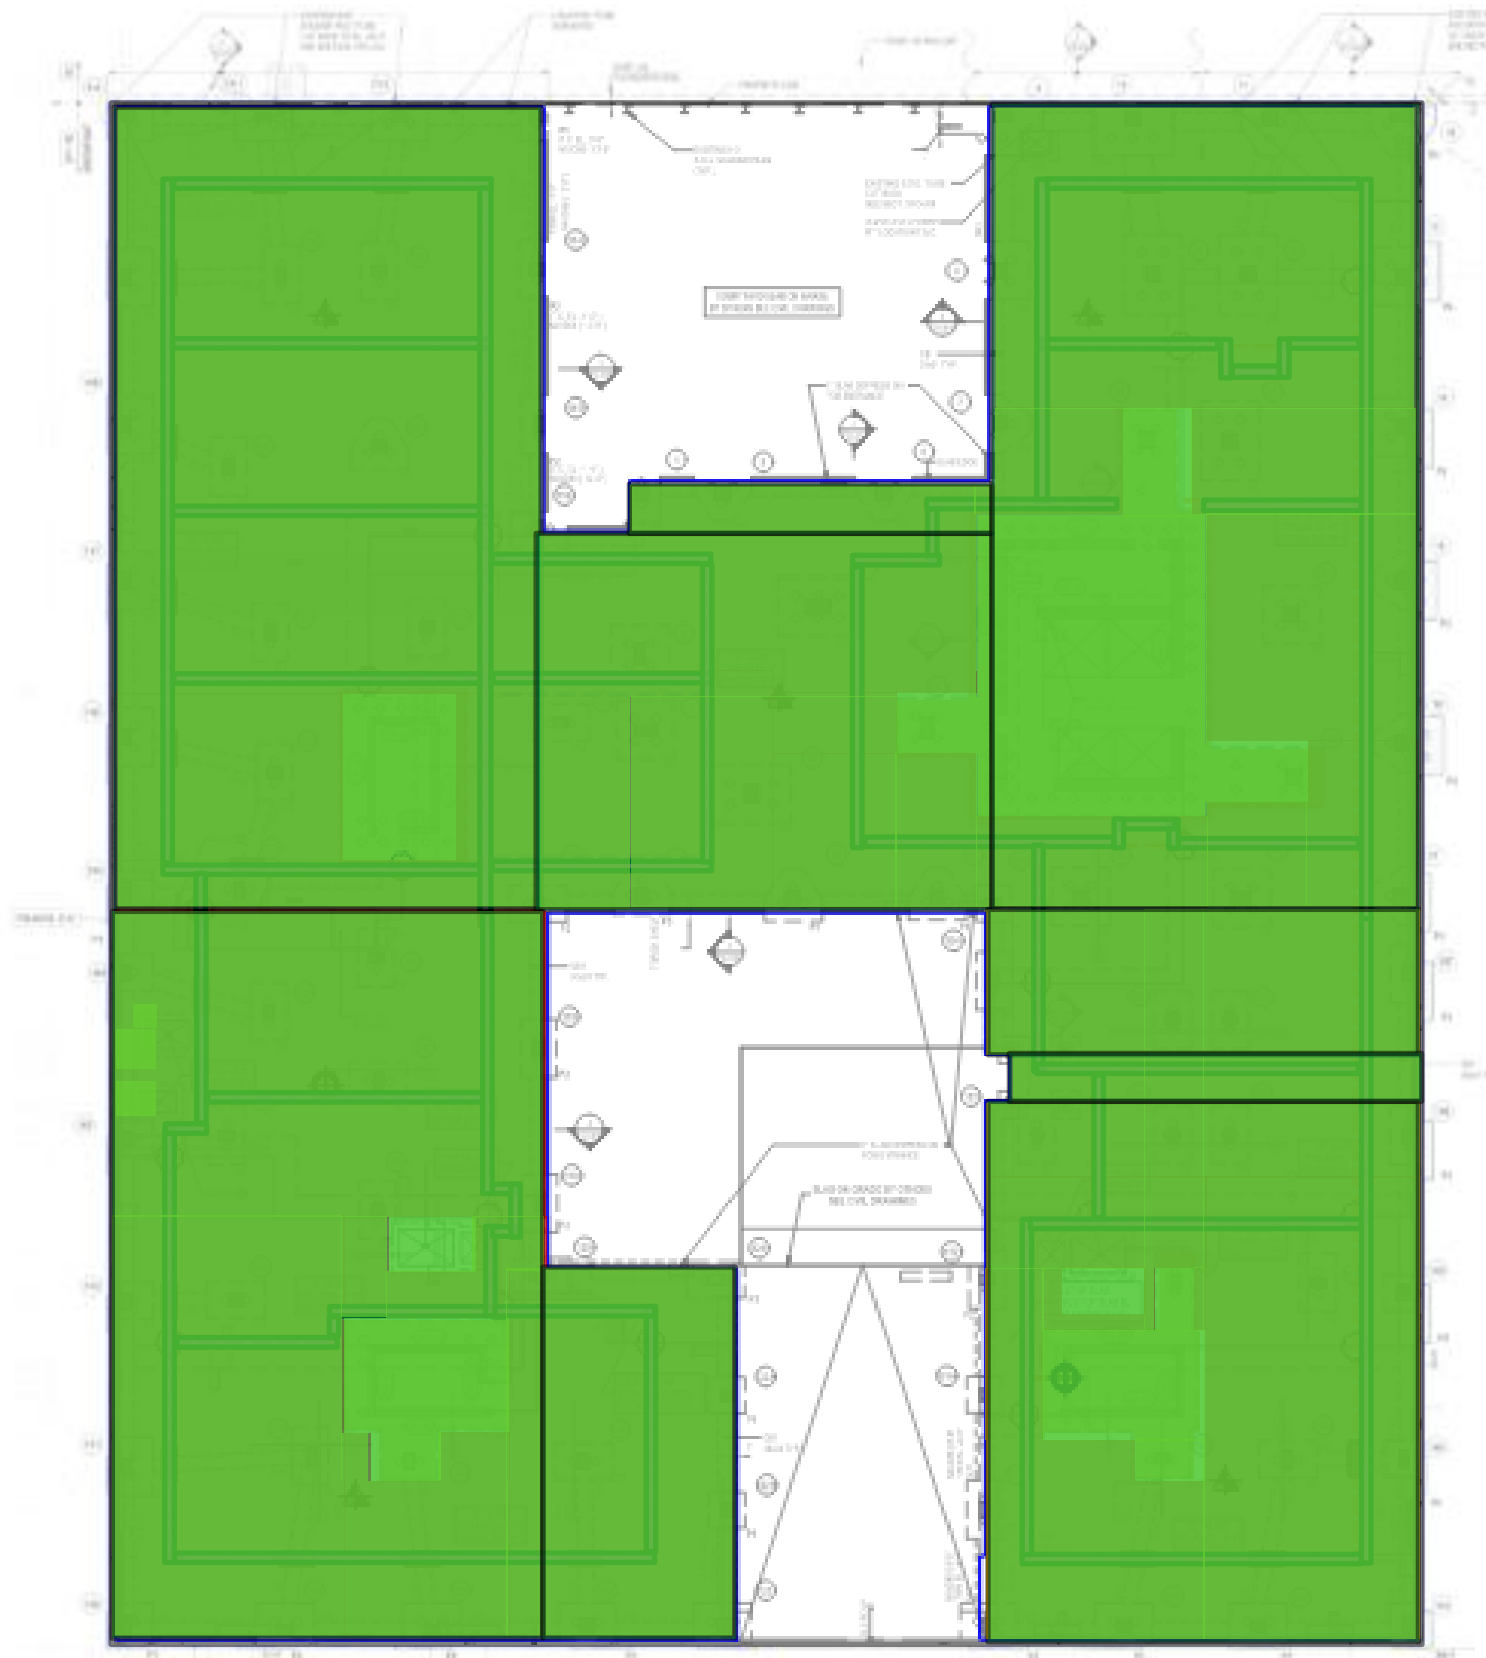
### WATERPROOFING/VAPOR BARRIER AND SMD INSTALLATION MAP

Approximate Location of Sub-Slab Vapor Collection Slotted Pipe Run – Blower A
-

Approximate Location of Sub-Slab Vapor Collection Slotted Pipe Run – Blower B
-

SMD System Installation In Progress (Geotextile/Aggregate)
-

SMD System Installation In Progress (SMD Piping)
-

SMD System Installation In Progress (Waterproofing/Vapor Barrier)
-

Concrete Foundation Slab Poured

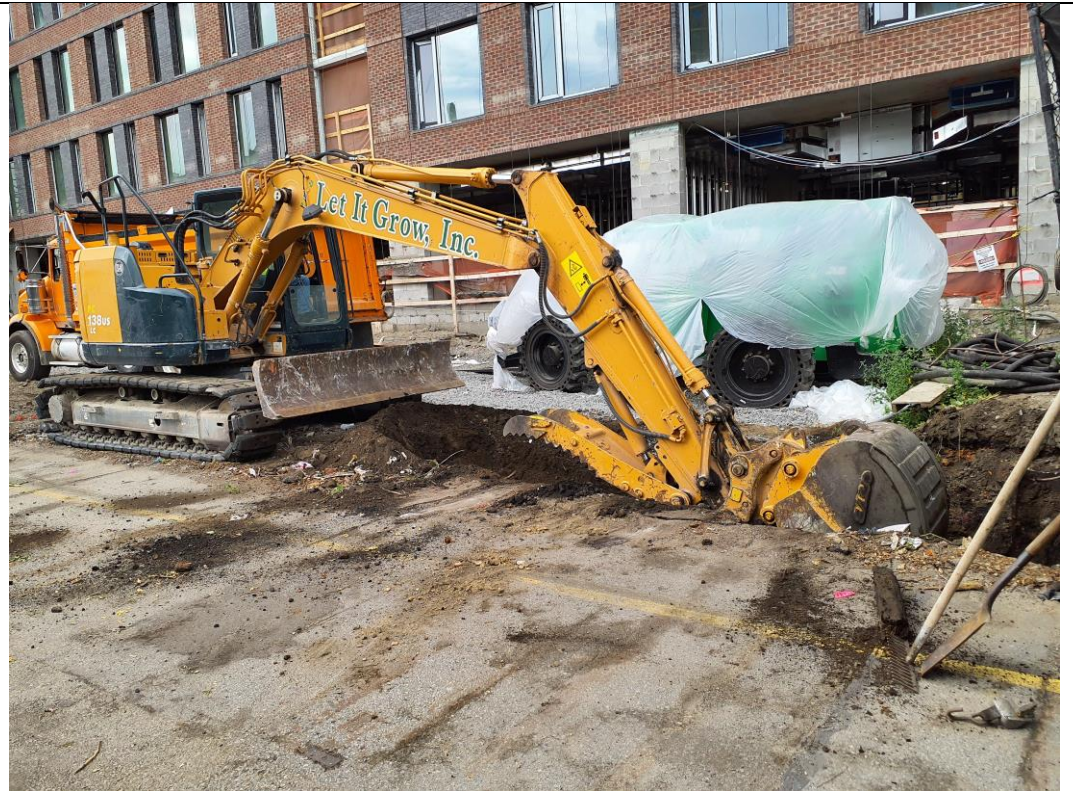
**Photo 1:**

View of Let It Grow excavating along the eastern site boundary in waste characterization grid COMP K and on the eastern adjoining property (facing southwest).

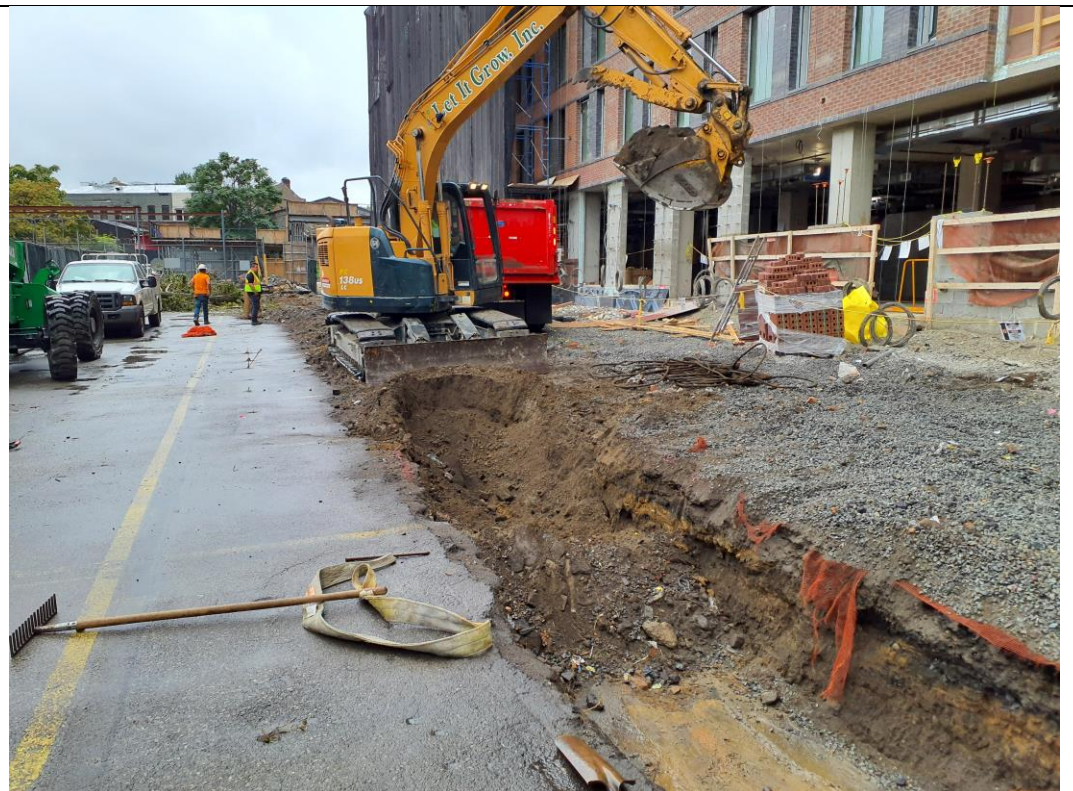
**Photo 2:**

View of Let It Grow excavating along the eastern site boundary in waste characterization grid COMP K and on the eastern adjoining property (facing south).

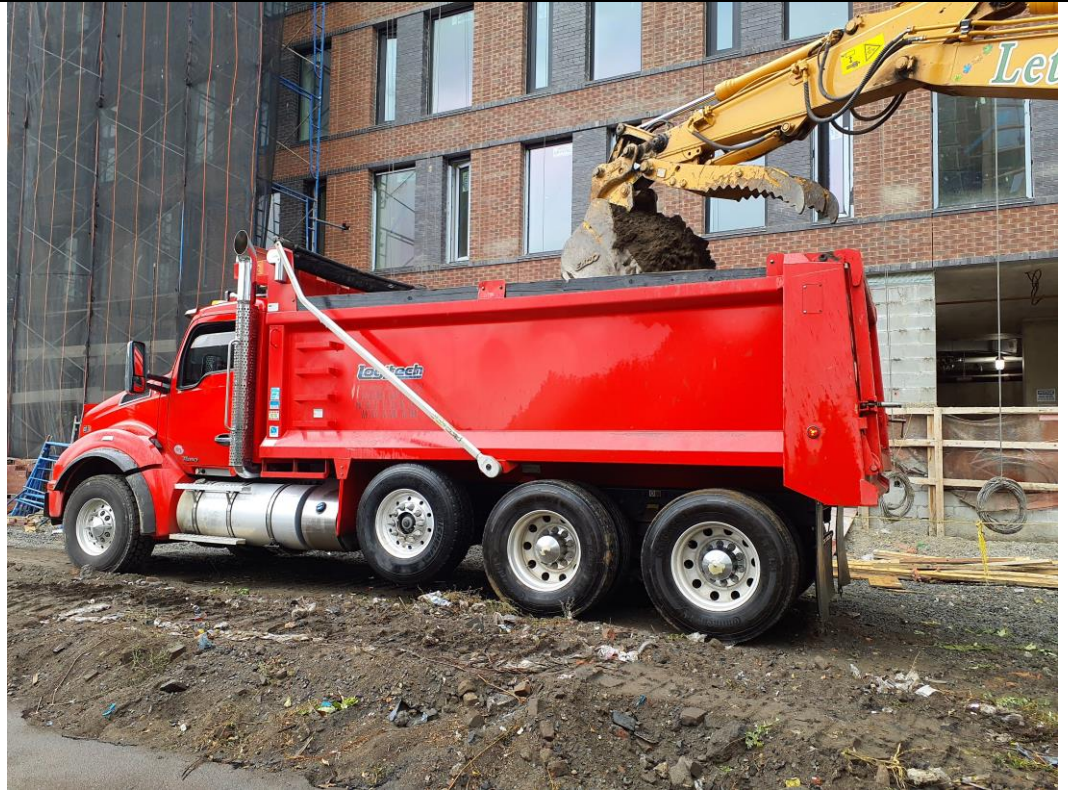
**Photo 3:**

View of Let It Grow loading a truck for off-site disposal to the CEC facility (facing southwest).

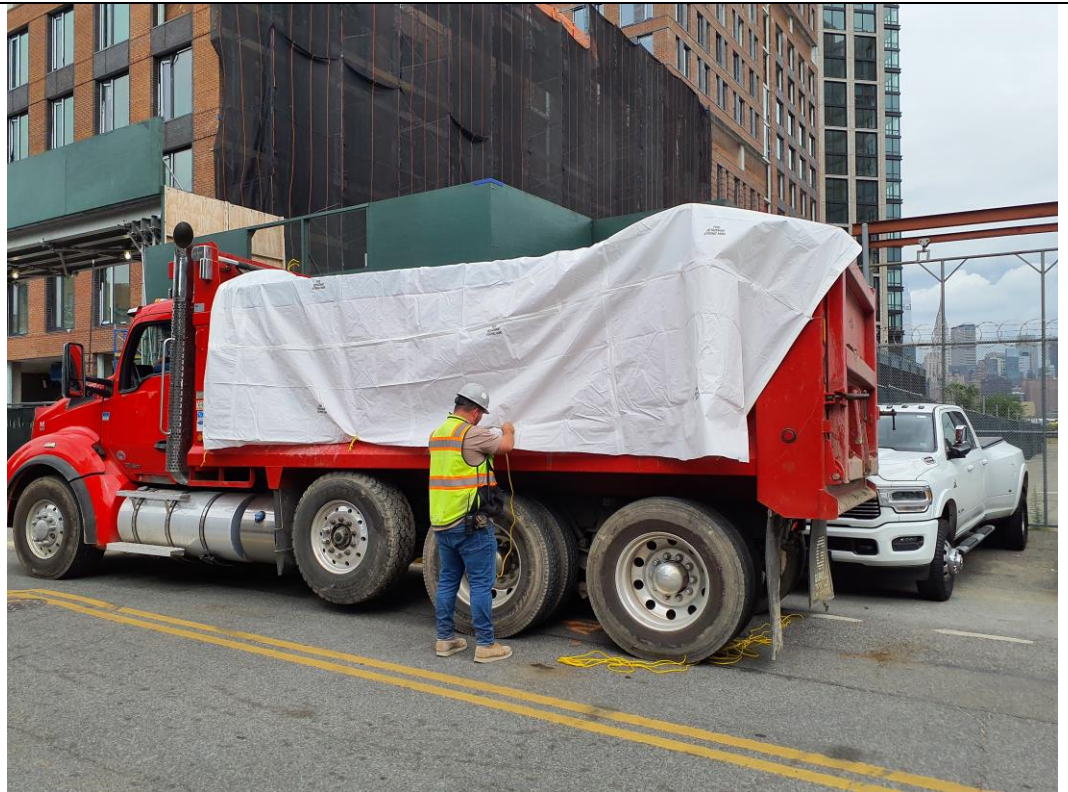
**Photo 4:**

View of loaded truck being secured prior to leaving the site (facing northwest).

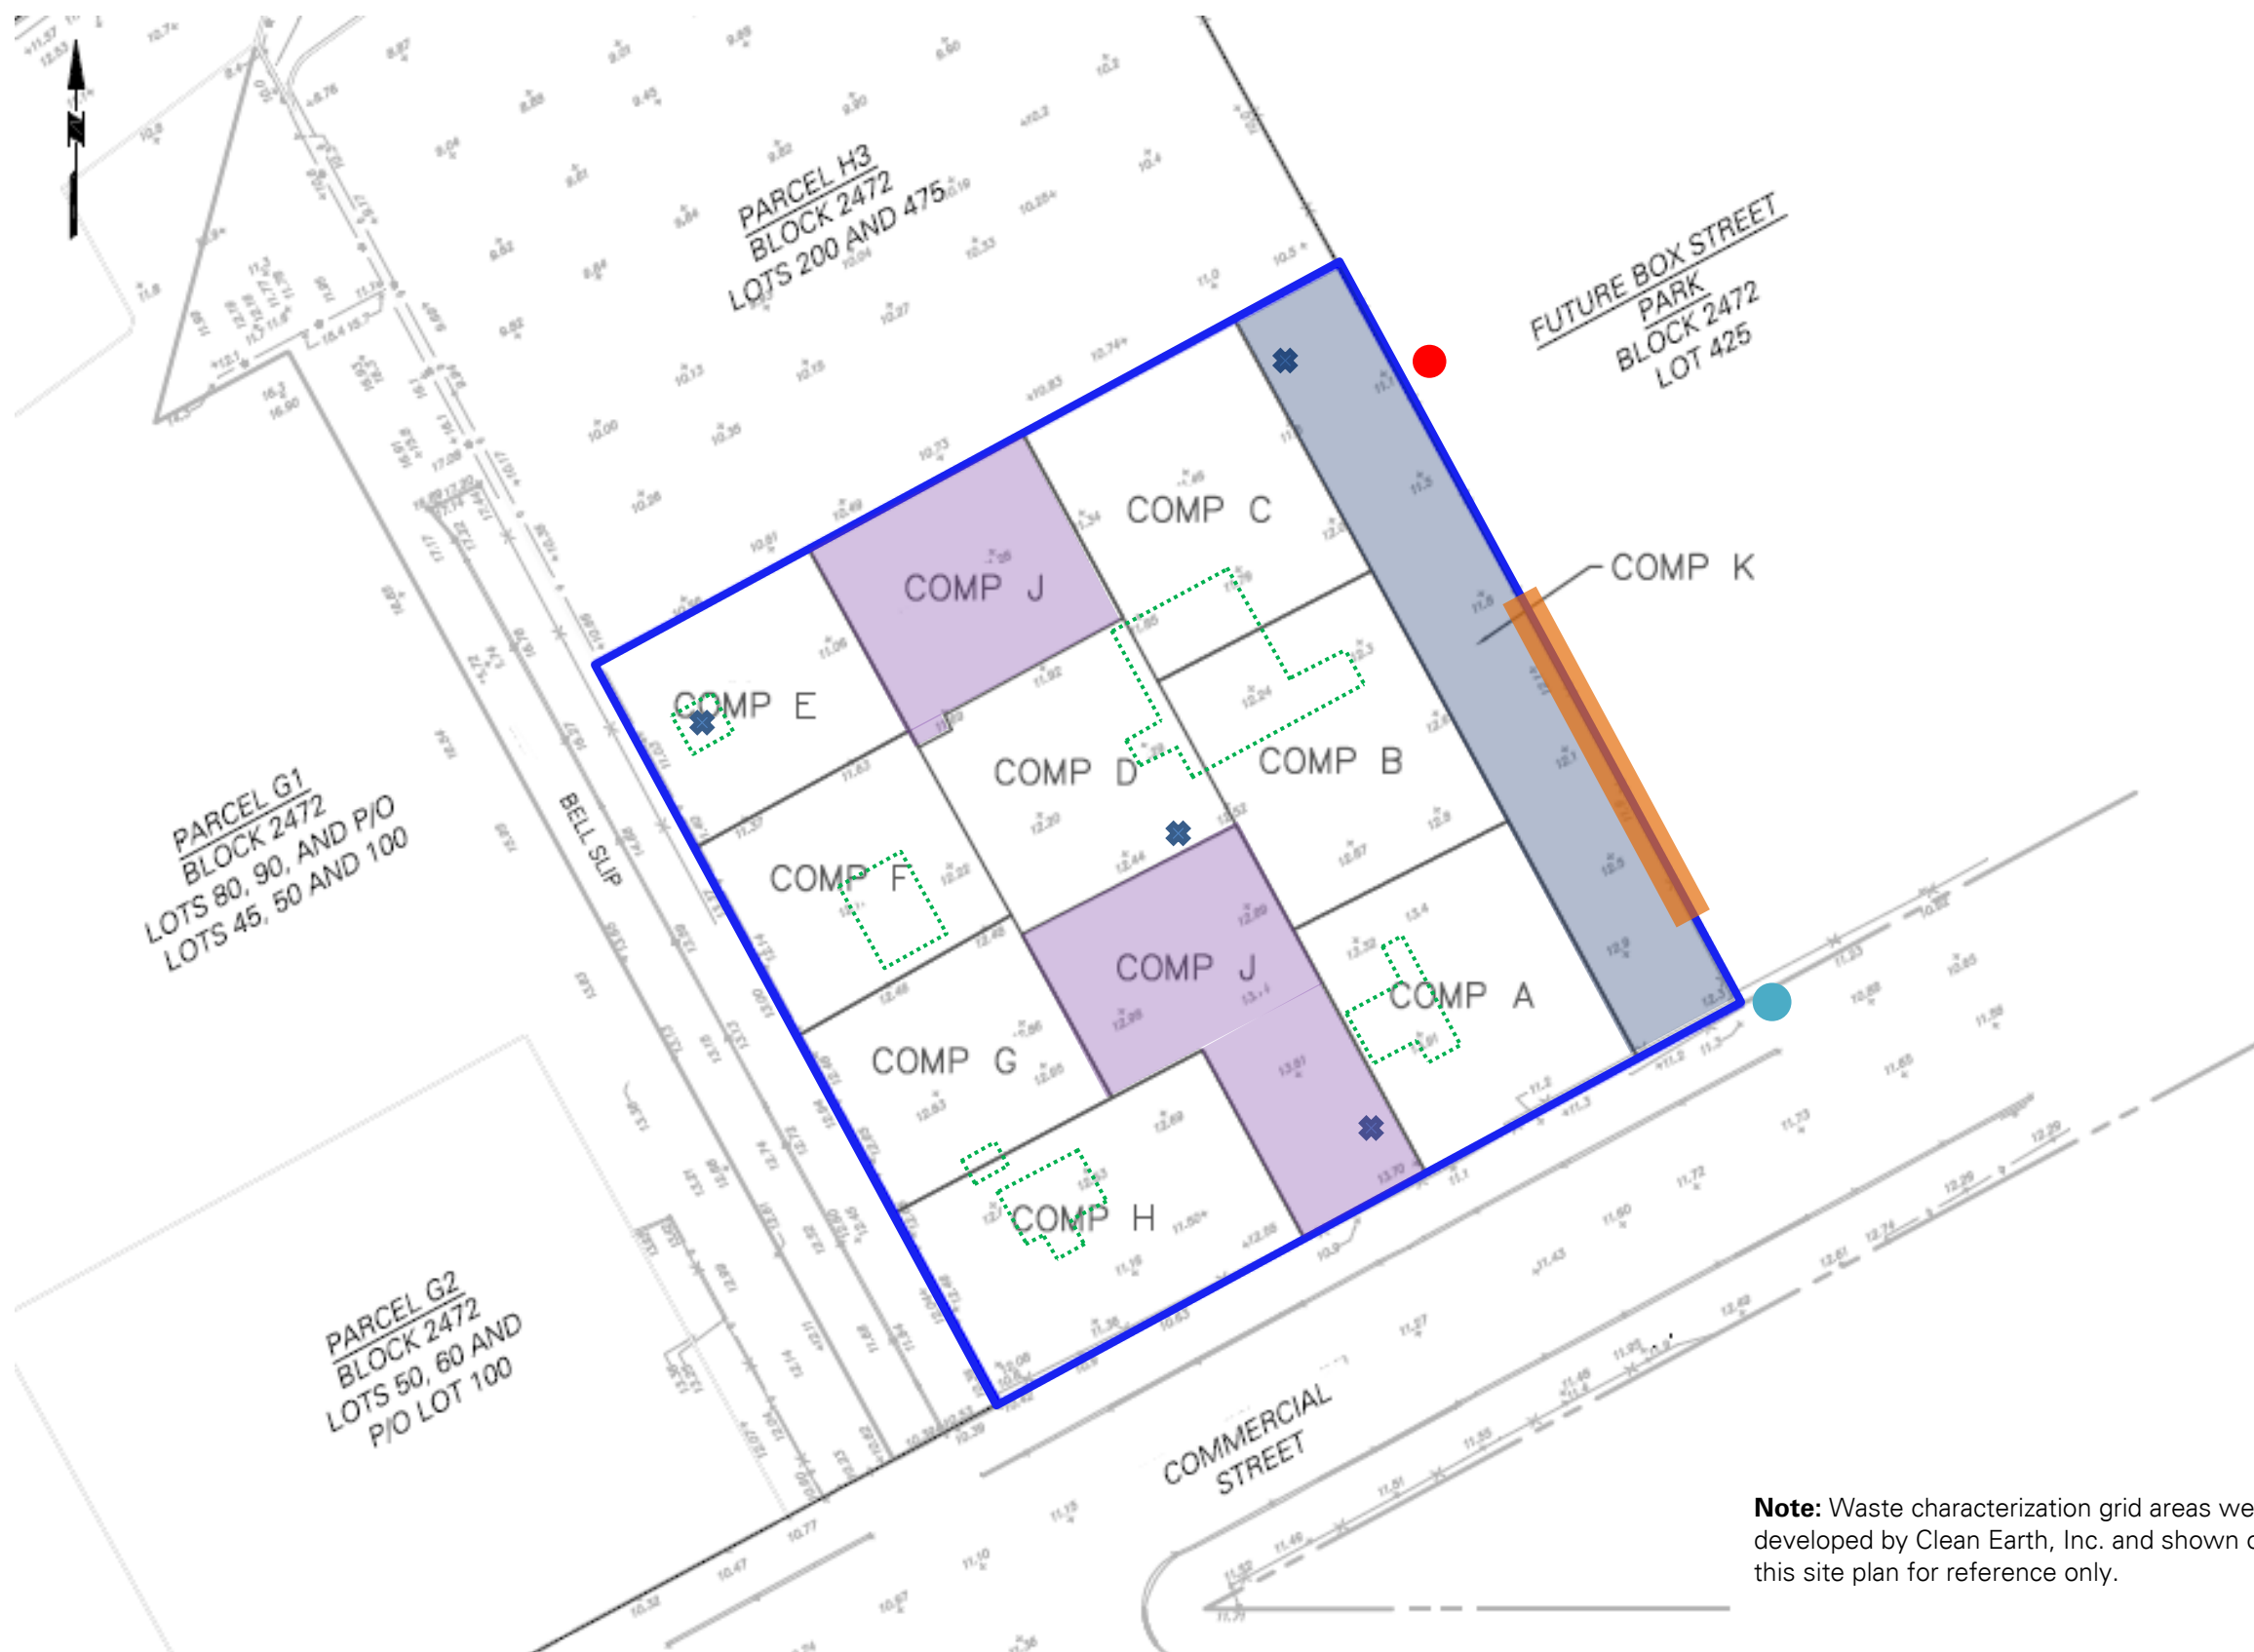
**SITE PLAN**

- Site Boundary**
- Waste Characterization Grid  
COMP I (5-10)**
- **Upwind CAMP station**
- **Downwind CAMP station**
- **Stockpile – Soil**
- **Stockpile – Imported Material**
- **Stockpile – C&D**
- Approximate Location of  
Excavation**
- Approximate Area of Backfilling**
- Approximate Area of Regrading**
- Approximate Location of  
Concrete Pouring**
- Approximate Area of Installed  
Demarcation Layer**
- 2 Foot Remedial Excavation  
Completed**
- 2 Foot Remedial Excavation  
Completed, Demarcation Layer  
Installed, and 1 Foot of Clean  
Cover Layer Placed**

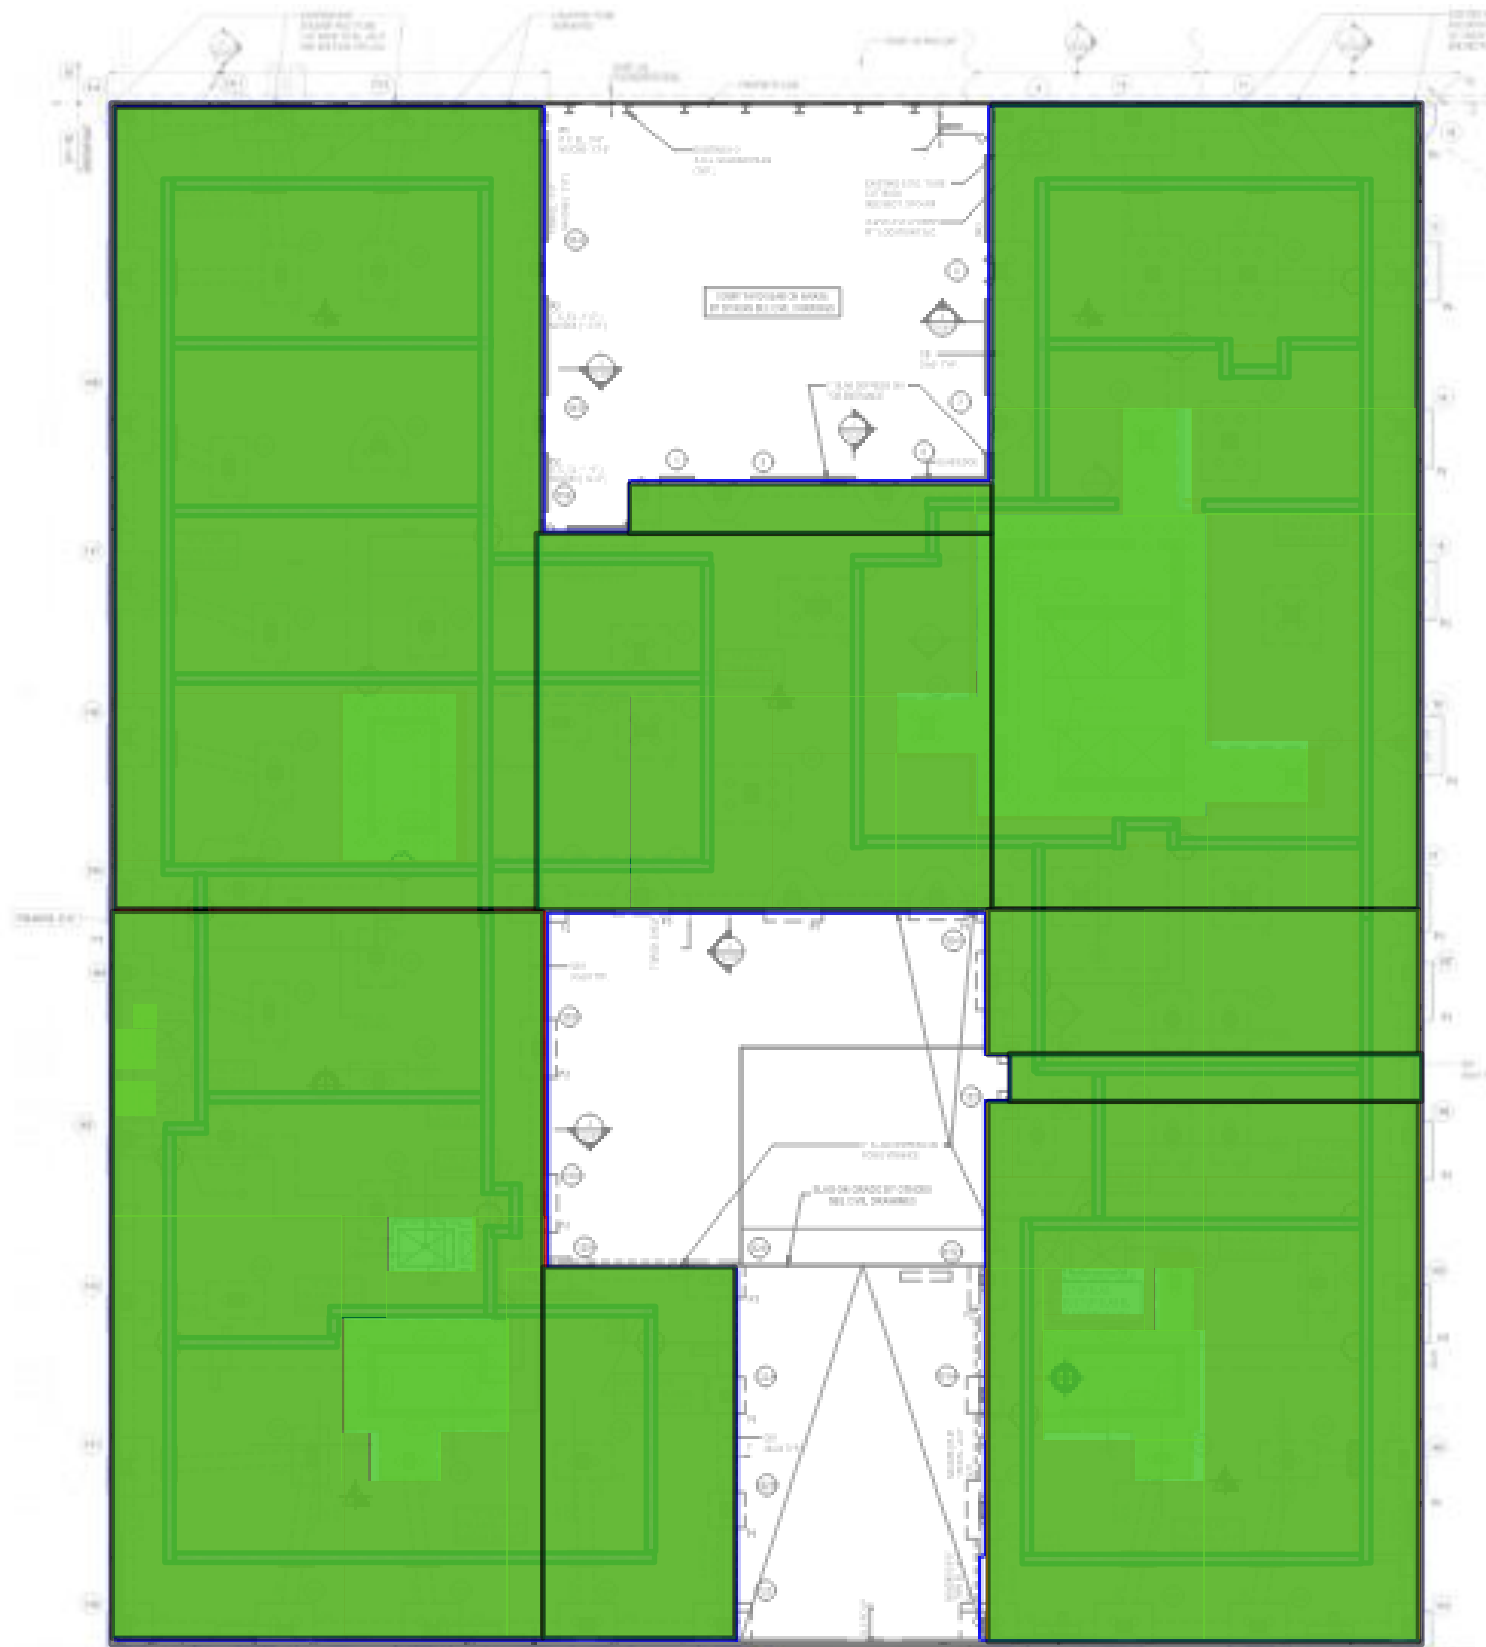
### WATERPROOFING/VAPOR BARRIER AND SMD INSTALLATION MAP

Concrete Foundation Slab Poured

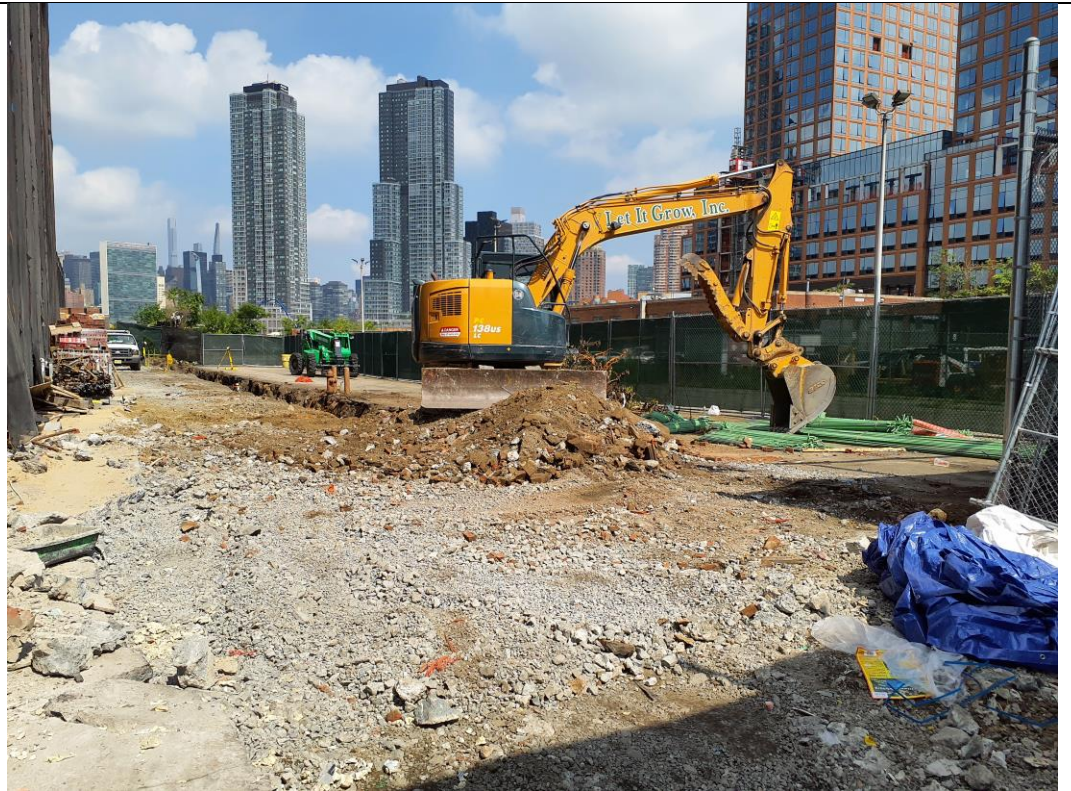
**Photo 1:**

General view of the eastern courtyard and retaining wall work area (facing northeast).

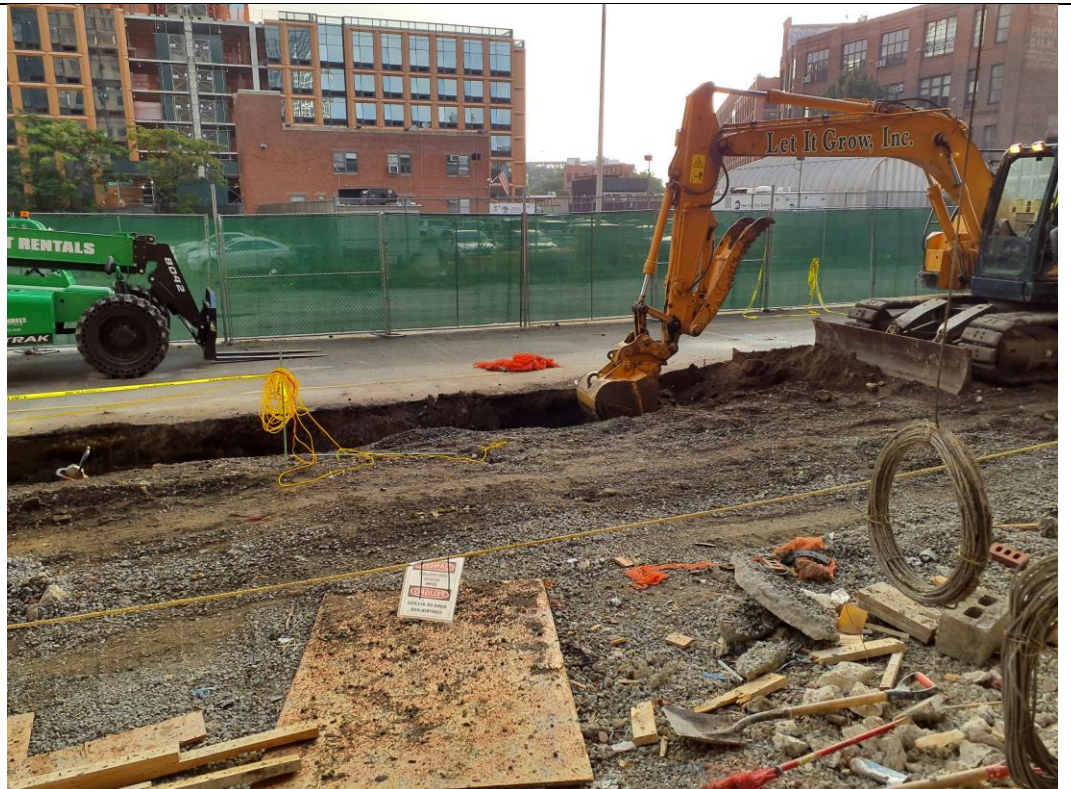
**Photo 2:**

View of Let It Grow excavating along the eastern site boundary in waste characterization grid COMP K and on the eastern adjoining property (facing southeast).

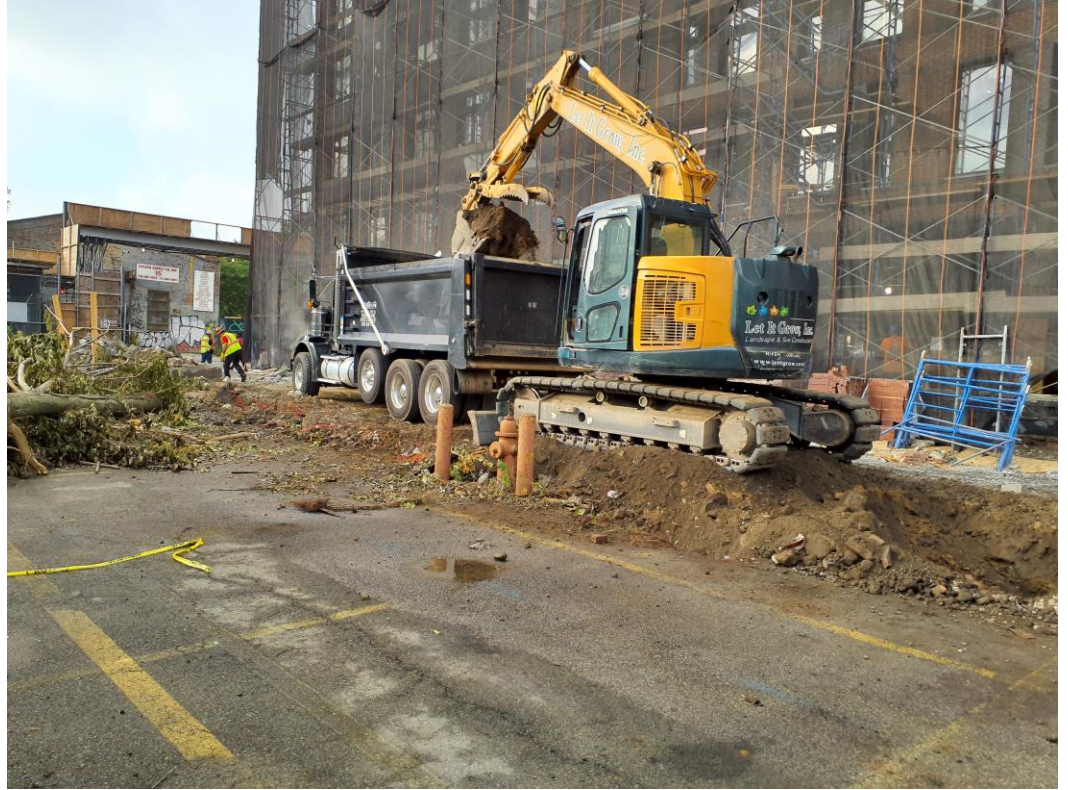
**Photo 3:**  
View of Let It Grow loading  
a truck for off-site disposal  
to the CEC facility (facing  
southwest).

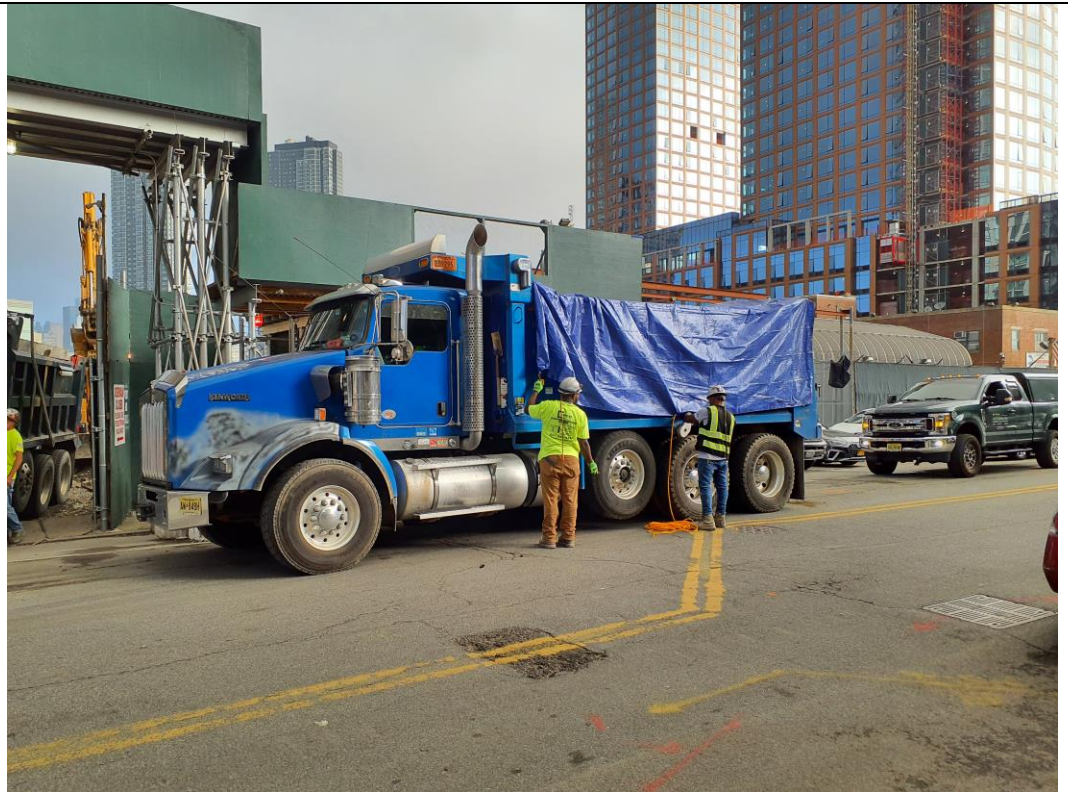
**Photo 4:**  
View of loaded truck being  
secured prior to leaving  
the site (facing northeast).

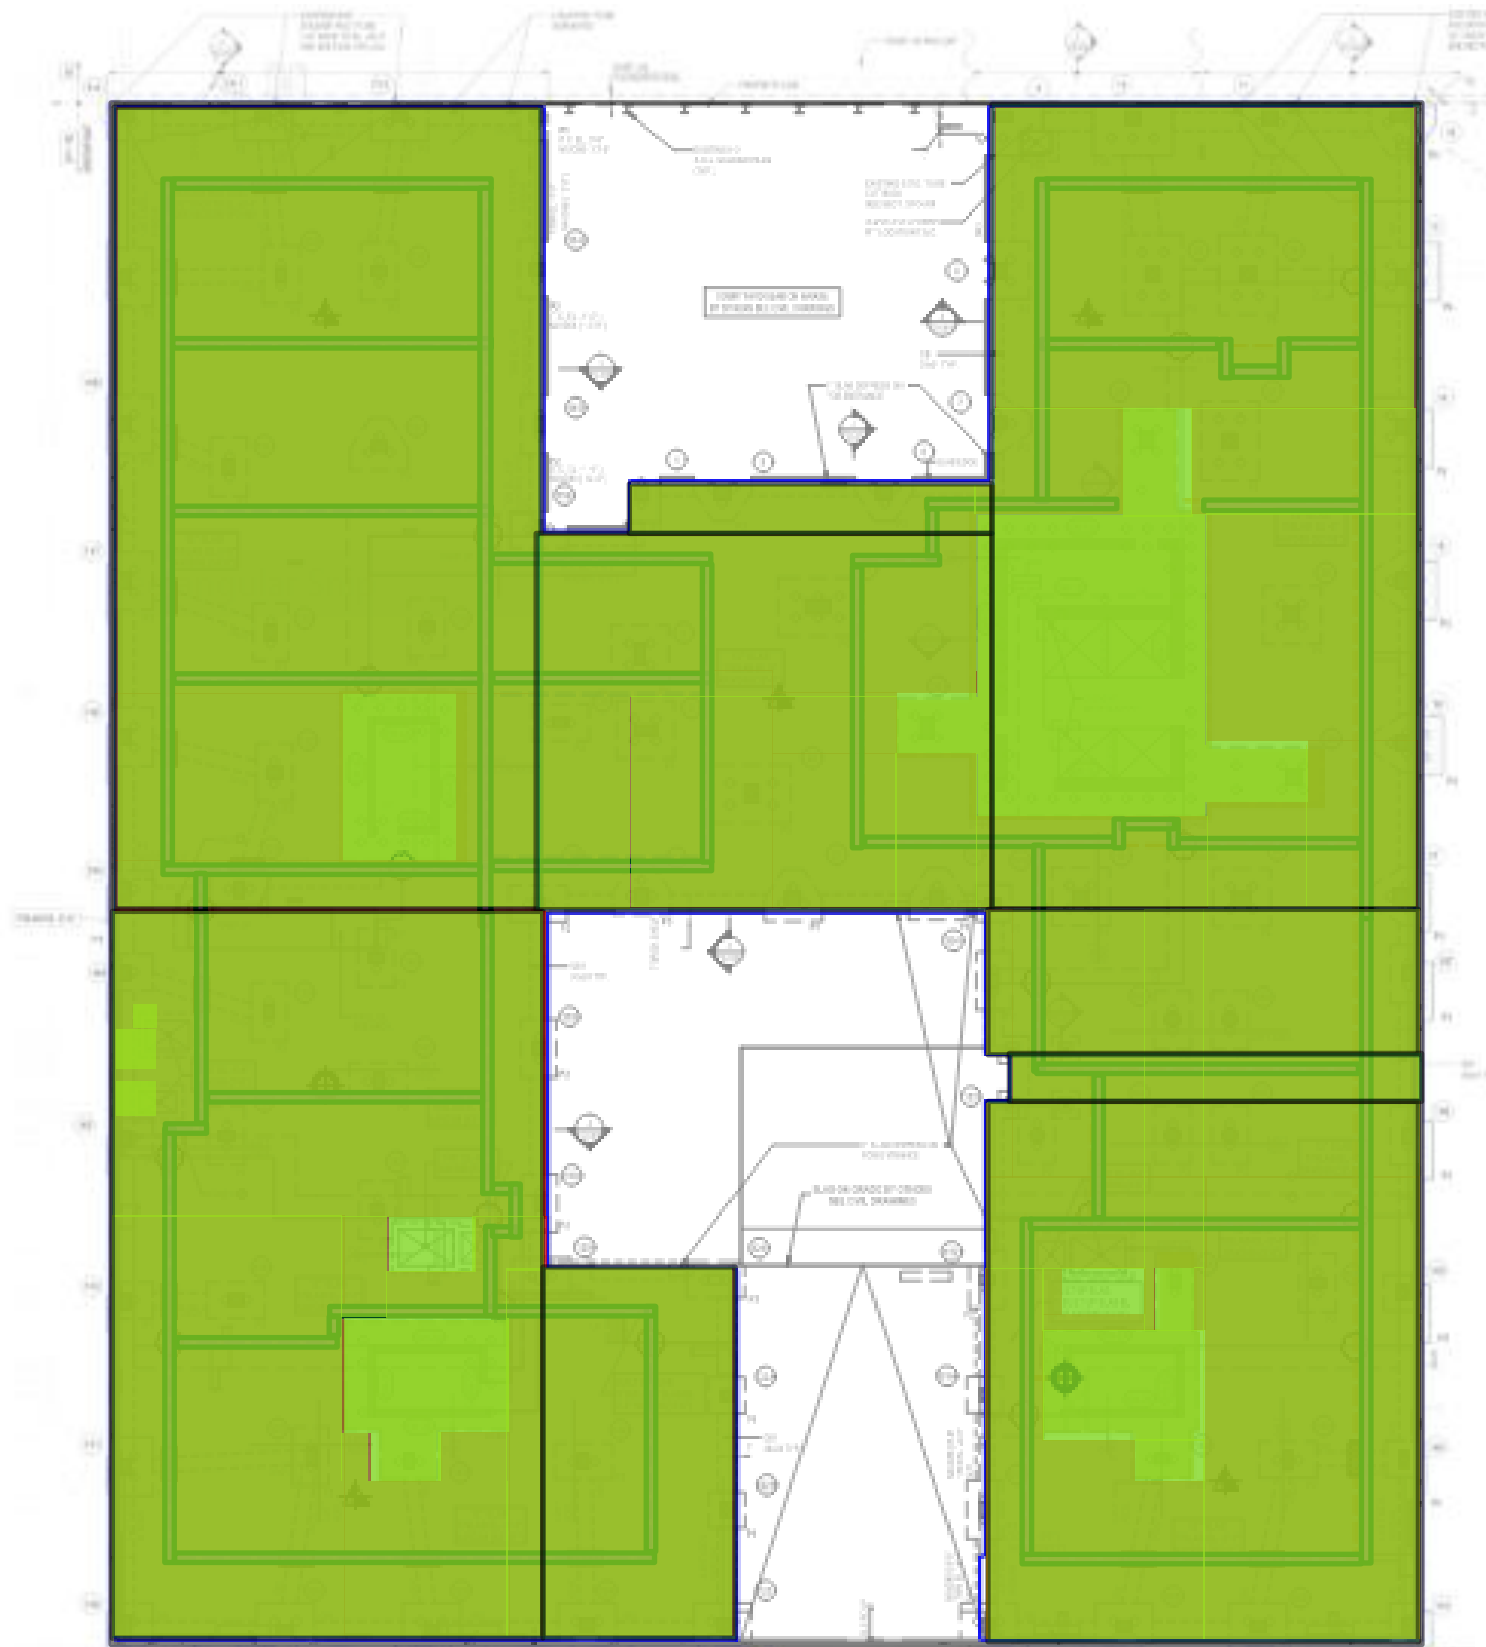
### WATERPROOFING/VAPOR BARRIER AND SMD INSTALLATION MAP

Concrete Foundation Slab Poured

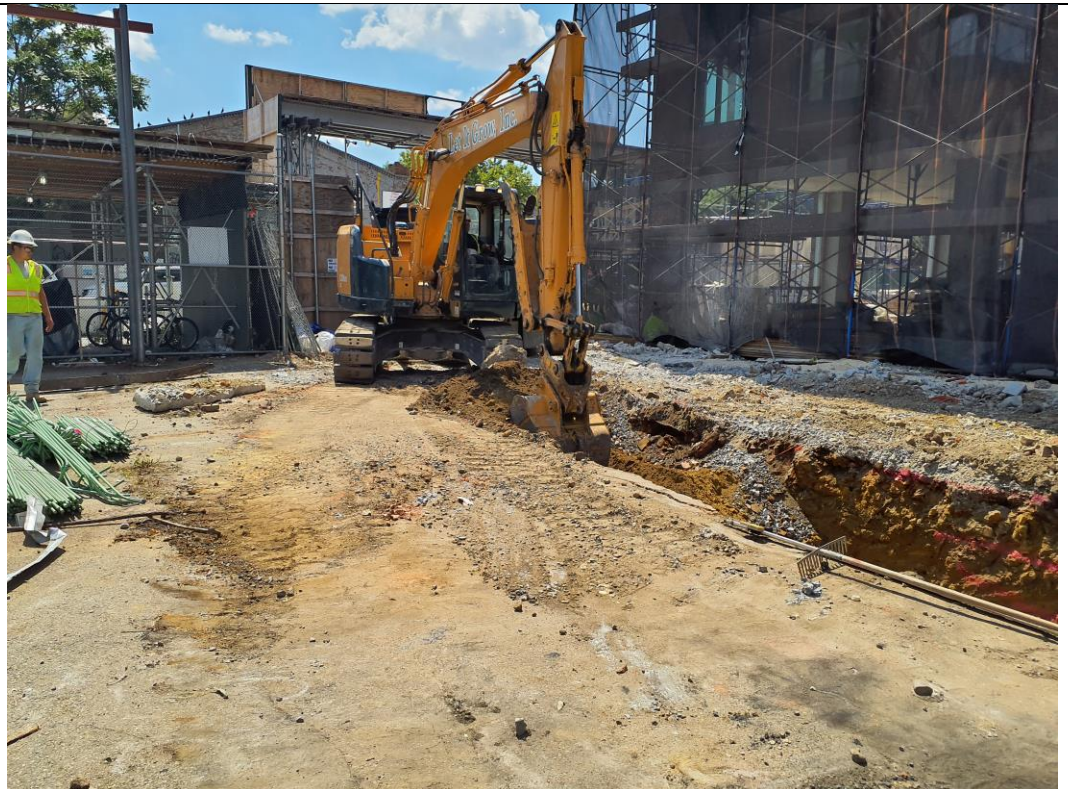
**Photo 2:**

View of Let It Grow excavating along the eastern site boundary in waste characterization grid COMP K and on the eastern adjoining property (facing southwest).

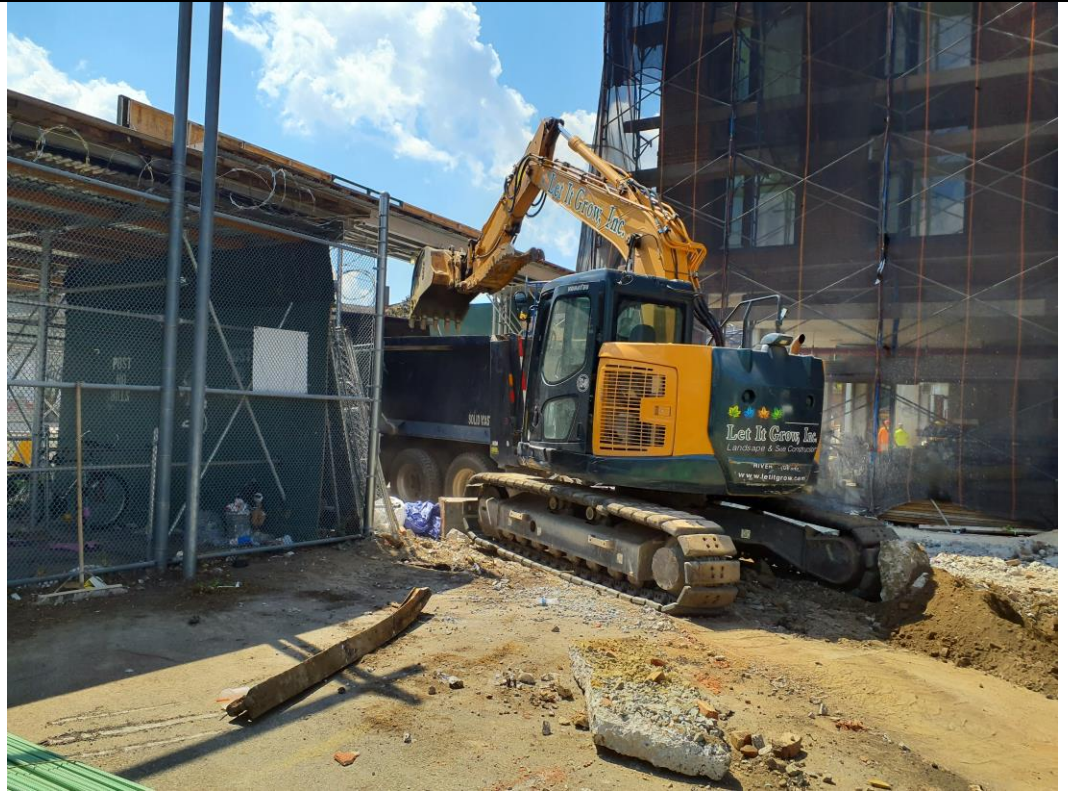
**Photo 3:**  
View of Let It Grow loading  
a truck for off-site disposal  
to the CEC facility (facing  
southwest).

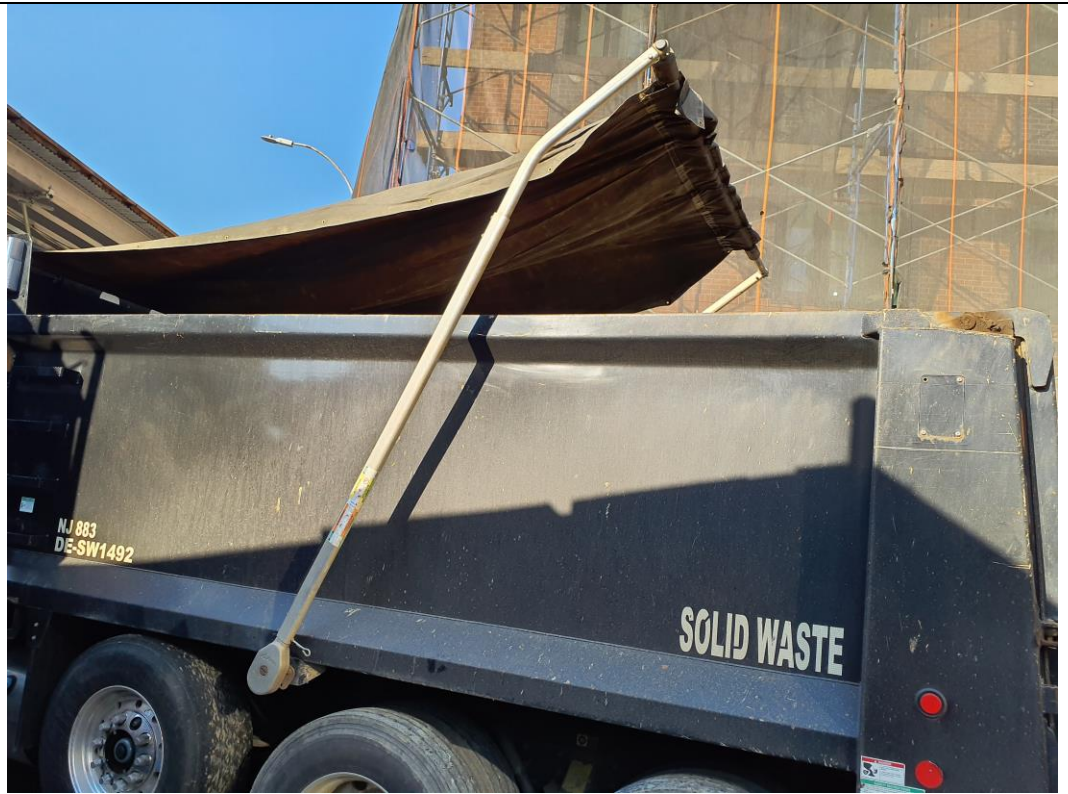
**Photo 4:**  
View of loaded truck being  
secured prior to leaving the  
site (facing southwest).
