**DAILY FIELD REPORT 108**

<b>BCP Project No:</b>	C224304	<b>Date:</b>	August 22, 2022
------------------------	---------	--------------	-----------------

<b>Project Name:</b>	45 Commercial Street	<b>Time:</b>	6:30 am to 3:30 pm
----------------------	----------------------	--------------	--------------------

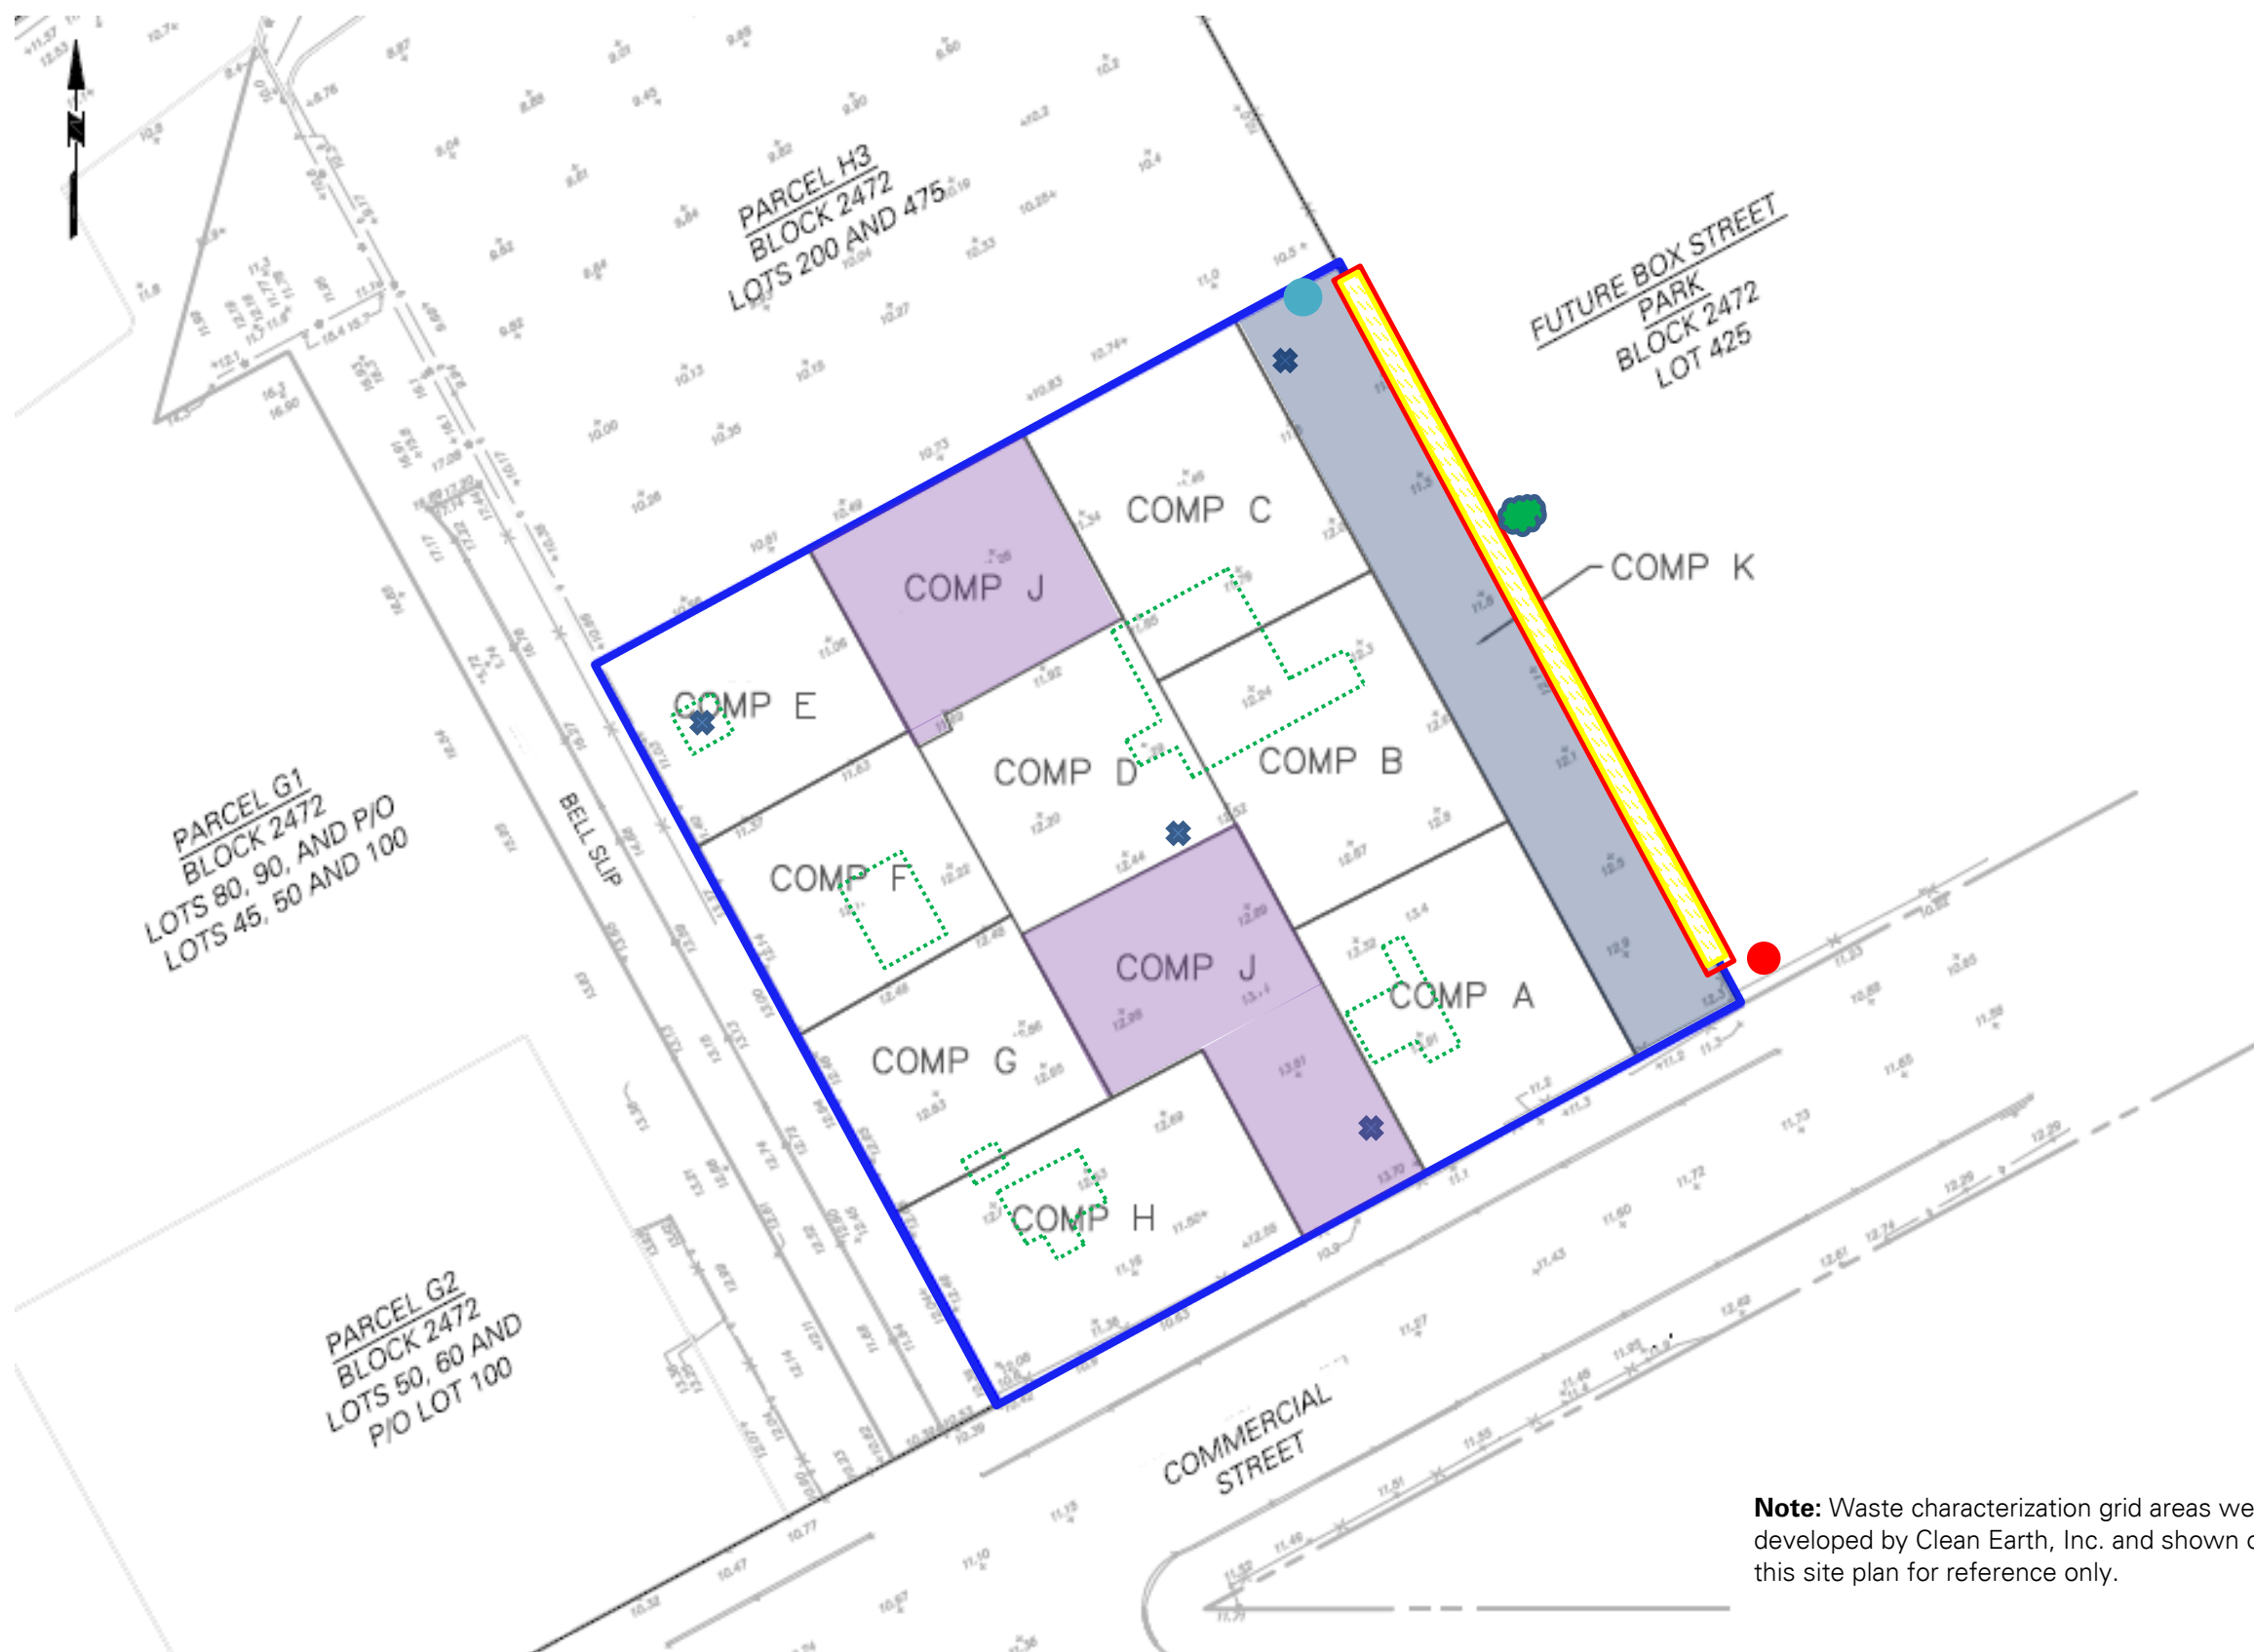
**SITE PLAN**

-   **Site Boundary**
-   **Waste Characterization Grid  
COMP I (5-10)**
-   **Upwind CAMP station**
-   **Downwind CAMP station**
-   **Stockpile – Soil**
-   **Stockpile – Imported Material**
-   **Stockpile – C&D**
-

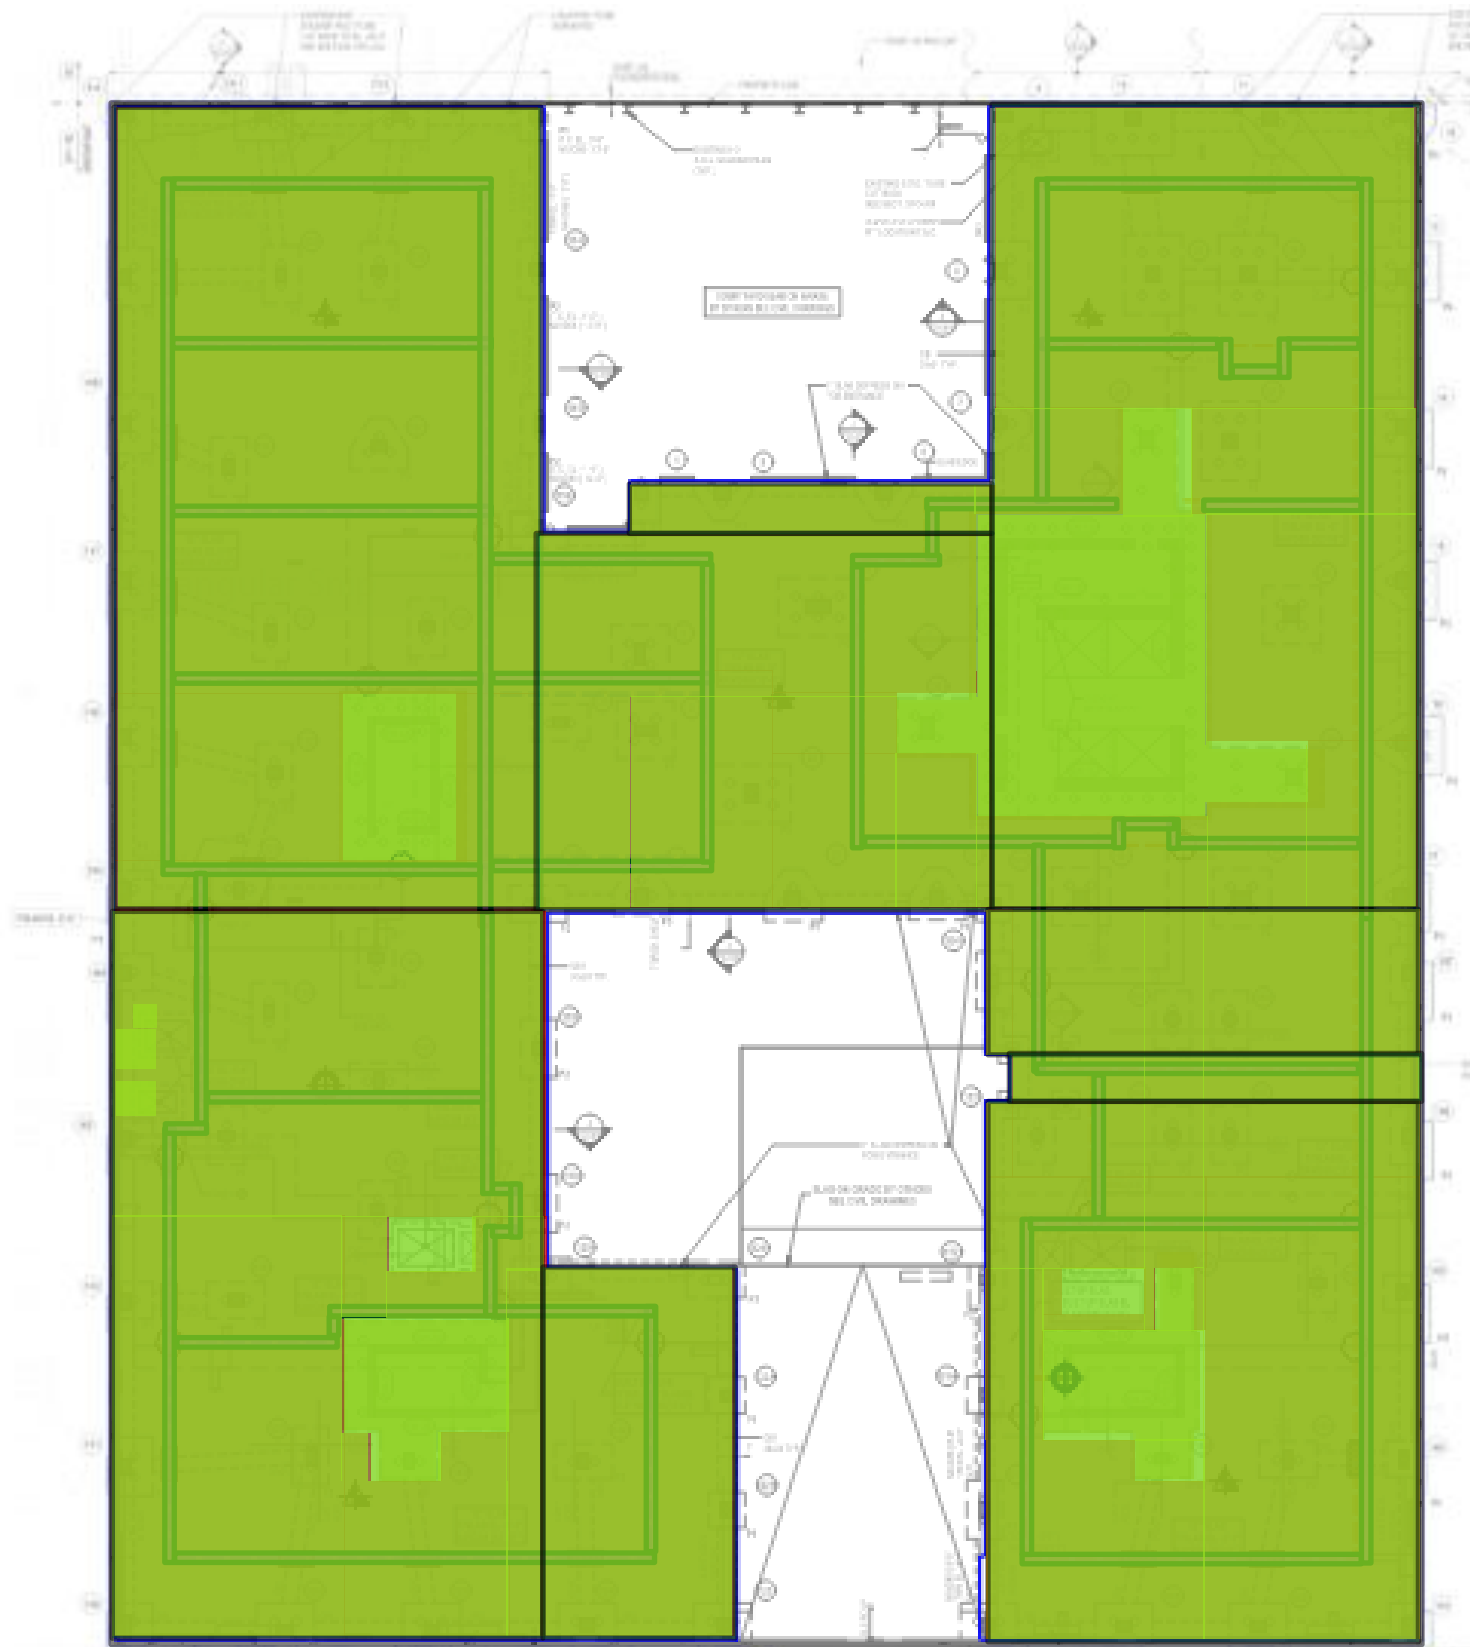
### WATERPROOFING/VAPOR BARRIER AND SMD INSTALLATION MAP

Concrete Foundation Slab Poured

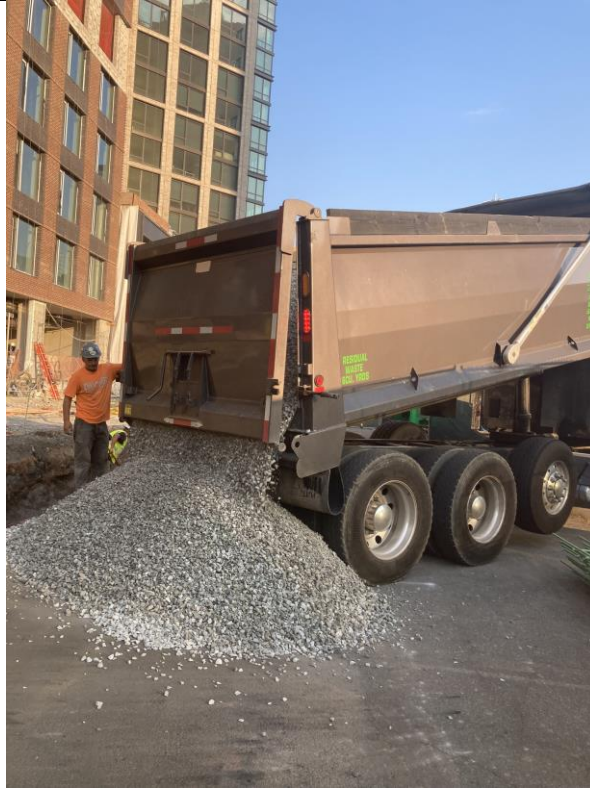
**Photo 1:**  
View of Let It Grow importing 0.75-inch stone to be used as backfill in the retaining wall excavation (facing northwest).

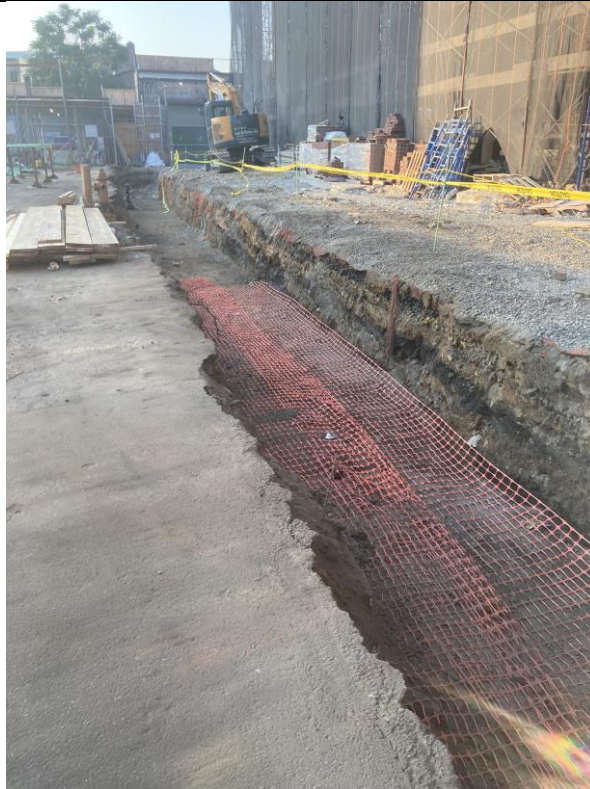
**Photo 2:**  
View of Let It Grow installing orange snow fence demarcation layer at the base of the retaining wall excavation (facing southwest).

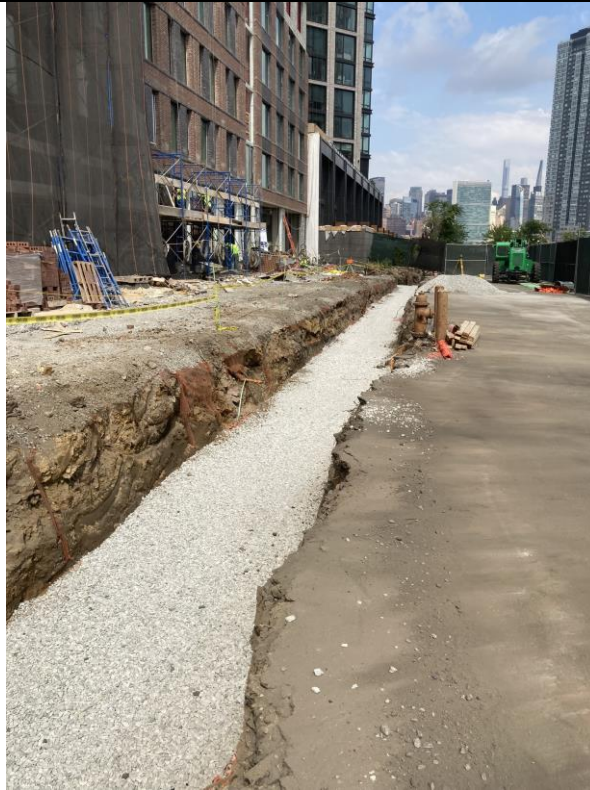
**Photo 4:**

View of retaining wall backfilled with an about 4-inch-thick layer of 0.75-inch stone in preparation for installation of concrete formwork (facing north).

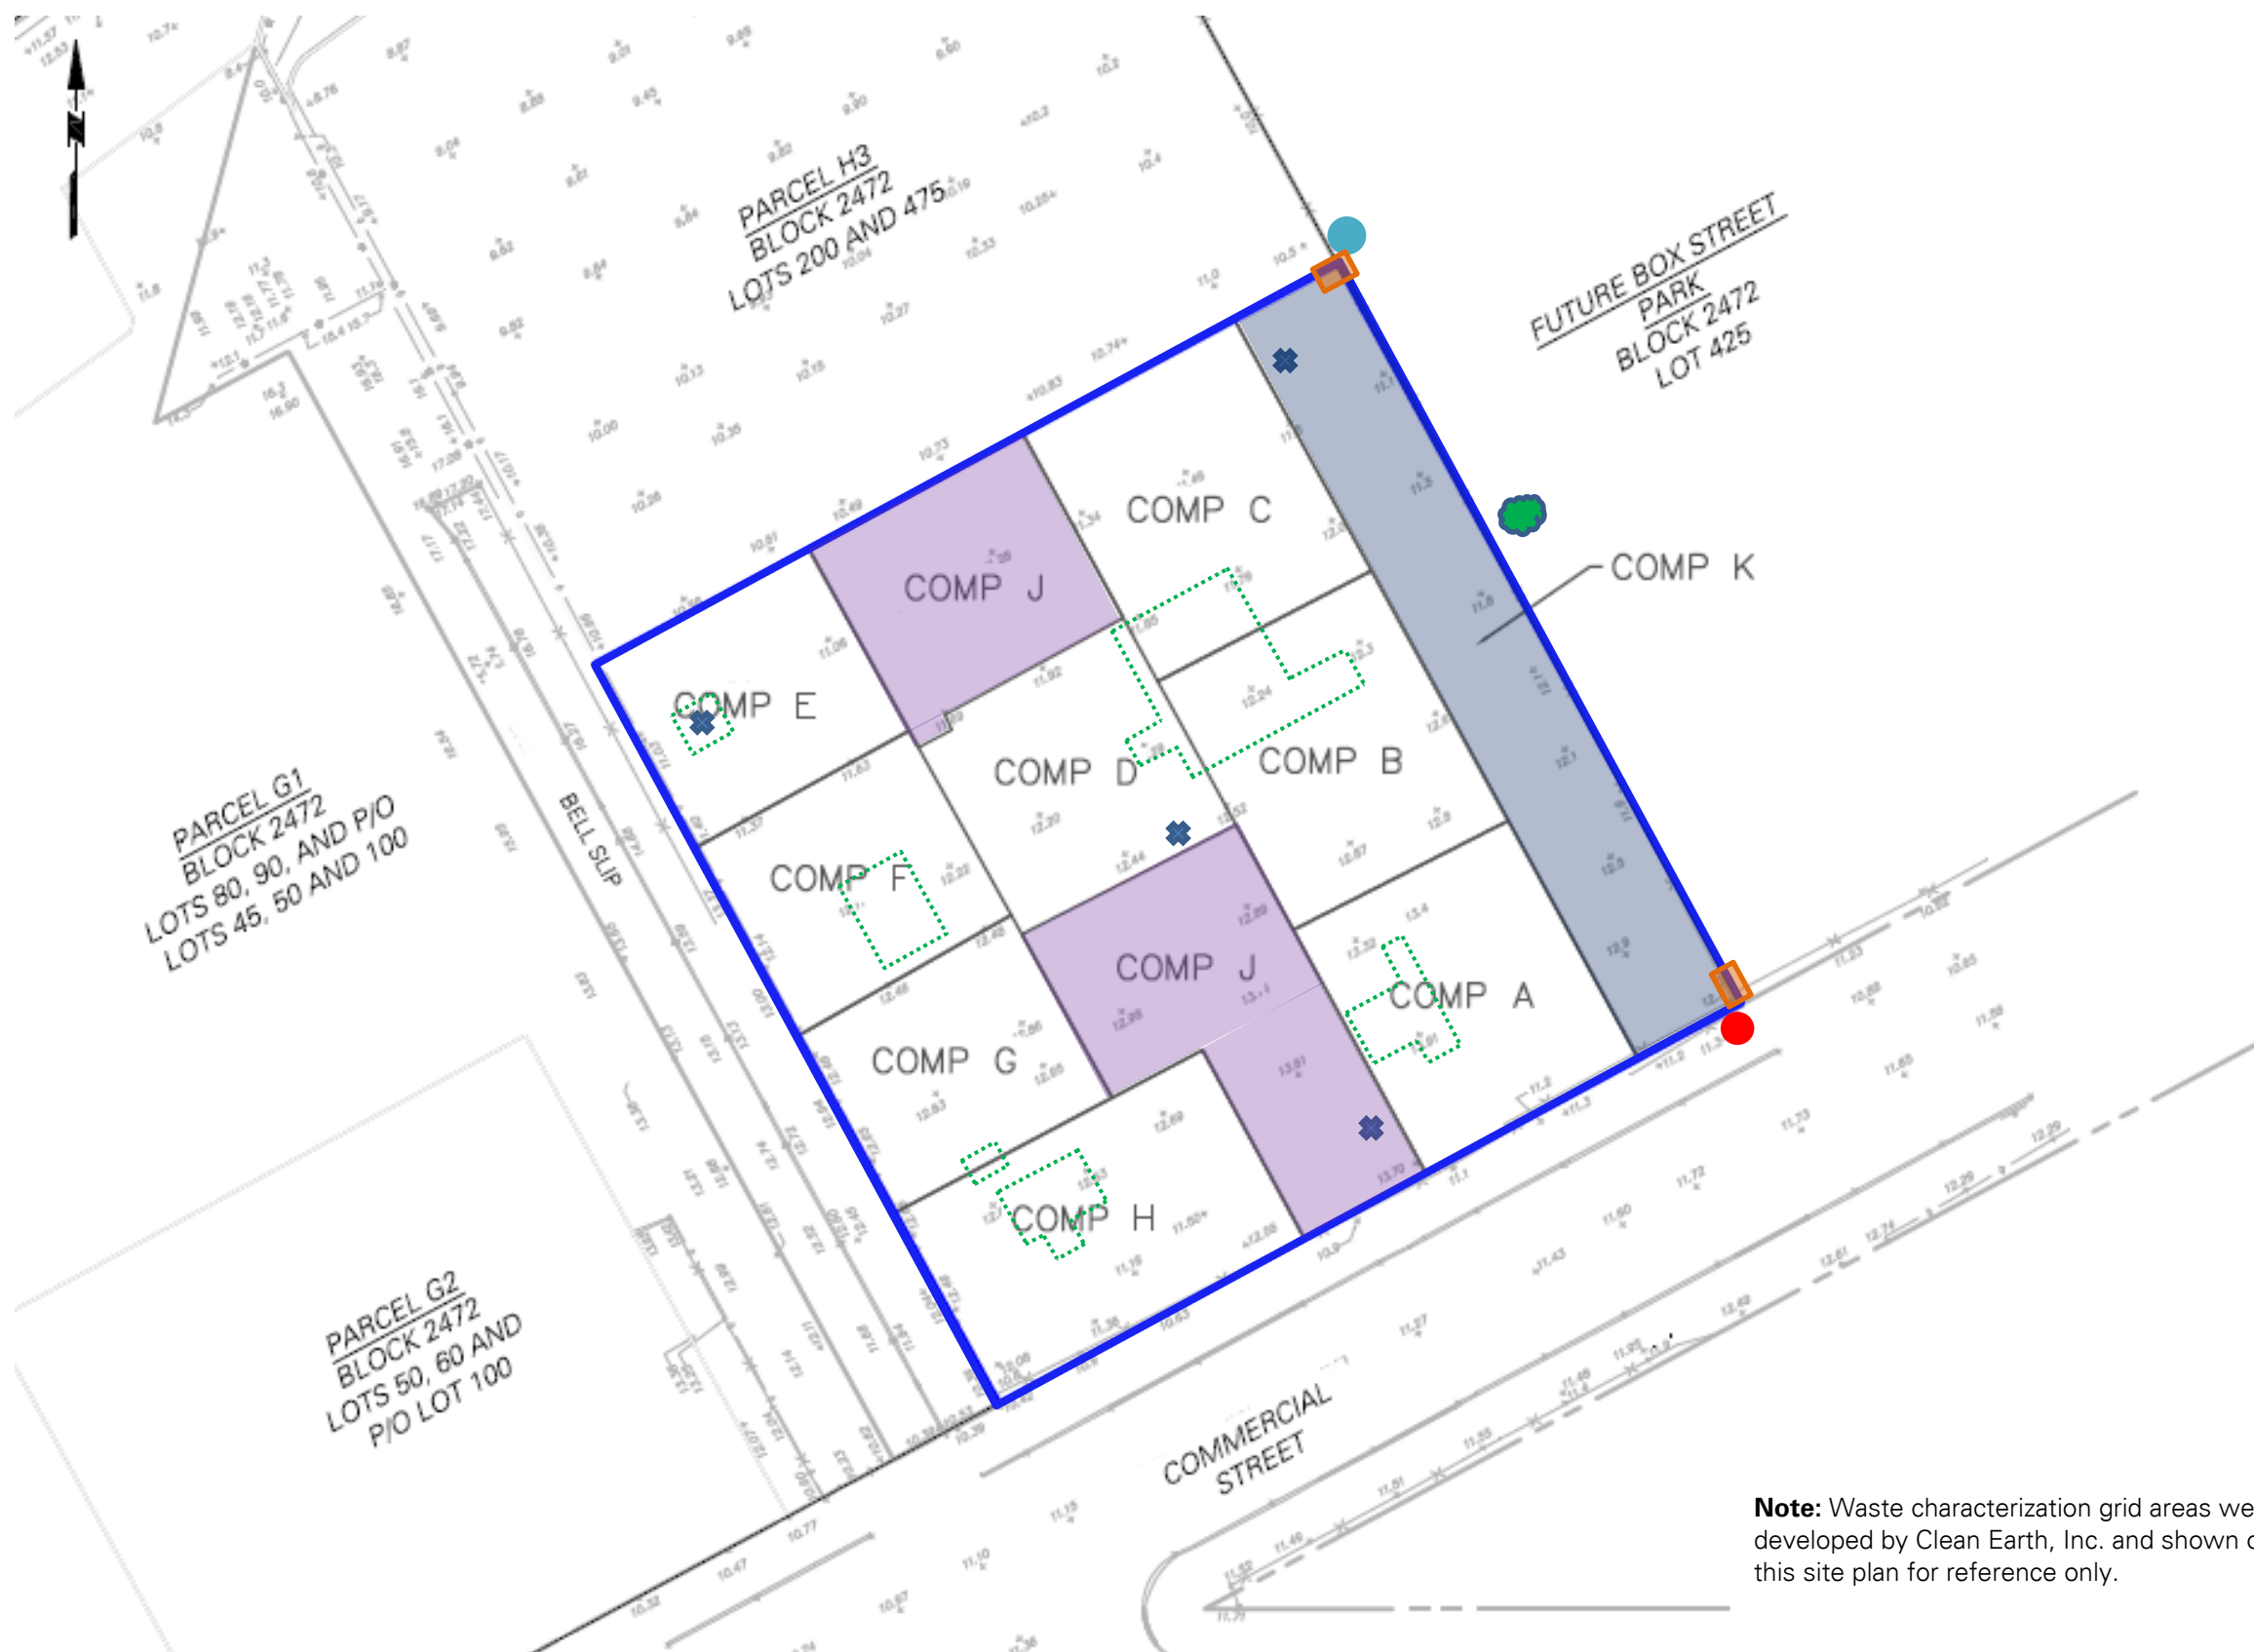
**SITE PLAN**

-   **Site Boundary**
-   **Waste Characterization Grid  
COMP I (5-10)**
-   **Upwind CAMP station**
-   **Downwind CAMP station**
-   **Stockpile – Soil**
-   **Stockpile – Imported Material**
-

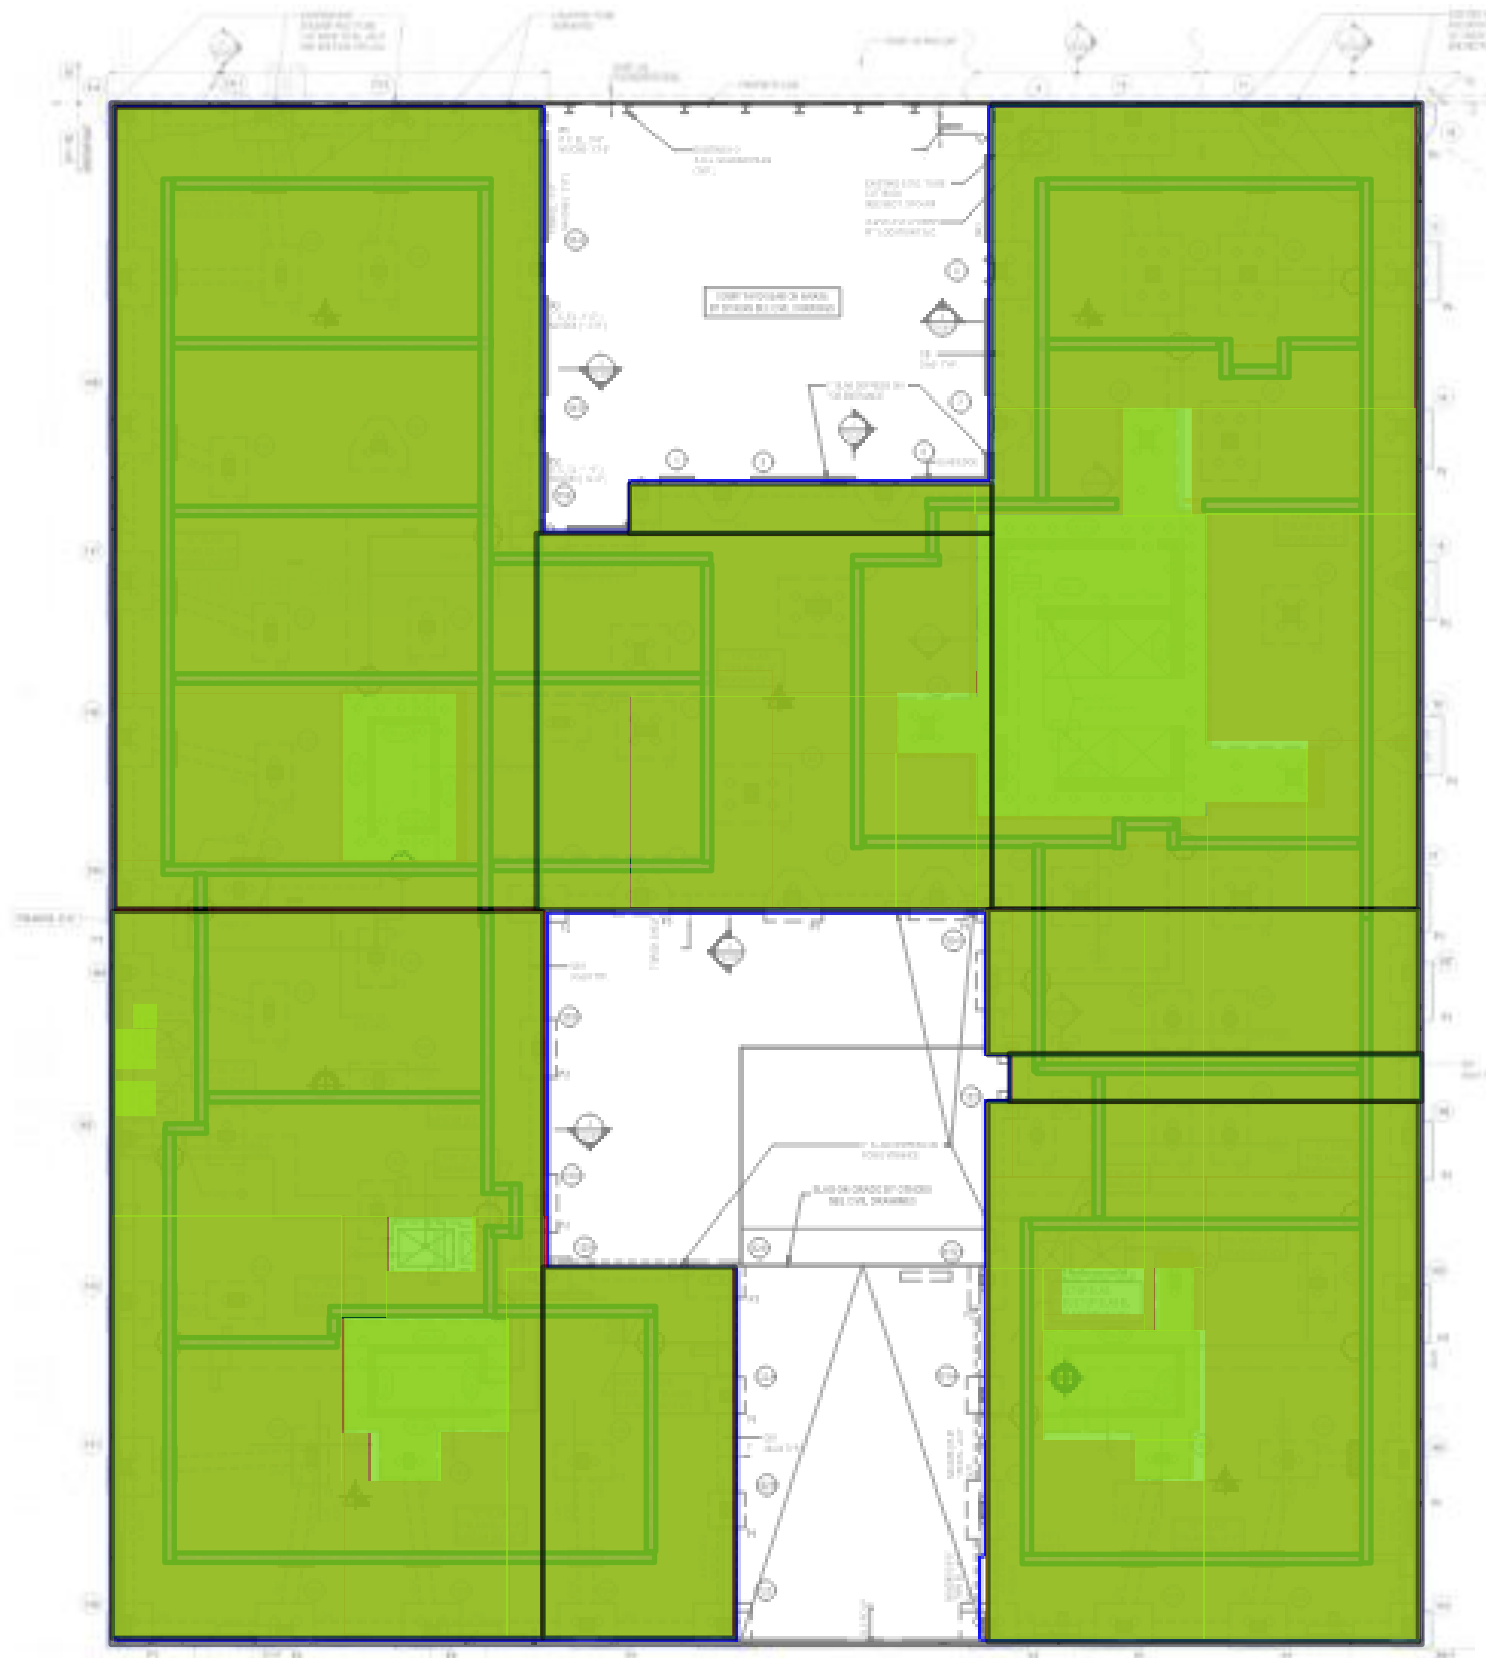
### WATERPROOFING/VAPOR BARRIER AND SMD INSTALLATION MAP

Concrete Foundation Slab Poured

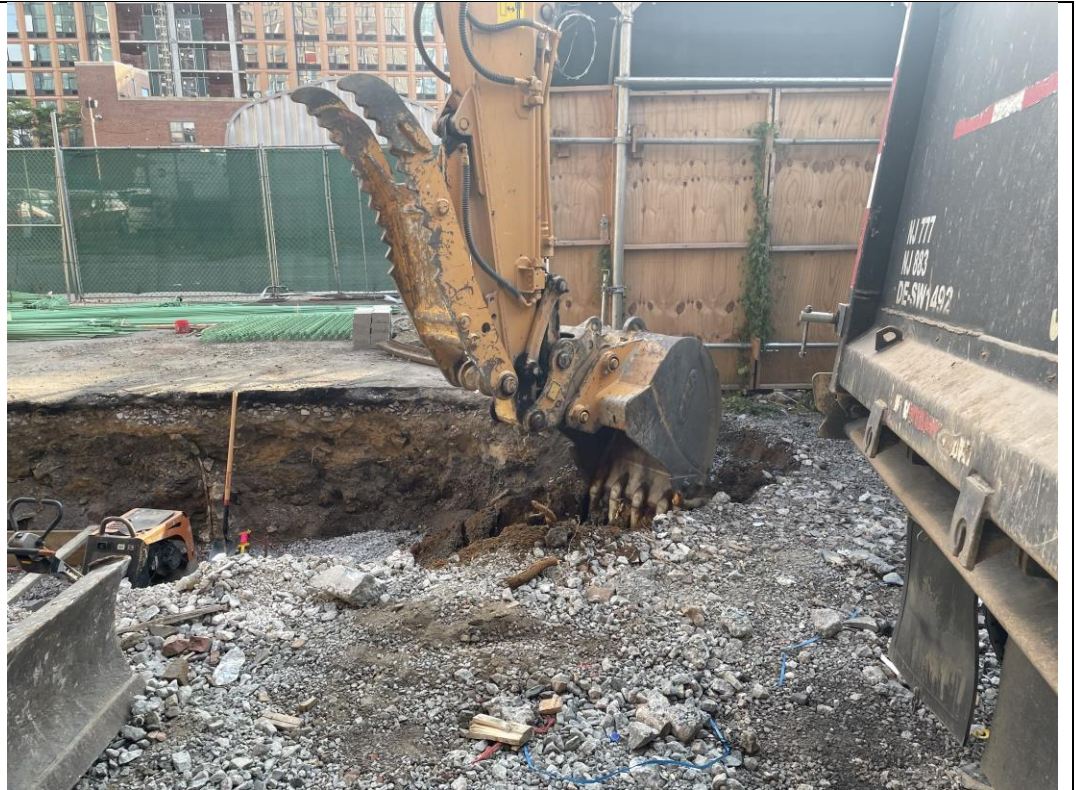
**Photo 1:**

View of Let It Grow excavating along the eastern site boundary in waste characterization grid COMP K and on the eastern adjoining property (facing east).

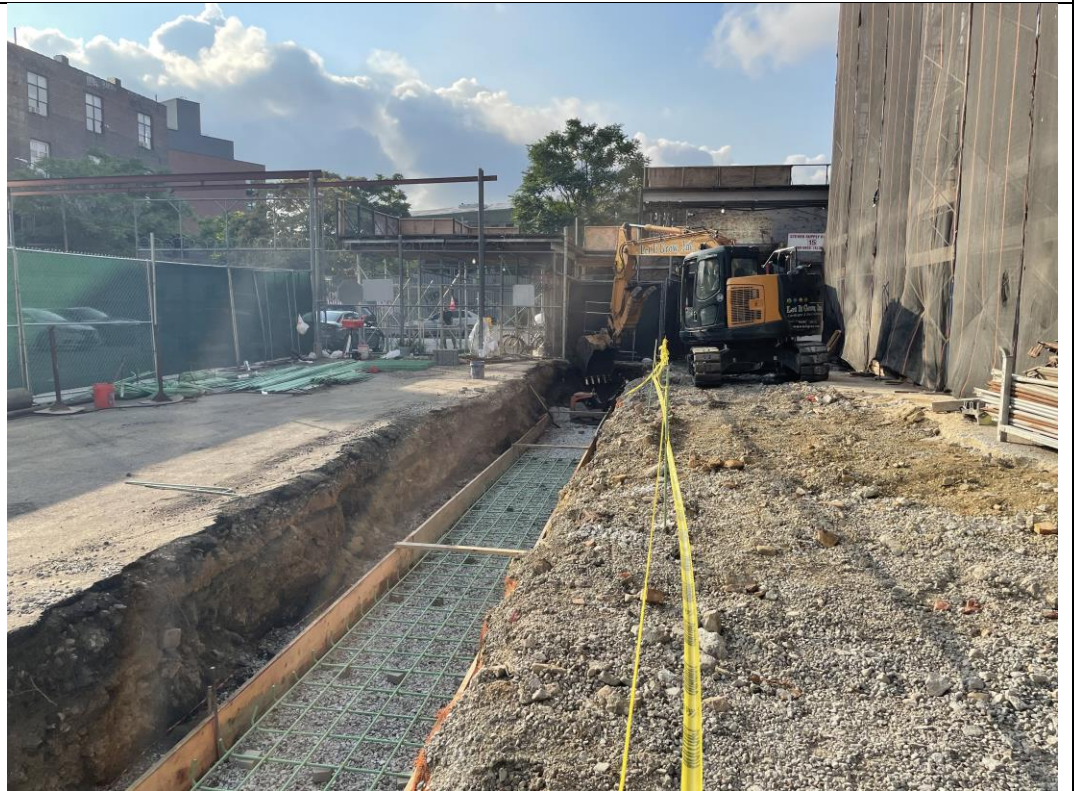
**Photo 2:**

View of Let It Grow excavating along the eastern site boundary in waste characterization grid COMP K and on the eastern adjoining property (facing south).

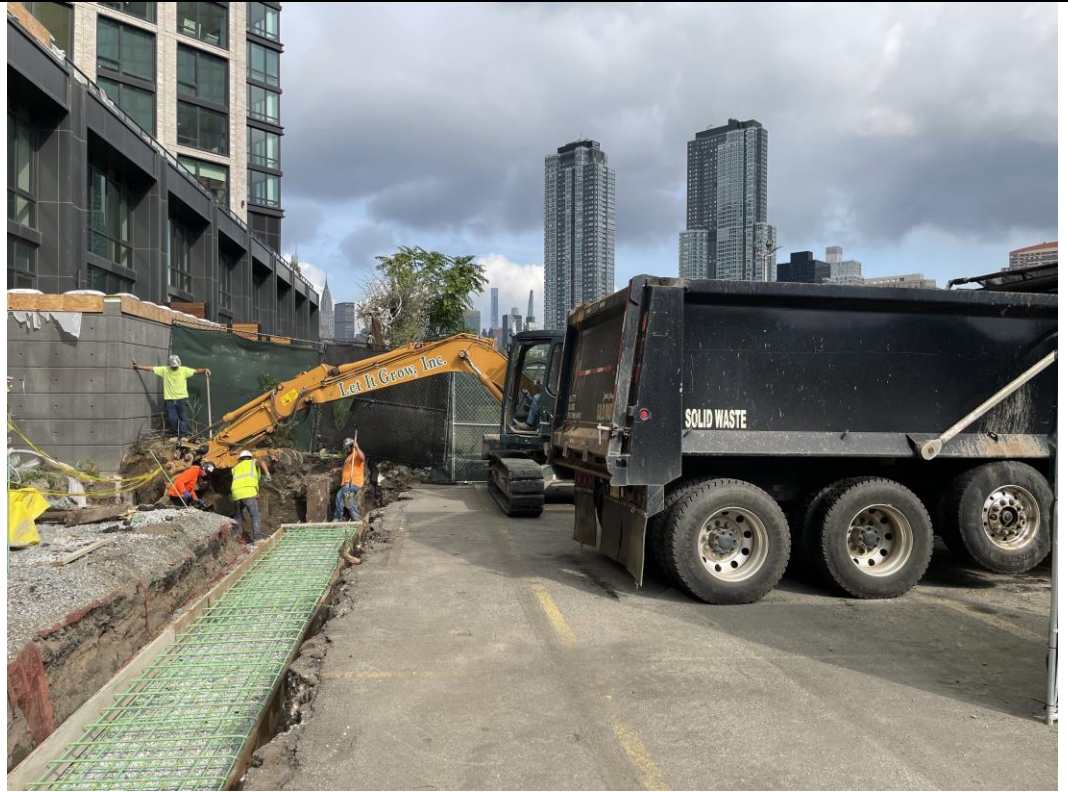
**Photo 3:**

View of Let It Grow excavating along the eastern site boundary in waste characterization grid COMP K and on the eastern adjoining property (facing north).

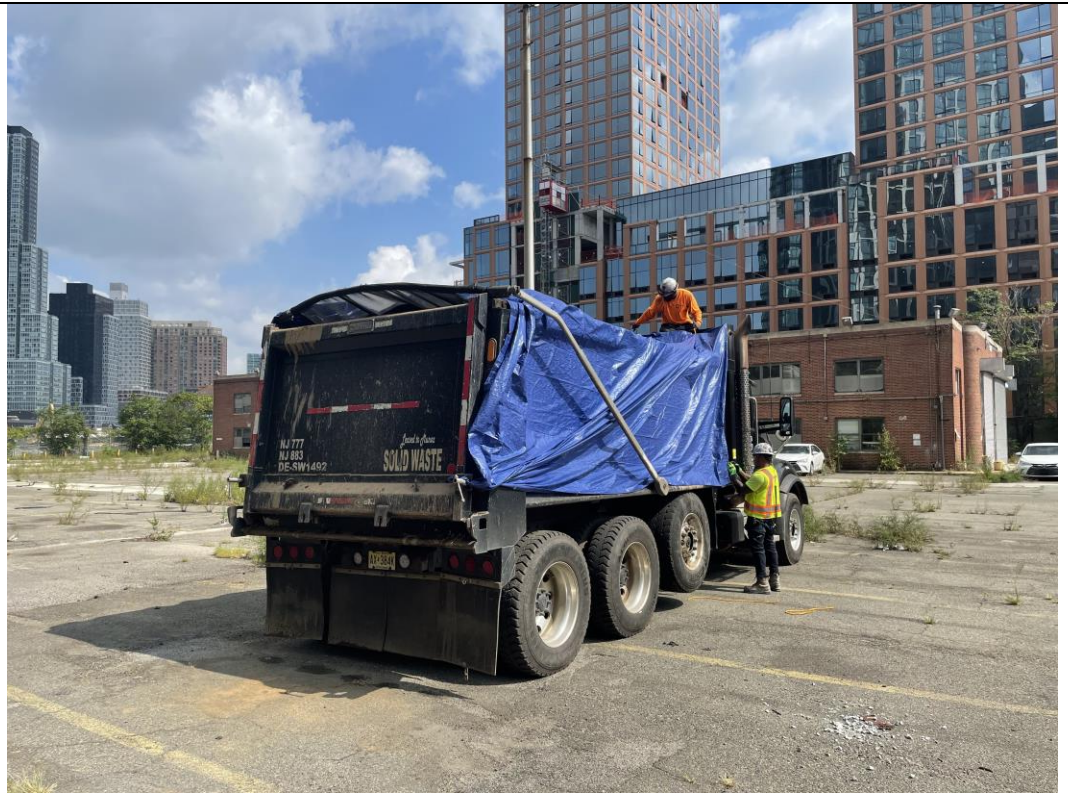
**Photo 4:**

View of loaded truck being secured prior to leaving the site (facing northeast).
