2023 PERIODIC REVIEW REPORT

45 COMMERCIAL STREET BROOKLYN, NEW YORK 11222 NYSDEC BCP Site No. C224304

June 11, 2024 170229024

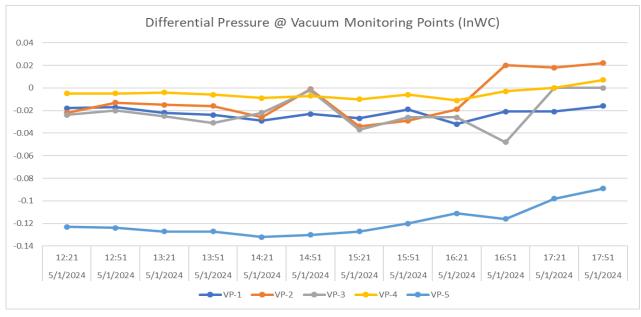
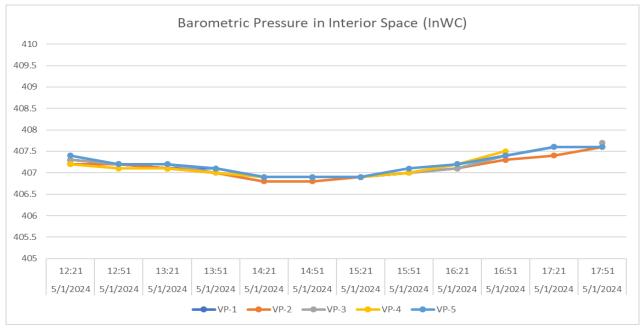
5/1 to 5/2 - VMP and Barometric Pressure Monitoring Event VMP Differential Pressure and Indoor Barometric Pressure Readings - May 1st

Readings were collected manually using a VelociCalc 9565 every 30 minutes VMP = Vacuum Monitoring Point InWC = Inches of Water Column

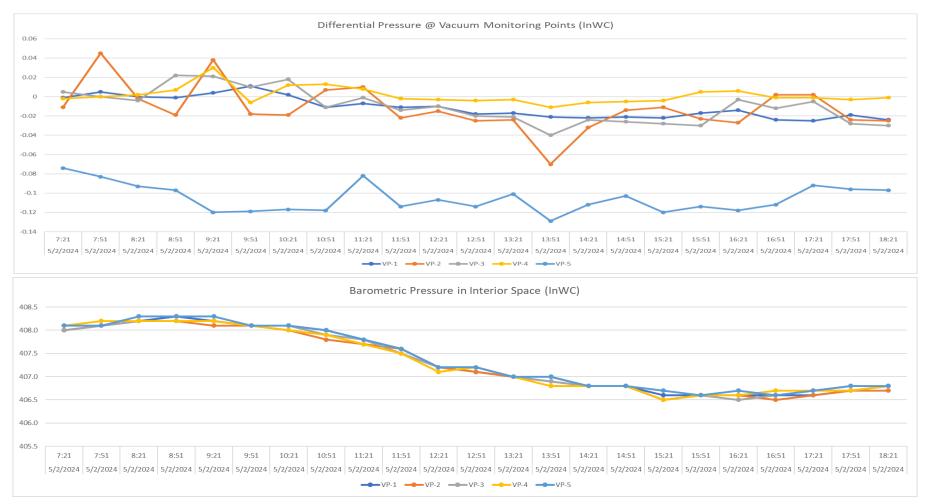
5/1 to 5/2 - VMP and Barometric Pressure Monitoring Event VMP Differential Pressure and Indoor Barometric Pressure Readings - May 2nd

Readings were collected manually using a VelociCalc 9565 every 30 minutes VMP = Vacuum Monitoring Point InWC = Inches of Water Column

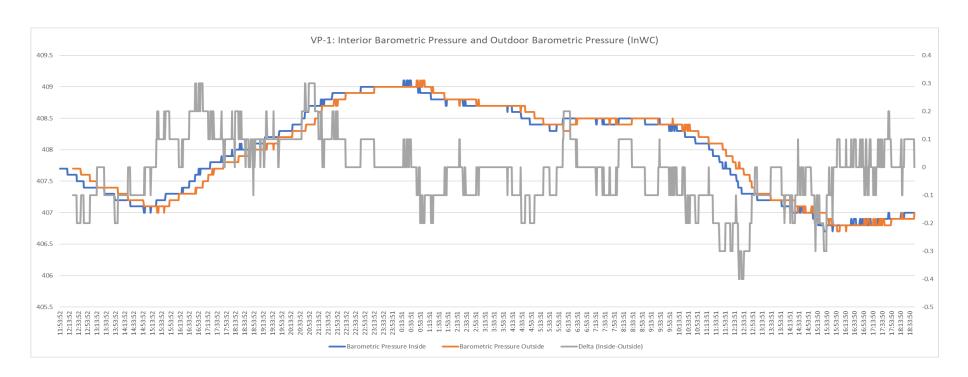
5/1 to 5/2 - VMP and Barometric Pressure Monitoring Event VP-1 - Indoor vs. Outdoor Barometric Pressure Chart

The barometric pressure data indicated that the building's HVAC system is creating lower indoor air pressure in the interior spaces containing VP-2, VP-3 and VP-4 relative to outdoor air pressure, which creates fluctuating negative indoor air pressure. Fluctuating negative indoor air pressure is a likely a source of the variation observed in the VMP differential pressure readings. Tabulated and charted barometric pressure data are included in Appendix C.

The project team, including the mechanical engineer responsible for the design, discussed potential options for adjusting the HVAC systems to increase interior air pressures. On May 16, 2024, Monadnock adjusted the HVAC system servicing the three conditioned spaces, balancing it, to the extent practical within operating requirements, with the goal of increasing indoor air pressure to more closely match outdoor air pressure. Following the adjustments, Langan

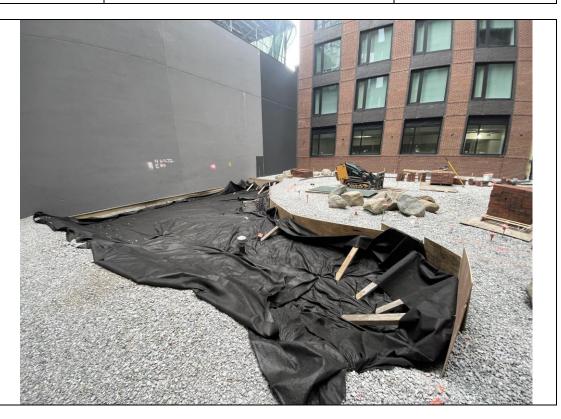
View of black geotextile fabric installed prior to topsoil backfilling in the north courtyard

The temporary 2-inch-thick concrete slab that was previously installed in the northern part of the north courtyard was removed and replaced with a minimum 2-foot-thick layer of imported topsoil. Black geotextile fabric was placed in the area prior to the placement of topsoil to demarcate the base of the topsoil layer (a typical photograph of geotextile fabric being installed is included in Appendix F). The concrete waste was disposed of off-site as construction and demolition debris.

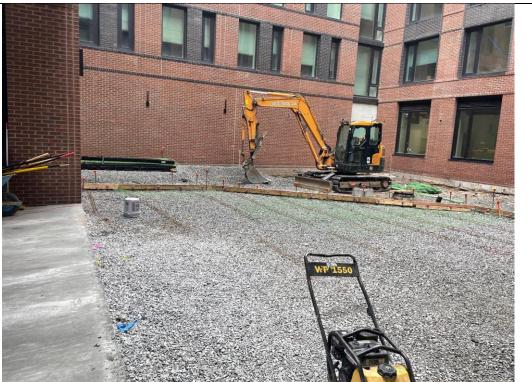
View of imported stone backfill and concrete slab partially installed in the southern courtyard

The temporary 2-inch-thick concrete slab that was previously installed across the southern courtyard was removed and replaced with the following elements:

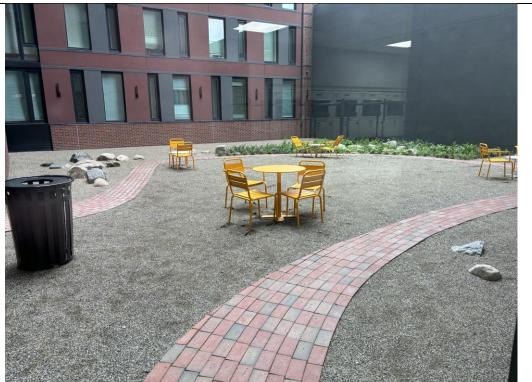
View of final cover system installed in the north courtyard

The composite cover system was inspected on May 1, 2024 during the annual site-wide inspection. The building slab and courtyards were inspected for quality and integrity. Damages or breaches to the site cover system were not observed during the inspection. No construction activity or indication of any construction activity that included the breaching of the site cover system was observed during the certification period. Photographs of the site cover system from the annual inspection are included in Appendix F.

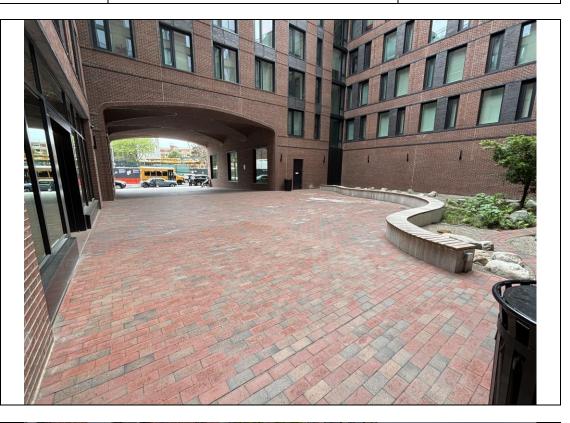
View of final cover system installed in the south courtyard

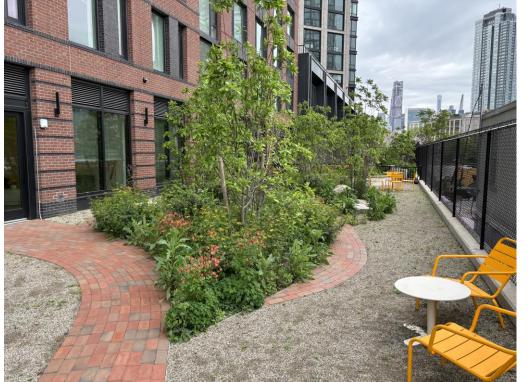
Final cover system installed in the east courtyard
