REMEDIAL INVESTIGATION REPORT

130 SAINT FELIX STREET SITE

Brooklyn, New York

NYSDEC BCP Site No. C224306

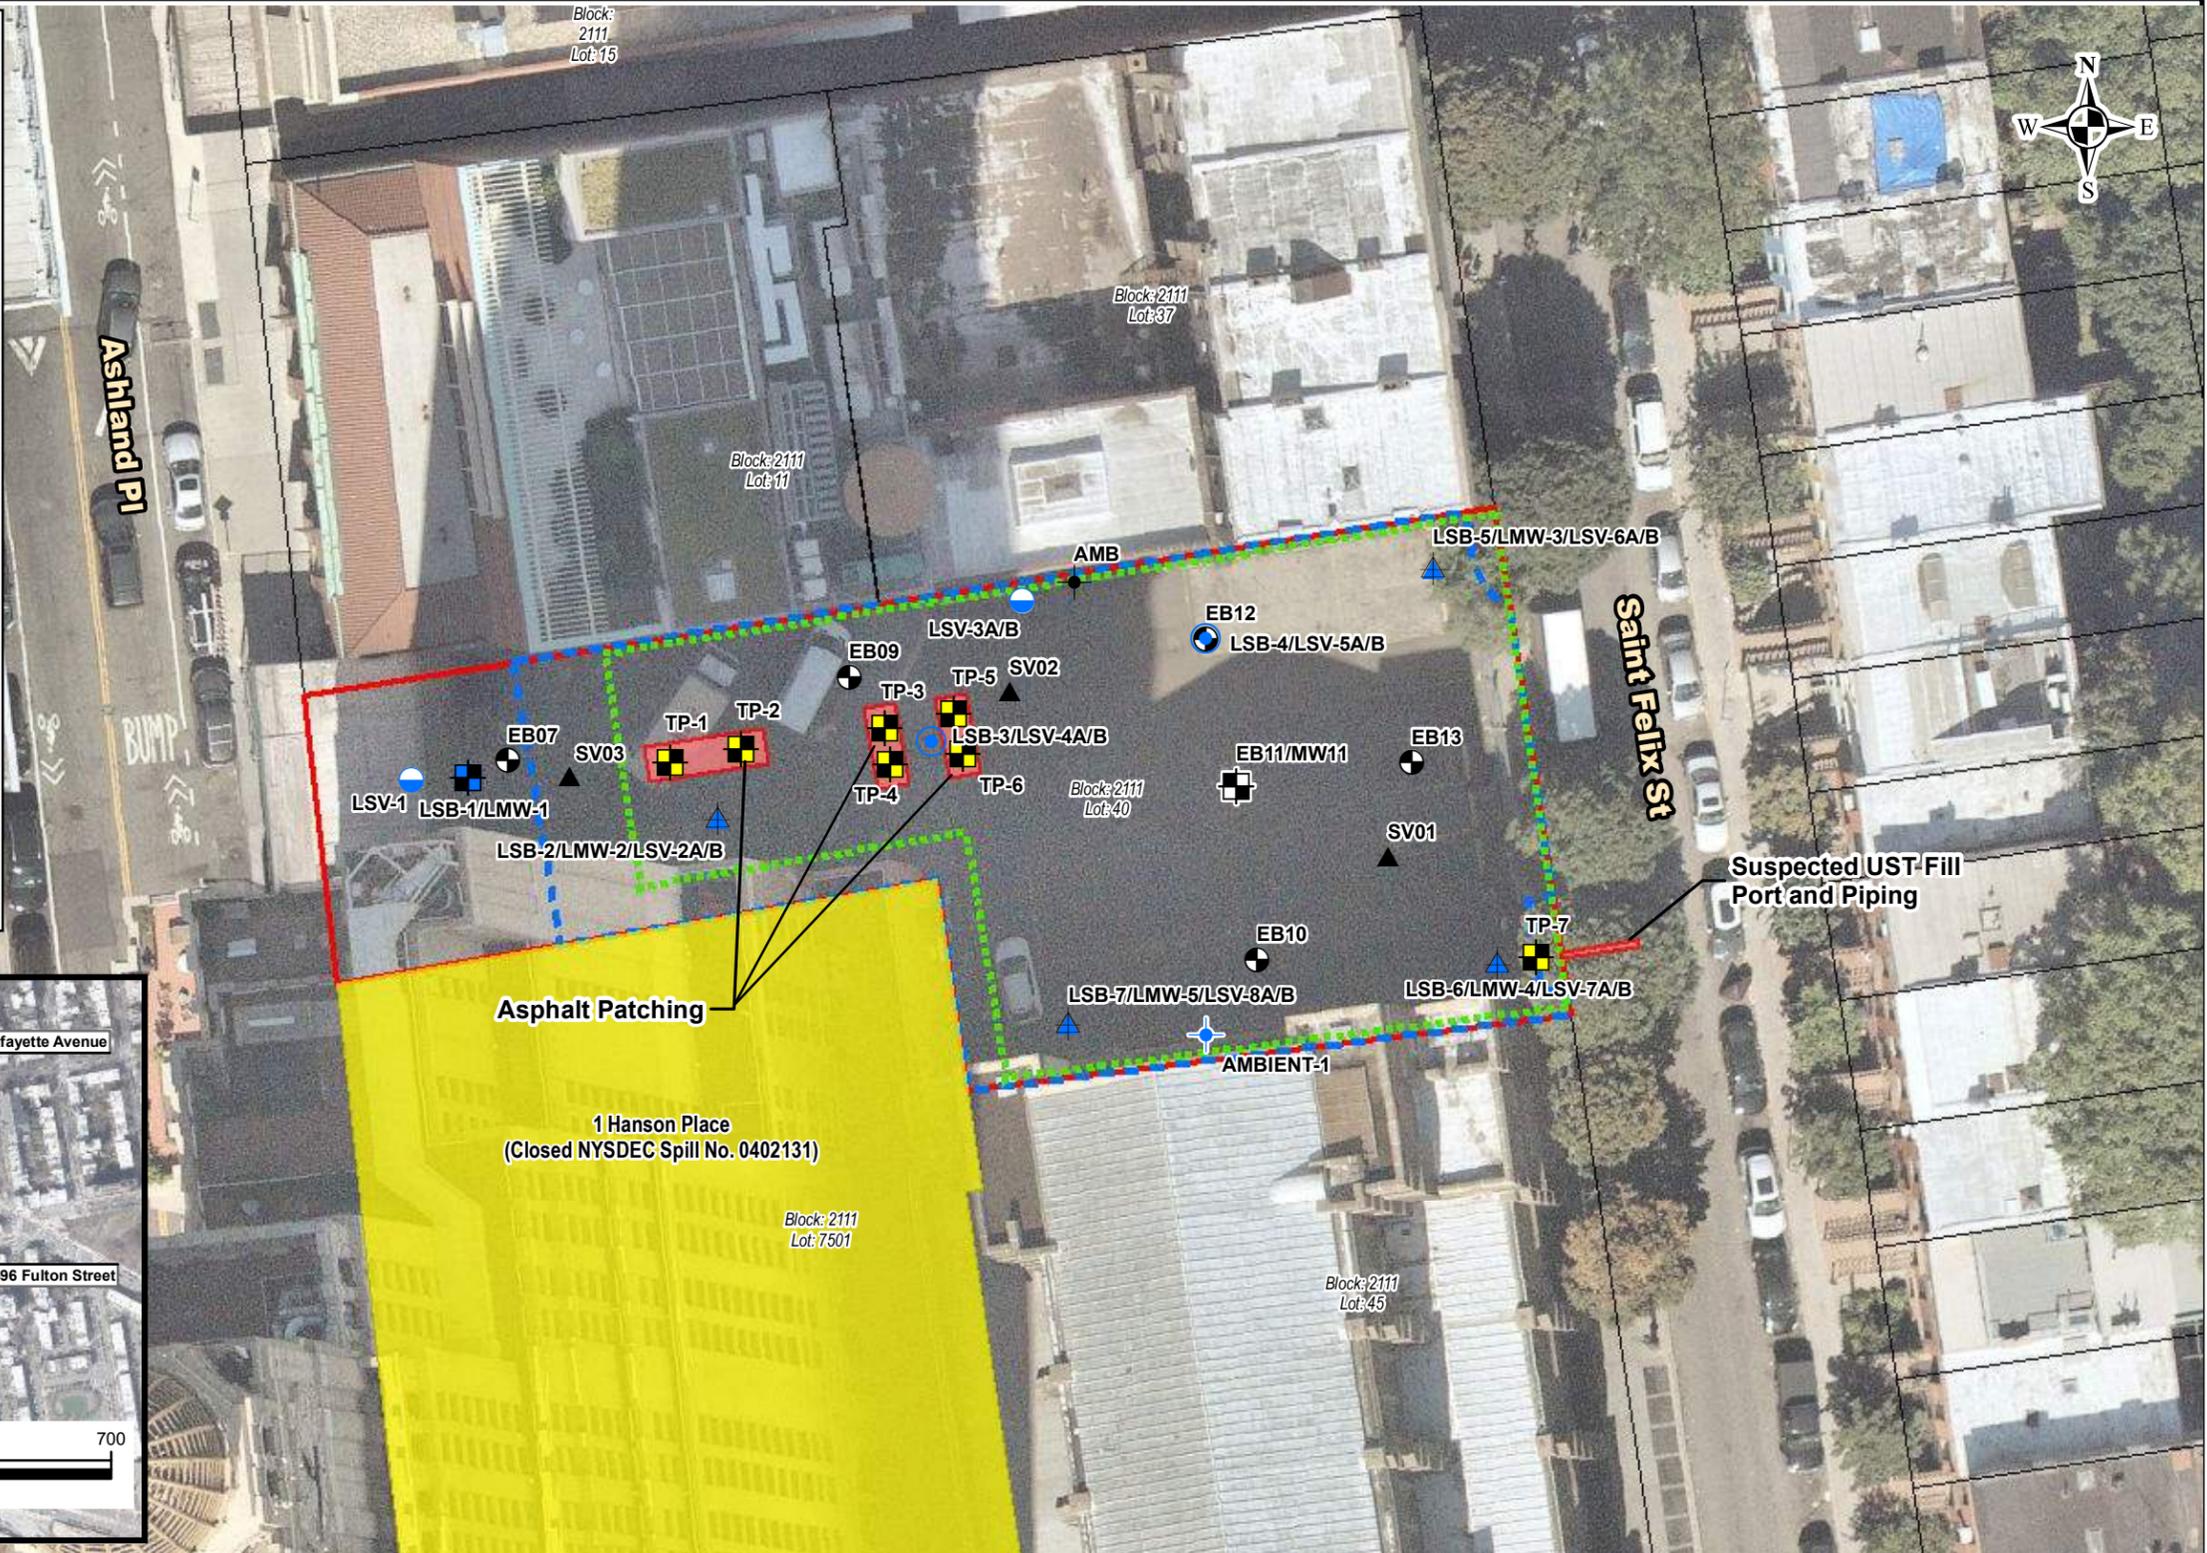
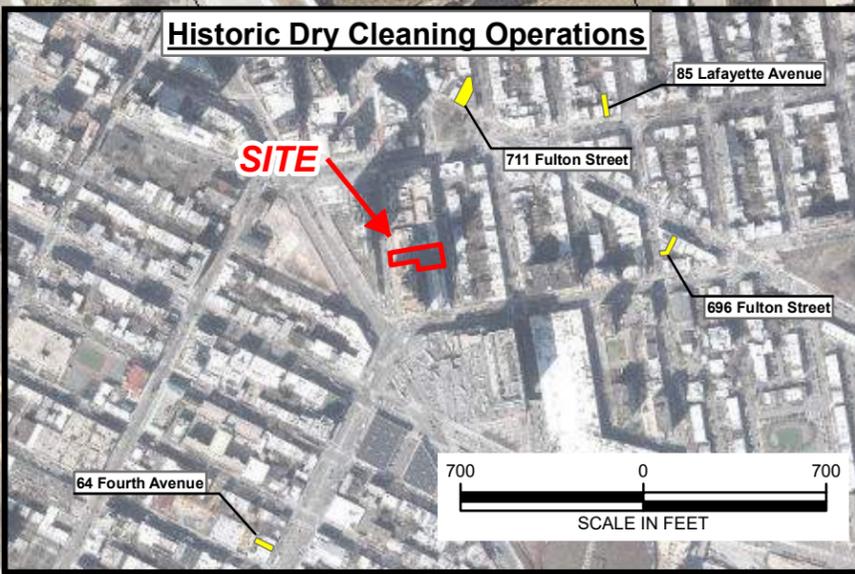
- Approximate Site Boundary
- Tax Lot
- AOC-1 - Historical Site Operations and Potential Historical Presence of USTs
- AOC-2 - Historical Adjacent and Surrounding Site Operations
- Proposed Building Extents
- Proposed Cellar Extents
- Ambient Air Sample (Langan 2015)
- Soil Boring (Langan 2015)
- Soil Vapor Sample (Langan 2015)
- Soil Boring/Monitoring Well (Langan 2015)
- Test Pit (Langan 2021)
- Ambient Air Sample 2021, Langan 2015
- Soil Boring/Monitoring Well (Langan 2021)
- Soil Boring/Soil Vapor Sample (Langan 2021)
- Soil Boring/Monitoring Well/Soil Vapor Sample (Langan 2021)
- Soil Vapor Sample (Langan 2021)

1. Aerial imagery provided by Nearmap Ltd., collected September 20, 2019.
2. Parcel information from MapPLUTO 18v2 copyrighted by the New York City Department of Planning.
3. Historic sample locations from June 2015 Subsurface Investigation Report, prepared by Langan.
4. All sample locations are approximate and based on field measurements.
5. UST fill port and piping were detected during NOVA's 2020 Geophysical Survey. Approximate locations of asphalt patches are based on field observations made by Langan in 2020.
6. LSV-1 and LSV-2A through LSV-8A were installed to 5 ft bgs and LSV-2B through LSV-8B were installed to 20.5 bgs.
