CLIENT: 473 President LLC	DATE: Friday, April 29, 2022
PROJECT No.: 170361303	WEATHER: Sunny, 42-60 °F, Wind: 6-15 mph NW
PROJECT: 473 President Street/President Street Portfolio	TIME: 06:45 – 16:15
LOCATION: Brooklyn, New York	BCP SITE Nos.: C224220/C224309
EQUIPMENT: Komatsu PC490LC excavator MiniRAE 3000 photoionization detector (3) TSI DustTrak II (2)	PRESENT AT SITE: Langan: Jack Millman Urban Atelier Group (UAG): Matthew Higgins/Matthew Barile Kingdom Associates, Inc. (Kingdom): Brian Keane WSP USA: Jason Robertson Fenagh Engineering and Testing: Louie Lactoen

Langan was on-site to document implementation of the New York State Department of Environmental Conservation (NYSDEC)-approved Remedial Action Work Plans (RAWP) for Brownfield Cleanup Program (BCP) Site Nos. C224220 (473 President Street) and C224309 (President Street Portfolio).

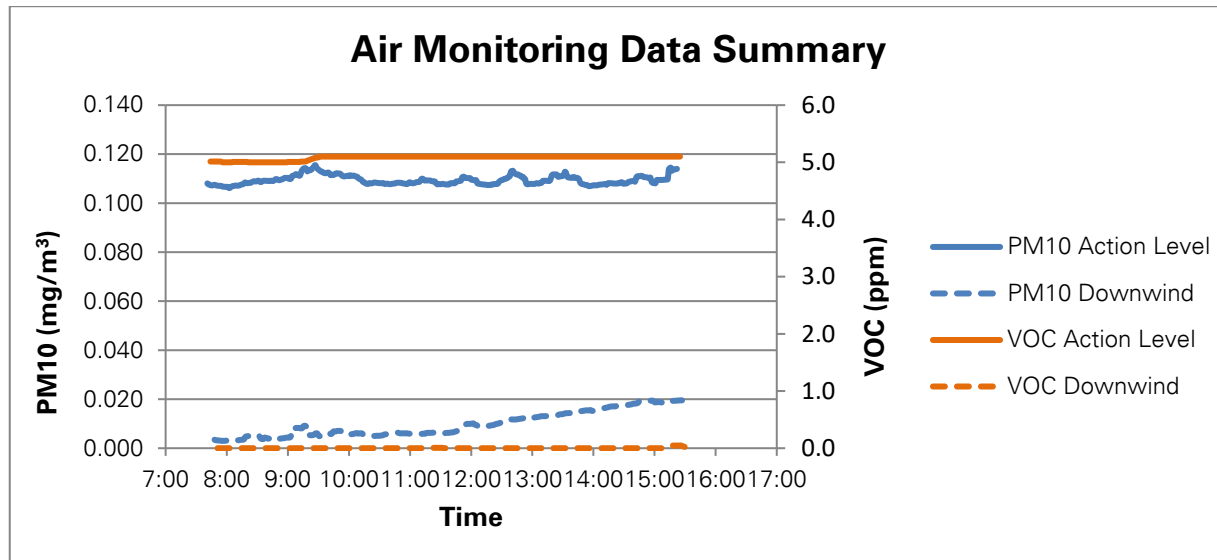
work area during ground-intrusive activities. VOC and PM10 action levels were not exceeded during the monitoring period. Recorded air monitoring data is presented on the following graph:

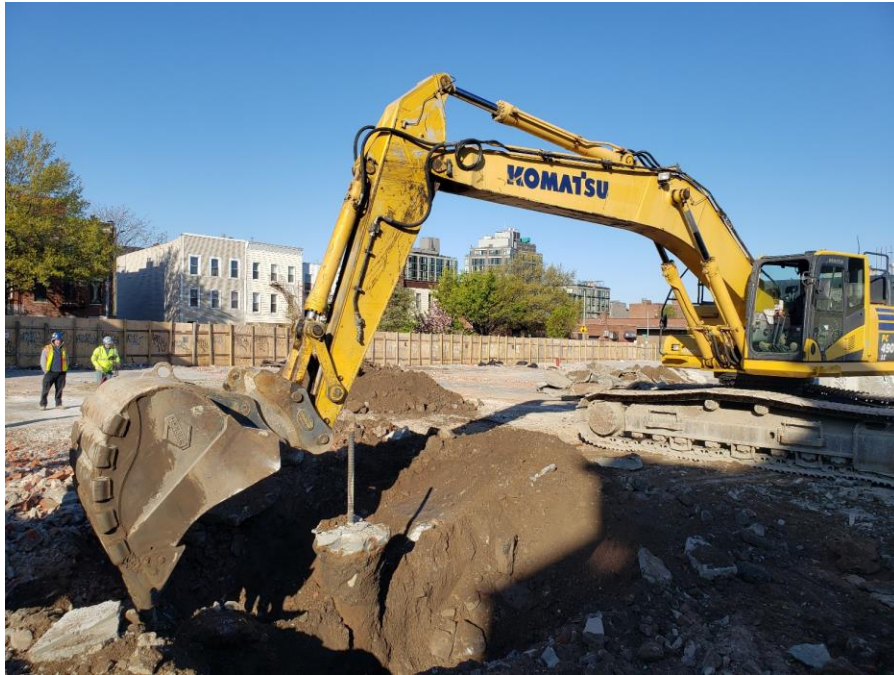
Photo 1: Kingdom excavating an area to install a foundation pile cap in the eastern part of the site (facing southwest)

- Kingdom excavated an about 10-foot-long by 10-foot-wide area to about 7 feet below grade surface (bgs) in the eastern part of the site in preparation for installation of foundation pile cap. Excavated fill consisted of sand with varying amounts of construction and demolition (C&D) debris, and was stockpiled in the eastern part of the site on a concrete slab. Visual, olfactory, and photoionization detector (PID) evidence of contamination was not observed.
- Kingdom installed formwork and placed concrete for a foundation pile cap in the eastern part of the site.
- Kingdom partially backfilled the about 10-foot-long by 10-foot-wide area around the pile cap with previously excavated fill (originating from the same excavation) in the eastern part of the site to about 4 feet bgs.

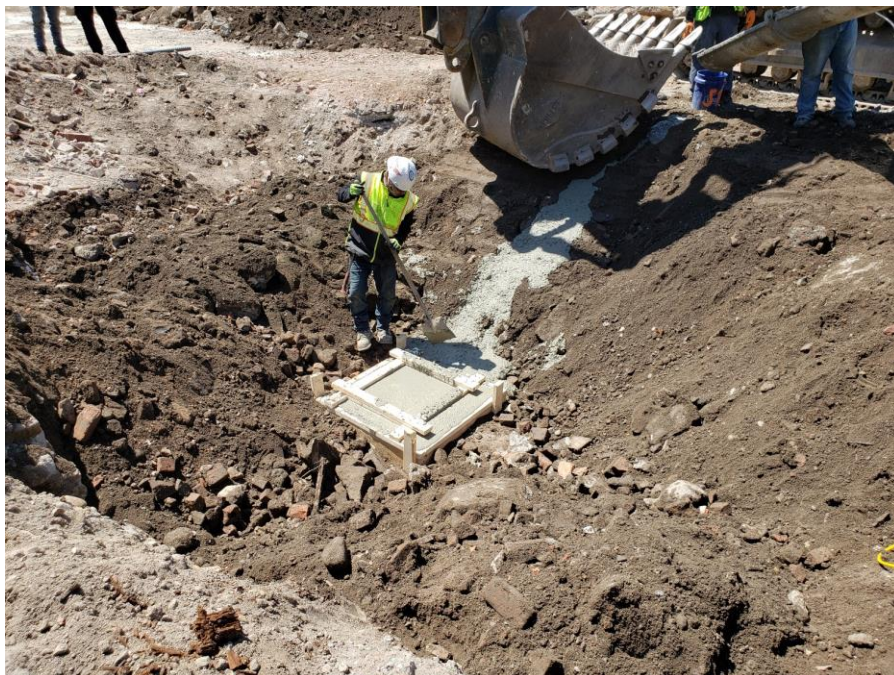
Photo 2: Kingdom placing concrete to install a foundation pile cap in the eastern part of the site (facing southwest)
