PROJECT No.: 170361306 PROJECT: 514 Union Street LOCATION: Brooklyn, New York BCP SITE ID: C224318	CLIENT: Gowanus President Owner LLC	DATE: Thu., February 9 th , 2023 WEATHER: Clear, 41 – 50 °F Wind: ESE @ 1 – 5 mph TIME: 6:45 am – 4:00 pm MONITOR: Audrey Seery
EQUIPMENT: RKI Photoionization Detector (PID) Groundwater sampling equipment Geoprobe 6011DT Air monitoring station (DustTrak II, MiniRAE 3000)	PRESENT AT SITE: Langan: Audrey Seery, Sophia Misiakiewicz Regenesis: Joshua Grasser, Julian Serrano, Neil Wang Coastal Environmental Solutions, Inc.: John Hudson	
OBSERVATIONS, DISCUSSIONS, TEST RESULTS, ETC.: Langan was on-site to document implementation of the New York State Department of Environmental Conservation (NYSDEC)-approved February 2 nd , 2023 Interim Remedial Measures Work Plan (IRMWP) No. 2.		
Site Activities <ul style="list-style-type: none"> Langan collected two baseline groundwater samples from newly installed groundwater monitoring wells MW14S and MW15D following well development. Soil cuttings and purged groundwater were containerized in separate 55-gallon drums. Coastal Environmental Solutions, Inc. (Coastal Environmental) advanced two soil borings (SC-1 and SC-

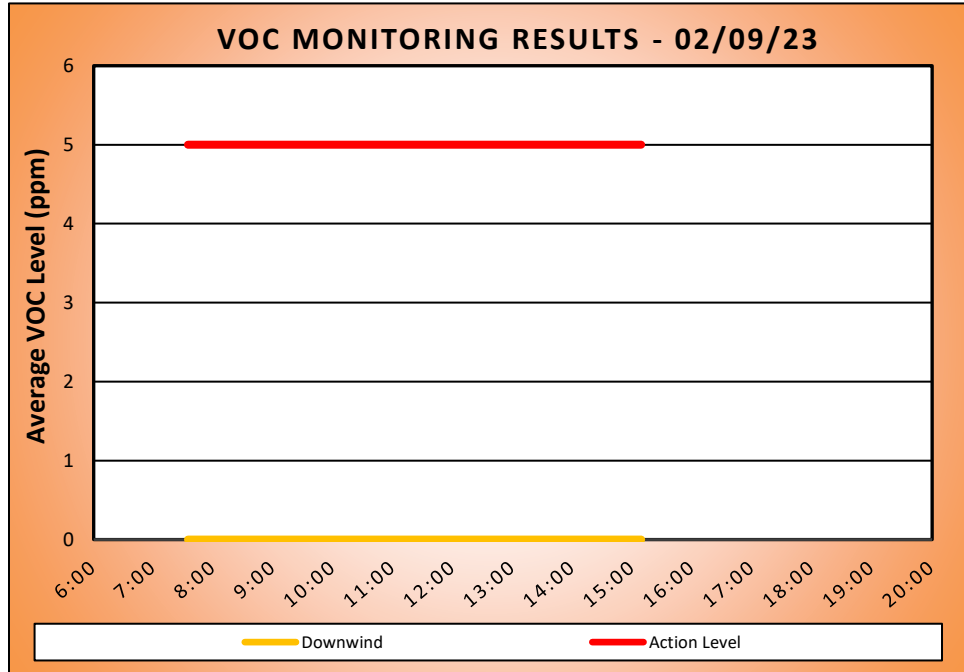
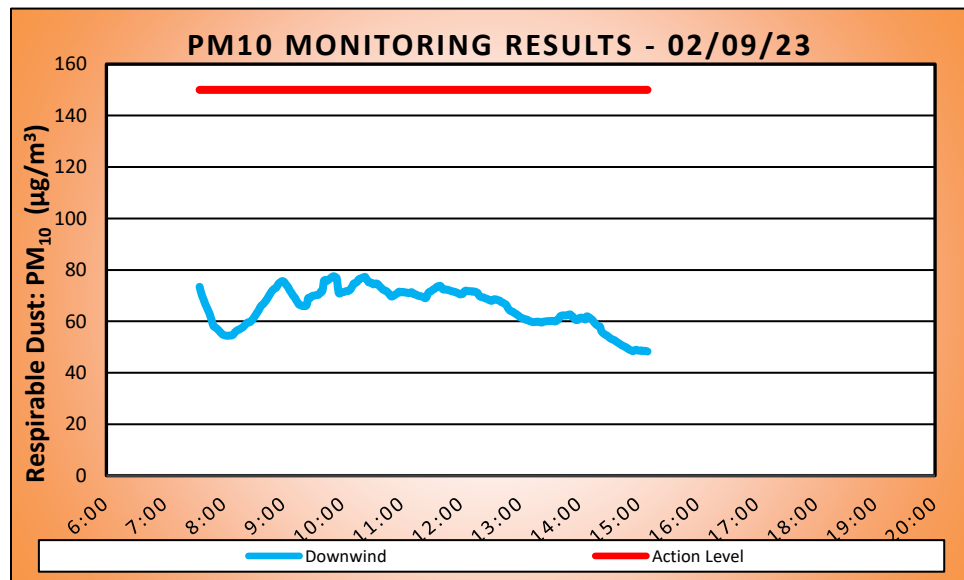
- Langan performed continuous air monitoring at downwind perimeter of the work zone for volatile organic compounds (VOCs) and particulate matter smaller than 10 microns in diameter (PM10) during ground-intrusive activity. VOC and PM10 action levels were not exceeded during the monitoring period. Recorded air monitoring data is summarized in the following graphs:

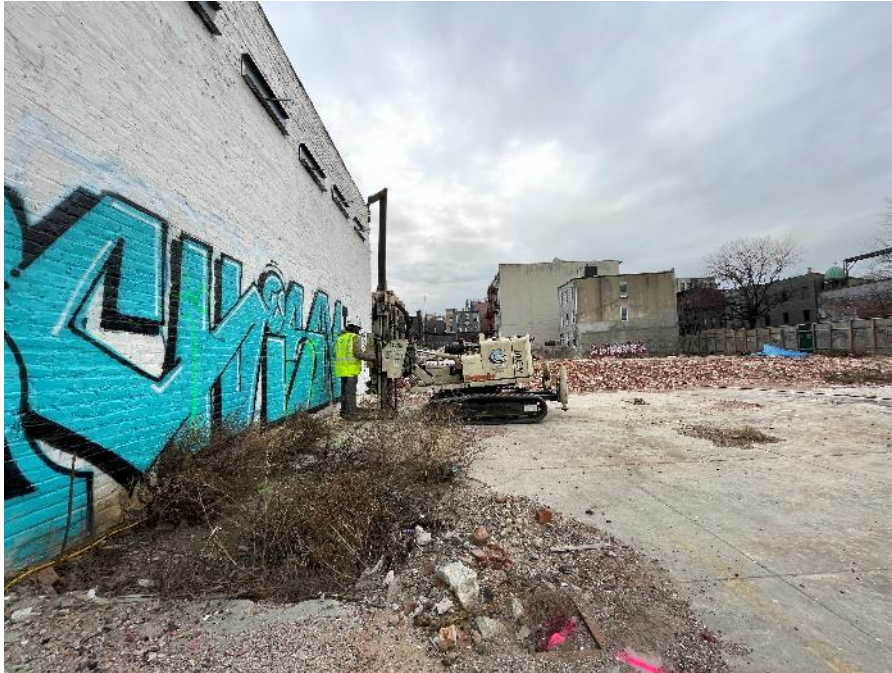
Photo 1: Coastal Environmental advancing soil boring SC-1 (facing east).

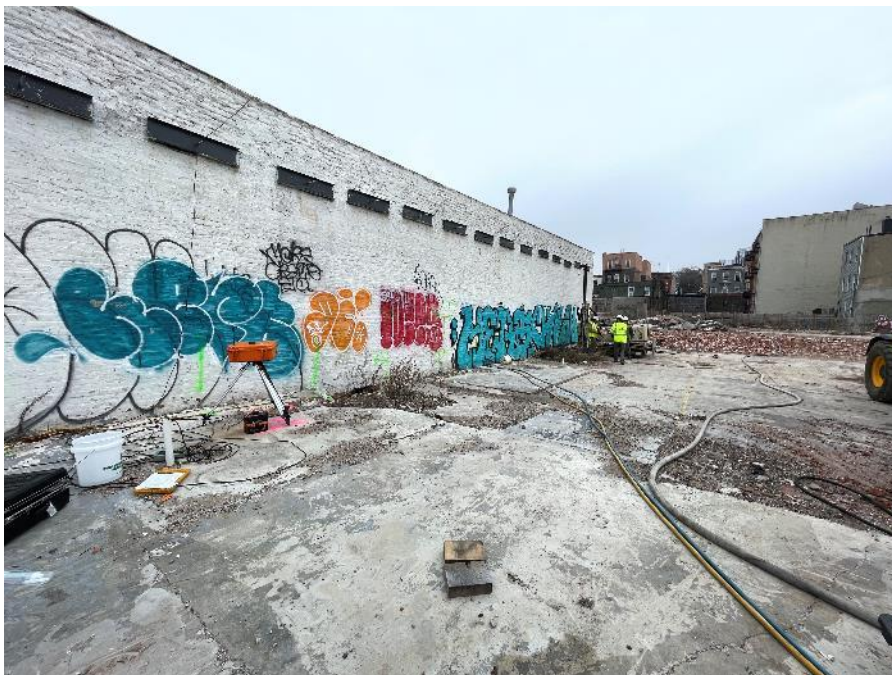
Photo 2: Regenesis applying remedial products at injection point IP-42 (facing east).

- Regeneration will continue application of remedial products via injection points.
