PROJECT No.: 170361306 PROJECT: 514 Union Street LOCATION: Brooklyn, New York BCP SITE ID: C224318	CLIENT: Gowanus President Owner LLC	DATE: Tue., February 28 th , 2023 WEATHER: Cloudy, 34 – 36 °F Wind: N @ 9 – 16 mph TIME: 7:00 am – 3:45 pm MONITOR: Audrey Seery
EQUIPMENT: Geoprobe 6620DT MiniRAE 3000 Photoionization Detector (PID) Air monitoring station (DustTrak II, MiniRAE 3000 PID) Solinst Water Level Meter YSI 600XL Water Quality Meter JCB 507 Forklift		PRESENT AT SITE: Langan: Audrey Seery Regenesis: Julian Serrano, Neal Wang, James Cobb Coastal Environmental Solutions, Inc.: Brandon Sullivan
<p>OBSERVATIONS, DISCUSSIONS, TEST RESULTS, ETC.: Langan was on-site to document implementation of the New York State Department of Environmental Conservation (NYSDEC)-approved February 2nd, 2023 Interim Remedial Measures Work Plan (IRMWP) No. 2.</p> <p>Site Activities</p> <ul style="list-style-type: none"> • Coastal Environmental Solutions, Inc. (Coastal Environmental) advanced one soil boring (SC-5) next to injection point IP30 to evaluate subsurface conditions prior to application of remedial products. <ul style="list-style-type: none"> ○ Recovered soil was screened with a PID; petro

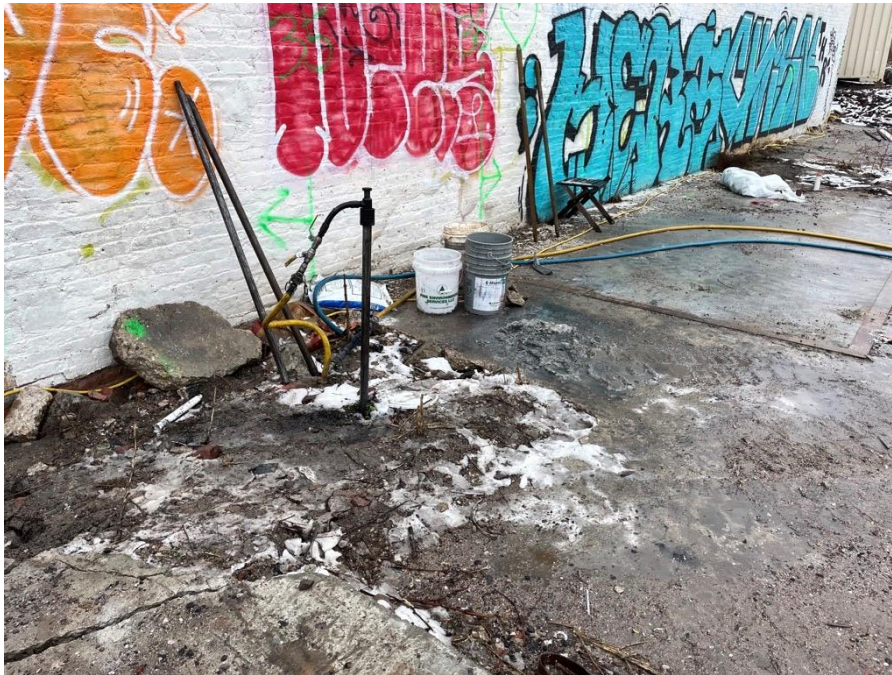
Photo 1: Regensis applying remedial products at injection point IP35 (facing northeast).

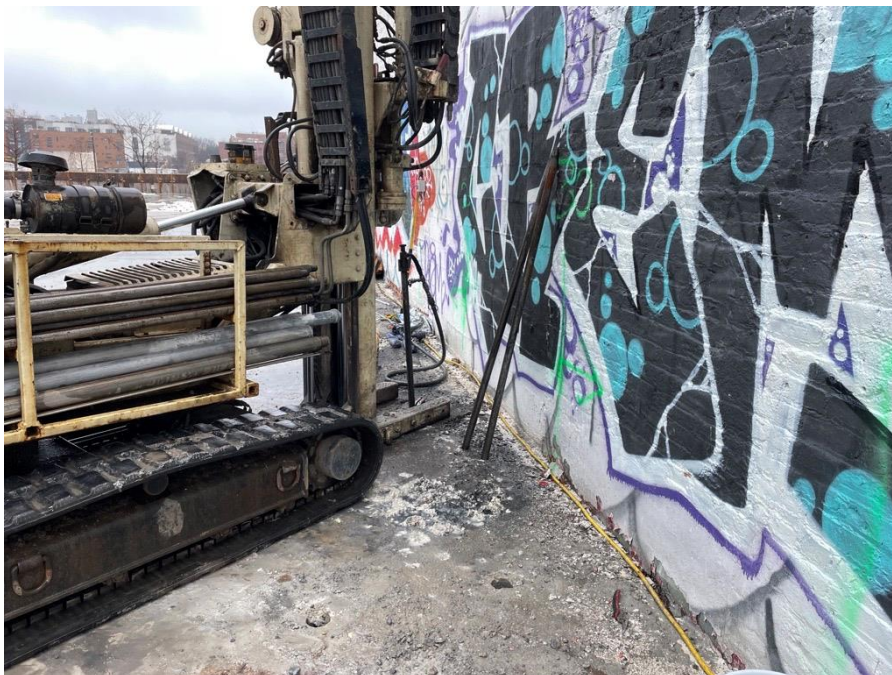
Photo 2: Regensis applying remedial products at injection point IP30 (facing northwest).
