REMEDIAL INVESTIGATION REPORT

SUTTER CROSSING **600 Sutter Avenue and 350 Sheffield Avenue** **Brooklyn, New York** **NYSDEC BCP Site No. C224331**

April 22, 2025
Langan Project No. 170456301

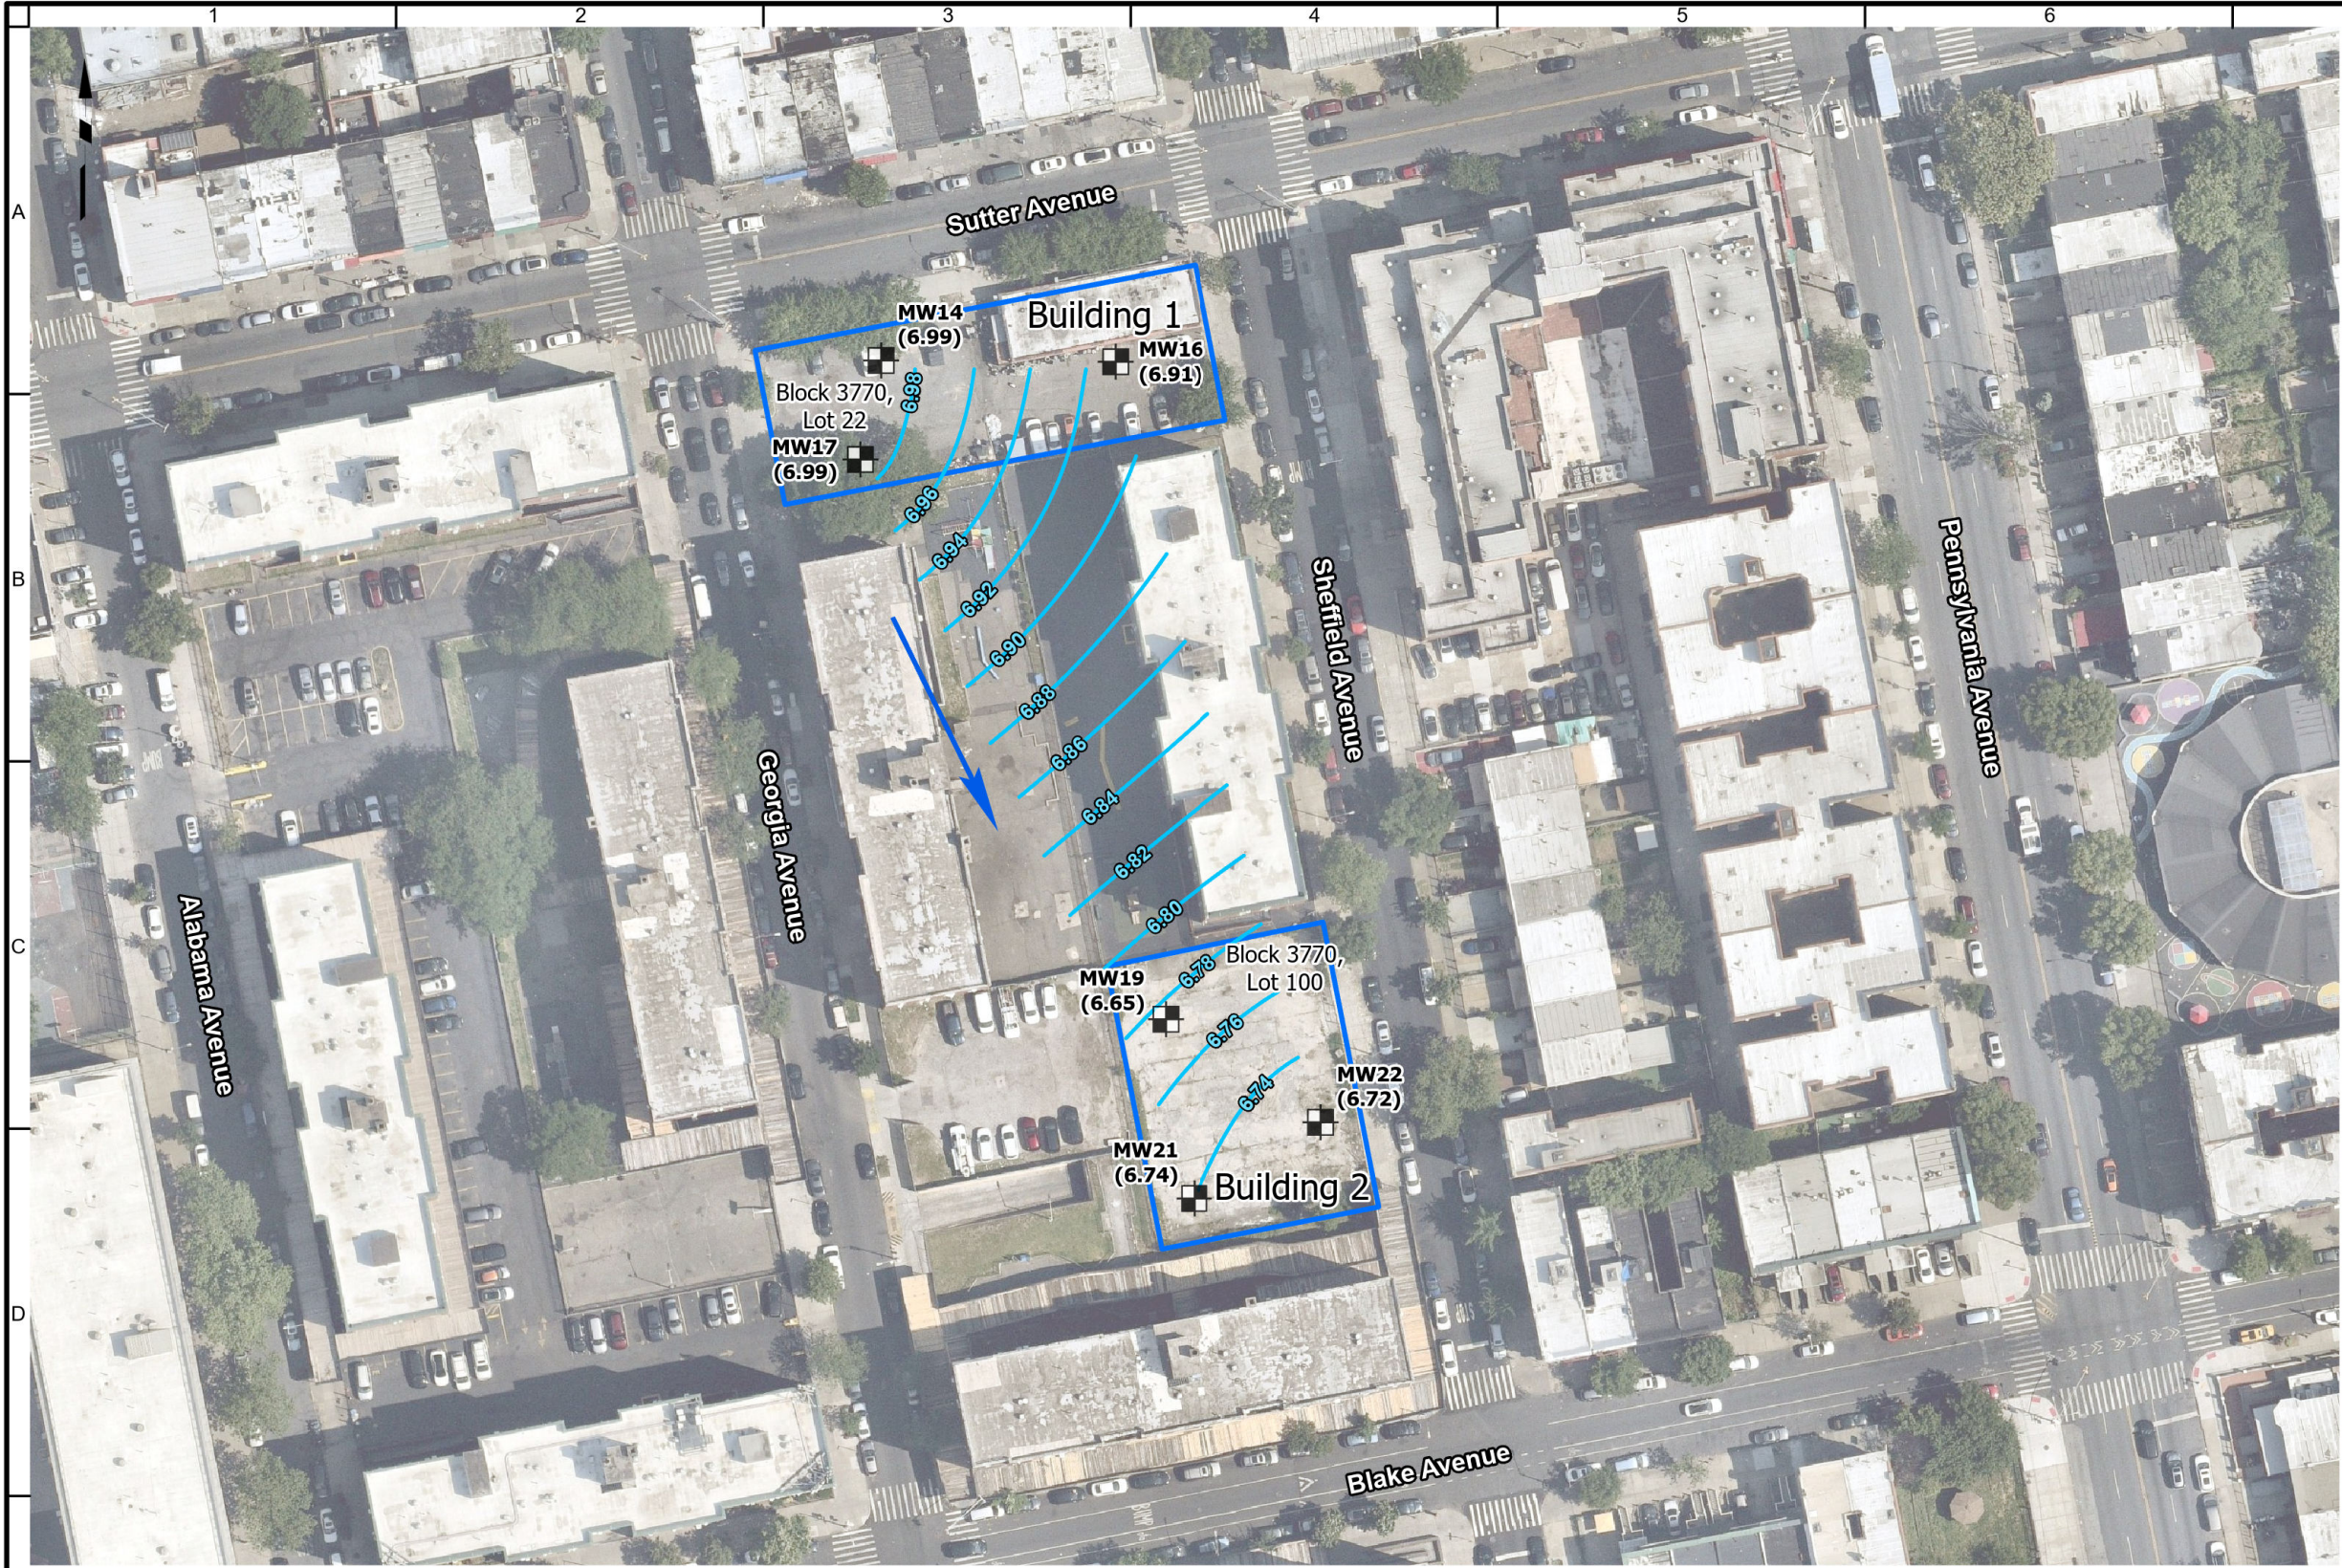
Project No. 170456301	Figure No. 4
Date 12/22/2023	
Scale 1"=80'	
Drawn By MG

- MONITORING WELL LOCATION
- GROUNDWATER ELEVATION CONTOUR
- INFERRED GROUNDWATER FLOW DIRECTION
- APPROXIMATE SITE BOUNDARY

Figure Title
**GROUNDWATER
CONTOUR MAP**

PID headspace readings ranged from 0.0 to 5.6 ppm with the highest reading observed in monitoring well MW22 (Lot 100) during groundwater sampling and corresponds to the boring with the highest PID reading. Groundwater depths ranged from about 29.2 to 29.6 feet bgs (el. 6.91 to el. 6.99) in Lot 22 and from about 27.1 to 28.1 feet bgs (el. 6.65 to el. 6.74) in Lot 100.

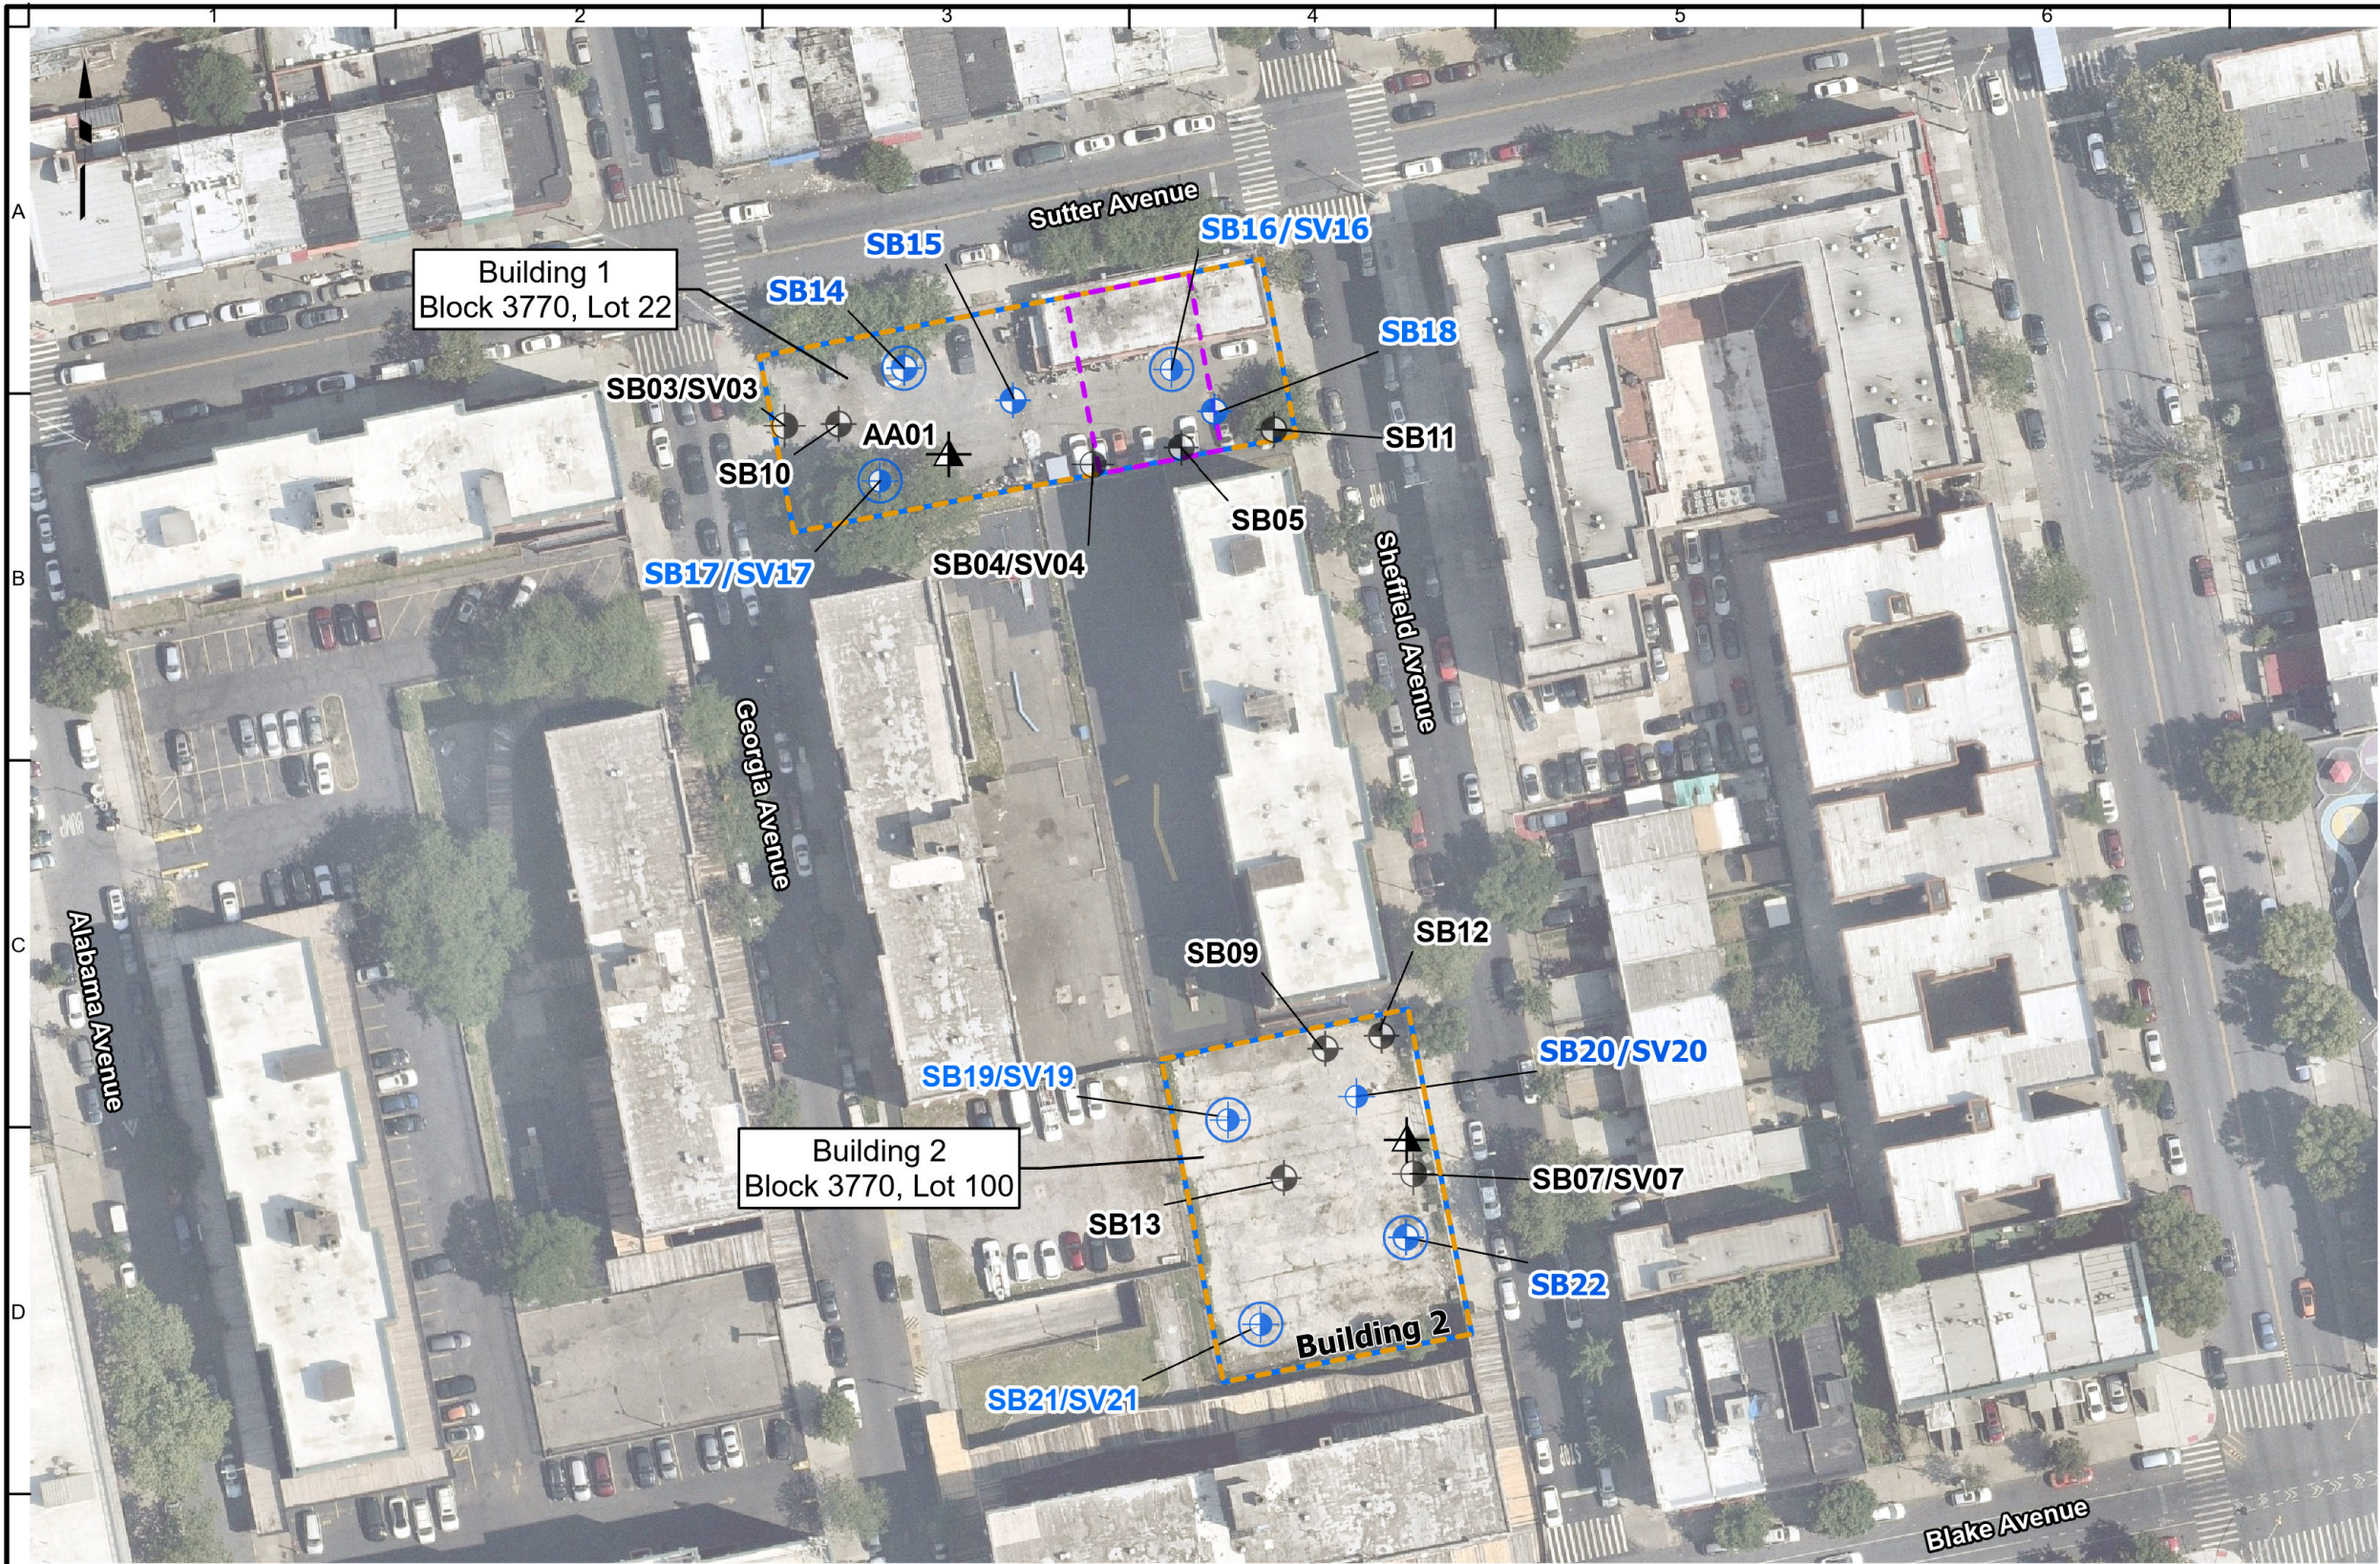
- PREVIOUS SOIL BORING LOCATION
- PREVIOUS SOIL BORING/SOIL VAPOR SAMPLE LOCATION
- SOIL BORING LOCATION
- SOIL BORING/SOIL VAPOR LOCATION
- MONITORING WELL LOCATION
- AMBIENT AIR SAMPLE LOCATION
- APPROXIMATE SITE BOUNDARY
- AOC 1: HISTORICAL SITE OPERATIONS, INCLUDING DRY CLEANING AND MILLINERY
- AOC 2: SVOC-, PESTICIDE- AND METALS-IMPACTED SOIL

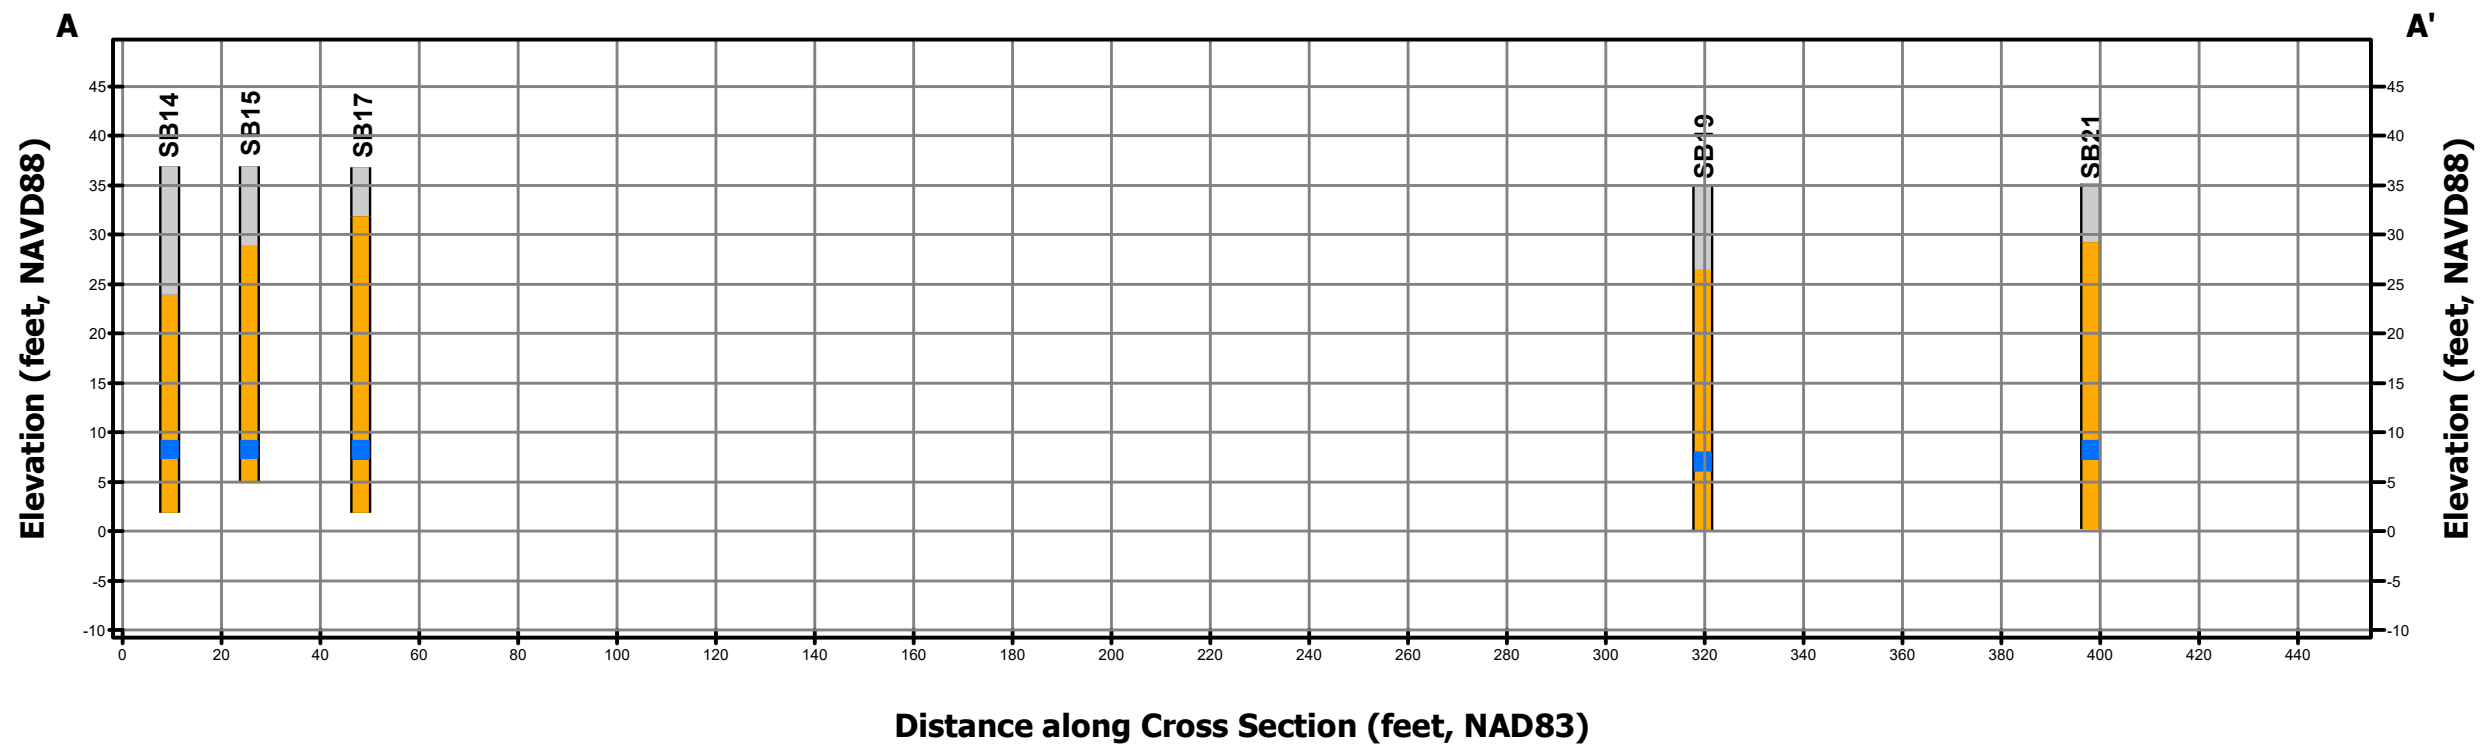
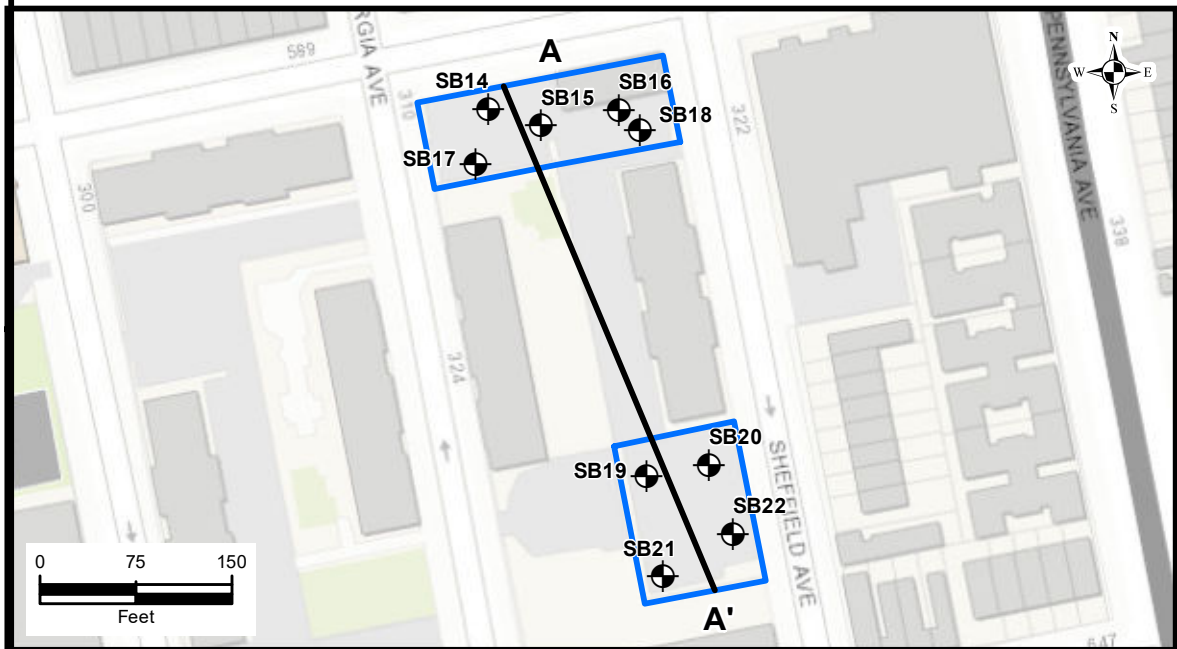
Project No. 170456301	6A
Date 1/9/2024	
Scale AS SHOWN	
Drawn By MG

- Approximate Site Boundary
- Soil Boring Location
- Shallow Soil Containing Anthropogenic Materials
- Fine-to Medium-grained Sand with Varying Amounts of Silt and Fine Gravel
- Groundwater Elevation

**SUBSURFACE
PROFILE A-A'**

Based on findings of the Phase II Environmental Site Investigation (ESI) Report, dated May 2021, the Site is underlain by soil, predominantly consisting of dark-brown to reddish-brown, gray, and tan, fine- to medium-grained sand with varying amounts of medium- and coarse-grained sand, silt, fine gravel, glass, brick, concrete, asphalt, slag, wood, and plastic. This soil was observed from surface grade to varying depths between about 1 and 30 feet bgs. The underlying native soil consists of light-brown and tan, fine- to medium-grained sand and fine gravel.

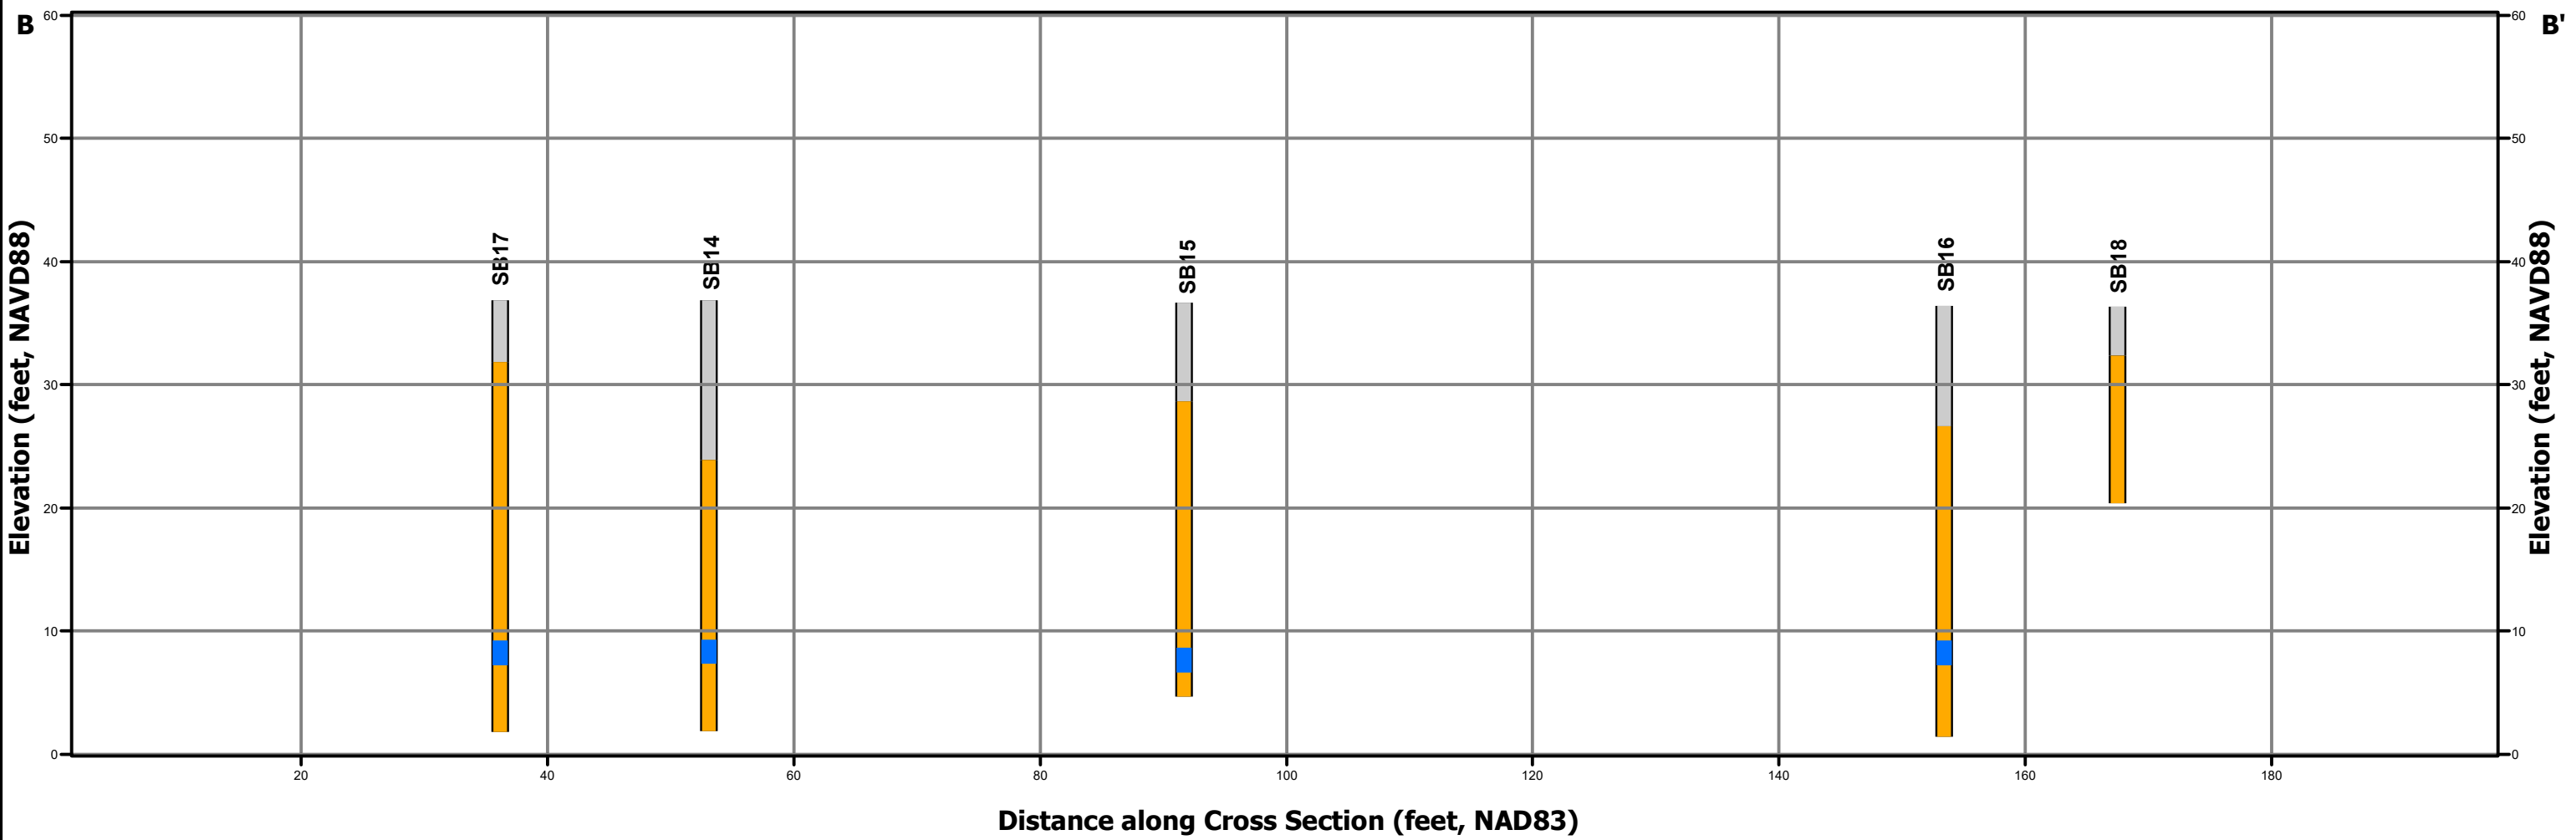
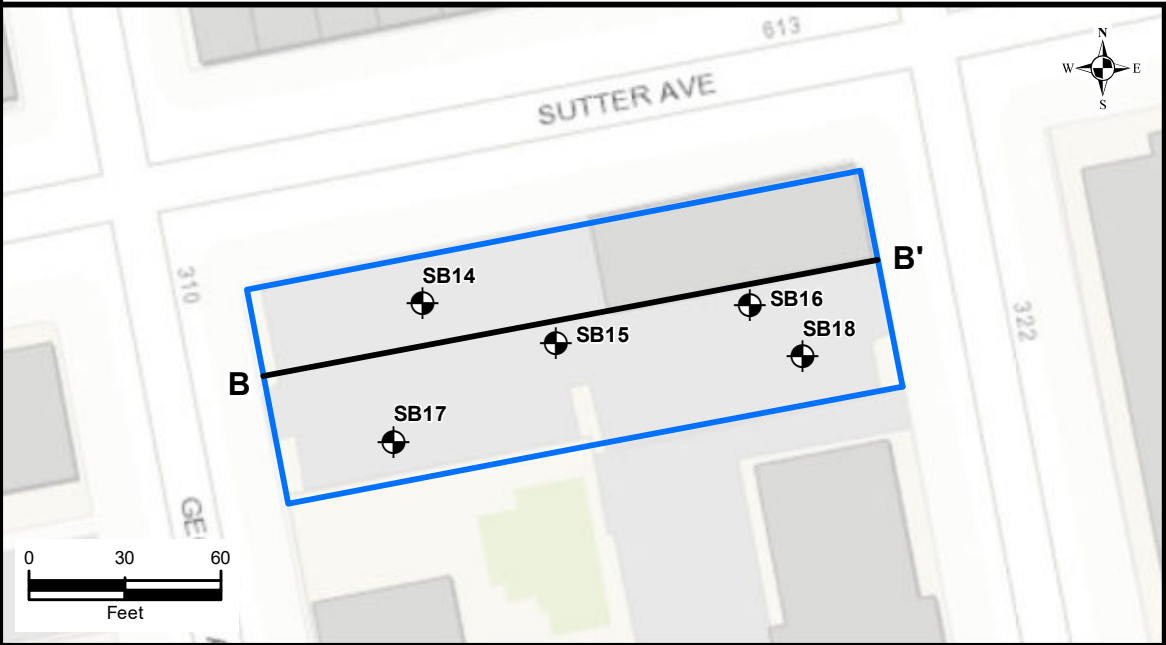
Project No. 170456301	6B
Date 1/9/2024	
Scale AS SHOWN	
Drawn By MG

- Legend**
- Approximate Site Boundary
 - Soil Boring Location
 - Shallow Soil Containing Anthropogenic Materials
 - Fine-to Medium-grained Sand with Varying Amounts of Silt and Fine Gravel
 - Groundwater Elevation

SUBSURFACE PROFILE B-B'

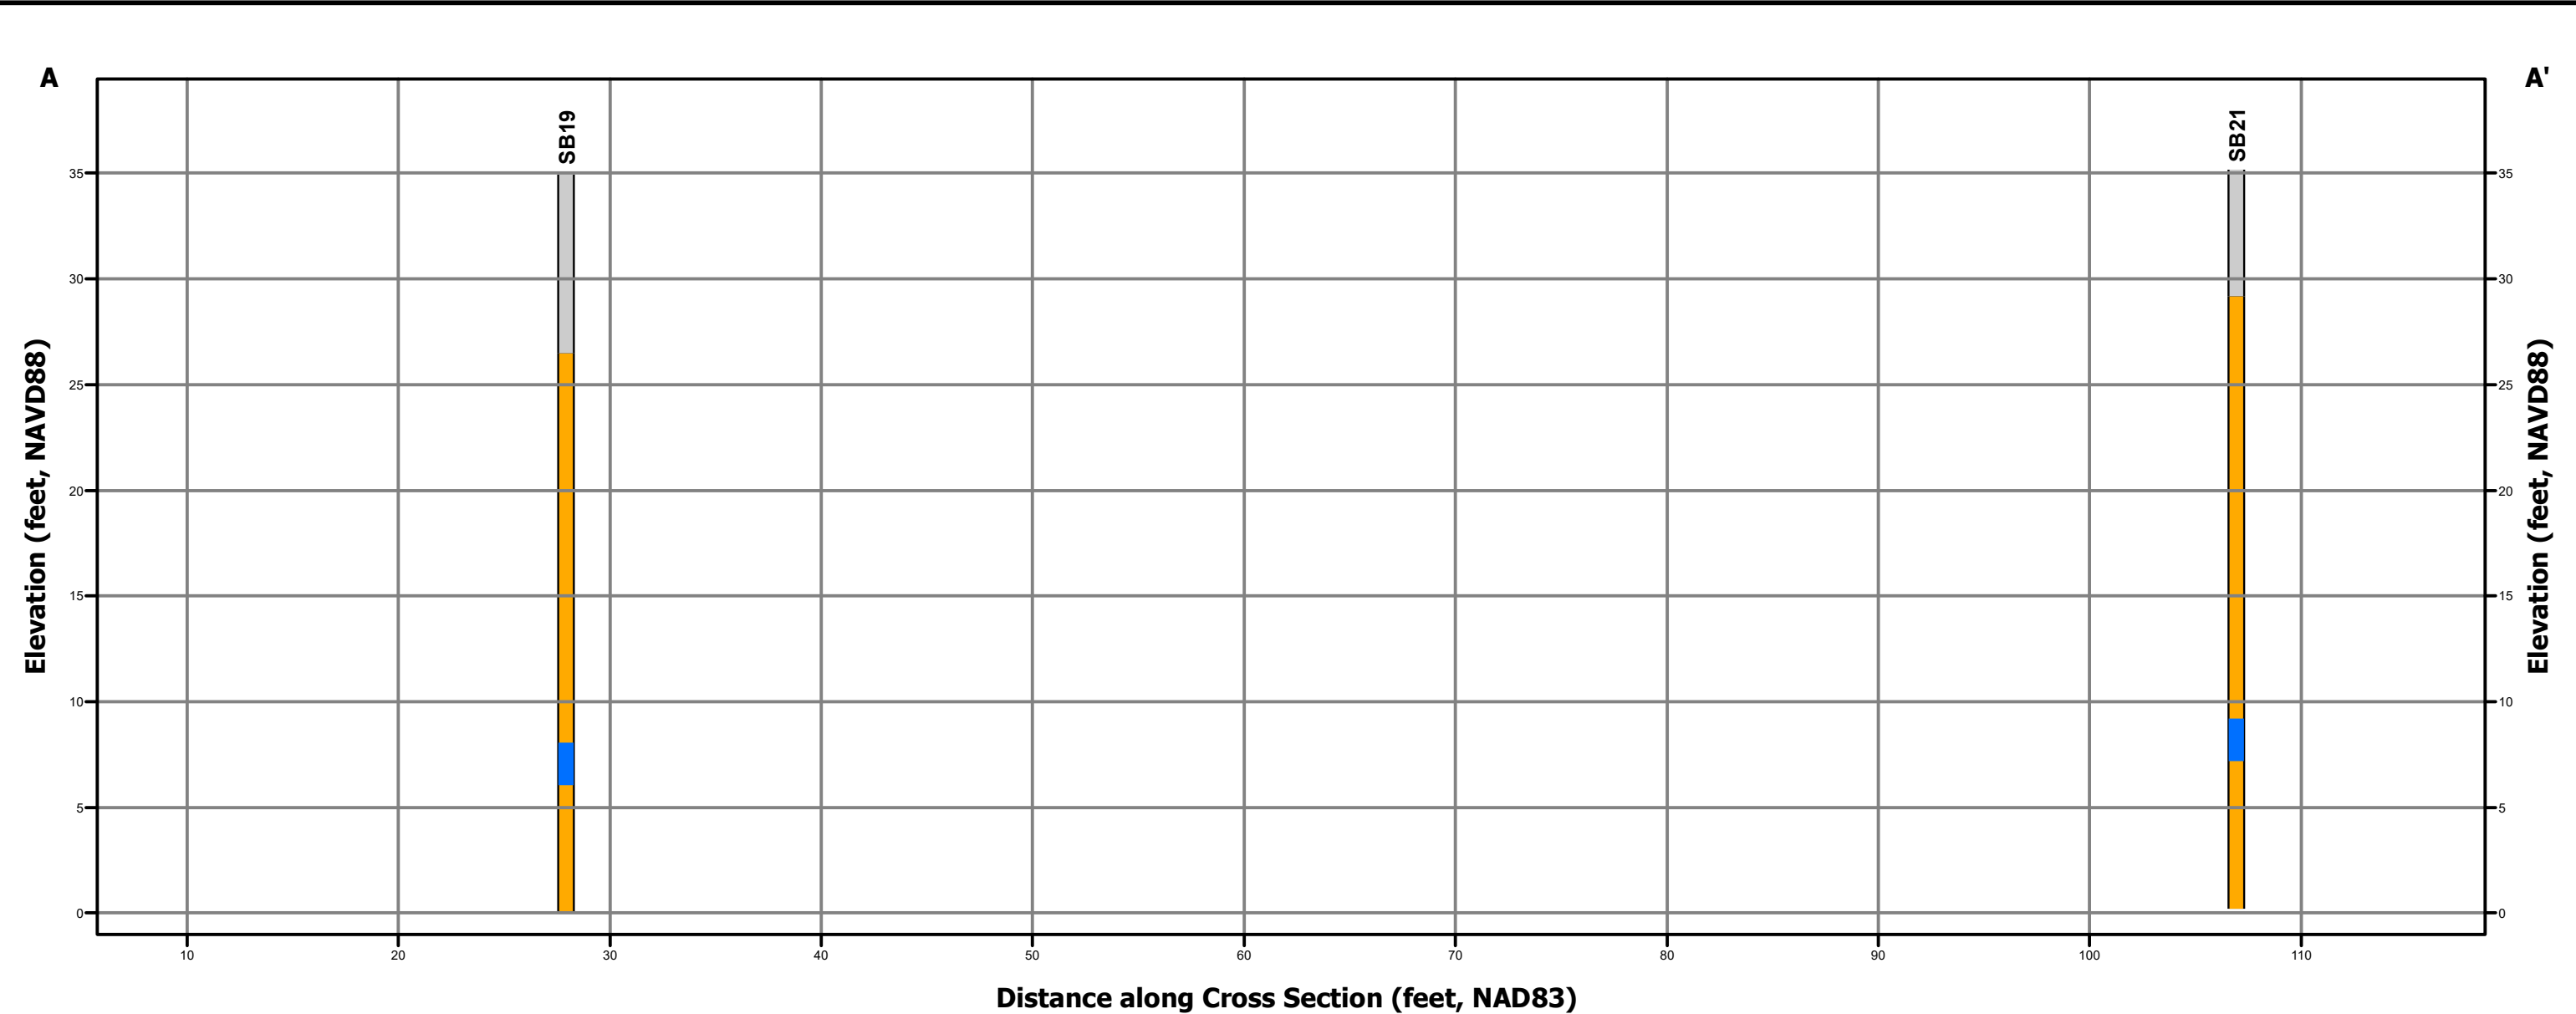
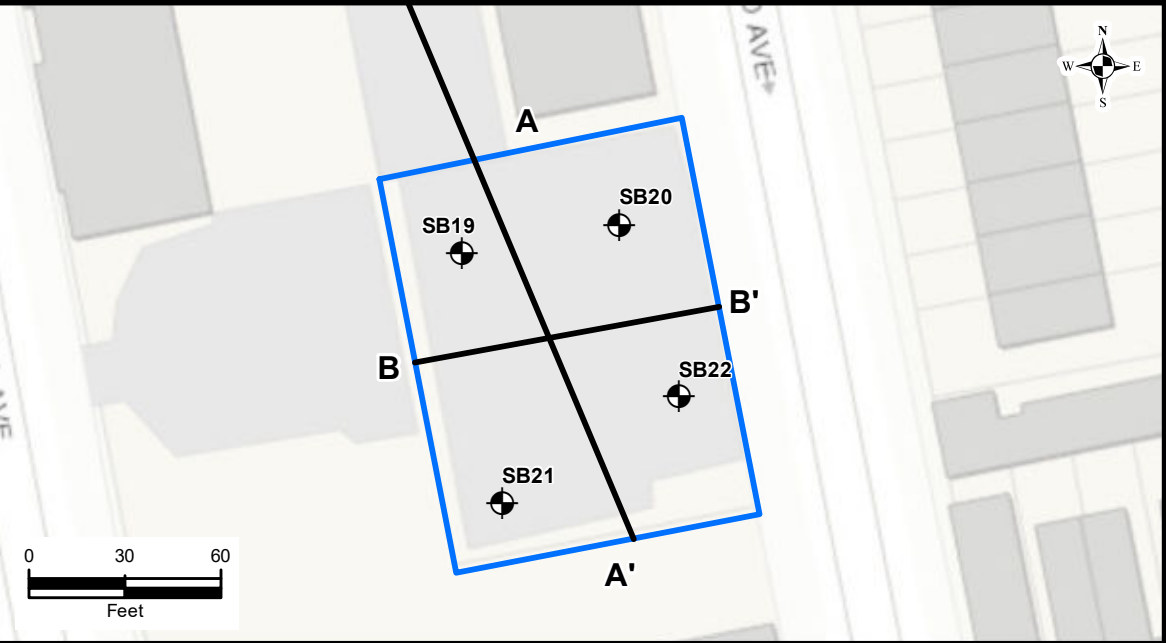
Figure
6C

- Approximate Site Boundary
- Sample Boring Location
- Shallow Soil Containing Anthropogenic Materials
- Fine-to Medium-grained Sand with Varying Amounts of Silt and Fine Gravel
- Groundwater Elevation

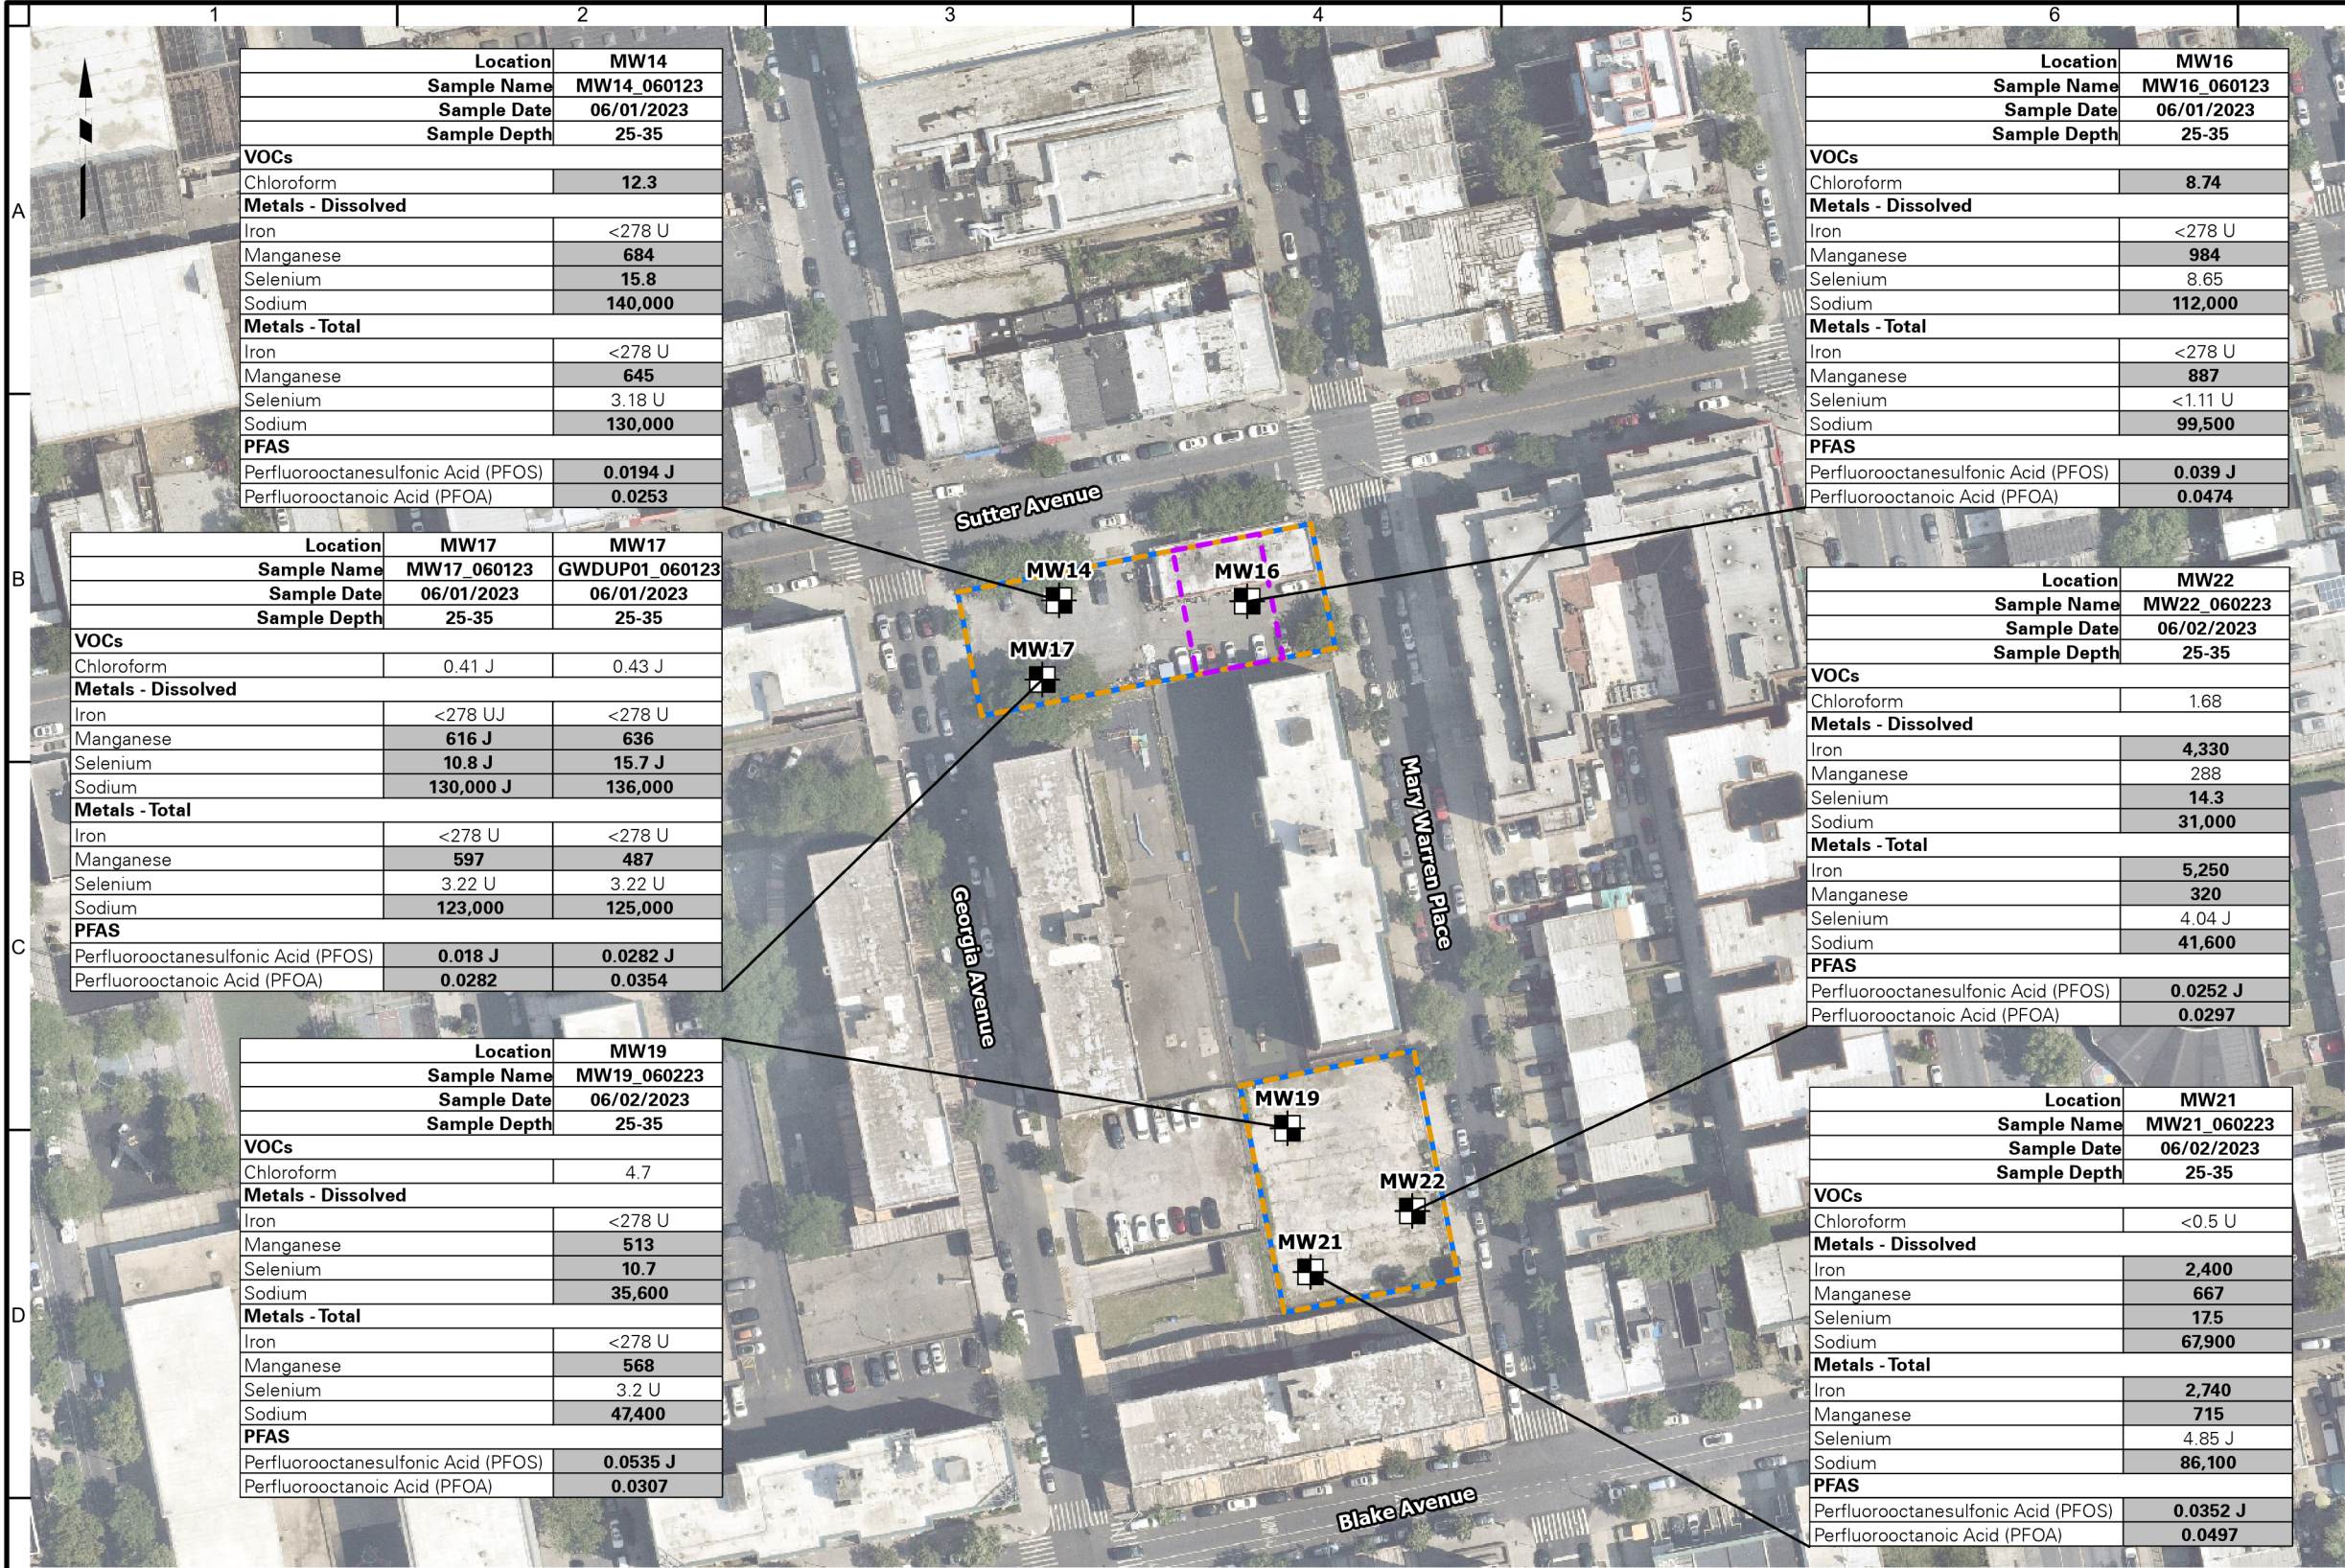
Project No. 170456301	Figure No. 8
Date 2/21/2024	
Scale 1"=100'	
Drawn By MG

- MONITORING WELL LOCATION
- APPROXIMATE SITE BOUNDARY
- AOC 1: HISTORICAL SITE OPERATIONS, INCLUDING DRY CLEANING AND MILLINERY
- SVOC-, PESTICIDE- AND METALS-IMPACTED SOIL

Figure Title
**GROUNDWATER
SAMPLE AND
ANALYTICAL
RESULTS MAP**

- SVOCs were not detected in groundwater above the SGVs.
- Dissolved and total metals, including iron, manganese, selenium, and sodium were detected at concentrations above the NYSDEC SGVs. The metal concentrations represent minerals typically found in regional groundwater and not contaminants of concern.
- Pesticides were not detected in the groundwater samples analyzed from Lots 22 or 100.
- PFOA and PFOS were detected at concentrations exceeding the SGVs; however, the concentrations are relatively consistent across all groundwater samples and not indicative of a source.

PFOA and PFOS were not detected in soil above the UU guidance values. PFOA and PFOS were detected in groundwater above the SGVs across both development lots, but at low-level concentrations. Considering the lack of soil impacts and no known historical uses of PFAS-containing products, the groundwater concentrations are considered a regional condition and not indicative of an on-Site release.
