REMEDIAL INVESTIGATION REPORT

SUTTER CROSSING **600 Sutter Avenue and 350 Sheffield Avenue** **Brooklyn, New York** **NYSDEC BCP Site No. C224331**

April 22, 2025
Langan Project No. 170456301

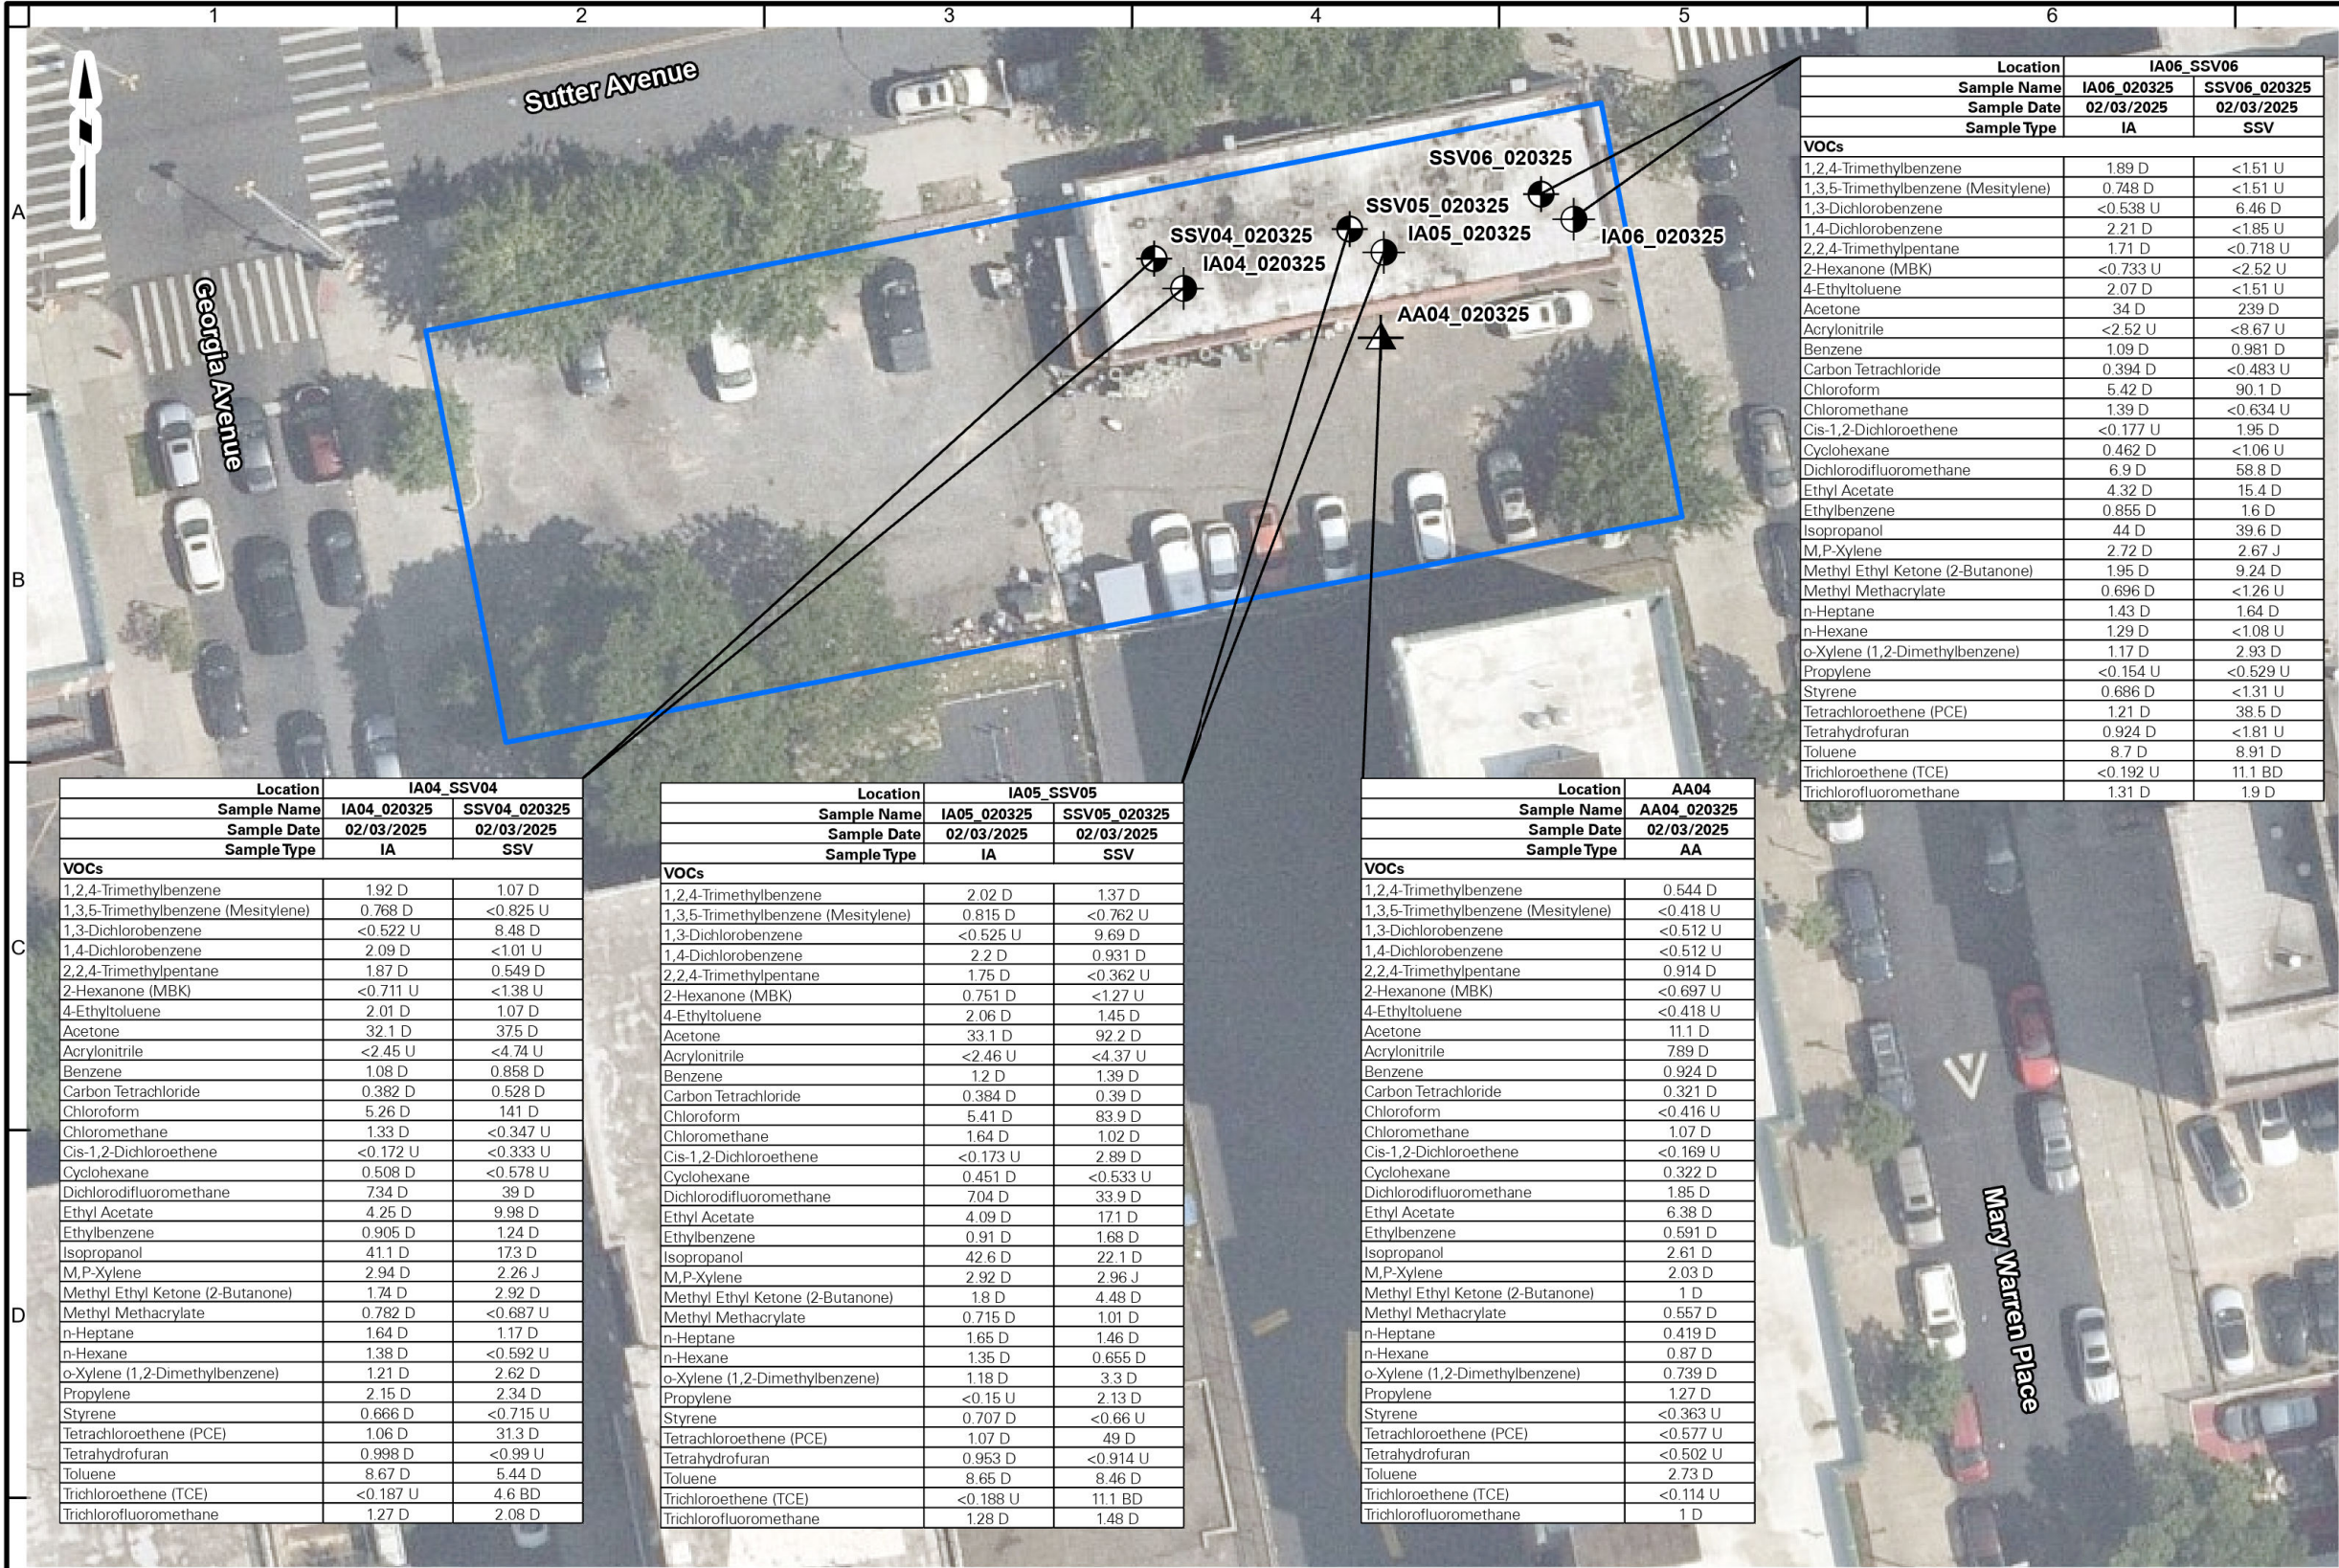
Location		
IA04_SSV04		
Sample Name	IA04_020325	SSV04_020325
Sample Date	02/03/2025	02/03/2025
Sample Type	IA	SSV
VOCs		
1,2,4-Trimethylbenzene	1.92 D	1.07 D
1,3,5-Trimethylbenzene (Mesitylene)	0.768 D	<0.825 U
1,3-Dichlorobenzene	<0.522 U	8.48 D
1,4-Dichlorobenzene	2.09 D	<1.01 U
2,2,4-Trimethylpentane	1.87 D	0.549 D
2-Hexanone (MBK)	<0.711 U	<1.38 U
4-Ethyltoluene	2.01 D	1.07 D
Acetone	32.1 D	375 D
Acrylonitrile	<2.45 U	<4.74 U
Benzene	1.08 D	0.858 D
Carbon Tetrachloride	0.382 D	0.528 D
Chloroform	5.26 D	141 D
Chloromethane	1.33 D	<0.347 U
Cis-1,2-Dichloroethene	<0.172 U	<0.333 U
Cyclohexane	0.508 D	<0.578 U
Dichlorodifluoromethane	7.34 D	39 D
Ethyl Acetate	4.25 D	9.98 D
Ethylbenzene	0.905 D	1.24 D
Isopropanol	41.1 D	173 D
M,P-Xylene	2.94 D	2.26 J
Methyl Ethyl Ketone (2-Butanone)	1.74 D	2.92 D
Methyl Methacrylate	0.782 D	<0.687 U
n-Heptane	1.64 D	1.17 D
n-Hexane	1.38 D	<0.592 U
o-Xylene (1,2-Dimethylbenzene)	1.21 D	2.62 D

Propylene	2.15 D	2.34 D
Styrene	0.666 D	<0.715 U
Tetrachloroethene (PCE)	1.06 D	31.3 D
Tetrahydrofuran	0.998 D	<0.99 U
Toluene	8.67 D	5.44 D
Trichloroethene (TCE)	<0.187 U	4.6 BD
Trichlorofluoromethane	1.27 D	2.08 D

- Carbon tetrachloride was detected in all three sub-slab vapor samples at concentrations from 1.64 $\mu\text{g}/\text{m}^3$ in SSV03 to 3.65 $\mu\text{g}/\text{m}^3$ in SSV02. Carbon tetrachloride was detected in the co-located indoor air samples at concentrations of 1.87 $\mu\text{g}/\text{m}^3$ at IA03 and 2.06 $\mu\text{g}/\text{m}^3$ at IA02. A source of carbon tetrachloride was not identified inside the building during the chemical product inventory. When the co-located analytical results are evaluated using the NYSDOH Decision Matrix, a recommendation of “identify source(s) and resample or mitigate” is provided.

- TCE was detected in all three sub-slab vapor samples at concentrations from 6.79 $\mu\text{g}/\text{m}^3$ in SSV01 to 38.2 $\mu\text{g}/\text{m}^3$ in SSV02. TCE was detected in the co-located indoor air samples at concentrations of 0.394 $\mu\text{g}/\text{m}^3$ at IA01 and 0.586 $\mu\text{g}/\text{m}^3$ at IA02. A source of TCE was not identified inside the building during the chemical product inventory. When the co-located analytical results are evaluated using the NYSDOH Decision Matrix, a recommendation of “monitor” is provided.
