**Re: Quarterly Monitoring Report – 2025 1<sup>st</sup> Quarter  
975 Nostrand Avenue, Brooklyn, NY  
NYSDEC Site No: C224335**

This Quarterly Monitoring Report has been prepared by AKRF, Inc. (AKRF) to summarize routine sampling and monitoring activities performed at the 975 Nostrand Avenue site located in Brooklyn, New York (the "Site"), also identified as Block 1309, Lot 6 on the New York City Tax Map. The Site is situated on an approximately 1.369-acre parcel bounded to the north by a vacant lot (under construction); to the east by Clove Road, followed by multi-family residential buildings; to the south by mixed residential and commercial uses; and to the west by Nostrand Avenue followed by mixed residential and commercial uses and Sullivan Place. A Site location map is provided as Figure 1. A Site plan is provided as Figure 2.

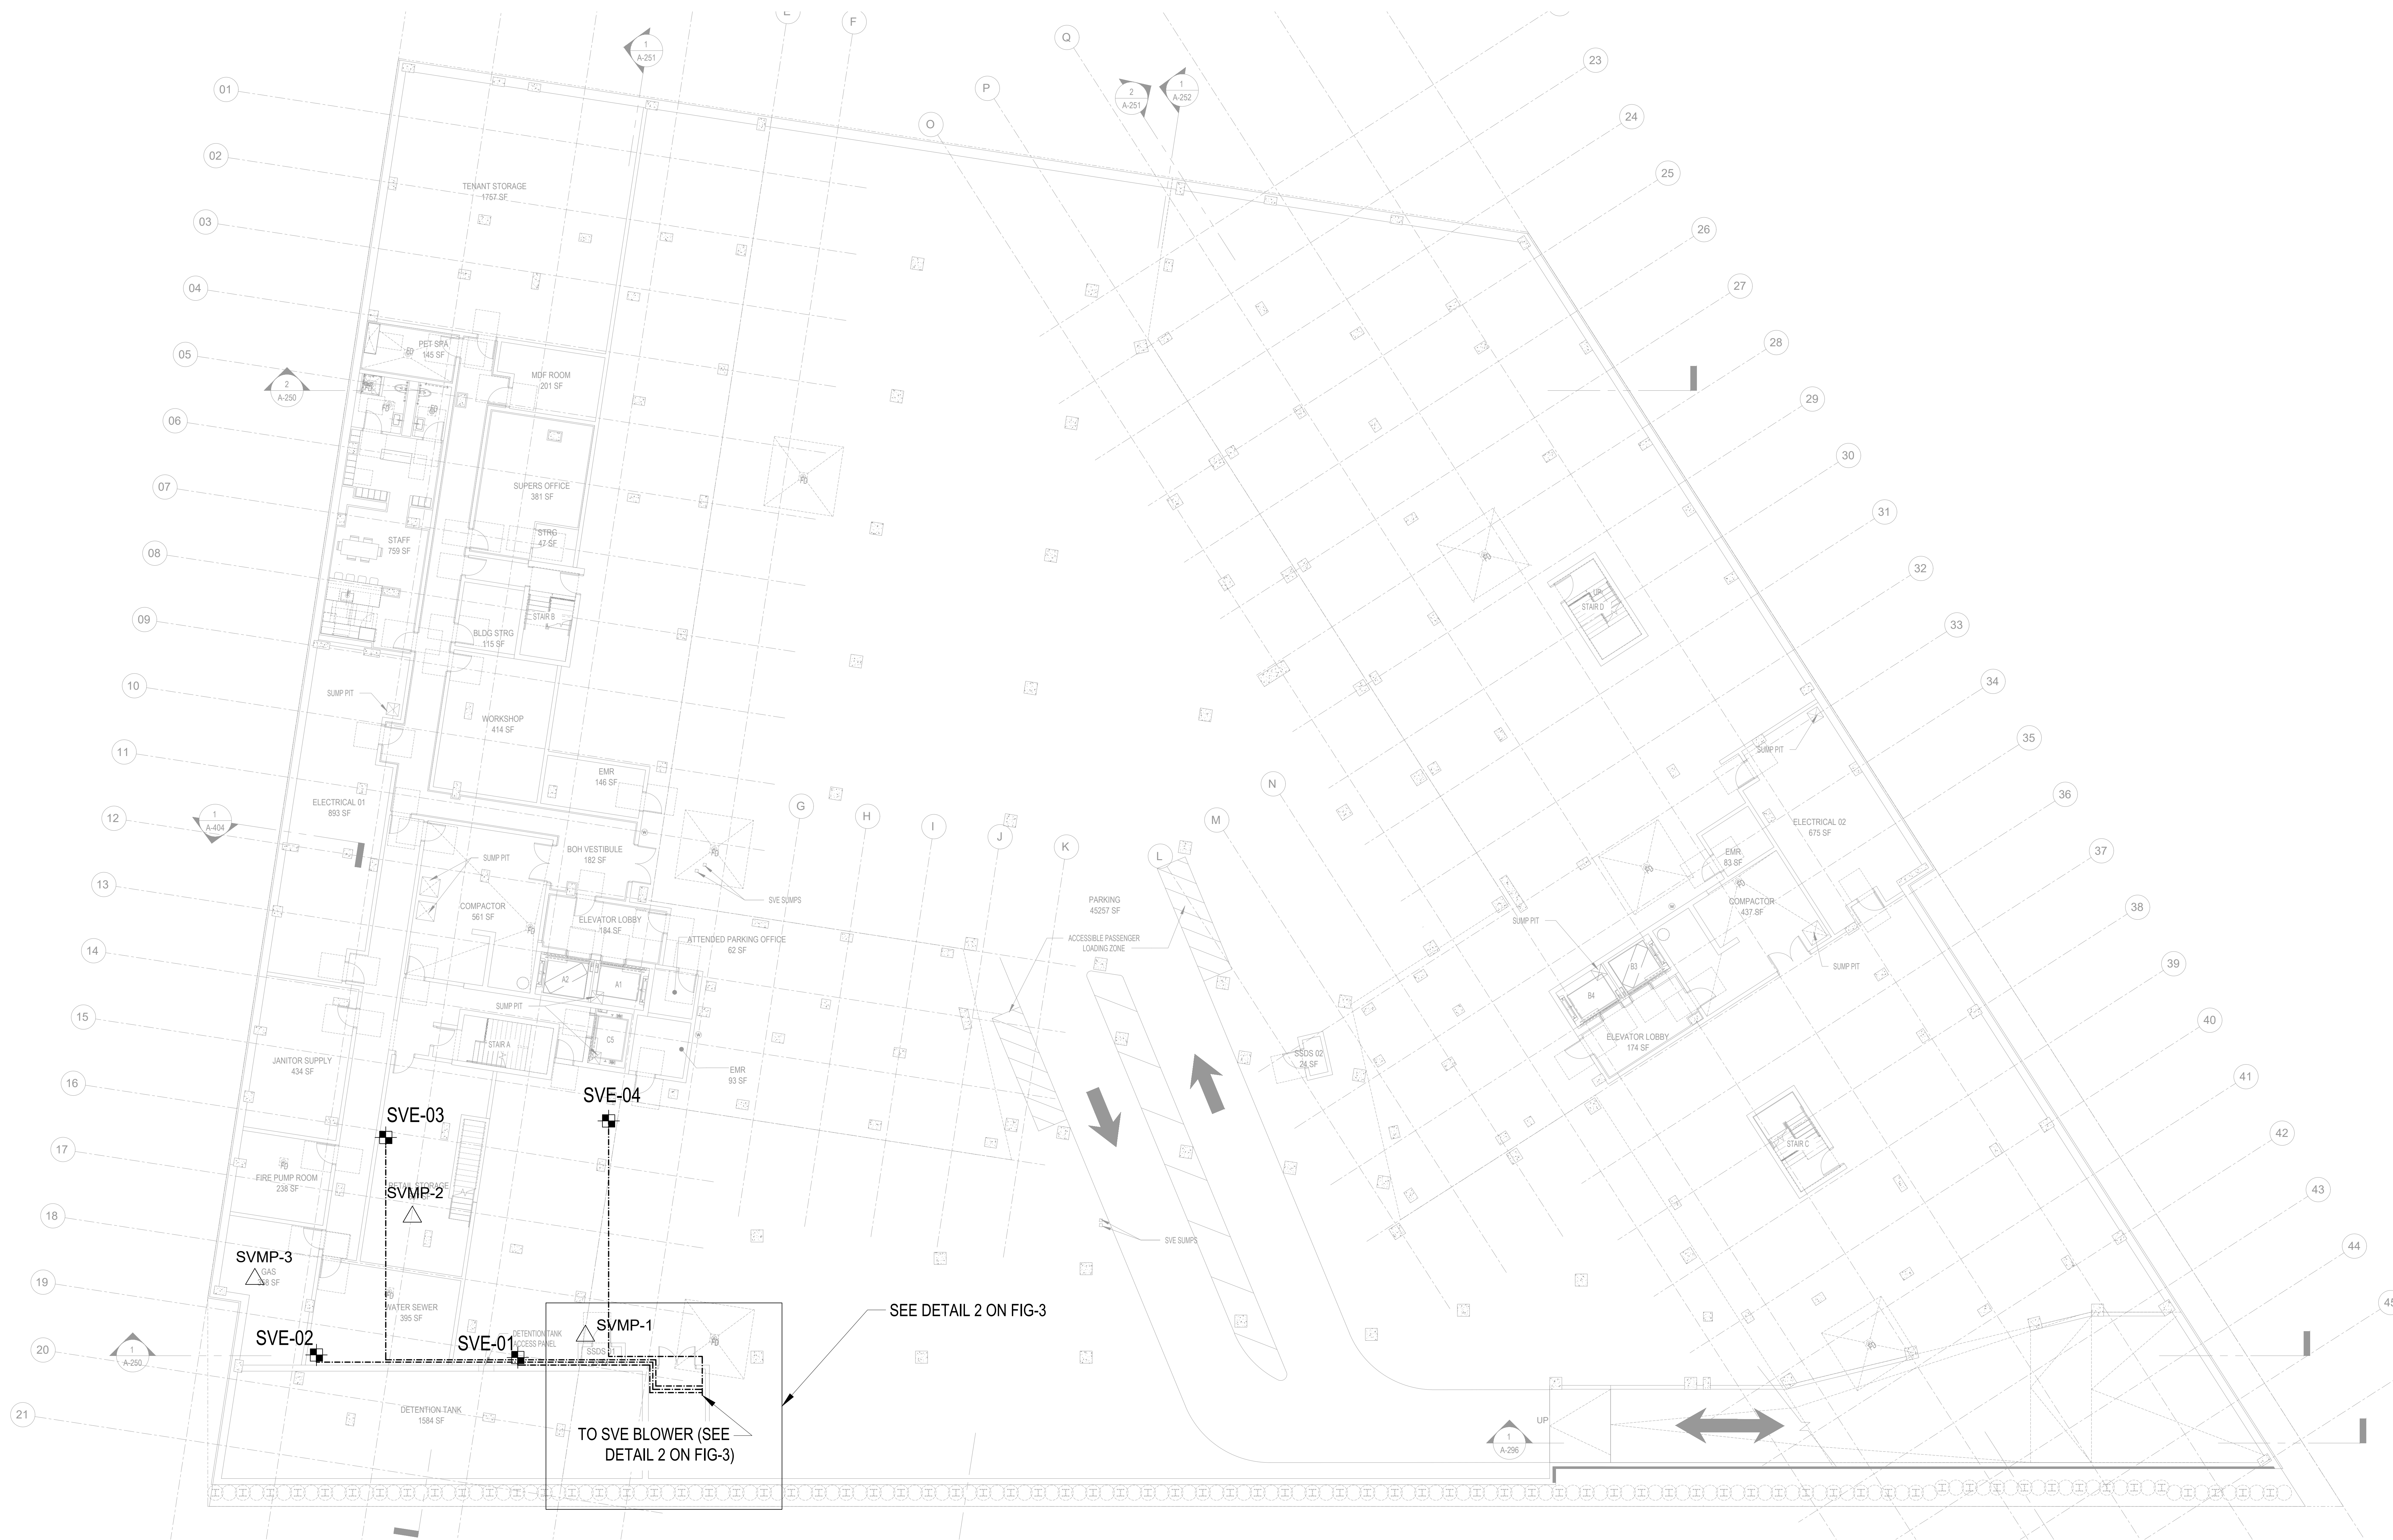
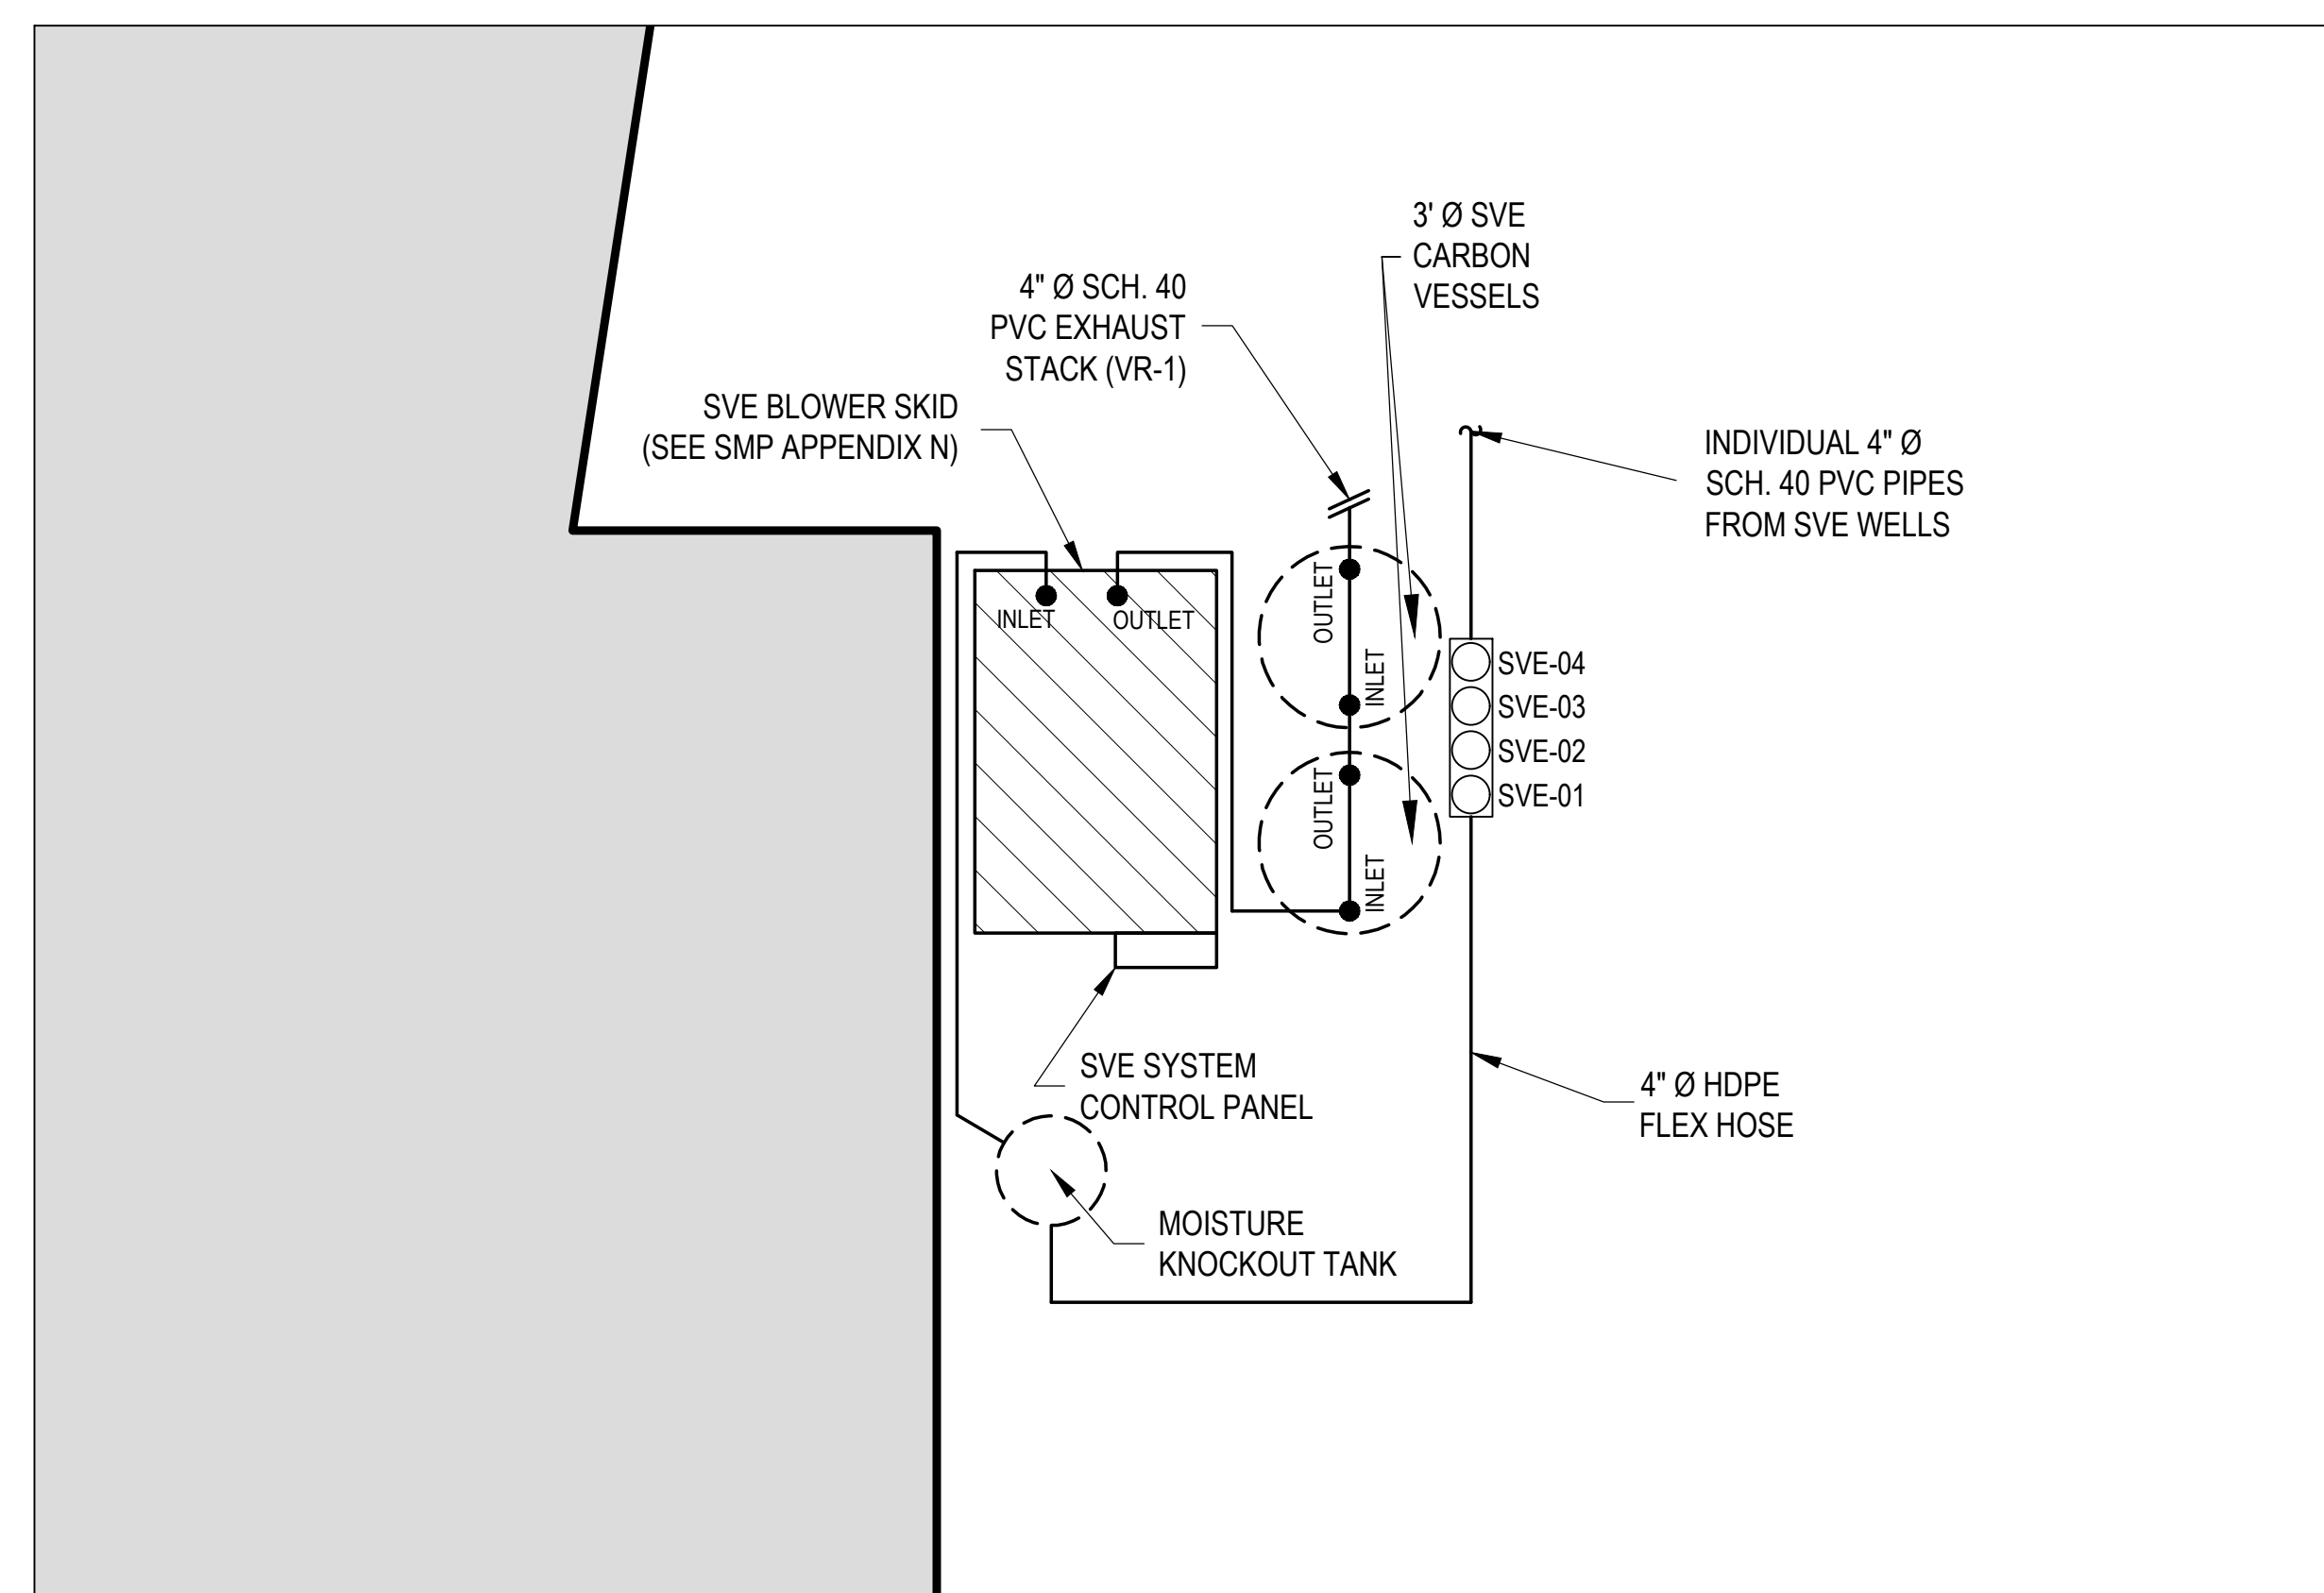
**SVES LAYOUT PLAN**

The system inspection completed in Q1 2025 did not detect elevated levels of VOCs (max. 0.5 parts per million) at the GAC vessel intermediate or effluent port, and as such, a GAC vessel changeout was not warranted during the reporting period. Previously spent GAC vessels were picked up for off-site disposal in February 2025, as discussed below. No other significant changes were observed. The SVES layout is shown on Figure 3. The inspection log is provided in Attachment A.

**1**  
FIG-3 SOIL VAPOR EXTRACTION SYSTEM AS-BUILT LAYOUT  
SCALE IN FEET

**2**  
FIG-3 SVE EQUIPMENT AREA  
SCALE IN FEET  
NOTE: PIPE SIZE AND SPACING NOT TO SCALE
