**Re: Quarterly Monitoring Report – 2025 2<sup>nd</sup> Quarter  
975 Nostrand Avenue, Brooklyn, NY  
NYSDEC Site No: C224335**

**SVE INSPECTION LOG**  
**MONTHLY SOIL VAPOR EXTRACTION SYSTEM INSPECTION**  
 975 Nostrand Avenue, Brooklyn, NY

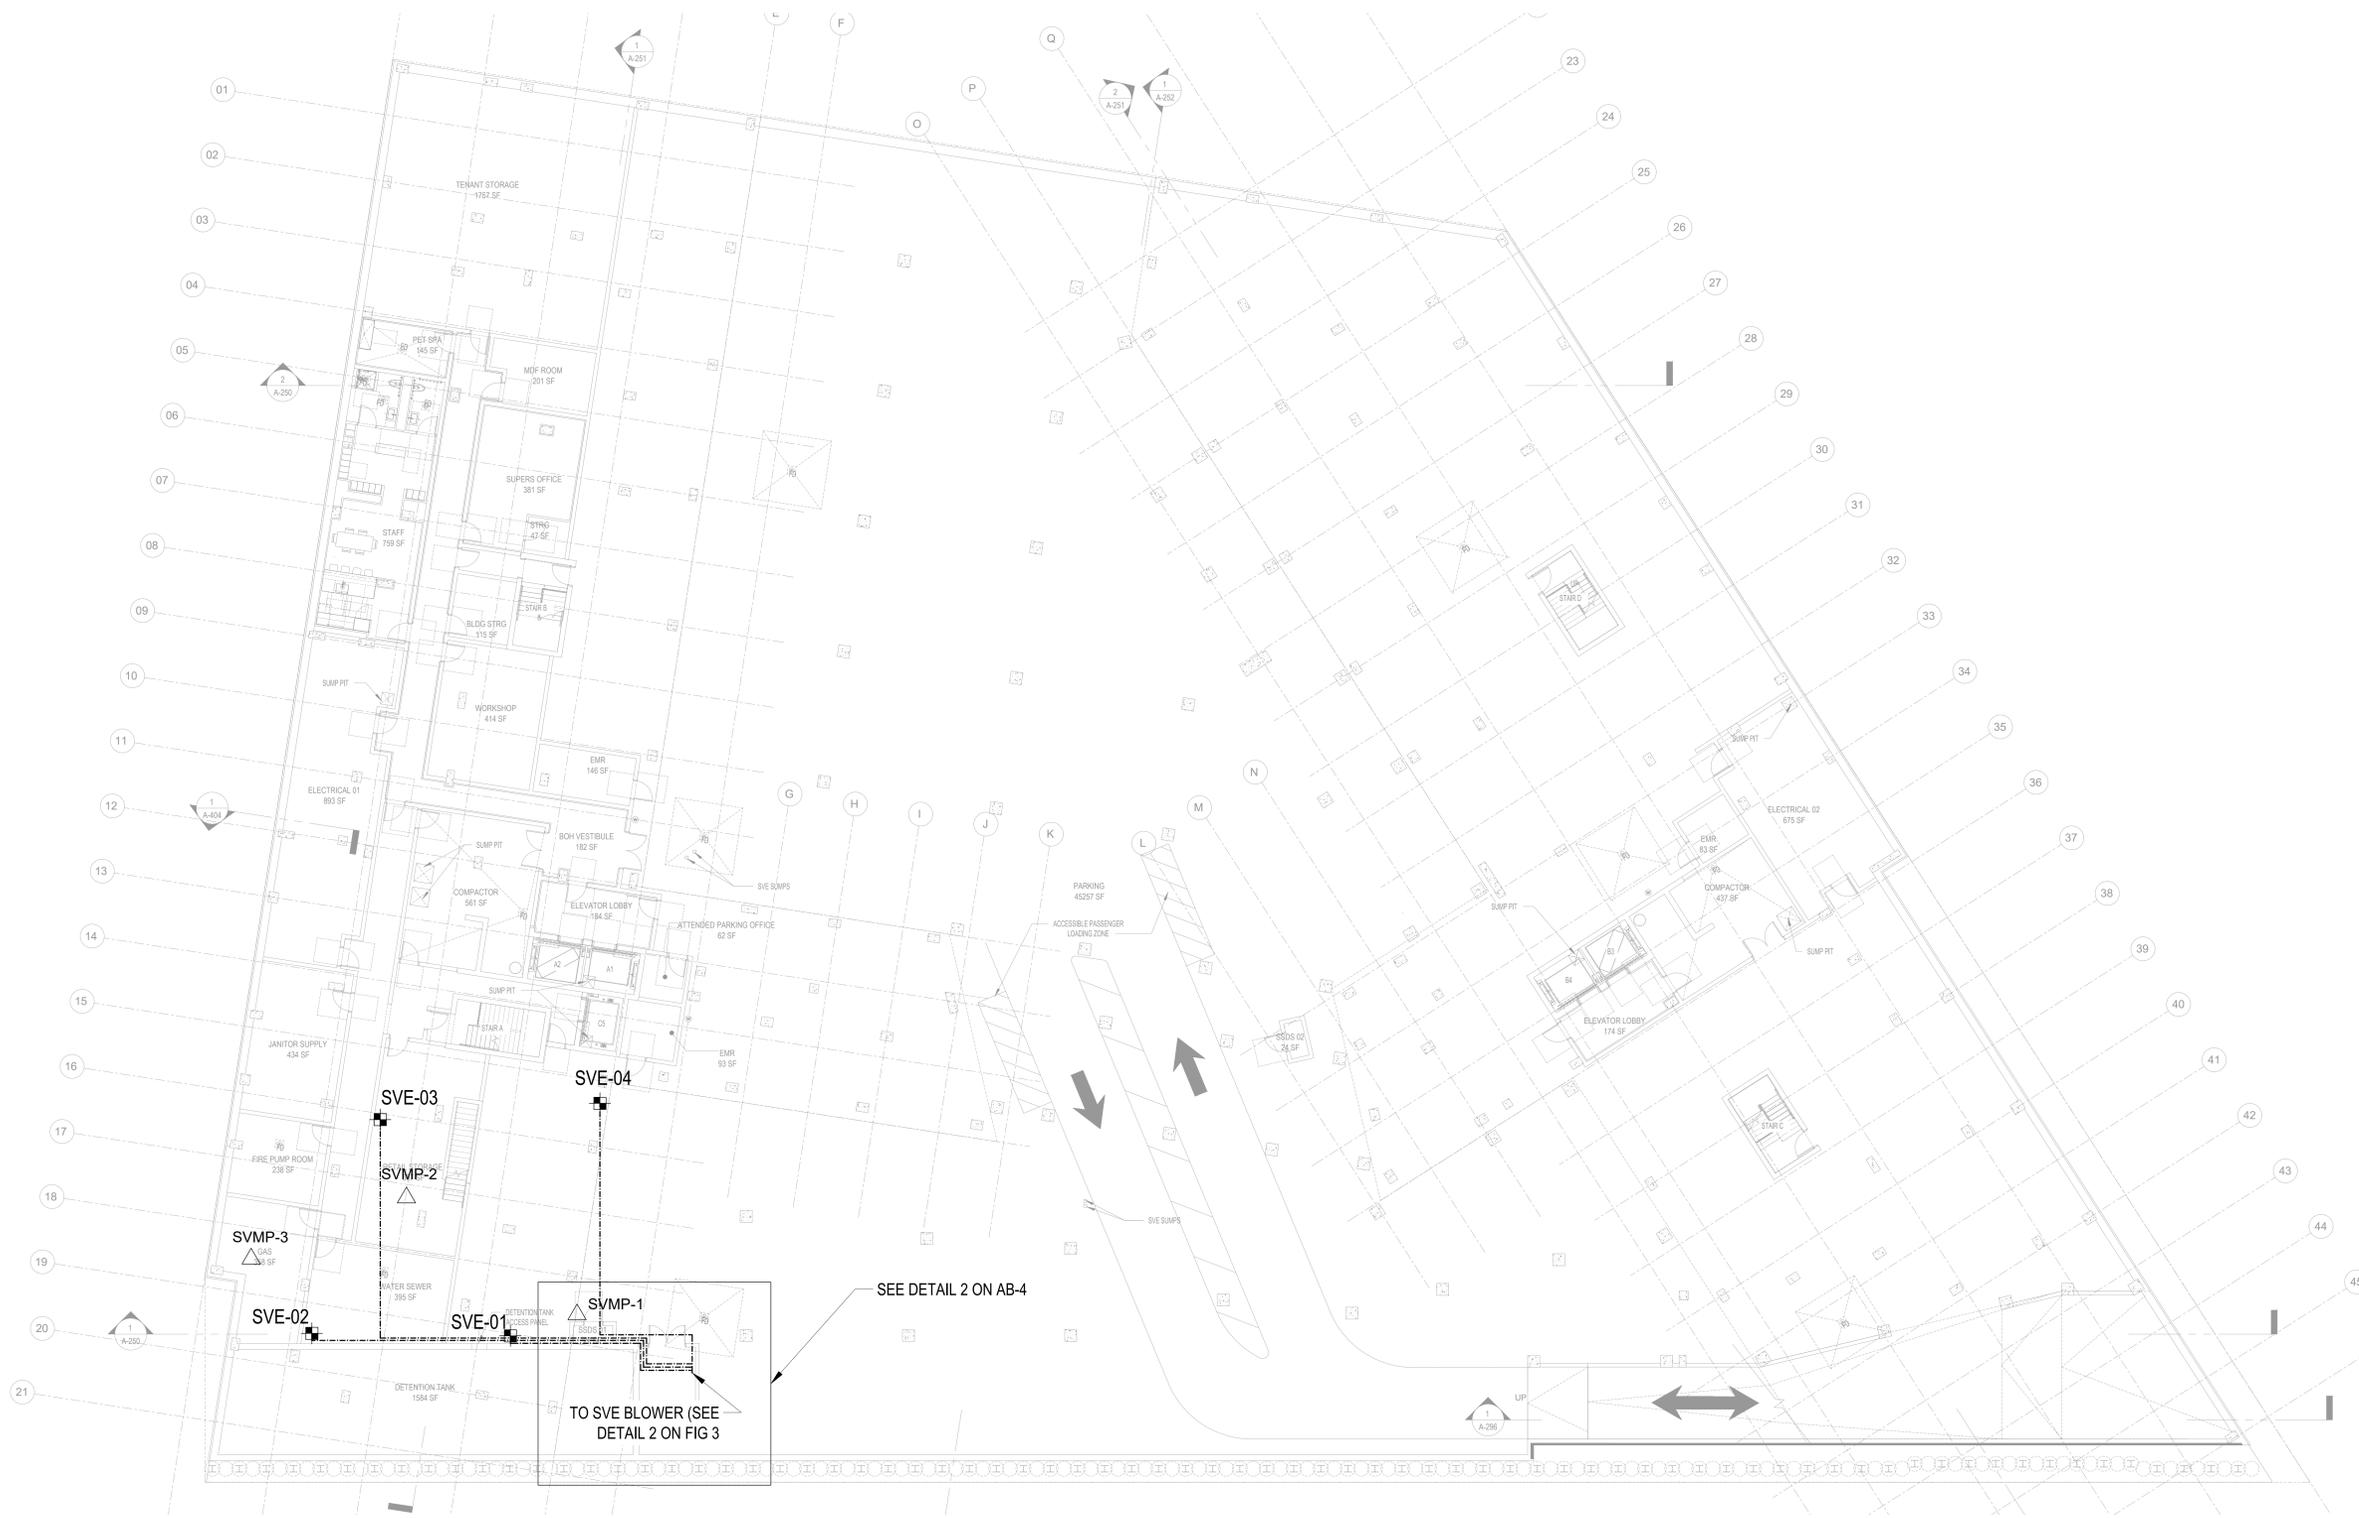
**1** SOIL VAPOR EXTRACTION SYSTEM AS-BUILT LAYOUT  
FIG 3

The system inspection completed in Q2 2025 did not detect elevated levels of VOCs [maximum 0.30 parts per million (ppm)] at the GAC vessel intermediate or effluent port, and as such, a GAC vessel changeout is not warranted at this time. No other significant changes were observed. The SVES layout is shown on Figure 3. The inspection log is provided in Attachment A.

SVE VAPOR MONITORING POINT LOCATIONS		
ID	COLUMN LOCATION	ROOM
SVMP-01	144	GARAGE (SOUTH)
SVMP-02	143	RETAIL STORAGE
SVMP-03	153	GAS ROOM

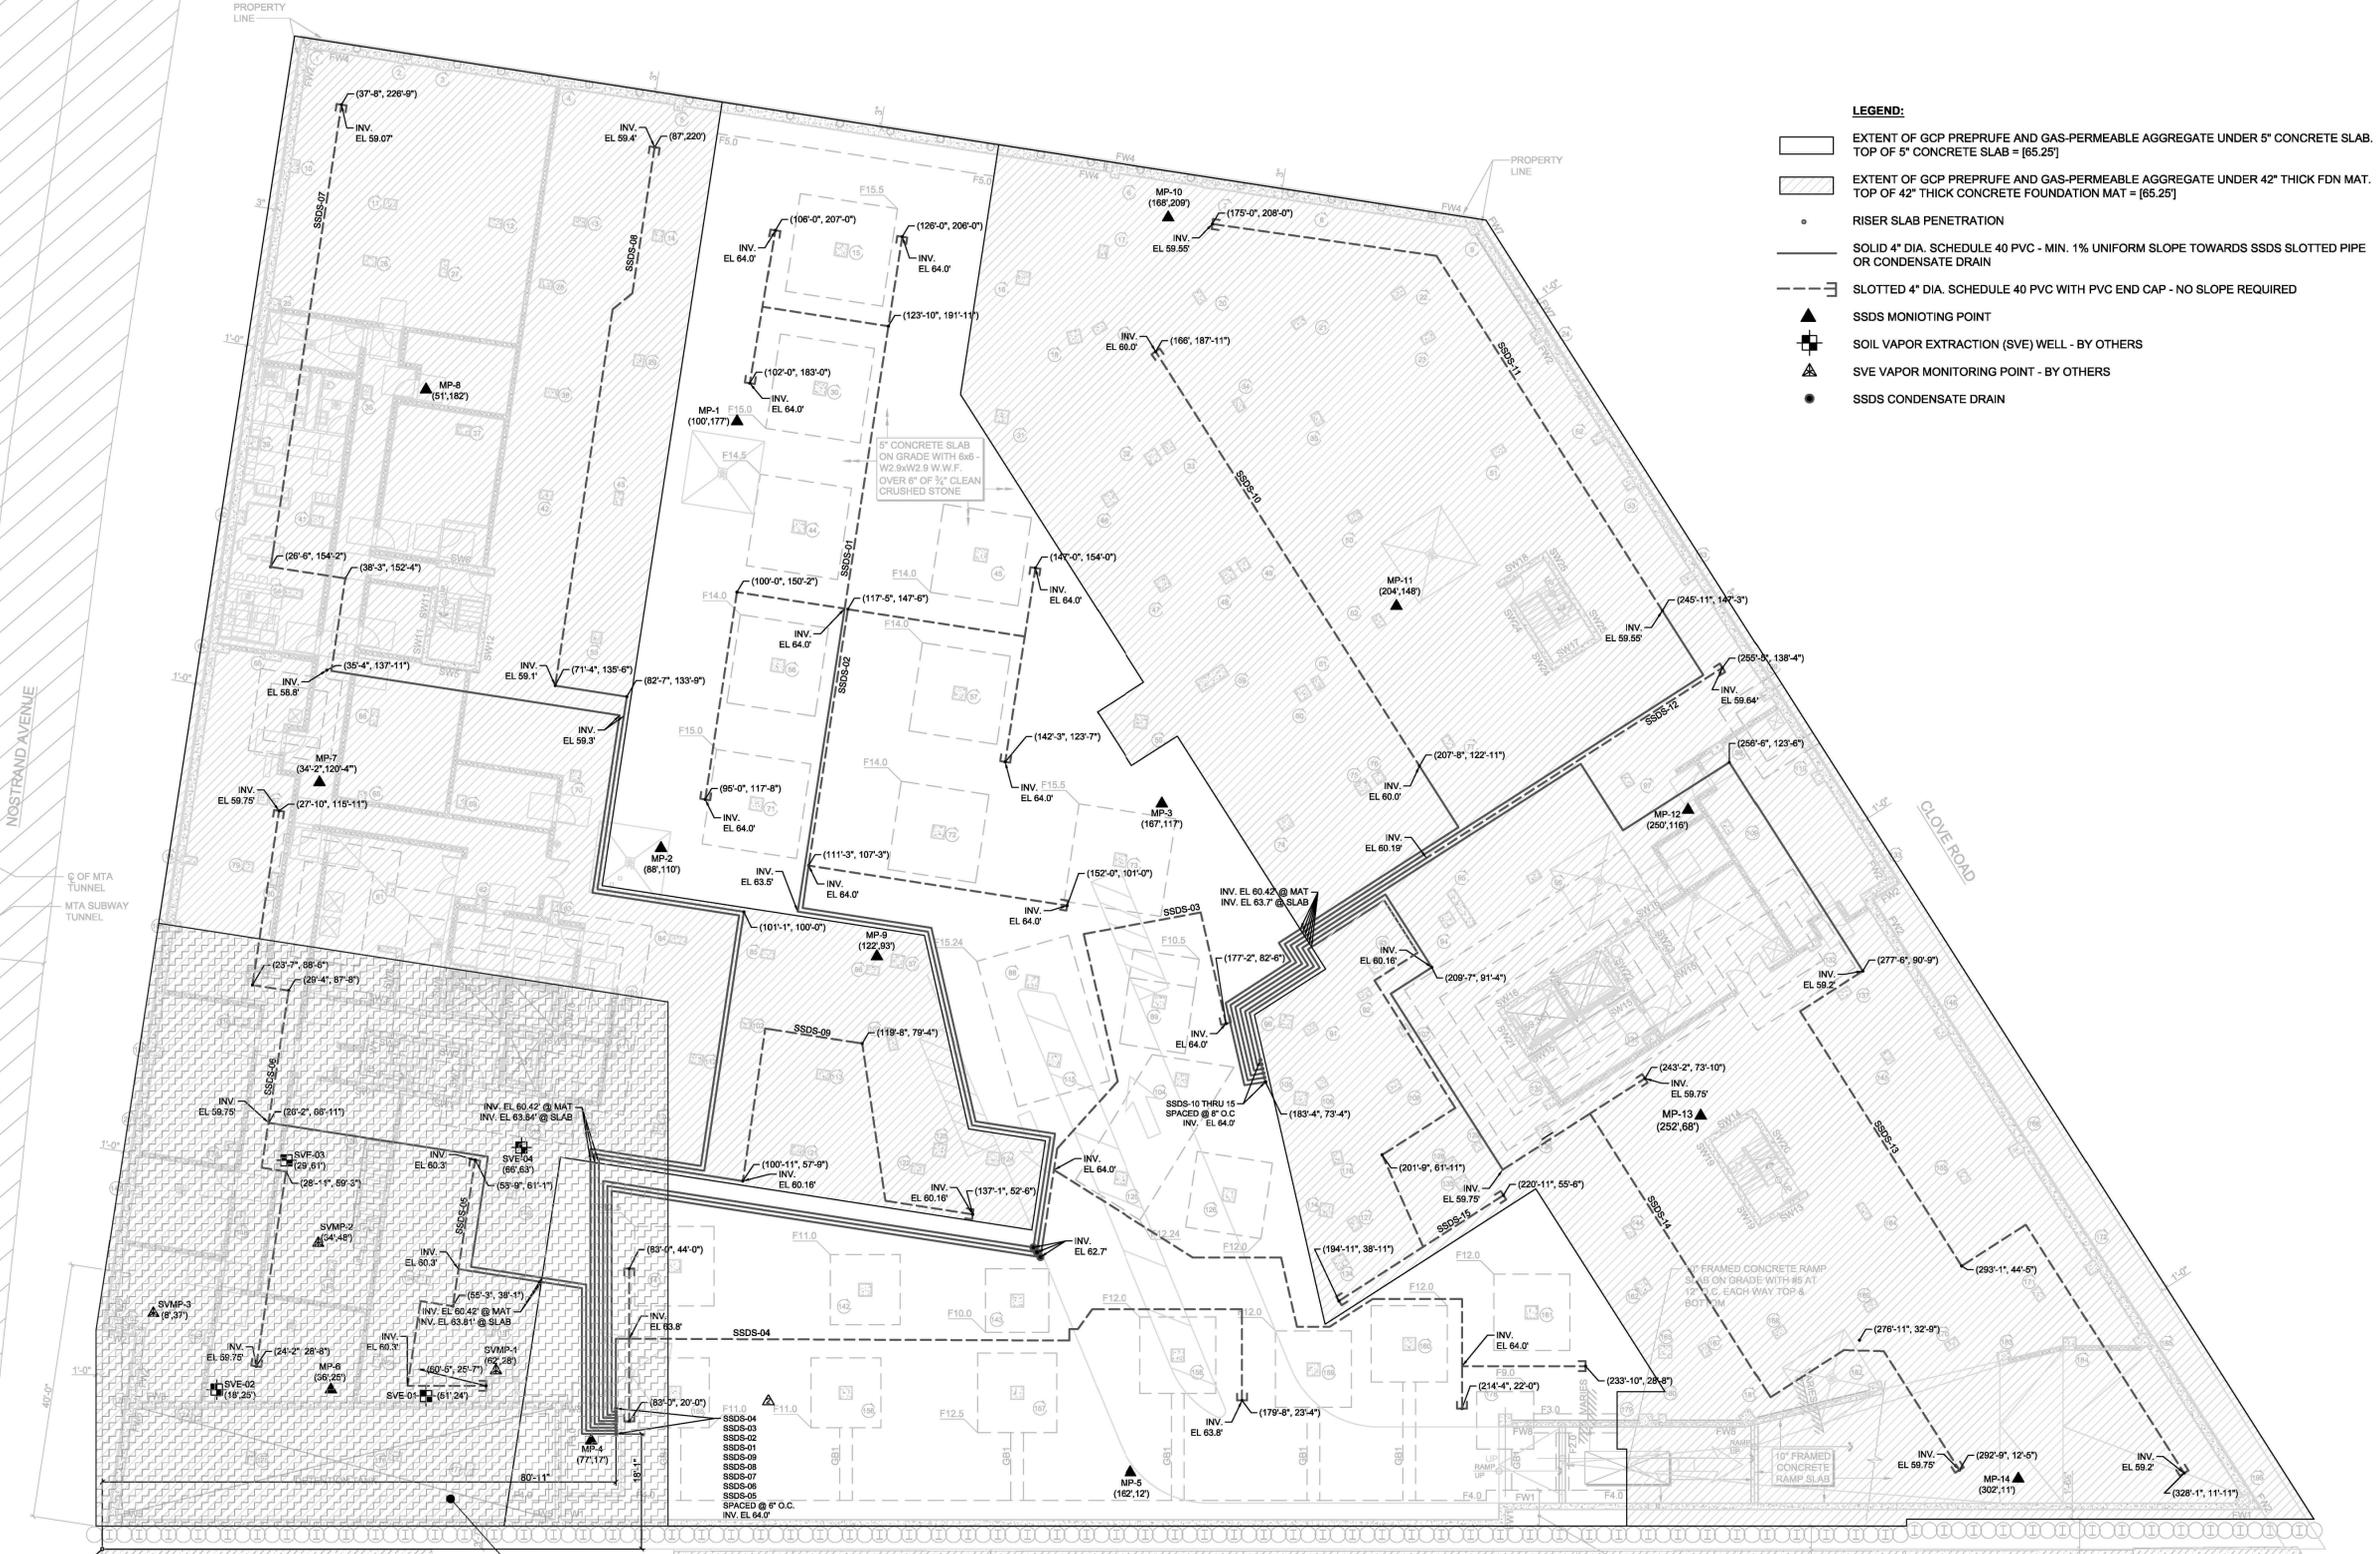
DATE	4/24/2024
PROJECT NO.	210225
FIGURE	4

An active SSDS (total 3 separate systems) will be operated at the Site to mitigate the potential for soil vapor intrusion into the new building. The SSDSs will induce a negative pressure (i.e., vacuum) beneath the newly constructed building slab. The underground elements of the SSDS were installed beneath the building slab following remedial excavation, prior to receipt of the CoC. The SSDS layout is shown on Figure 4. Since the last SSDS inspection in October 2024, the SSDS suction fans have been installed on the roof of the building. All installed elements were noted to be in good condition and no issues were noted. The SSDSs are scheduled to be started in Q3 2025.

APPROXIMATE EXTENT WHERE 6-MIL PLASTIC SHEETING INSTALLED UNDER GAS PERMEABLE AGGREGATE IN LIEU OF GEOTEXTILE FABRIC

EXISTING 1 STORY BRICK BUILDING. BOTTOM OF FOOTING INCONCLUSIVE BASED ON TEST PIT TP-3 PERFORMED BY LANGAN ENGINEERING. ASSUME BOTTOM OF FOOTING ELEVATION = 73.0', V.I.F.

EXISTING 1 STORY BRICK BUILDING. BOTTOM OF FOOTING ELEV. = 60.0' PER TEST PIT, TP-4, PERFORMED BY LANGAN ENGINEERING, V.I.F.
