CLIENT: Orange Management Inc.	DATE: Wednesday, June 1, 2022
PROJECT No.: 170698601	WEATHER: Cloudy, 60-70 °F, Wind: 10-20 mph WNW
PROJECT: Third Street Gowanus	TIME: 08:00 – 15:30
LOCATION: 125 Third Street, Brooklyn, New York	BCP SITE No.: C224346
EQUIPMENT: Ponar Grab Sampler Drum Solid Core Sampler	PRESENT AT SITE: Langan: Daniel Arnstein, Audrey Seery

Langan was at the site to collect waste characterization samples of excess soil/sediment generated during initial foundation construction in May 2022 at Brownfield Cleanup Program (BCP) Site No. C224346.

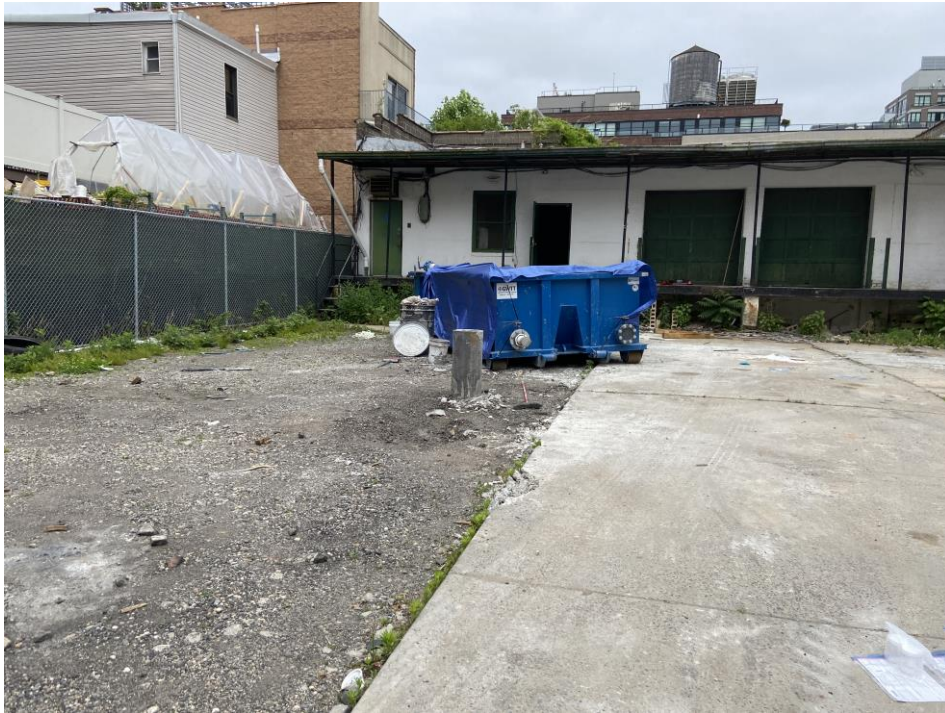
Photo 1: Settling tank in the southern part of the site (facing north)

- Langan used a Ponar grab sampler to collect one sediment sample set (consisting of one grab and one composite sample) from two settling tanks at the site. Langan covered the settling tanks with plywood and a tarp at the end of the day.
- Langan used a drum solid core sampler to collect one soil sample set (consisting of one grab and one composite sample) from five 55-gallon drums at the site.

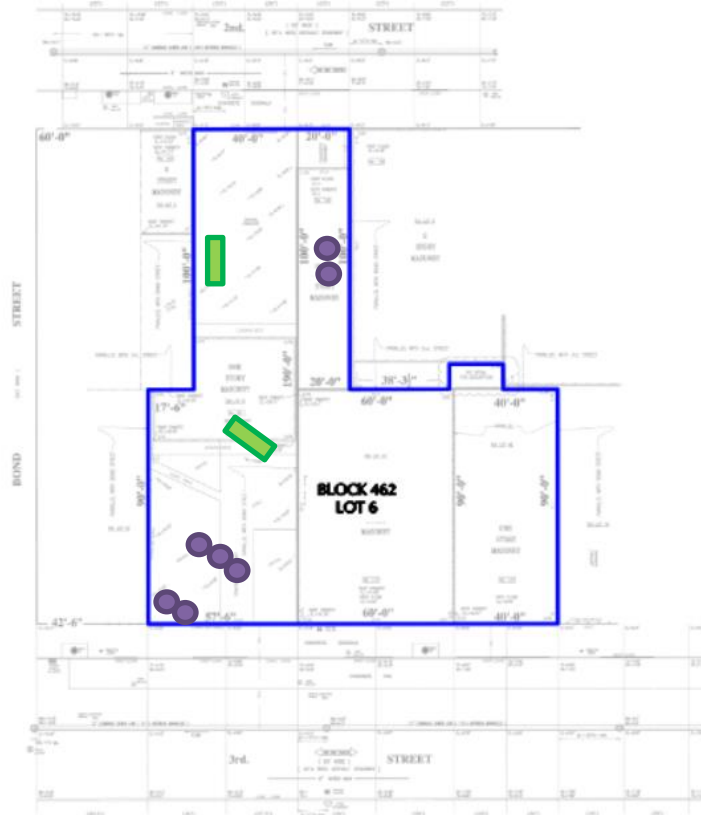
SITE MAP

1. Base map adapted from Architectural Survey prepared by AAA Group R.R Services, Inc. dated August 7, 2021
2. Locations are approximate.
