**SITE INSPECTION REPORT  
T & J SALVAGE  
2647 STILLWELL AVENUE  
BROOKLYN, NEW YORK**

**EPA ID No.: NYN000203544**

December 2021

Weston Solutions, Inc.  
Edison, New Jersey 08837

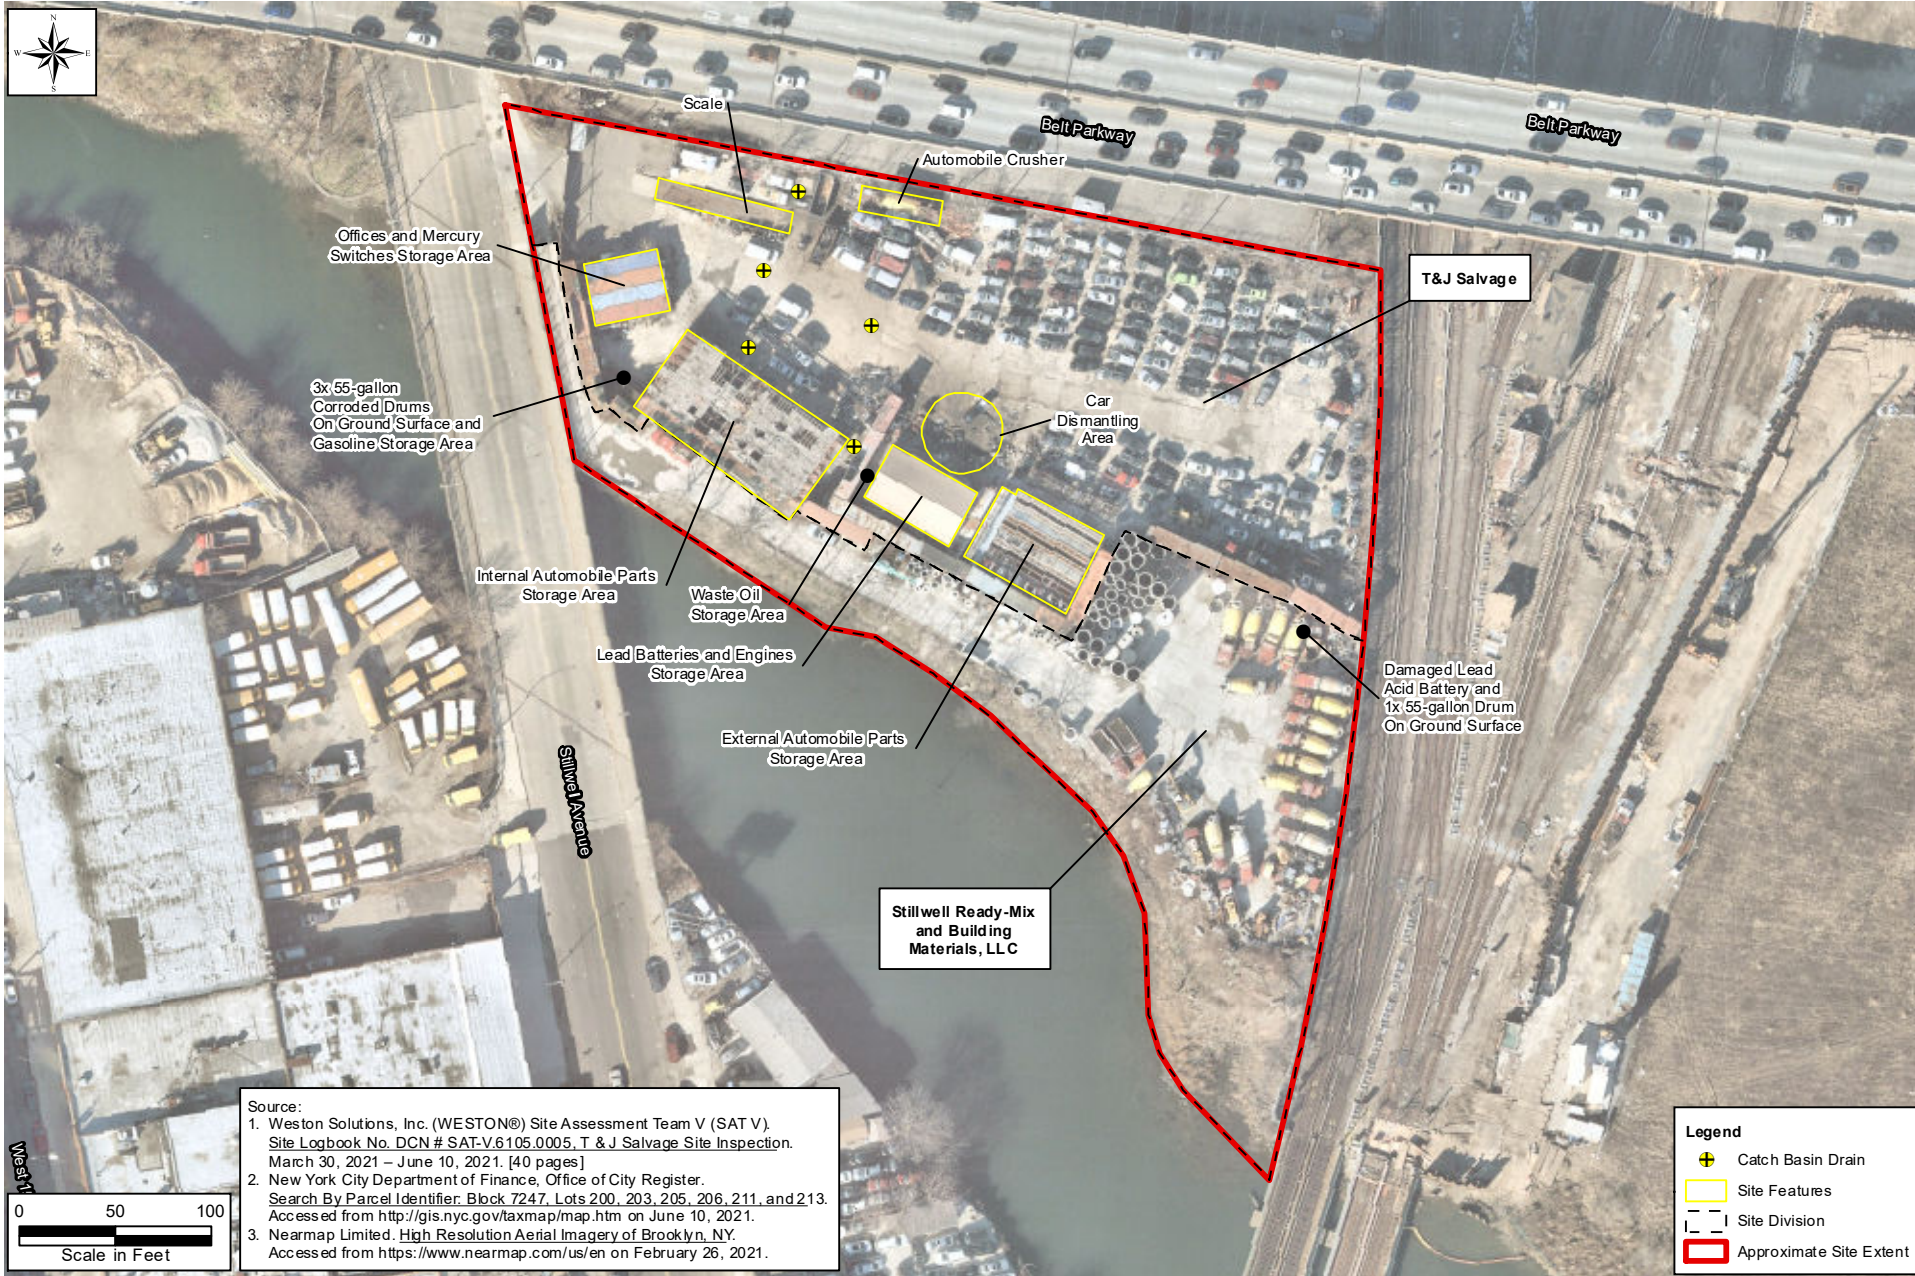
FIGURE #: 2

On March 30, 2021, Region 2 Site Assessment Team V (SAT V) personnel conducted pre-sampling reconnaissance activities at and in the vicinity of the T & J site [Ref. 8, pp. 3–5]. The objective of the reconnaissance was to observe current site conditions and to select potential on- and off-site SI sample locations [Ref. 8, pp. 3–5]. Based on observations made during the reconnaissance, the facility comprises one covered garage, two open-air storage sheds, and conjoined Conex boxes that serve as offices and storage areas. ELVs are stored in the eastern portion of the subject property [Ref. 8, pp. 4, 15]. The southern portion of the property is leased by Stillwell Ready-Mix and Building Materials, LLC, and it is used for the storage of concrete mixing trucks and large-diameter concrete piping [Ref. 8, p. 3]. The ground surface of the property consists mostly of concrete pavement, bordered by narrow strips of vegetated land in some areas [Ref. 8, p. 5]. The concrete is impermeable; however, it is weathered in several places. No exposed soil was observed by Region 2 SAT V in the weathered areas [Ref. 8, p. 15]. **Figure 2** presents a Site Features Map.

TITLE: SITE FEATURES MAP  
T & J SALVAGE  
BROOKLYN, KINGS COUNTY, NY

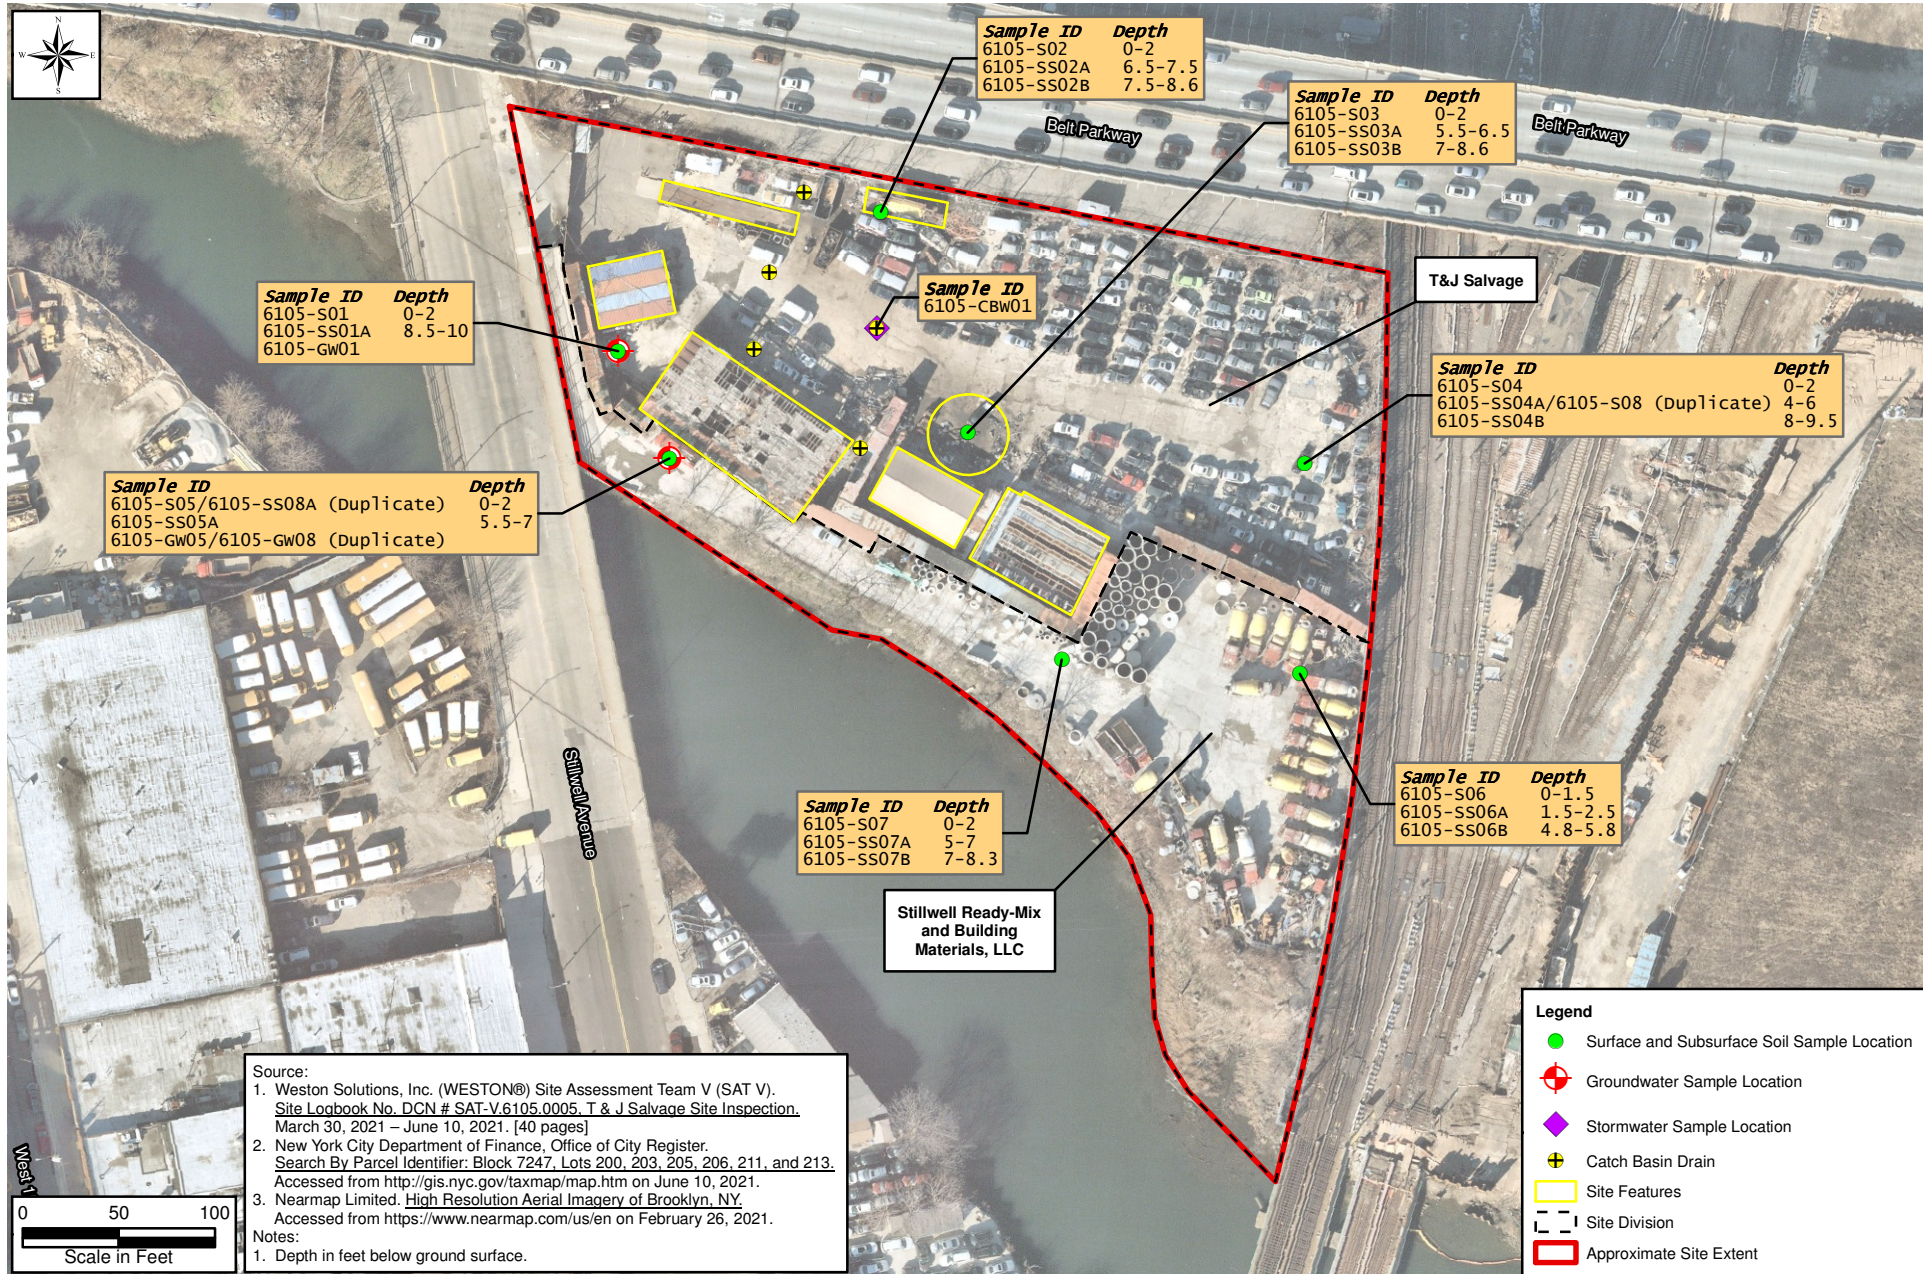
FIGURE #: 3

On June 2 and 3, 2021, Region 2 SAT V personnel collected soil, groundwater, and stormwater samples as part of the SI evaluation of the T & J site. Region 2 SAT V collected a total of 21 soil samples (including two environmental duplicates), three groundwater samples (including one environmental duplicate), and one stormwater sample from the T & J site [Ref. 8, pp. 10–21; 24, pp. 3, 5–11]. **Figure 3** presents the T & J Site Sample Location Map.

TITLE: SITE SAMPLE LOCATION MAP  
T & J SALVAGE  
BROOKLYN, KINGS COUNTY, NY

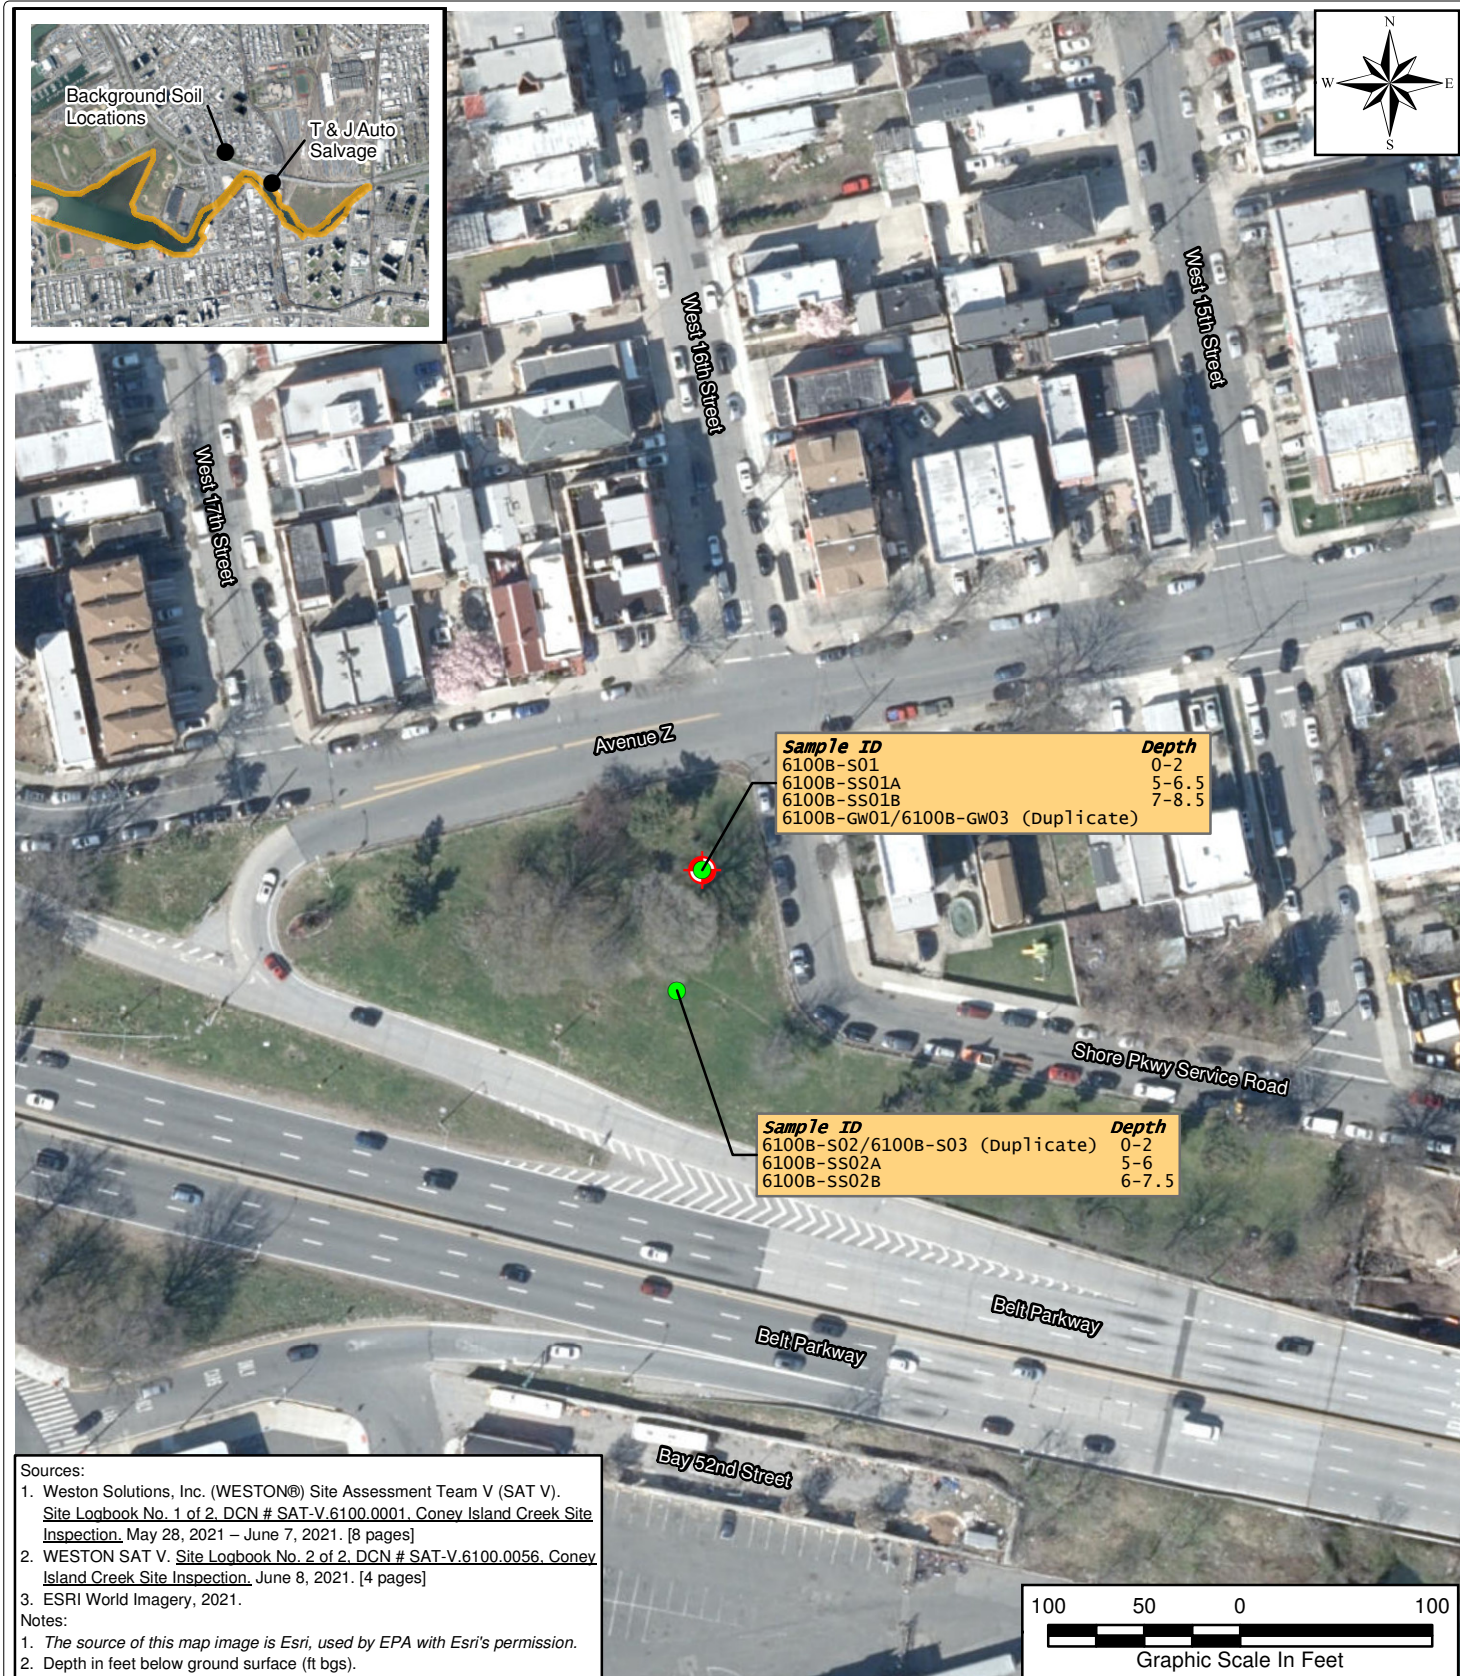
On June 7 and 8, 2021, Region 2 SAT V personnel collected background soil and groundwater samples associated with the SI evaluation of the T & J site. Region 2 SAT V collected a total of seven soil samples (including one environmental duplicate) and two groundwater samples (including one environmental duplicate) from a grass area just north of the Belt Parkway Exit 6N. The location is considered to represent background conditions for the SI evaluation because it is believed to be unaffected by activities or possible releases at the T & J site [Ref. 25, pp. 3, 5–8; 34, pp. 2–4; 35, p. 2]. **Figure 4** presents the Background Sample Location Map. All samples collected in support of the T & J Salvage site SI evaluation were analyzed by CLP laboratories for TAL VOCs, SVOCs, Pesticides, and Aroclors; and ICP-AES 11+ Metals (including mercury) [Ref. 24, p. 4; 25, p. 4].
