DAILY STATUS REPORT-11/16/2022

IEC Project No:	13928	NYSDEC BCP Site No:	C224367	Date:	11/16/22
Project:	251 Douglass Street, Brooklyn, NY

Scope of Work:

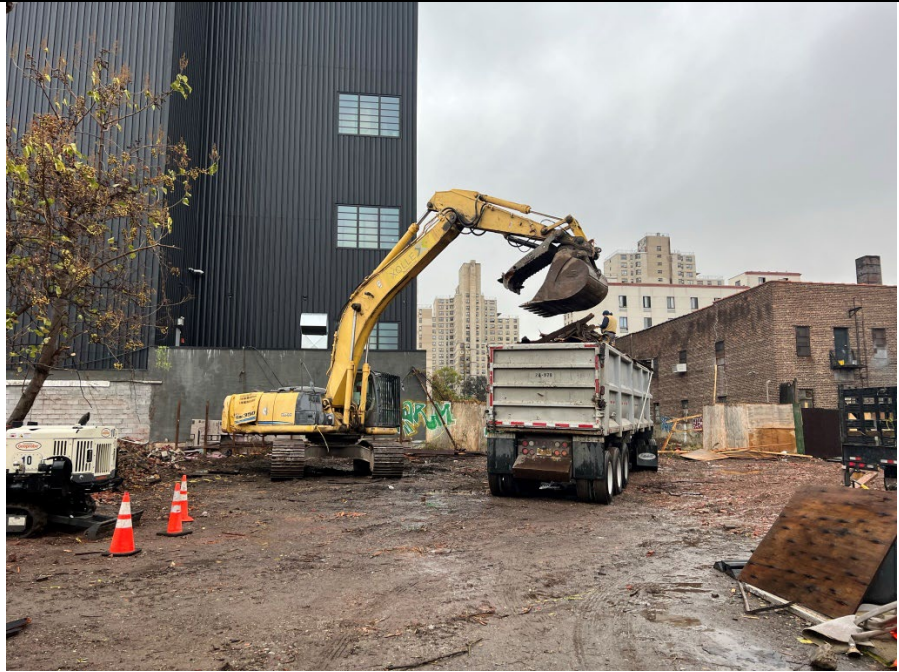
Photo 1 – Representative photo of garbage being removed offsite to Cooper Dump by JDJ Trucking.

- One (1) load of garbage was loaded offsite to Cooper Dump of Brooklyn, NY transported by JDJ Trucking;
- Xolle demo crew continued to remove bricks off the North wall from the one (1) story warehouse structure and placed into stockpiles;

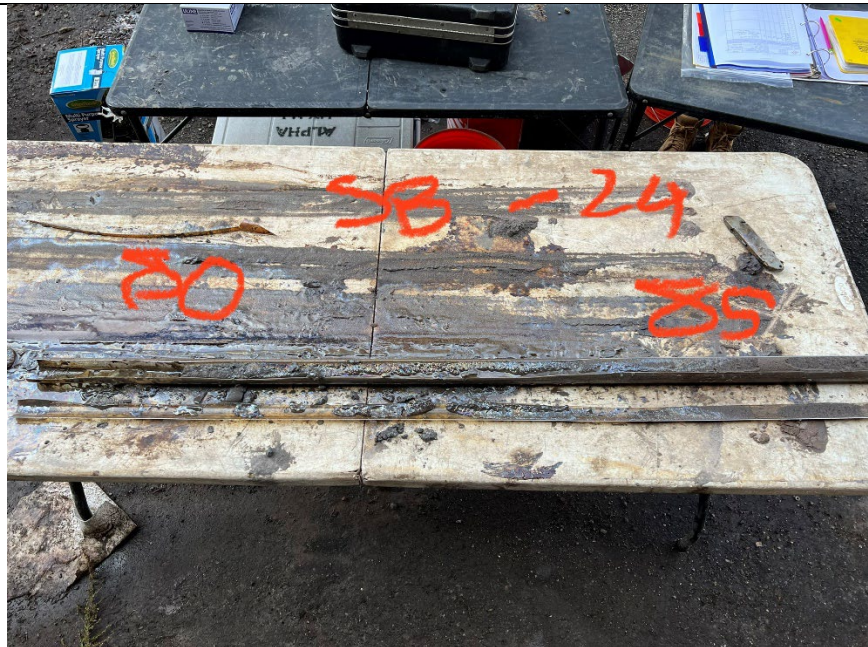
Photo 2 – Representative photo of SB-24 at the 80-85' interval.

- Completed drilling SB-24 to 115'. Impacted material was encountered beginning at 32'. It should be noted that IEEG requested the PG advance the boring beyond 100' as slightly elevated PID readings and a sheen were noted in the 95-100' interval. This was also noted in 100-105'; 105-110' and 110-115'. A call was placed to D.Posten the IEEG PM and she mentioned due to the depth of the boring and being in the saturated zone the sheen and elevated PID could be the result of drag down, Scott and Aaron of the NYSDEC agreed and instructed A.Keenan to not advance the boring any further and a sample from the material at 113-115' would suffice as a bottom sample; and

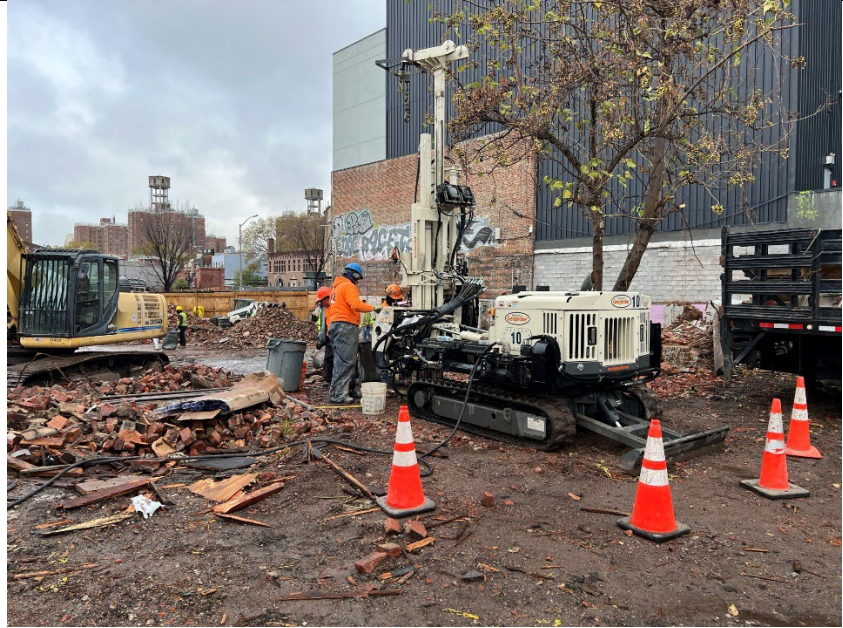
Photo 3 – Representative photo of drillers (PG Environmental) advancing SB-24.

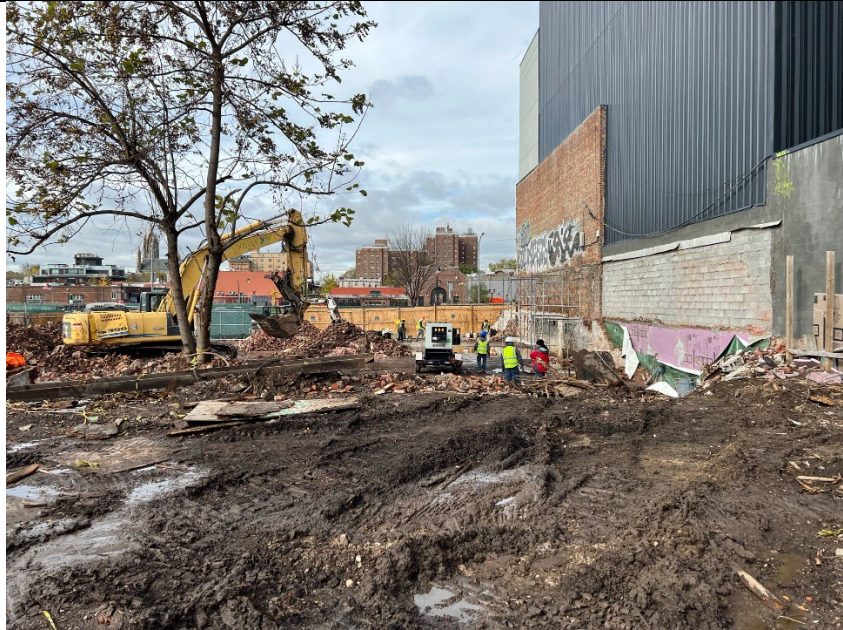
Photo 4 – Representative photo of workers removing bricks off the northern wall from the one (1) story warehouse structure.

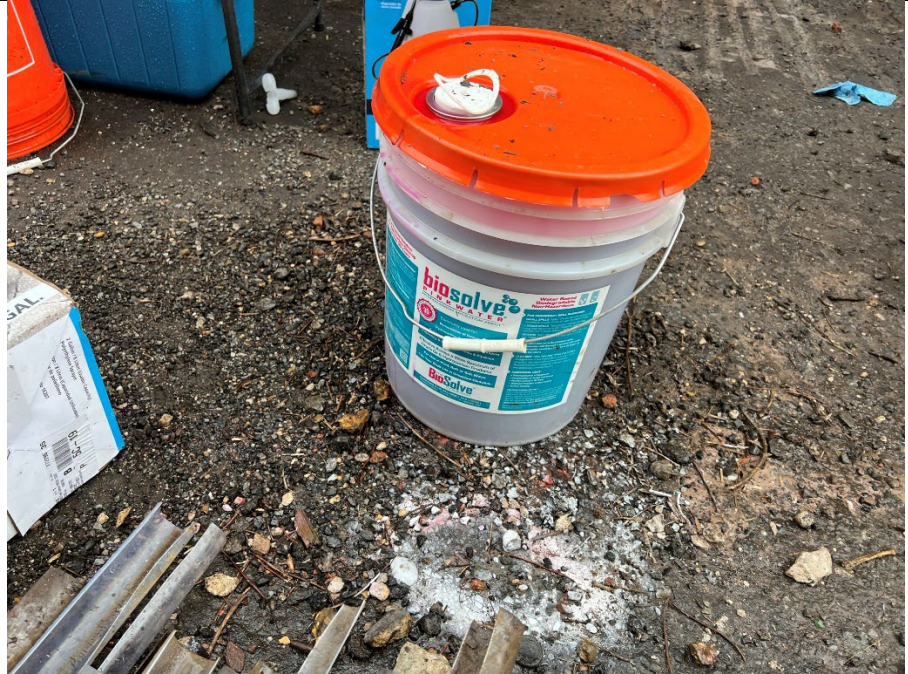
Photo 5 – Representative photo of BioSolve which will be used on the Site, as needed for odor mitigation.

- Once the bottom sample was taken from SB-24 the boring hole was covered with surround soil and Biosolve was misted just downgradient of the boring location to mitigate odors.
