DAILY FIELD REPORT

Project	Former A&A Brake Service Site	Report No.	17
BCP Site	NYSDEC BCP SITE C224372	Date	7/18/2024
Location	558 Sackett Street	File No.	0206384
Client	Sackett Heights LLC	Temperature	H: 88 L: 69
Contractor	Blue Sky Builders	Wind Direction	NW to SE, 11 mph
Weather	Partly Cloudy	Personnel on Site	G. Poulton
Humidity	51%	Time on Site	6:30 am to 4:15 pm

H & A of New York Engineering and Geology, LLP (Haley & Aldrich) was present document implementation of the May 2024 NYSDEC-Approved Remedial Action Work Plan (RAWP) and Decision Document for the Former A&A Brake Service Site C224372, located at 558 Sackett Street, Brooklyn, NY. Site observations are summarized below.

WEEKLY MONITORING REPORT

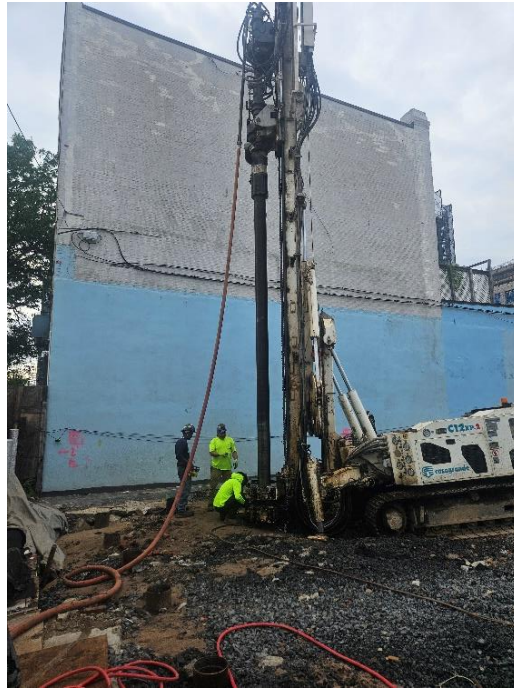
Photo 1: View of contractor installing piles for SOE, facing east.

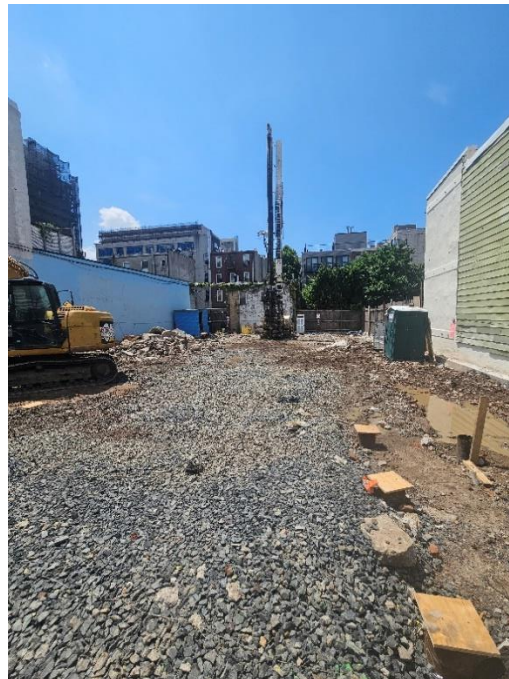
Photo 2: View of general site conditions, facing south.
