Project	Former A&A Brake Service Site	Report No.	21
BCP Site	NYSDEC BCP SITE C224372	Date	7/24/2024
Location	558 Sackett Street	File No.	0206384
Client	Sackett Heights LLC	Temperature	H: 78 L: 71
Contractor	Blue Sky Builders	Wind Direction	NE to SW, 12 mph
Weather	Overcast	Personnel on Site	G. Poulton
Humidity	87%	Time on Site	6:30 am to 4:30 pm

H & A of New York Engineering and Geology, LLP (Haley & Aldrich) was present document implementation of the May 2024 NYSDEC-Approved Remedial Action Work Plan (RAWP) and Decision Document for the Former A&A Brake Service Site C224372, located at 558 Sackett Street, Brooklyn, NY. Site observations are summarized below.

WEEKLY MONITORING REPORT

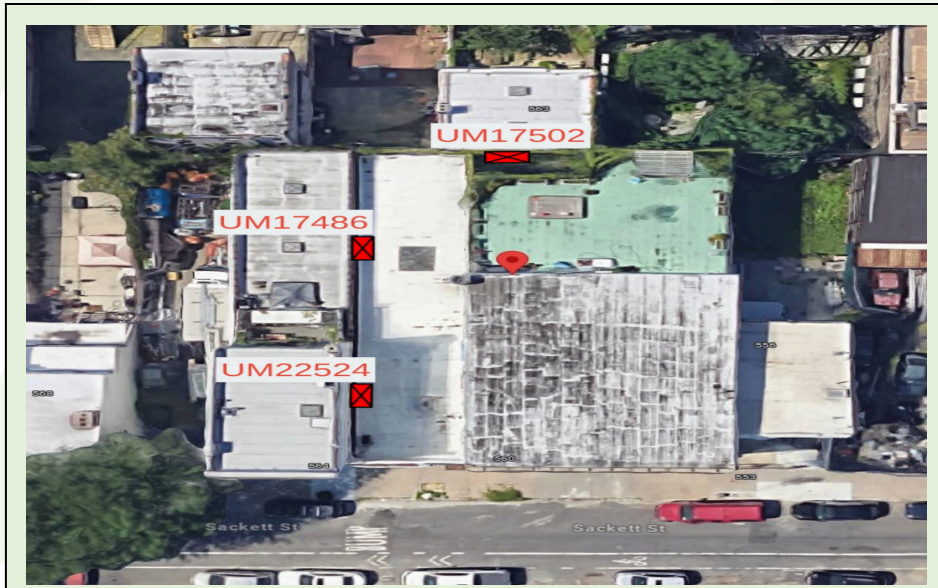
<p>QUIVER MONITORING</p>	<p>Vibration Monitoring Layout 558 Sackett Street, Brooklyn Brooklyn NY 11215</p>	<p>Date of Installation MM/DD/YY 06/24/24</p>
---	---	---

Quiver Monitoring recommends the following vibration monitoring layout.

1. **UM17486:** Is installed at the 564 Sackett Street Exterior, front.
2. **UM17502:** Is installed at the 563 Union Street Exterior.
3. **UM22524:** Is installed at the 564 Sackett Street Exterior, rear.

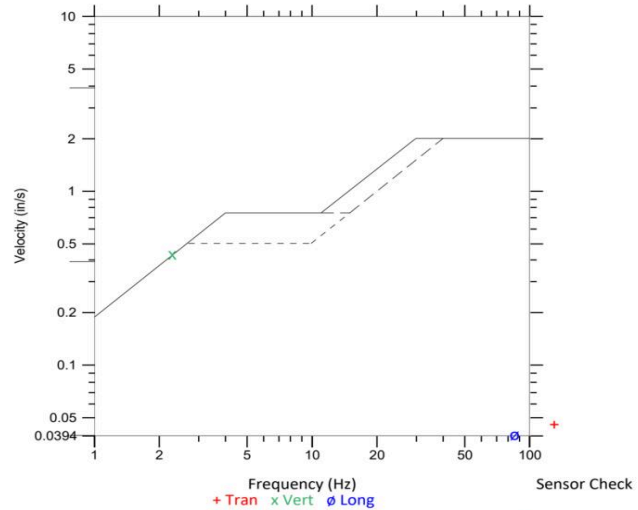
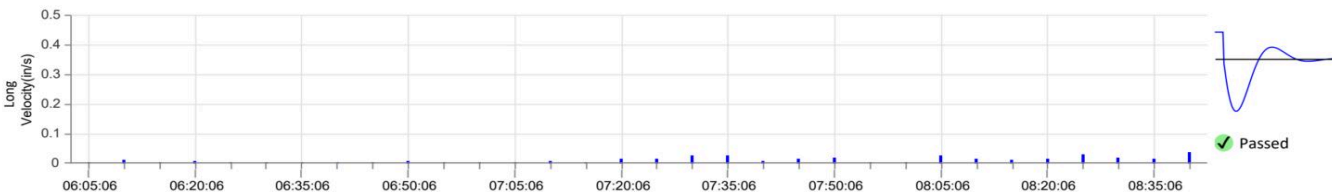
USBM R18507 And OSMRE Velocity versus Frequency (Zero Crossing)

- Daily vibration monitoring data appended to this report.
 - A first peak vector sum of 0.4373 in/s was observed at 8:40:06 on July 24. There was no site activity at that time.

- A second peak vector sum of 3.2194 in/s was observed at 11:21:57 on July 24. There was no site activity at that time.

Peak Vector Sum 0.4373 in/s at July 24, 2024 08:40:06

Start July 24, 2024 08:36:57
Finish July 24, 2024 11:21:23
Number of Intervals/Interval 32.89/300 sec
Sample Rate 1024 sps
Setup File Name 558 Sackett Street S1.mmb
Operator Quiver League

Geophone	Tran	Vert	Long
Peak Particle Velocity	1.8224 in/s	2.6389 in/s	1.6121 in/s
Zero Crossing Frequency	17.1 Hz	1.8 Hz	1.8 Hz
Date	Jul 24, 2024	Jul 24, 2024	Jul 24, 2024
Time	11:21:23	11:21:23	11:21:23
Sensor Check	✘ Check	✔ Passed	✔ Passed
Frequency	1024.0 Hz	7.5 Hz	7.3 Hz
Overswing Ratio	0.0	4.5	4.2
Peak Vector Sum	3.2194 in/s at July 24, 2024 11:21:57

Extended Note IF VIBRATIONS REACH 0.25 IN/S ALERT THE CONSTRUCTION MANAGER AND ENGINEER. IF VIBRATIONS EXCEEDED 0.50 IN/S STOP ALL VIBRATION PRODUCING ACTIVITIES AND NOTIFY THE CONSTRUCTION MANAGER AND ENGINEER. FOLLOW UP WITH OPTICAL AND CRACK GAUGE MONITORS AND SUBMIT ALL RESULTS TO THE PROJECT ENGINEER. WORK SHALL RESUME WHEN APPROVED BY CONSTRUCTION MANAGER AND ENGINEER.

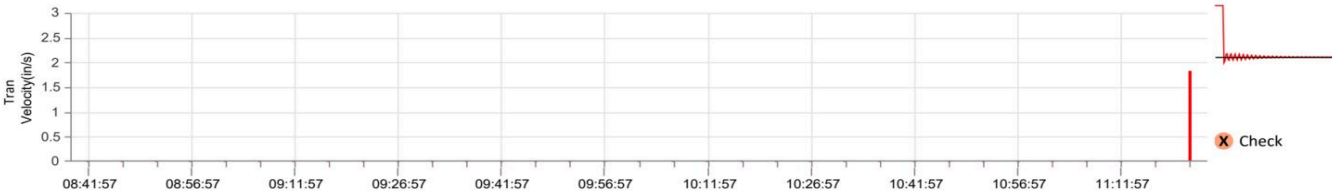
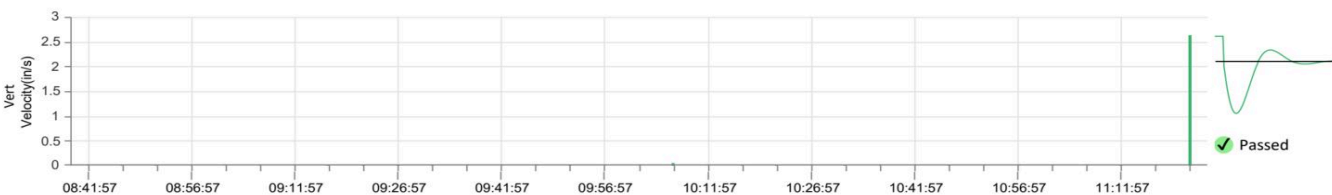
Start July 24, 2024 11:21:57
Finish July 24, 2024 17:51:43
Number of Intervals/Interval 77.96/300 sec
Sample Rate 1024 sps
Setup File Name 558 Sackett Street S1.mmb
Operator Quiver League

Geophone	Tran	Vert	Long
Peak Particle Velocity	<0.005 in/s	0.0645 in/s	0.0574 in/s
Zero Crossing Frequency	N/A	3.1 Hz	10.7 Hz
Date	Jul 24, 2024	Jul 24, 2024	Jul 24, 2024
Time	11:26:57	16:16:57	15:06:57
Sensor Check	✘ Check	✔ Passed	✔ Passed
Frequency	1024.0 Hz	7.3 Hz	7.3 Hz
Overswing Ratio	0.0	4.5	4.2
Peak Vector Sum	0.0645 in/s at July 24, 2024 16:16:57

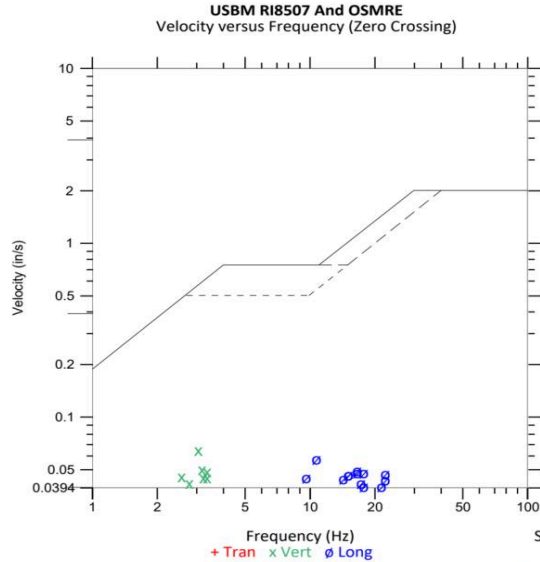
Start July 24, 2024 18:08:51
Finish July 24, 2024 19:59:59
Number of Intervals/Interval 22.23/300 sec
Sample Rate 1024 sps
Setup File Name 558 Sackett Street S1.mmb
Operator Quiver League

Serial Number UM22524
Model Number Micromate ISEE 11.0AK
Battery Level 3.8 volts
Unit Calibration December 22, 2023 by Instatel
Event File Name UM22524_20240724180851.IDFH
USB Sensor Support Disabled

Geophone	Tran	Vert	Long
Peak Particle Velocity	<0.005 in/s	<0.005 in/s	0.0062 in/s
Zero Crossing Frequency	5.4 Hz	10.2 Hz	9.0 Hz
Date	Jul 24, 2024	Jul 24, 2024	Jul 24, 2024
Time	19:48:51	19:48:51	19:48:51
Sensor Check	✓ Passed	✓ Passed	✓ Passed
Frequency	7.3 Hz	7.5 Hz	7.3 Hz
Overswing Ratio	4.5	4.4	4.1
Peak Vector Sum	0.0064 in/s at July 24, 2024 19:48:51

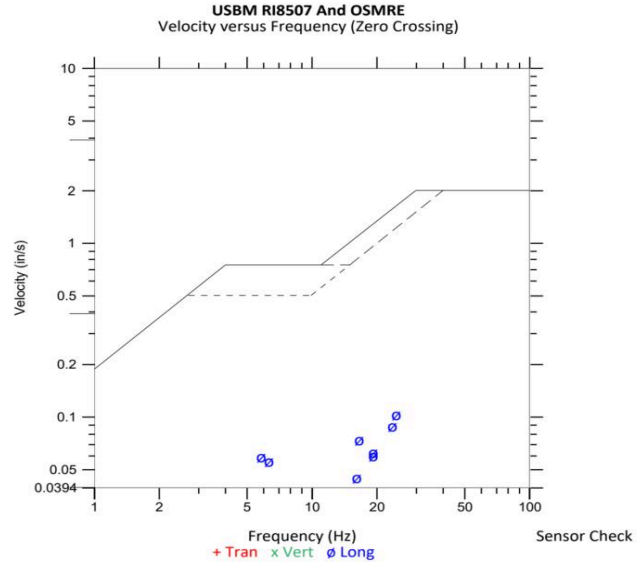
Start July 25, 2024 06:00:05
Finish July 25, 2024 13:28:14
Number of Intervals/Interval 89.63/300 sec
Sample Rate 1024 sps
Setup File Name 558 Sackett Street S2.mmb
Operator Quiver League

Geophone	Tran	Vert	Long
Peak Particle Velocity	0.0388 in/s	0.0400 in/s	0.1341 in/s
Zero Crossing Frequency	19.0 Hz	20.5 Hz	36.6 Hz
Date	Jul 25, 2024	Jul 25, 2024	Jul 25, 2024
Time	13:00:05	12:40:05	12:25:05
Sensor Check	✓ Passed	✓ Passed	✓ Passed
Frequency	7.5 Hz	7.3 Hz	7.3 Hz
Overswing Ratio	4.5	4.7	4.9
Peak Vector Sum	0.1344 in/s at July 25, 2024 12:25:05

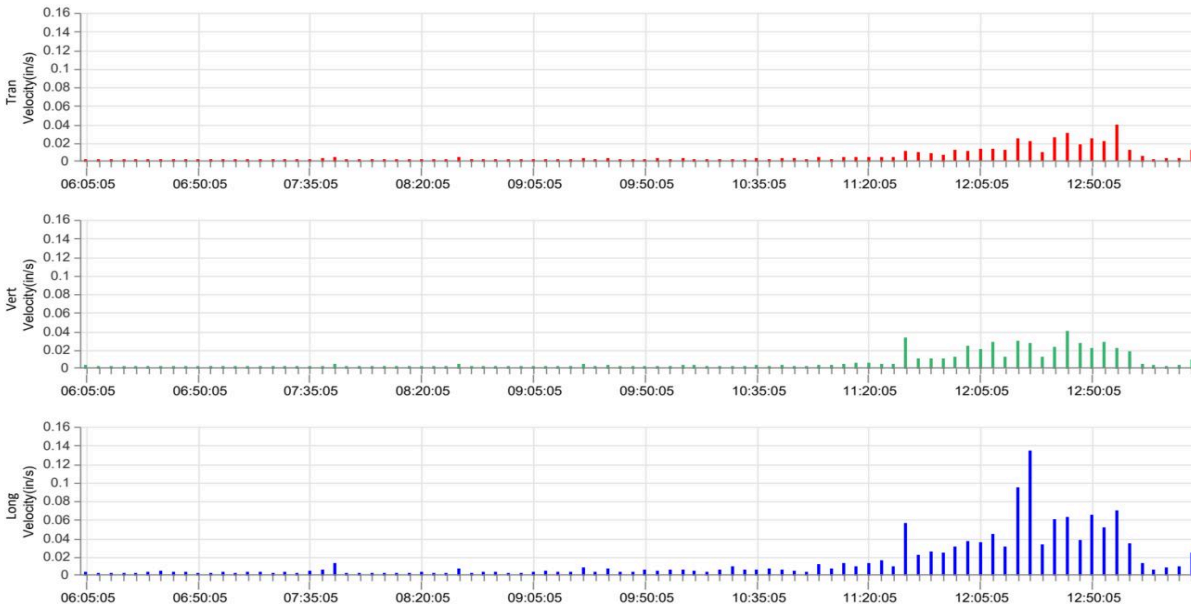
UM17486

Geophone	Tran	Vert	Long
Peak Particle Velocity	0.0183 in/s	0.0580 in/s	0.0723 in/s
Zero Crossing Frequency	13.5 Hz	10.9 Hz	>100 Hz
Date	Jul 24, 2024	Jul 24, 2024	Jul 24, 2024
Time	13:50:06	14:10:06	09:25:06
Sensor Check	✓ Passed	✓ Passed	✓ Passed
Frequency	7.5 Hz	7.7 Hz	7.3 Hz
Overswing Ratio	4.0	3.7	4.2

Peak Vector Sum 0.0725 in/s at July 24, 2024 09:25:06
