Project	Former A&A Brake Service Site	Report No.	23
BCP Site	NYSDEC BCP SITE C224372	Date	7/26/2024
Location	558 Sackett Street	File No.	0206384
Client	Sackett Heights LLC	Temperature	H: 86 L: 70
Contractor	Blue Sky Builders	Wind Direction	N to S 4 mph
Weather	Clear	Personnel on Site	G. Poulton
Humidity	38%	Time on Site	6:30 am to 4:45 pm

H & A of New York Engineering and Geology, LLP (Haley & Aldrich) was present document implementation of the May 2024 NYSDEC-Approved Remedial Action Work Plan (RAWP) and Decision Document for the Former A&A Brake Service Site C224372, located at 558 Sackett Street, Brooklyn, NY. Site observations are summarized below.

WEEKLY MONITORING REPORT

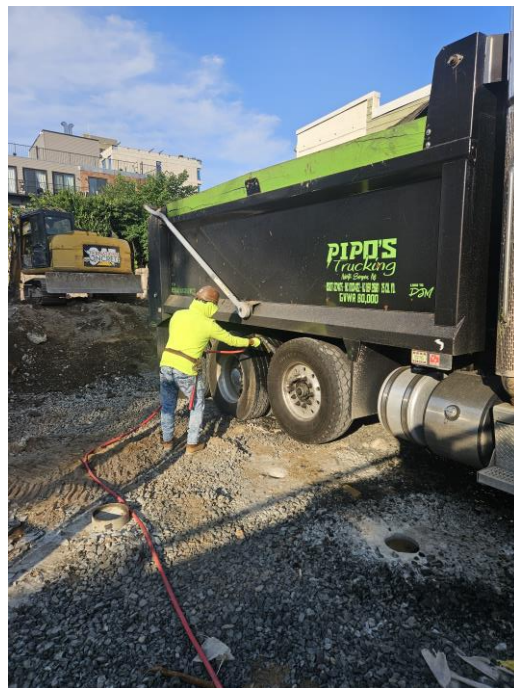
Photo 2: View of laborer cleaning truck undercarriage prior to departure, facing Southwest.

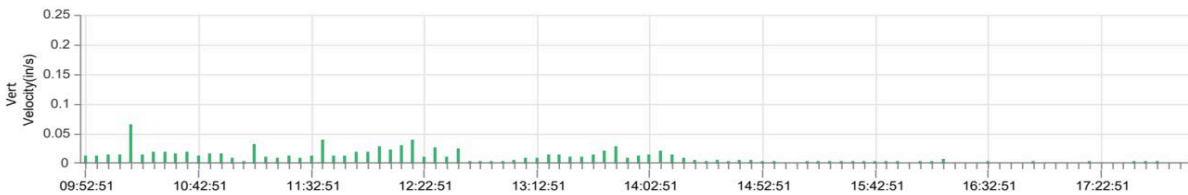
Geophone	Tran	Vert	Long
Peak Particle Velocity	0.1725 in/s	0.0652 in/s	0.1890 in/s
Zero Crossing Frequency	>100 Hz	9.5 Hz	26.9 Hz
Date	Jul 26, 2024	Jul 26, 2024	Jul 26, 2024
Time	12:02:51	10:12:51	12:17:51
Sensor Check	✓ Passed	✓ Passed	✓ Passed
Frequency	7.5 Hz	7.7 Hz	7.3 Hz
Overswing Ratio	4.0	3.7	4.2
Peak Vector Sum	0.2343 in/s at July 26, 2024 12:02:51

Start July 26, 2024 18:00:47
Finish July 26, 2024 19:59:59
Number of Intervals/Interval 23.84/300 sec
Sample Rate 1024 sps
Setup File Name 558 Sackett Street S4.mmb
Operator Quiver League
